GUIDELINES FOR RELIABLE EXTENSION OF TURBINE BLADE LIFE

Joseph Liburdi

James Wilson

Liburdi Engineering Limited

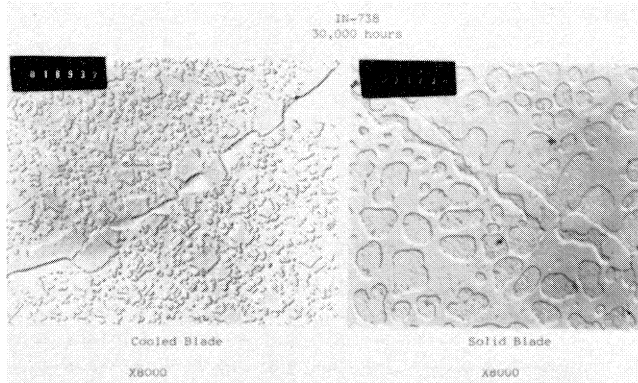
approximately 30,000 hours of service, exhibited radically different results, depending on the engine and application [4]. In one case, as illustrated in Figure 1, the material was found to be stable and virtually unaltered; whereas, in a different application, the metal temperatures were probably higher, and the structure was severely overaged, resulting in premature creep failure.

Figure 1. Electron Microscope Replicas of the Microstructures Exhibited by Two In738 Blades After Approximately 30,000 Hours of Service in Different Engines. The Structure on the Left, from a Cooled Blade, is Virtually Unaltered; Whereas, the Microstructure on the Right, from an Uncooled Blade Which Was Probably Exposed to Higher Metal Temperatures, Is Severely Overaged and Failed in Creep. Original Magnification $\times 8,000$.

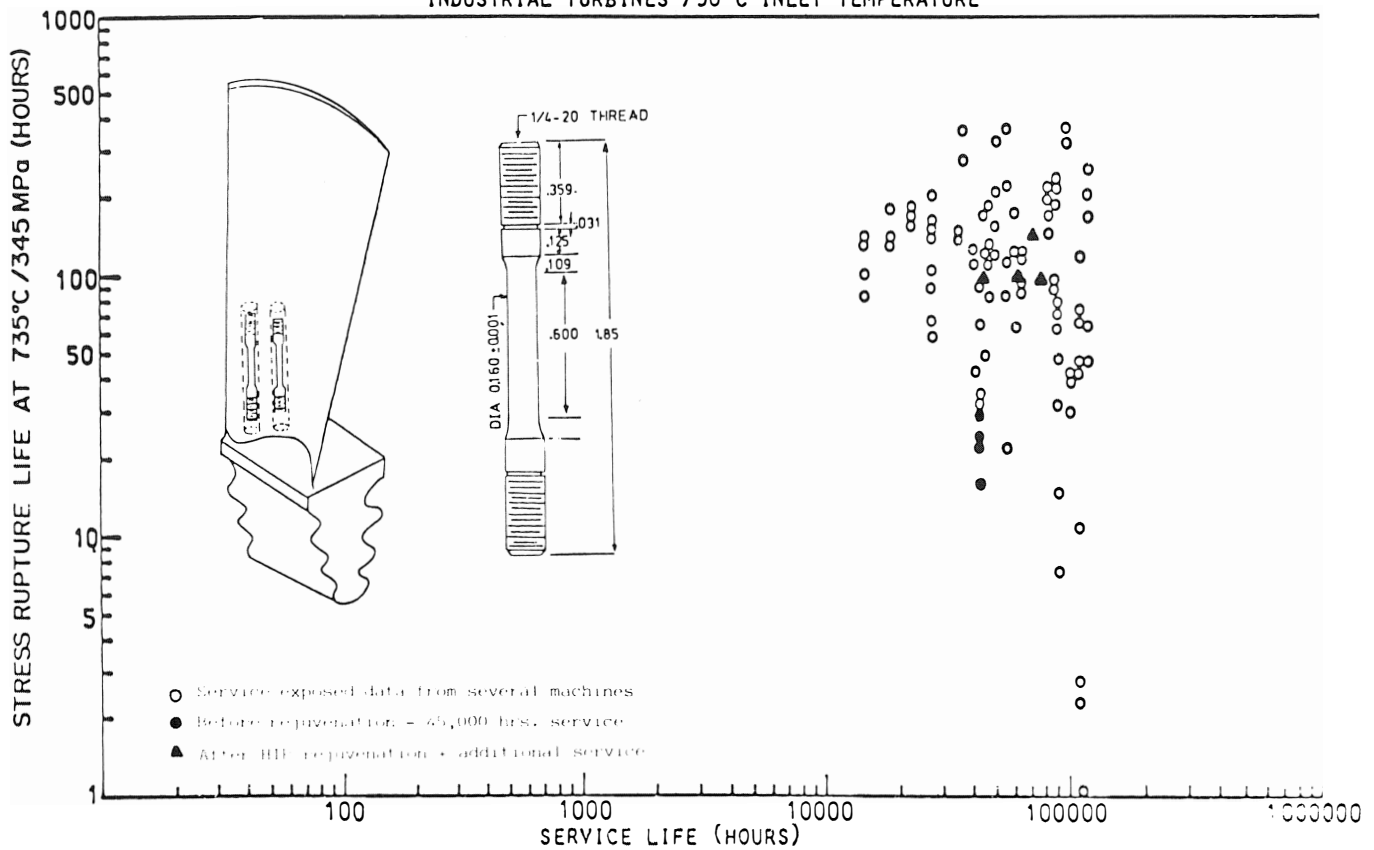
The usefulness of a life trend plot can be best illustrated for the Inconel X-750 family of blades shown in Figure 2. These are uncooled, solid blades which are relatively easy to test.

The blades in question were removed from service in 1977, after approximately 45,000 hours of service. As indicated by the life trend curve, they had not yet reached their critical creep life, but because the properties fell below the specified minimum level, it was decided to rejuvenate the blades at this time. Subsequent investigations [3, 5] revealed that the premature decrease in life was probably due to a slightly weaker chemistry, and possibly original heat treatment. As noted in the original paper [1], conventional reheat treatment was not capable of fully restoring the properties, and superior results were obtained by adding hot isostatic pressing to the recovery cycle.

Figure 2. Life Trend Curve for Inconel X-750 Blades, Highlighting the Properties Exhibited by the W62 Row 3 Blades Before and After Rejuvenation.

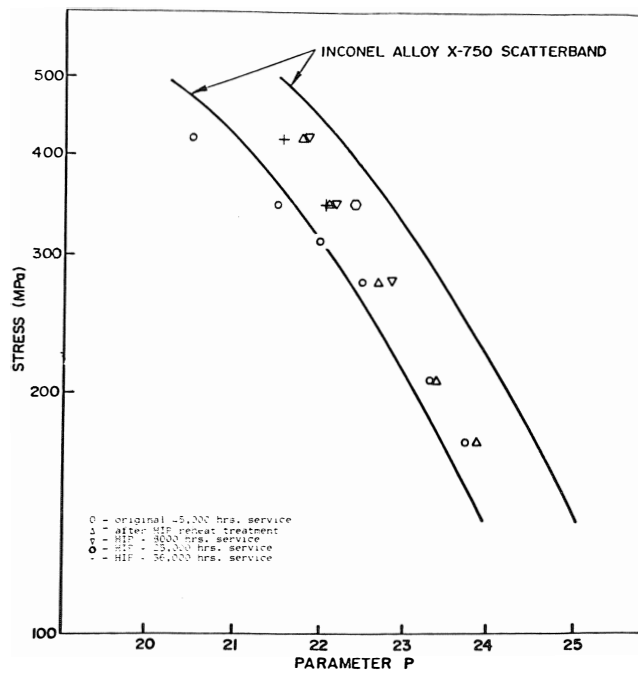
The results of stress rupture tests taken from the blade airfoil are illustrated in Figures 2 and 3. The graphs clearly illustrate that the mechanical properties have remained stable and the blades are suitable for continued service.

Figure 3. Larson-Miller Plot ($P = T \times 10^{-3} (20 + \log t)$, T in $^{\circ}K$, t in Hours) Showing Original Service Exposed and HIP Processed Blade Stress Rupture Properties. After HIP the Blades Were Returned to Service and Monitored Periodically for Remaining Life.

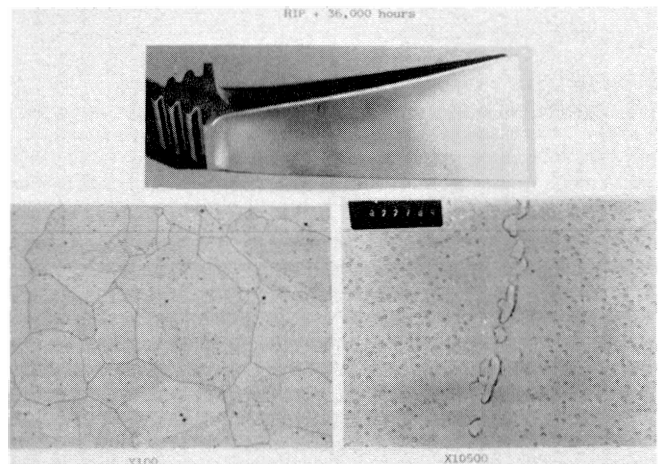
The microstructural analysis shown in Figure 4 confirms that the alloy is behaving in a stable manner. The structure is typical of Inconel X-750 and shows little or no sign of overaging.

Figure 4. Photographs of the HIP Reheat Treated Inconel X-750 Blade After an Additional 36,000 Hours' Service. The Microstructure Is Virtually Unchanged, With Only Slight Grain Boundary Carbide Coarsening Evident.

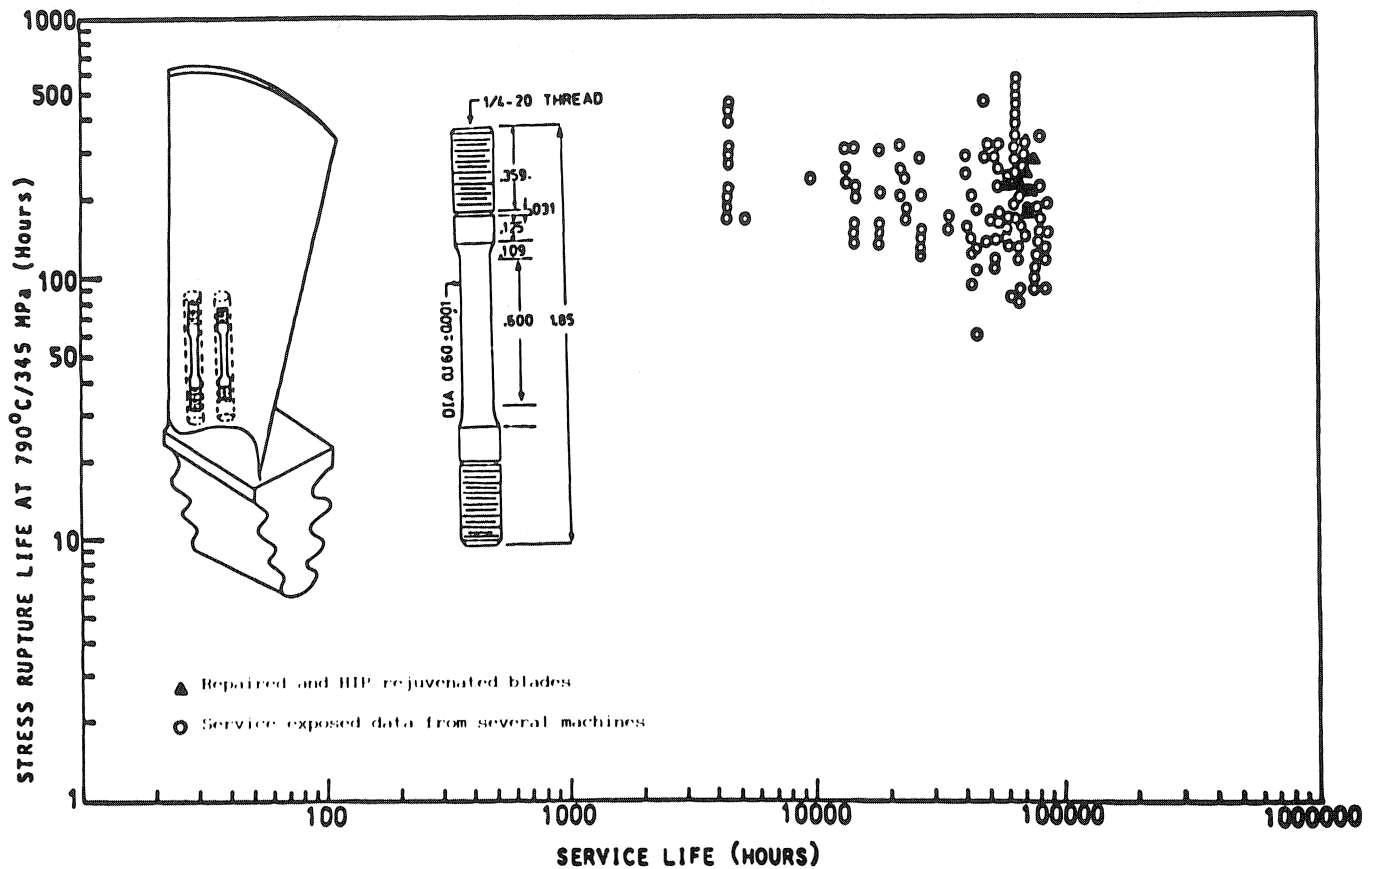
In contrast, Inconel 700 blades from the same engines exhibit virtually no creep damage after approximately 100,000 hours of service (Figure 5). However, blades are often rejected because of foreign object damage, tip rubs or hot corrosion. In the past, these damaged blades could not be weld repaired or coated because they did not respond well to reheat treatment [6].

The stress rupture results after HIP rejuvenation, shown in Figure 5, are consistent with new material properties, and the ductility was restored to the required levels. The microstructure illustrated in Figure 6 is typical of new Inconel 700, with no detrimental acicular phases evident.

Figure 5. Life Trend Curve for Inconel 700 Blades, Showing the Effectiveness of the HIP Reheat Treatment Process on Repaired Blades.

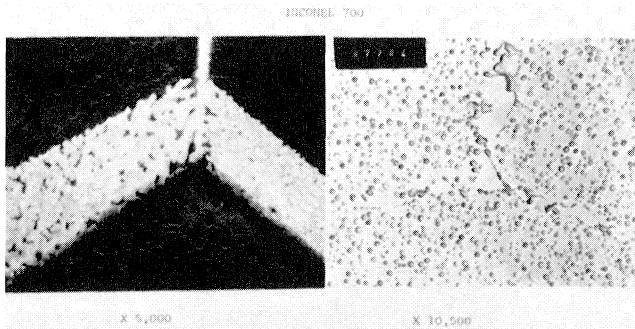
Figure 6. Photographs Illustrating the Structure of the Inconel 700 Blades After HIP Reheat Treatment. The Photograph on the Left Shows the Grain Boundary Carbide Network, While the Replica on the Right Shows the Strengthening Gamma Prime Particles.

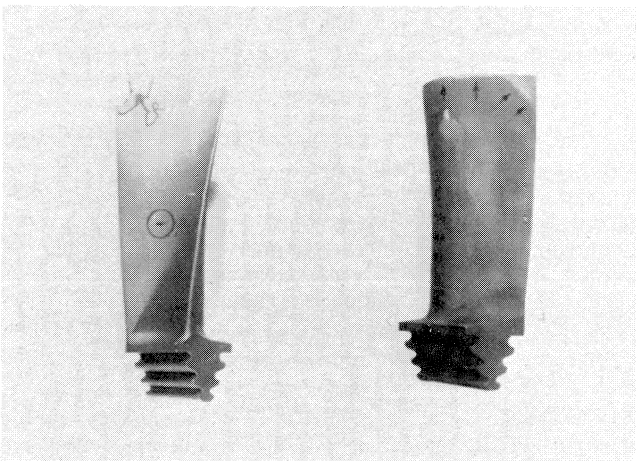
As indicated previously, the majority of the repairs performed to date have been accomplished using weaker weld filler materials such as Inconel 625 and, therefore, limited to the lower stressed portions of the airfoil. An analysis of a typical stress pattern for a free-standing blade, as shown in Figure 7, indicates that the margin of allowable stress over actual net section stress is greatest at the tip. This feature permits the use of lower strength welding materials close to the blade tip and accounts for the relative success enjoyed by such repairs. For example, Figure 8 shows a typical tip repair on an Inconel 700 blade using Inconel 625 weld metal.

Figure 8. Photographs of a Service Damaged Inconel 700 Turbine Blade Before and After Weld Repair. Inconel 625 Filler Metal Was Used for Repairs Close to the Blade Tip Where the Stresses Are Low. Note That the Trailing Edge Repair Is Opened to the Tip to Minimize the Effect of Thermal Strains Resulting from the Different Coefficients of Expansion.

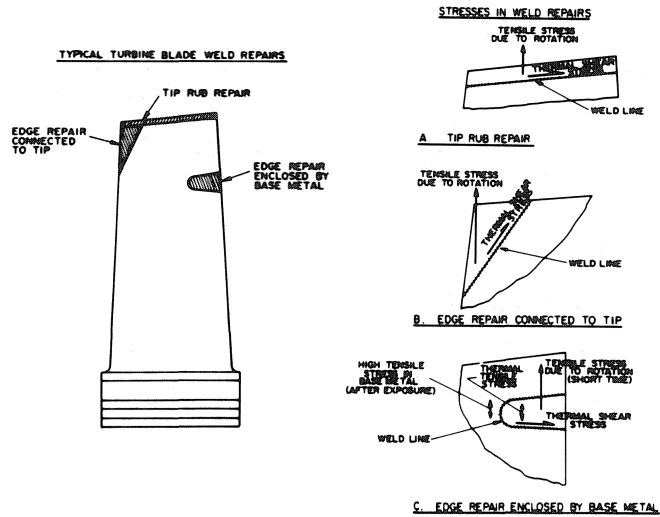
Figure 9. Diagrams Illustrating the Geometry of Typical Airfoil Weld Repairs, Along With a Summary of the Principal Stresses Due to Centrifugal Loading and Thermal Strains. In the Case of the Enclosed Notch, Differences in Coefficient of Expansion Will Result in Additive Tensile Stresses at the Tip of the Notch. Also, With Time, the Weaker Filler Metal Will Creep or Relax and Lose Its Load Carrying Ability.

In addition to the overall stress distribution, one must also consider the stress patterns associated with the various geometries or weld preparations used. The diagrams shown in Figure 9 illustrate the principal stresses along the weld interface arising from both centrifugal loading and differences in thermal expansion characteristics. The analysis indicates that, for tip- and edge-connected welds, the thermal shear stresses can be accommodated along the weld interface. However, care must be exercised when the weld repair geometry approximates a notch in the edge of the airfoil.

The notch repair can cause local high stresses due to material property differences between the weld and base metals. For instance, if the weld metal has a lower coefficient of thermal expansion than the base metal, the weld will be loaded in tension when the blade temperature rises during operation. Also, as the weld metal generally will have lower creep strength than the base metal, it will relax in service, and most of the load on the section will be transferred to the base material. The net effect can be that the weld metal carries almost no load and the repaired notch acts as a stress concentration.

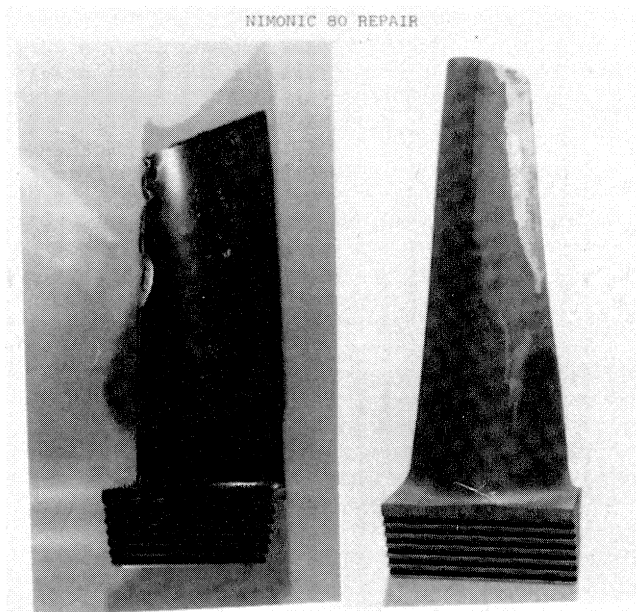
An example of the application of high strength welding is shown in Figure 11. These Nimonic 80 turbine blades had suffered extensive foreign object damage, which extended into the highly stressed areas of the leading edge and required the use of a matching filler metal. Inconel X-750 welding wire was chosen because of its availability and close match to the base material chemistry. The blades were HIP reheat treated after welding and tested for stress rupture properties. Favourable results, exceeding the new material requirements, were obtained from both the weld metal and the base material.

Figure 11. Photographs of a Nimonic 80 Service Damaged Blade Before and After High Strength Weld Repair. The Damage Extended into Highly Stressed Areas of the Leading Edge, and a Stronger Load Carrying Weld Material, Such as Inconel X-750, Was Required.

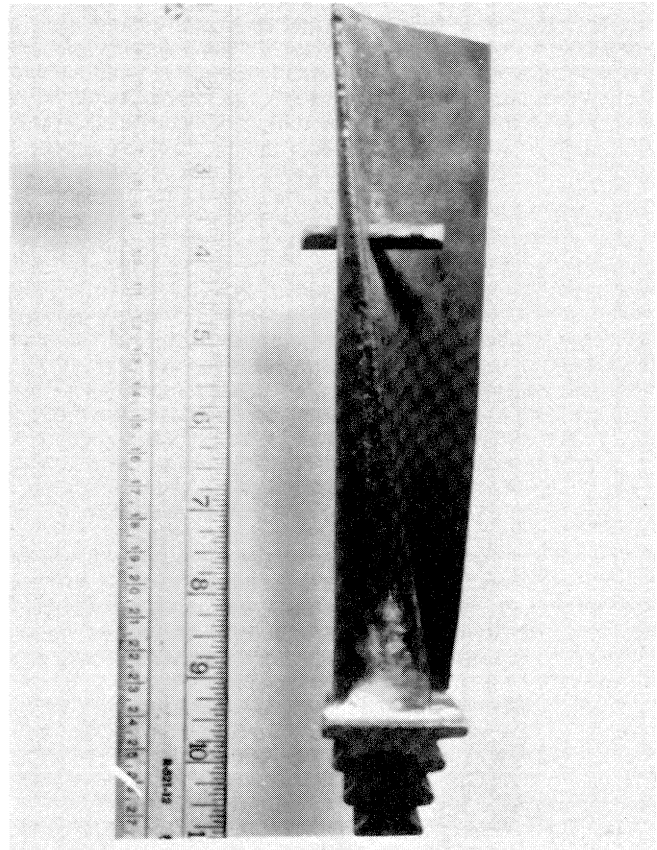
Another critical area which requires special attention is the repair of a blade lashing wire hole. Lashing wires are used on turbine stages to modify blade frequencies and to provide damping in order to avoid fatigue failures (Figure 12). The use of lashing wires creates a unique problem because the presence of the hole in the airfoil, combined with the centrifugal load of the wire, produces high local stresses. Premature creep rupture damage can occur near the hole, and corrosion and wear can make a repair necessary.

Figure 12. Photograph Showing an A286 Turbine Blade With Lashing Wire Still in Place. Lashing Wires Cause High Local Stresses in the Airfoil at the Hole, and Their Repair Requires Special Attention.

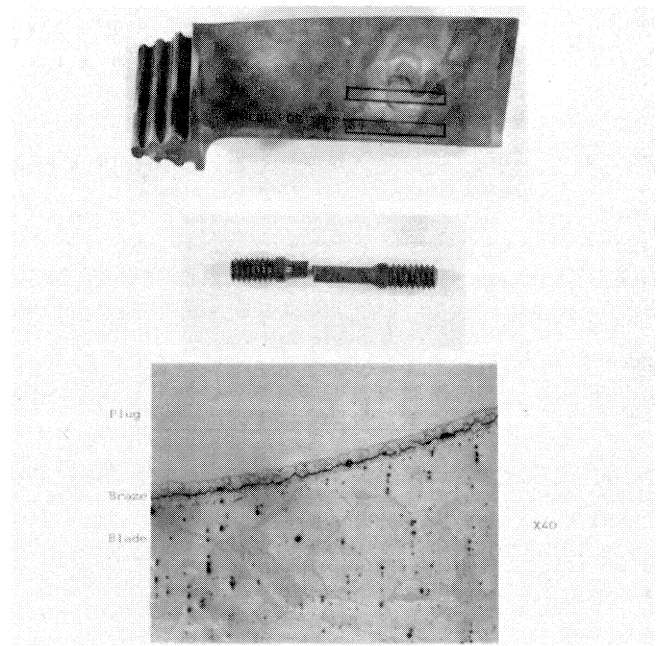
A common repair technique is to braze a bushing into the oversize hole. However, an evaluation of the strength of the braze repair, as shown in Figure 13, indicates that the interface does not have the necessary creep strength. Stress rupture samples taken through the brazed plug failed prematurely on loading along the weak braze interface.

Figure 13. Photographs of the Failed Stress Rupture Sample Taken Through the Brazed Plug, Illustrating the Intergranular Failure Through the Braze Metal. The Braze Showed Much Lower Strength Than the Base Metal and Therefore Would Not Be Able to Adequately Transmit Load Across the Interface.

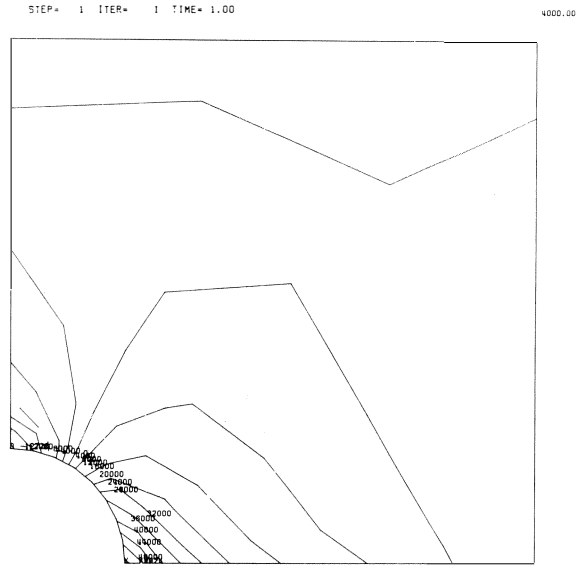
A plot of equivalent stress in the structure is shown in Figure 15. The analysis indicates that the peak stress is at the edge of the hole and is five times higher than the average section stress. This implies that optimum material properties are required at the surface of the hole to withstand the high local stresses.

Figure 15. Computer Plot of Principal Stress at the Lashing Wire Hole With Uniform Material Properties.

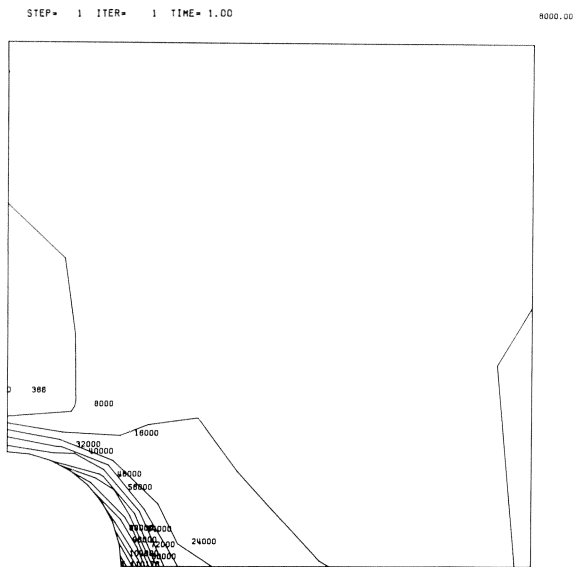
Next, we considered the case of possible repairs to the hole using dissimilar weld metals or braze. The material properties of the row of elements closest to the hole were changed to model the effect of a mismatched weld metal repair. The results, illustrated in Figure 16, indicate that even higher local stresses are induced by this geometry. The reduction in creep rupture life caused by this type of repair was then calculated, and the results are summarized in Table 2. Obviously, this is a critical area of the blade, and any repair procedure should approach the strength of the original blade alloy.

Figure 16. Computer Plot of Principal Stress at the Lashing Wire Hole Using Unmatched Weld Metal Properties Near the Hole. The Isostress Lines Show a Peak Stress of 110,000 psi in the Weld Metal at the Edge of the Hole.
