TURBINE ROTORS WHIRL AFTER DYNAMICALLY STABLE DESIGNS ARE UPRATED

Fred L. VanLaningham

Union Carbide Corporation

ABSTRACT

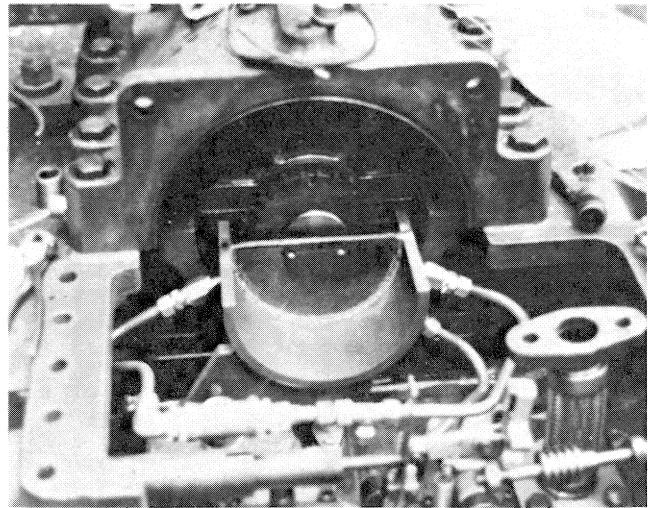
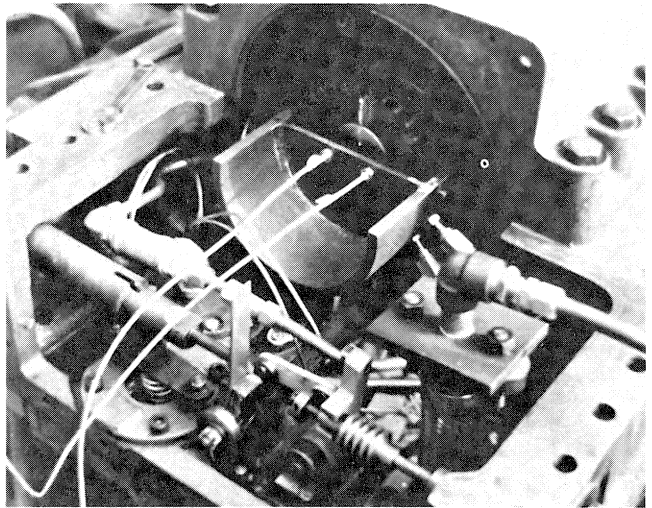
Figure 4. View of Steam End Bearing Housing Showing Shortened Rotor, Probe Mounting Bracket and Toothed Speed Wheel.

Figure 5. Probe Mounting Bracket with Magnetic Speed Pickup Probes Installed.

Figure 6. Probe Mounting Bracket with Axial Position Proximity Probes Installed.

For all three cases, reduce the amount of the overhung weight by shortening the coupling end and shorten the governor end of the rotor by removing the overspeed trip bolt and oil pump drive, and modify the trip system to a total electronic overspeed and governing system as shown in Figures 4, 5, and 6.

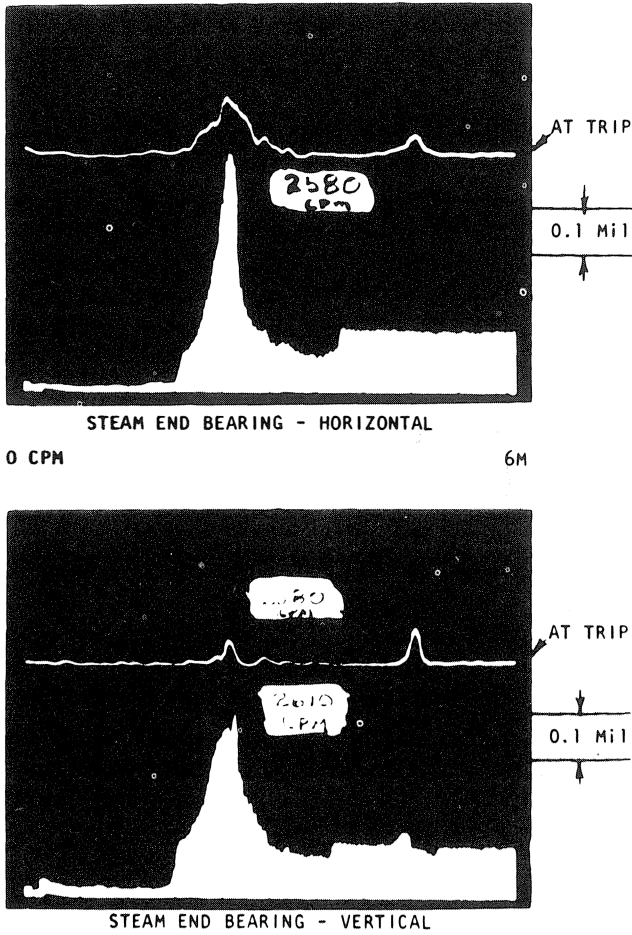
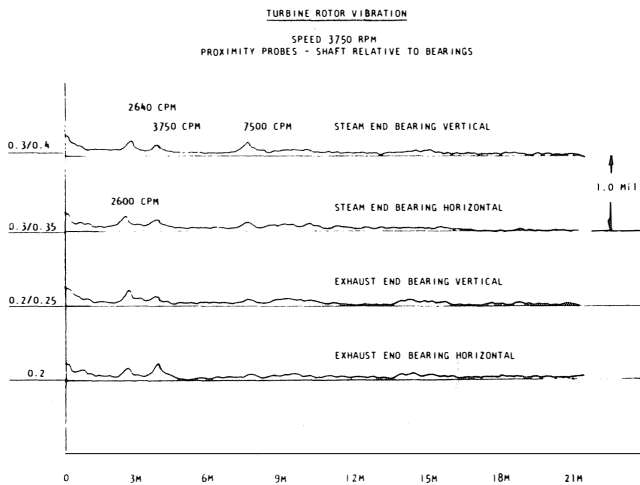
The first modified rotor was installed in the original machine that was field modified with the diaphragm coupling and started up. Vibration data were recorded on tape during the startup. The unit appeared to be extremely stable but, with the very low amount of residual unbalance in the rotor, we could see a certain amount of what we termed "inch worm" activity on the spectrum analyzer at the first critical speed of

the machine (Figures 8 and 9). This activity is present on all units; however, we do not see it as a vibration problem but as activity only, especially when at design speed the total amount of rotor vibration peak-to-peak double-amplitude is 3/10 of a mil. We continued with the modification of rotors to the larger shaft diameter, replacing the coupling with the diaphragm type, shortening the shaft, and installing the electronic overspeed trip system.

Figure 8. Photos of Real Time Analyzer Scope Face (Peak Hold) During Solo-Overspeed Check.

Figure 9. Plots of Frequency VS. Amplitude of Turbine Rotor Vibration, Coupled to Compressor Operating at Reduced Speed.
