# Failure Analysis of Power Devices Based on Real-Time Monitoring

著者	Watanabe A., Tsukuda M., Omura I.
journal or publication title	Microelectronics reliability
volume	55
number	9-10
page range	2032-2035
year	2015-07-17
URL	<a href="http://hdl.handle.net/10228/00006262">http://hdl.handle.net/10228/00006262</a>

A. Watanabe<sup>a, c\*</sup>, M. Tsukuda<sup>b, c</sup>, I. Omura<sup>a, c</sup>

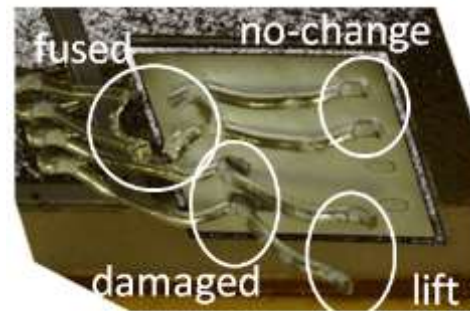
Fig. 3. Failed specimen diode after 4677 cycles. This photograph was flipped upside down to adjust orientation of following SAT images.

A failure occurred due to bond wire lift-off after 4677 power cycles (Fig. 3). Fig. 4 shows behavior of forward voltage  $V_F$  of the DUT at the power cycling test. Remarkable change of  $V_F$  was observed after 4300 cycles and in a few ten cycles just before the failure occurred. Fig. 5 shows a series of SAT images at the top of the diode chip, namely interface 4 in Fig. 2(b). Few bonding marks on the diode chip disappeared after 3500 cycles. This disappearance of the bonding marks in the SAT images was not caused by defocus during image acquisition because bonding marks on the IGBT chip, which placed on almost

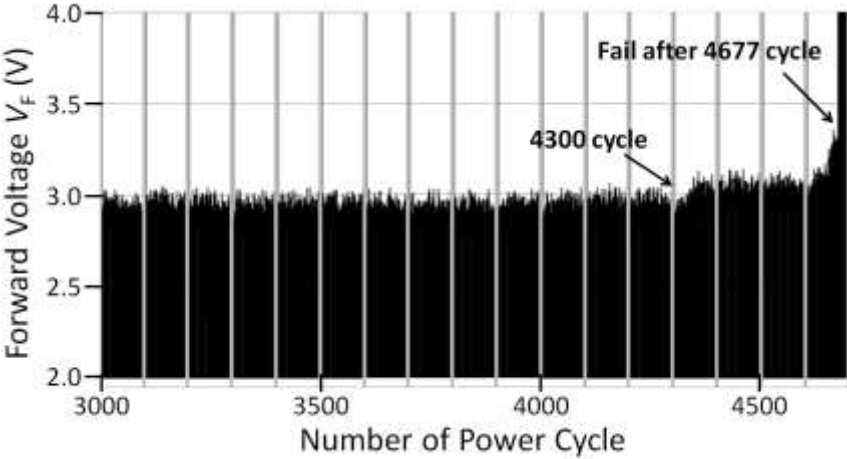
Fig. 4. Behavior of forward voltage  $V_F$  of the DUT at the power cycling test.

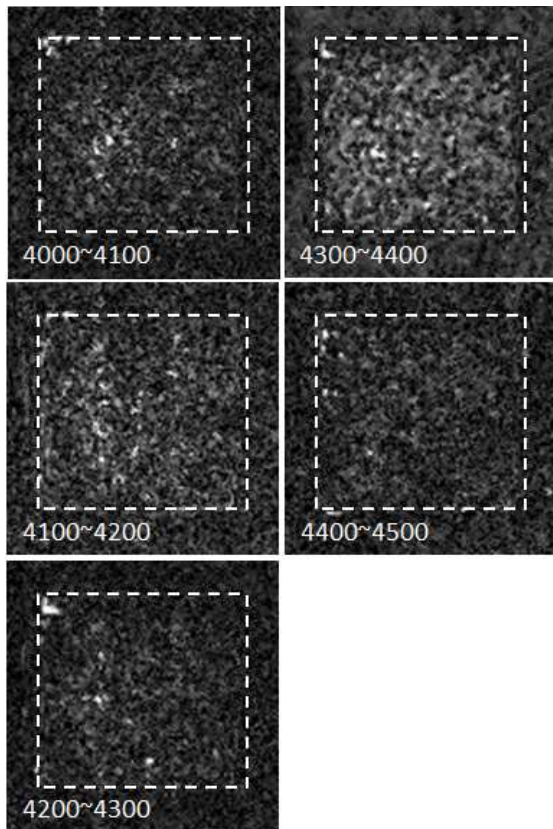
Fig. 6. Image change around 4300 cycle where the  $V_F$  change was observed. These images suggest that bonding condition was not affected in this period.

Fig. 5 also shows a series of subtract images. These images were obtained to subtract a former image from a latter one of a power cycling period. The subtract images illuminates changing point in the interface as high-grayscale value, namely bright pixel. The subtract images in Fig. 5 indicated that the bonding condition varied in the power-cycling period of 3000 ~ 4000 and 4600~failure. This result suggests that the bond lift-off at the lower right site of the chip took place and then the bond lift-off with anode metal damage occurred. The same technique was applied to the power cycling period of around 4300 where a remarkable change of  $V_F$  was observed. According to Fig. 6, the change of  $V_F$  was most likely caused by a degradation of the bonding wire itself (e.g. heel-crack) because there was no change at the bonding site on the chip.

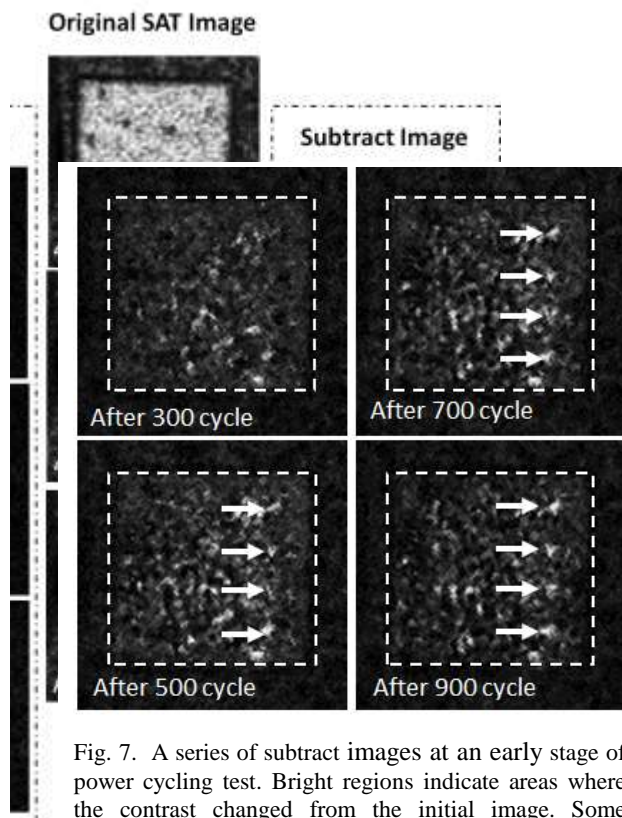
Fig. 7. A series of subtract images at an early stage of power cycling test. Bright regions indicate areas where the contrast changed from the initial image. Some bonding sites became brighter after 500 cycles. This result means that the bonding interface was affected in a very early stage of the failure process.

power cycling test, changing points become clearer. Fig. 7 shows subtract images obtained with the initial images. The bonding site became brighter after 500 cycles which means that the bonding interface was affected at a very early stage in the failure process. This finding can be obtained only by the time-domain analysis of the real-time monitoring on internal structure of DUT.
