Article

Failure Analysis of High Strength Galvanized Bolts Used in Steel Towers

Abstract: This paper analyses the failure of three bolts used in the structural connections of a number of steel towers located in northern Europe. The analysis comprises optical and scanning electron microscopy, microstructural and hardness analysis, mechanical testing and structural integrity assessments. The three bolts present very similar failure processes, with a circumferential external crack that led to the final failure. The morphology of the crack propagation is typical of Hydrogen-Induced Stress Corrosion Cracking (HISCC), with mixed intergranular-transgranular micromechanisms, tearing processes and secondary cracking. The cracks then grew subcritically until they reached their critical size. Quench cracking or fatigue processes have been ruled out.

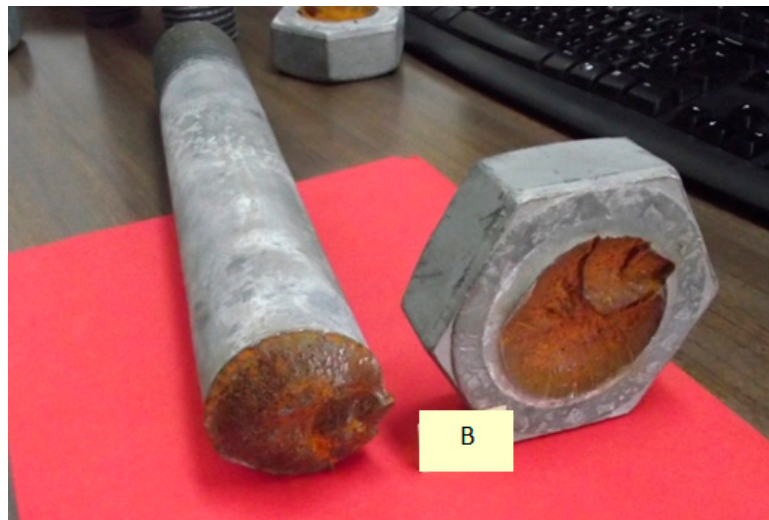
Figure 1. Bolt B at reception, showing the failure section.

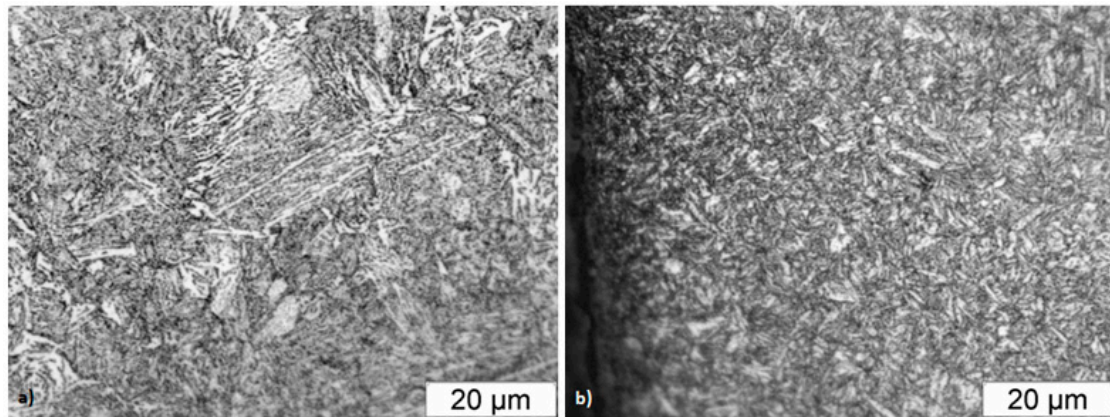
Samples 2.1 and 2.2 were polished and etched in 3% nital solution. The corresponding microstructures were obtained along a radius of Section 2. Figure 4 shows the results obtained in the centre (sample 2.1) and from the surface (sample 2.2) of Section 2. It can be observed that the centre of the section (Figure 4a) presents tempered martensite together with bainite, whereas the microstructure on the surface of the bolt is basically tempered martensite. This agrees with the material specification.

Figure 4. Microstructures observed in bolt A. (a) Centre of the section (sample 2.1); (b) sub-surface material (sample 2.2).

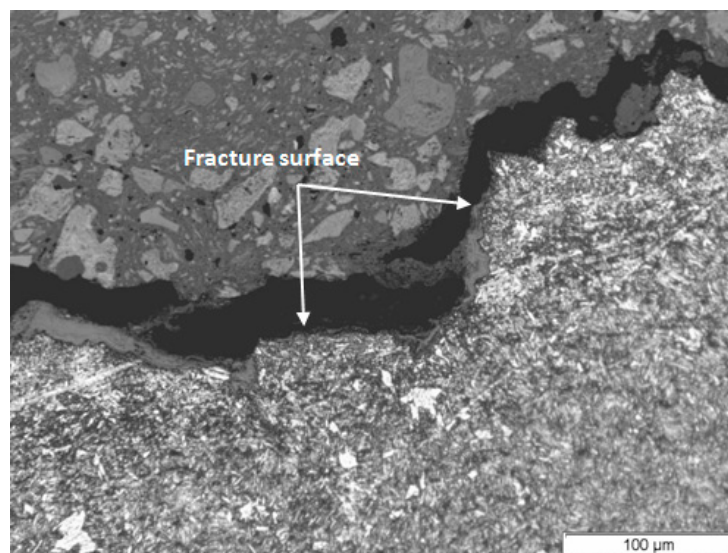
The heads of the three bolts were also cut (see Figure 5) into three sections (named 3, 4 and 5). Different samples were obtained from Section 4 in order to analyse the corresponding microstructure. This was analysed at different points (A to D, as shown in Figure 6). In all cases, tempered martensite was found to be the dominant microstructure, with bainite in the centre of the section (point D, see Figure 7).

Figure 7. Microstructure observed in the head of bolt A (sample 4.3, point D).

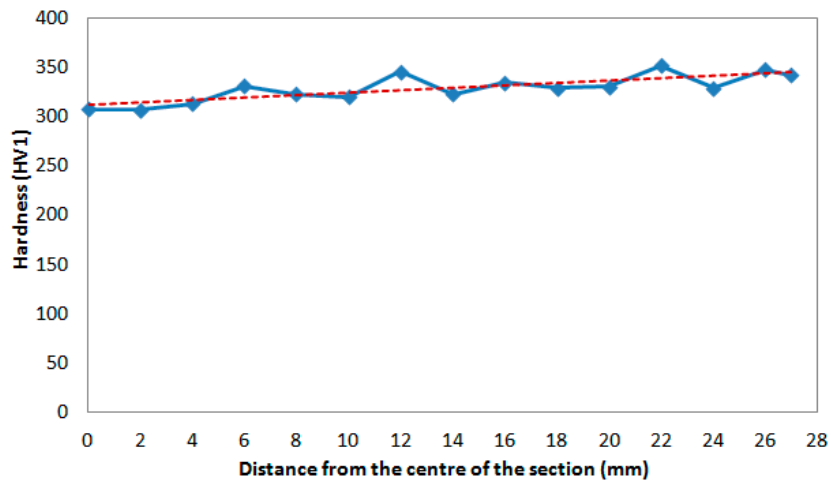
Figure 8. Hardness measurements along the radius of the bolt shank (bolt A). The dotted line shows the trend line.

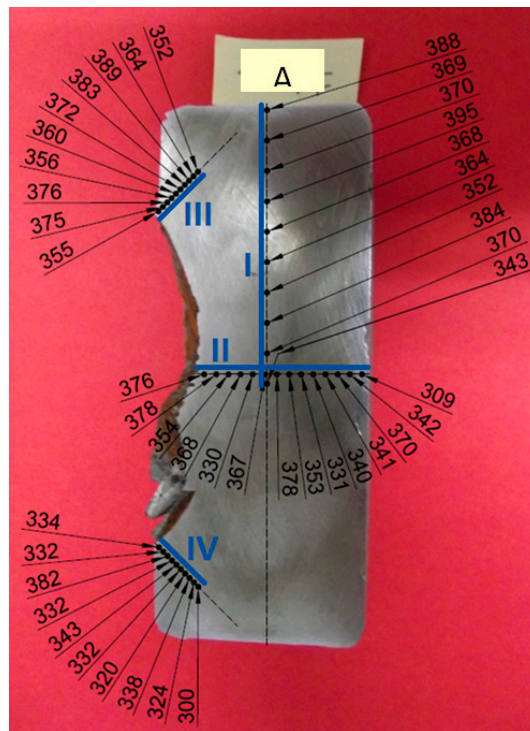
Figure 9. Hardness measurements (HV1) in the bolt head (bolt A).

The results reveal an average hardness value between 350 and 370 HV1 in paths I, II and III, and slightly lower than 350 in path IV. In any case, the hardness values observed in the bolt head are higher than those measured along the radius of the bolt shank (which vary from 300 HV1 up to 350 HV1).

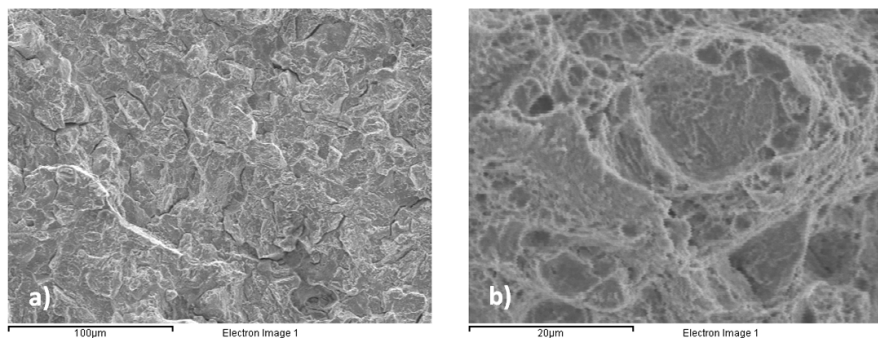
The fracture surfaces of the three bolts were analysed in a Scanning Electron Microscope (SEM). Images were taken from different areas of the fracture surfaces, as shown in Figure 2b (points “a” to “e”) for bolt A. The most significant observations are shown in Figure 10: the perimeter of the section (i.e., points “a”, “b”, and “c”) presented a mixed fracture surface combined with a predominant intergranular fracture with transgranular tearing and secondary cracking (Figure 10a). This confirms a subcritical crack propagation process prior to final fracture; the inner part of the fracture surface (i.e., points “d” and “e”) reveals a ductile fracture with multiple microvoids, corresponding to the remnant ligament of the section at failure.

**Figure 10.** Fracture surface of bolt A. (a) Point “b”; (b) point “d”.

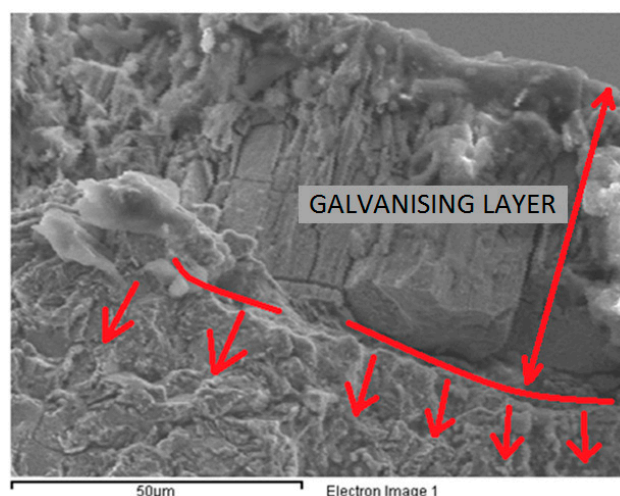
Figure 11, taken at point “c”, shows the galvanising layer with an important presence of cracks. Cracks are also observed in the interface between the galvanising layer and the base material of the bolt, with multiple initiation points.

**Figure 11.** Zone “c” of the fracture surface, showing subcritical crack growth starting at the interface between the base material and the galvanising layer.

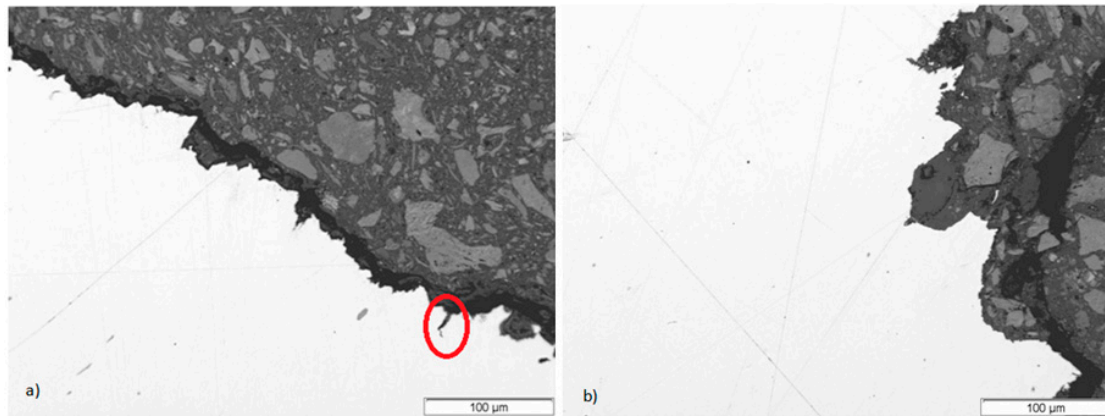
The profile of the fracture surface was also analysed using optical microscopy. As an example, Figure 12 shows some significant results. Figure 12a corresponds to an area located in the external perimeter, near point “b”. A brittle aspect with secondary cracks emerging from the primary quasi-plane crack path can be observed, proof of the HISSC mechanism; Figure 12b corresponds to an area around point “d”, revealing a much more ductile behaviour.

Figure 12. Profile of the fracture surface in bolt A: (a) Brittle aspect of the external perimeter (the red circumference shows secondary cracking); (b) ductile aspect of the inner area.

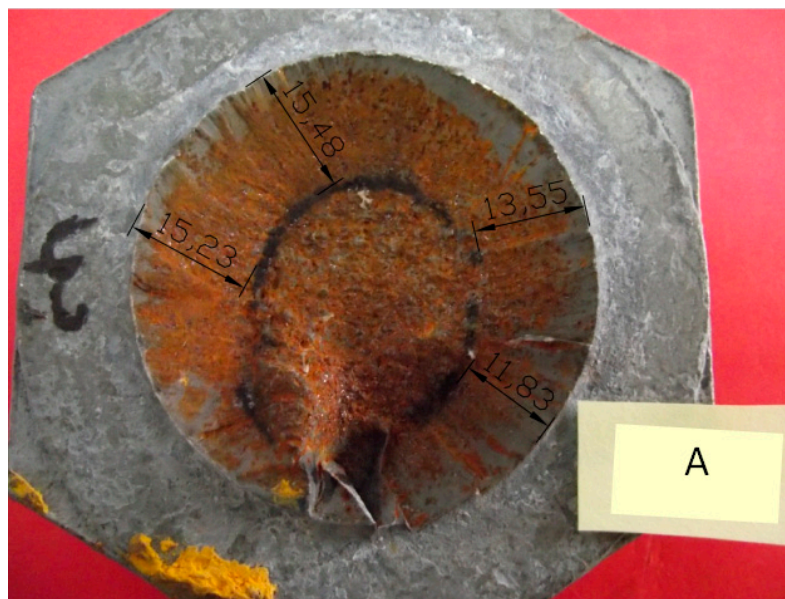
Figure 13. Approximate measurement of the external perimeter. Bolt A.

Concerning the crack size, the results shown above (at both the macro- and microscopical levels) reveal that the fracture surfaces present two distinct zones: an external smooth perimeter corresponding to a mixed fracture surface combining a predominant intergranular fracture with transgranular tearing, and an internal area with a clear presence of ductile micromechanisms. The external perimeter seems to correspond to subcritical crack propagation prior to final failure, and it has been macroscopically marked out in the three bolts, as shown in Figure 14 for the particular case of bolt A. The extension (thickness) of this perimeter, corresponding to the crack size at failure, generally varies between 11.5 mm and 16.5 mm, although it may be punctually lower.

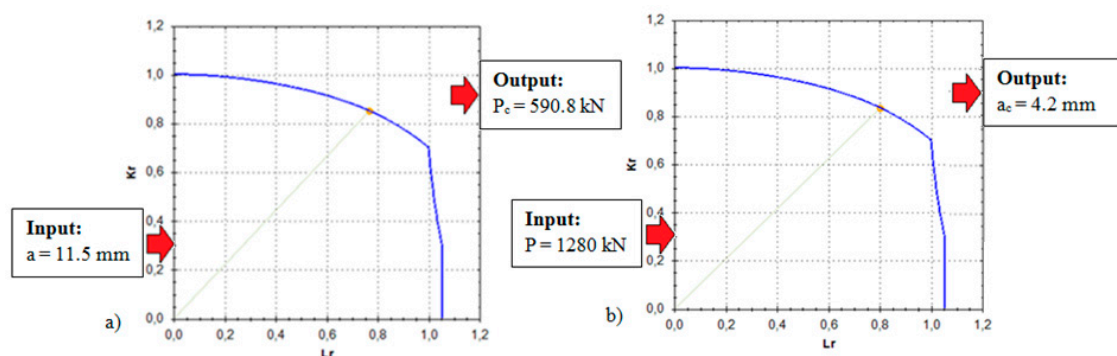
Figure 16 shows the corresponding results obtained for analysis Option 1 [19,20], which defines the FAL from both the yield stress and the ultimate tensile strength of the material (Equations (4)–(9)). In the first analysis (Figure 16a), the critical load is 5908 kN, which is noticeably lower than the applied preload. This discards that the notion that the external smooth area found in the fracture section corresponds to a pre-existing crack (e.g., quench cracking), given that, in such a case, the application of the preload (1280 kN) would have caused the failure of the bolts. The discarding of quench cracking is also supported by the lack of zinc deposits in the surface of the pre-existing cracks.

Figure 16. FAD analysis of the bolts: (a) critical load (P_c) for a 11.5 mm crack size (a); (b) critical crack size (a_c) for a 1280 kN load (P).

The second analysis (Figure 16b) provides a critical defect of 4.2 mm. This corresponds to the maximum crack size in the bolts during the application of the preload (larger cracks would also have caused failure).
