White Paper Report

Implementing Sustainability Strategies for the Abbe Museum's Collections Environment

Grantee Institution: Abbe Museum

## **BUILDING AIR-BARRIER EVALUATION REPORT—ABBE MUSEUM**

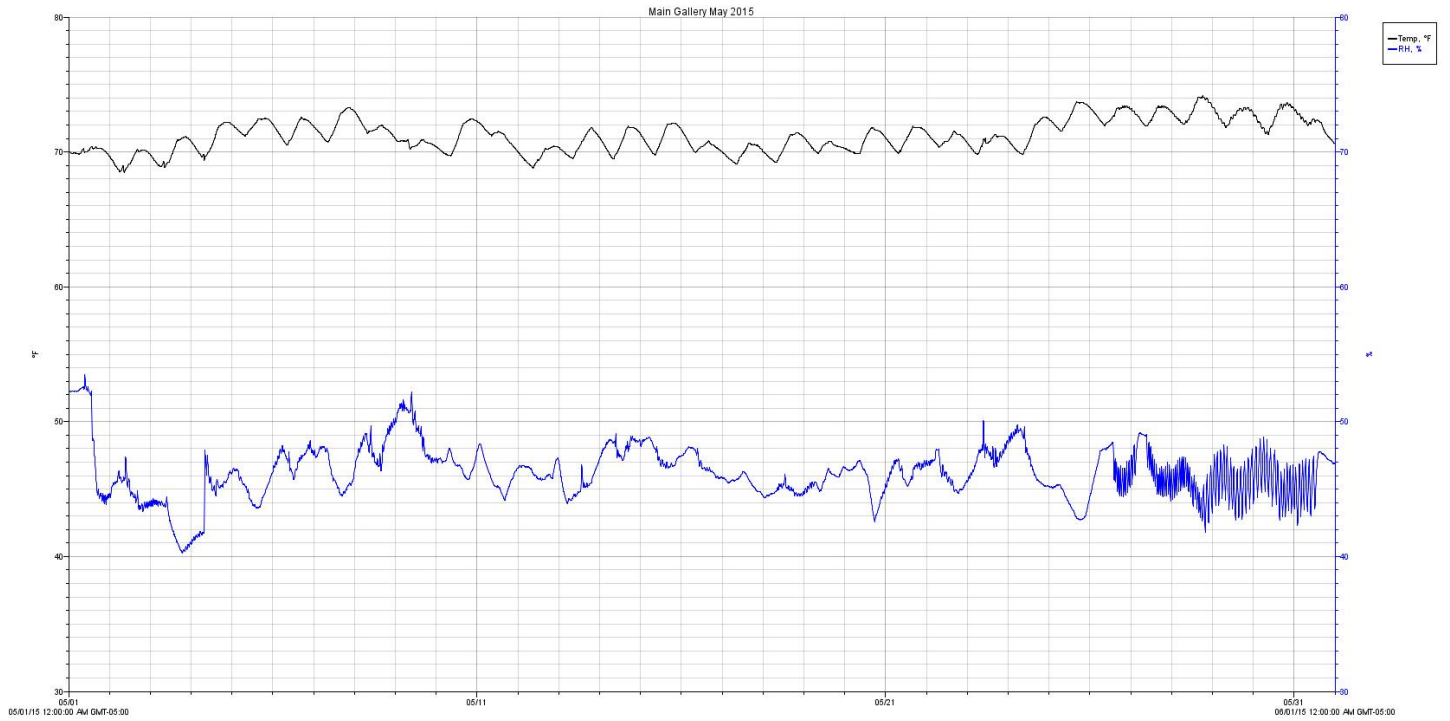
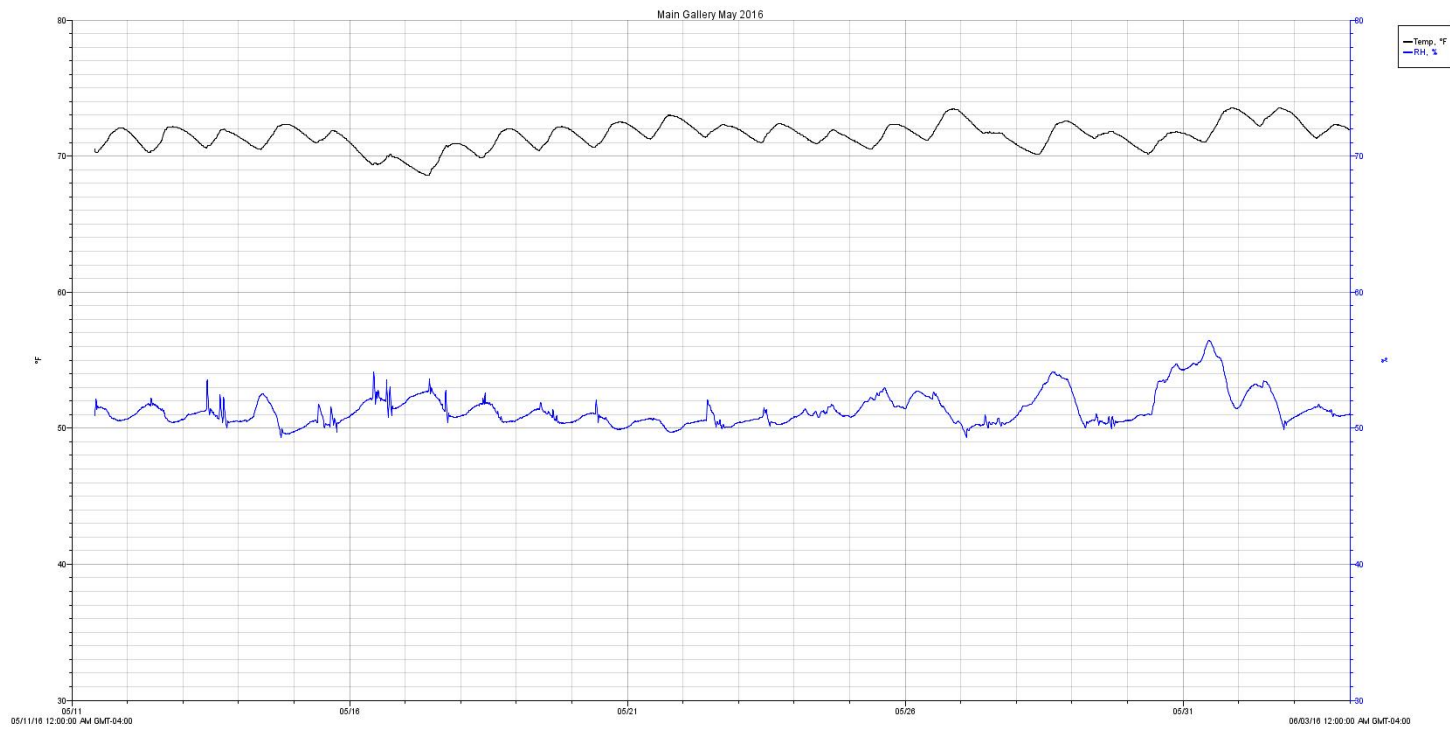
Main Gallery, May 2015 (top) compared to May 2016 (bottom), with new dehumidification system.

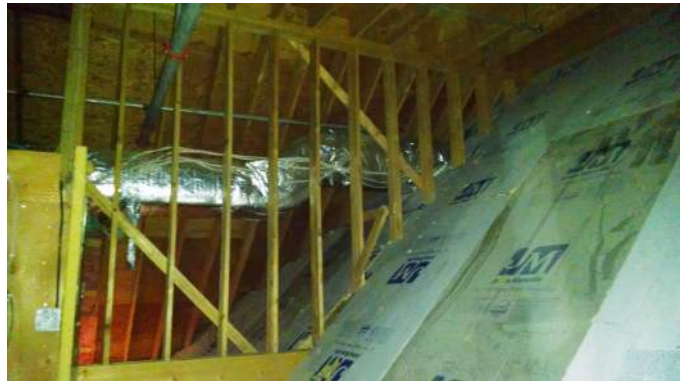
This is one of the identified leak areas. Note metal adjacent to leak.

Priority	Retrofit/Air-sealing recommendations
<b>High</b>	<p><b>EAVE</b>—In the attic, remove the lower 6-foot section of foamboard insulation (2 layers) to expose the membrane over the ceiling. Remove all debris and insulation at building assembly transition to opposing slope and wall of computer room. Seal all penetrations in the membrane with flexible adhesive sealant. Install new 6” polyisocyanurate foamboard (in 2 or 3” alternating layers) from pitch change to within 1-foot of transition above common-wall with hallway below. Install 4” SPF (in 2 applications of 2”) to exposed ceiling membrane and building-assembly transition (to either wall or sloped-ceiling).</p> <p><b>SUPPLY DUCT</b>—cut back existing insulation roughly 1-foot from edge of duct/duct-insulation. Air-seal duct penetration in the ceiling with flexible adhesive caulking. Be sure to remove insulation at the bottoms of the adjacent valley rafters, and air-seal all cracks/holes/seams with canfoam. Install 4” SPF (in 2 applications of 2”) to exposed ceiling encasing rafter-bottoms/plate.</p>

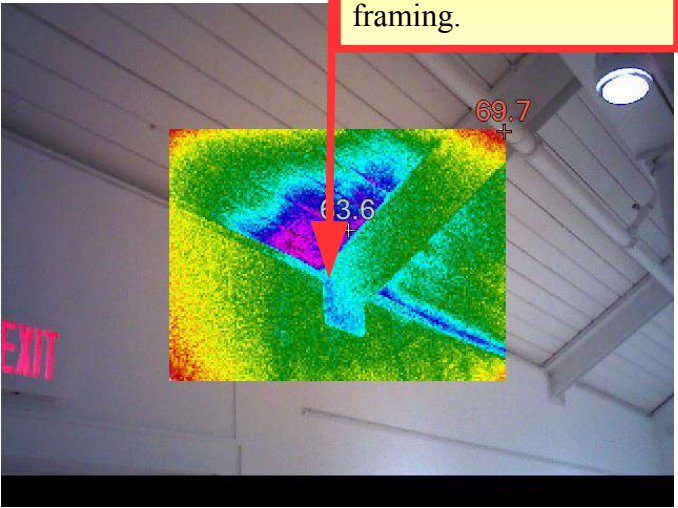
This is the attic-side of the same ductwork.

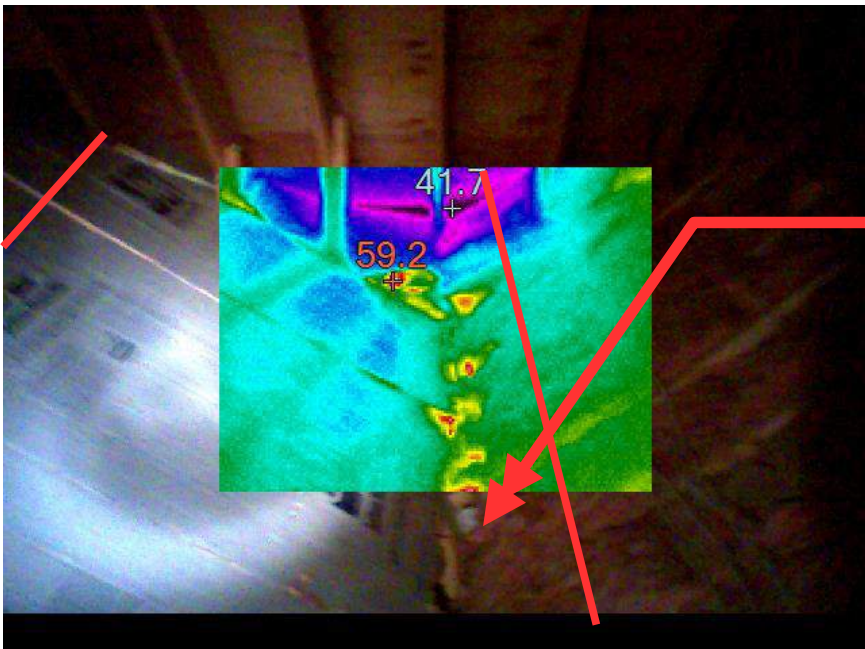
*East-facing eave of exhibit room, above common-wall with hallway.*

Site of ceiling leak at HVAC supply ductwork. Remove insulation inside of red-line in attic for proper air-sealing.

The eave-leak issue is both an air-barrier and thermal barrier breach. Therefore complete removal of foamboard to pitch change (at red-line left) and removal of fiberglass along reverse slopes (to the right red-line) followed by comprehensive membrane-sealing, air-sealing, and re-insulation should fix the water leaking in, and air leaking out.

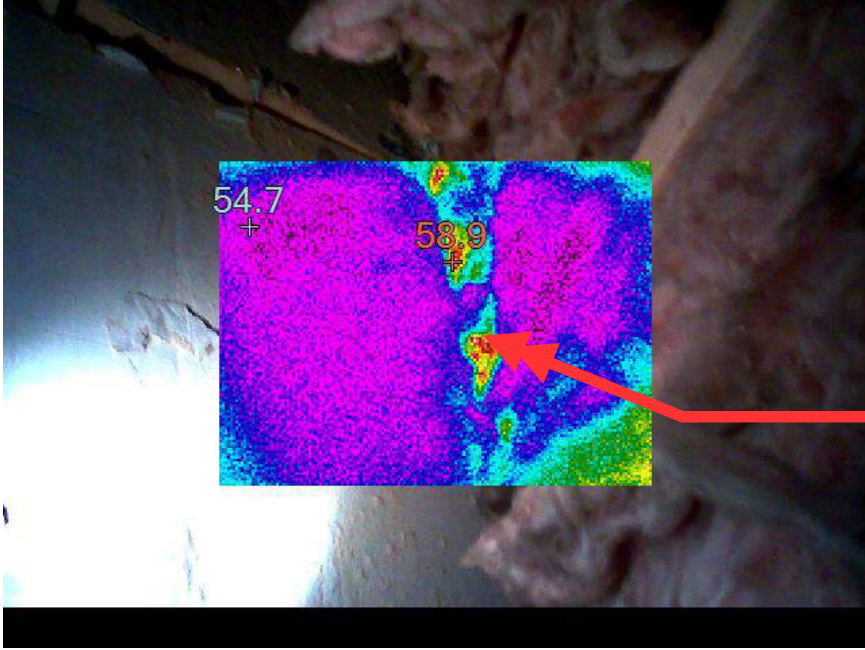
*East-facing eave of exhibit room, adjacent to 2nd story computer room.*

Location of pitch-change on east-facing exhibit room ceiling. Currently the 2 layers of foamboard are not contacting the ceiling surface because the sheets are spanning transition, instead of being cut/fit and sealed to ceiling. Note seams not sealed.

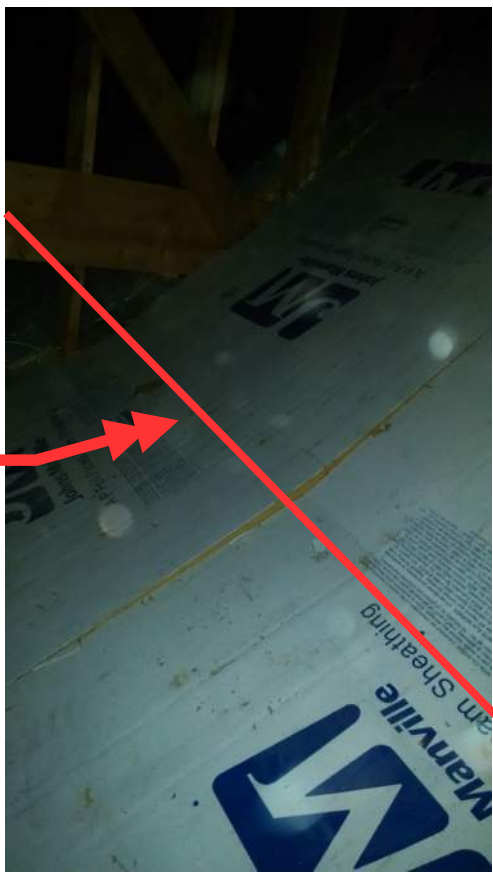
Location of “eave” at intersection with framed-wall of 2<sup>nd</sup> story computer room. This foamboard is heavily impacted, poorly air-sealed and is discontinuous where it intersects the wall framing. Remove foam up to the 6-foot mark, pulling the fiberglass and debris, then subsequent SPF installation should eliminate this problem.

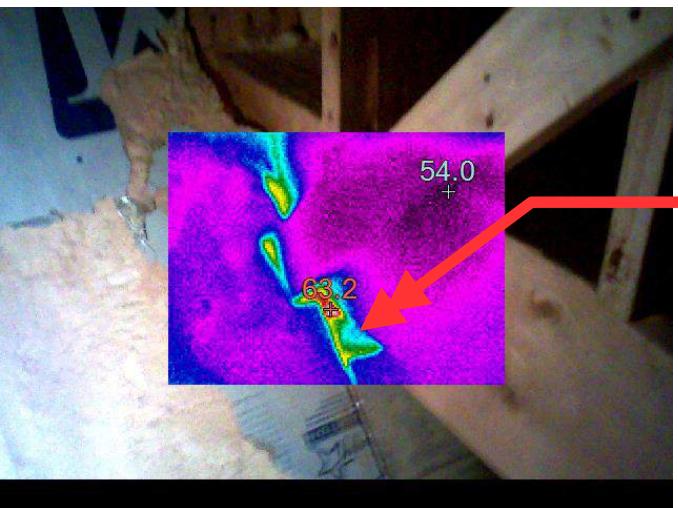
This image shows conditioned air exfiltrating through breaches in the membrane and the poorly air-sealed foamboard adjacent to and over the associated roof-support framing.

Priority	Retrofit/Air-sealing recommendations
<b>High</b>	<p><b>ROOF SUPPORTS</b>—In the attic, atop and along both sides of the 2 roof-support structures, remove at least 1-foot of foamboard to expose ceiling membrane—from the ridge down to the eave (above the common-wall with hallway). Repair/seal membrane, air-seal any gaps/seams, then install 4” SPF (in 2 applications of 2”) to exposed ceiling encasing bottom-plate of roof-support.</p> <p><b>VALLEYS</b>—Along both north and south valleys—where perpendicular roof overlays/intersects the sloped-roof of the exhibit hall, cut back existing insulation roughly 2-feet from valley point. Air-seal holes drilled into bottoms of rafters (intended to connect the bottoms of the adjacent exterior-exposed slopes to the ridge vent, but are ineffective in their current location), air-seal all framing seams/gaps with canfoam. Install 4” SPF (in 2 applications of 2”) to exposed ceiling encasing rafter-bottoms/plate.</p>

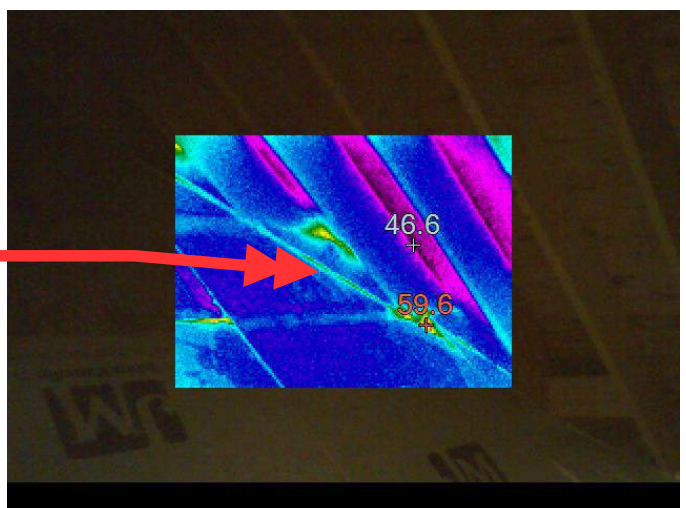
Looking west in the attic toward the northern valley which overlays the exhibit room. Yellow and reds show air-leaks associated with the framing intersection between the exhibit room ceiling/roof and the connector roof.

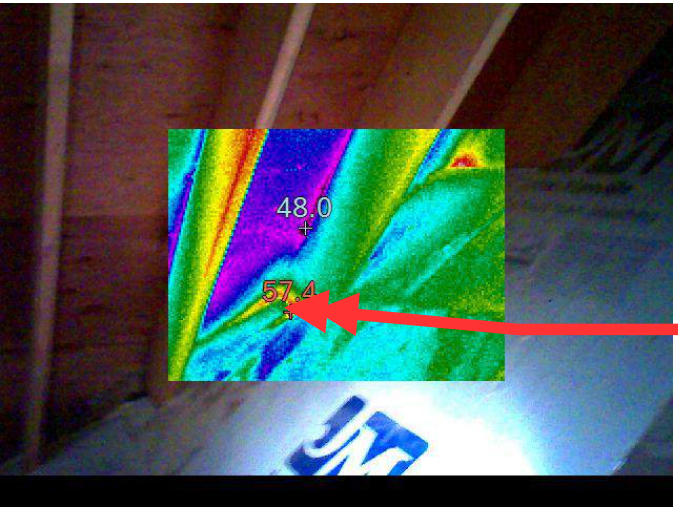
Looking south in the attic toward the southern valley which overlays the exhibit room. Again, yellow and reds show air-leaks associated with the framing intersection between the exhibit room ceiling/roof and the connector roof.

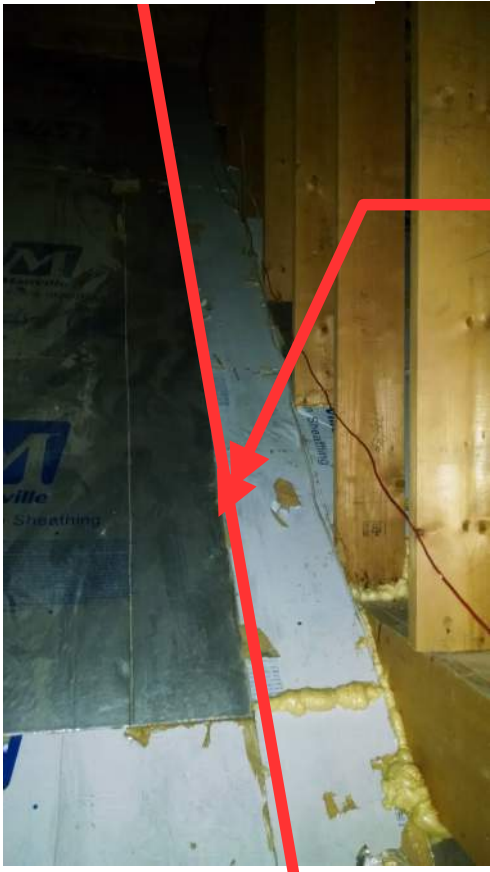
Looking west up one of the roof-support structures. Note the high concentration of seams in the foamboard. Remove existing foamboard to the red-line, seal membrane, air-seal gaps, cracks and seams, then install 4" SPF over exposed ceiling and bottom plate of the support-wall.

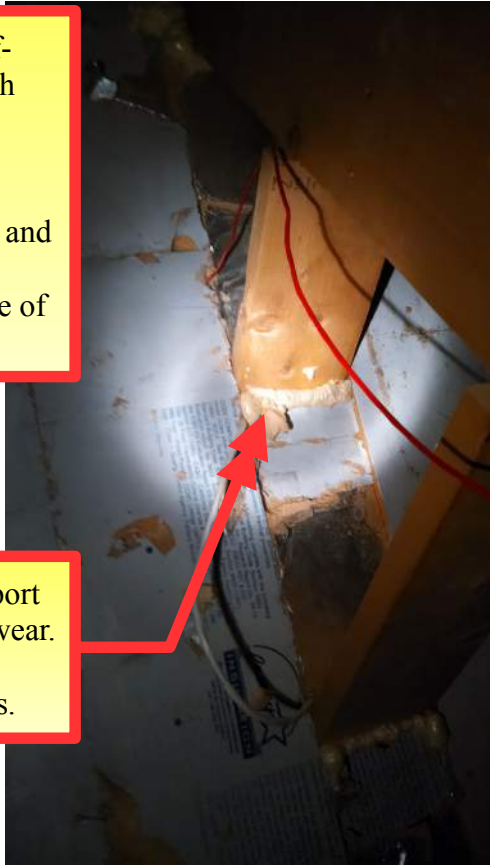
Close-up of bottom of roof-support showing seams, and insulation wear. SPF will effectively encase the framing to prevent air/vapor loss.

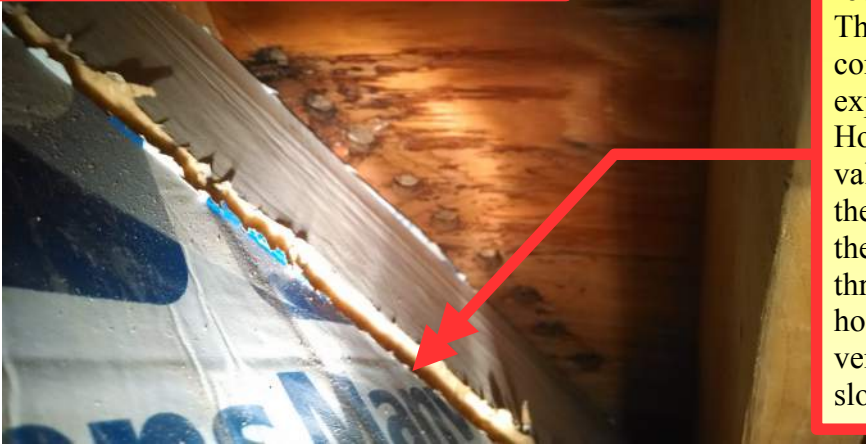
Close-up of after-the-fact venting into the adjacent overlaying roof assembly of exhibit room at very north end (same at south end). These holes are drilled all along the valley to connect and allow the stranded roof cavities exposed to the exterior to ventilate. However, moist attic air accumulates in these valley pockets, some of which exhausts into the adjacent sloped ceiling cavities through the drilled holes, condensing on it's way through the restricted, cold pathway. These holes should be sealed, and an alternative ventilation strategy proposed for the stranded slopes.

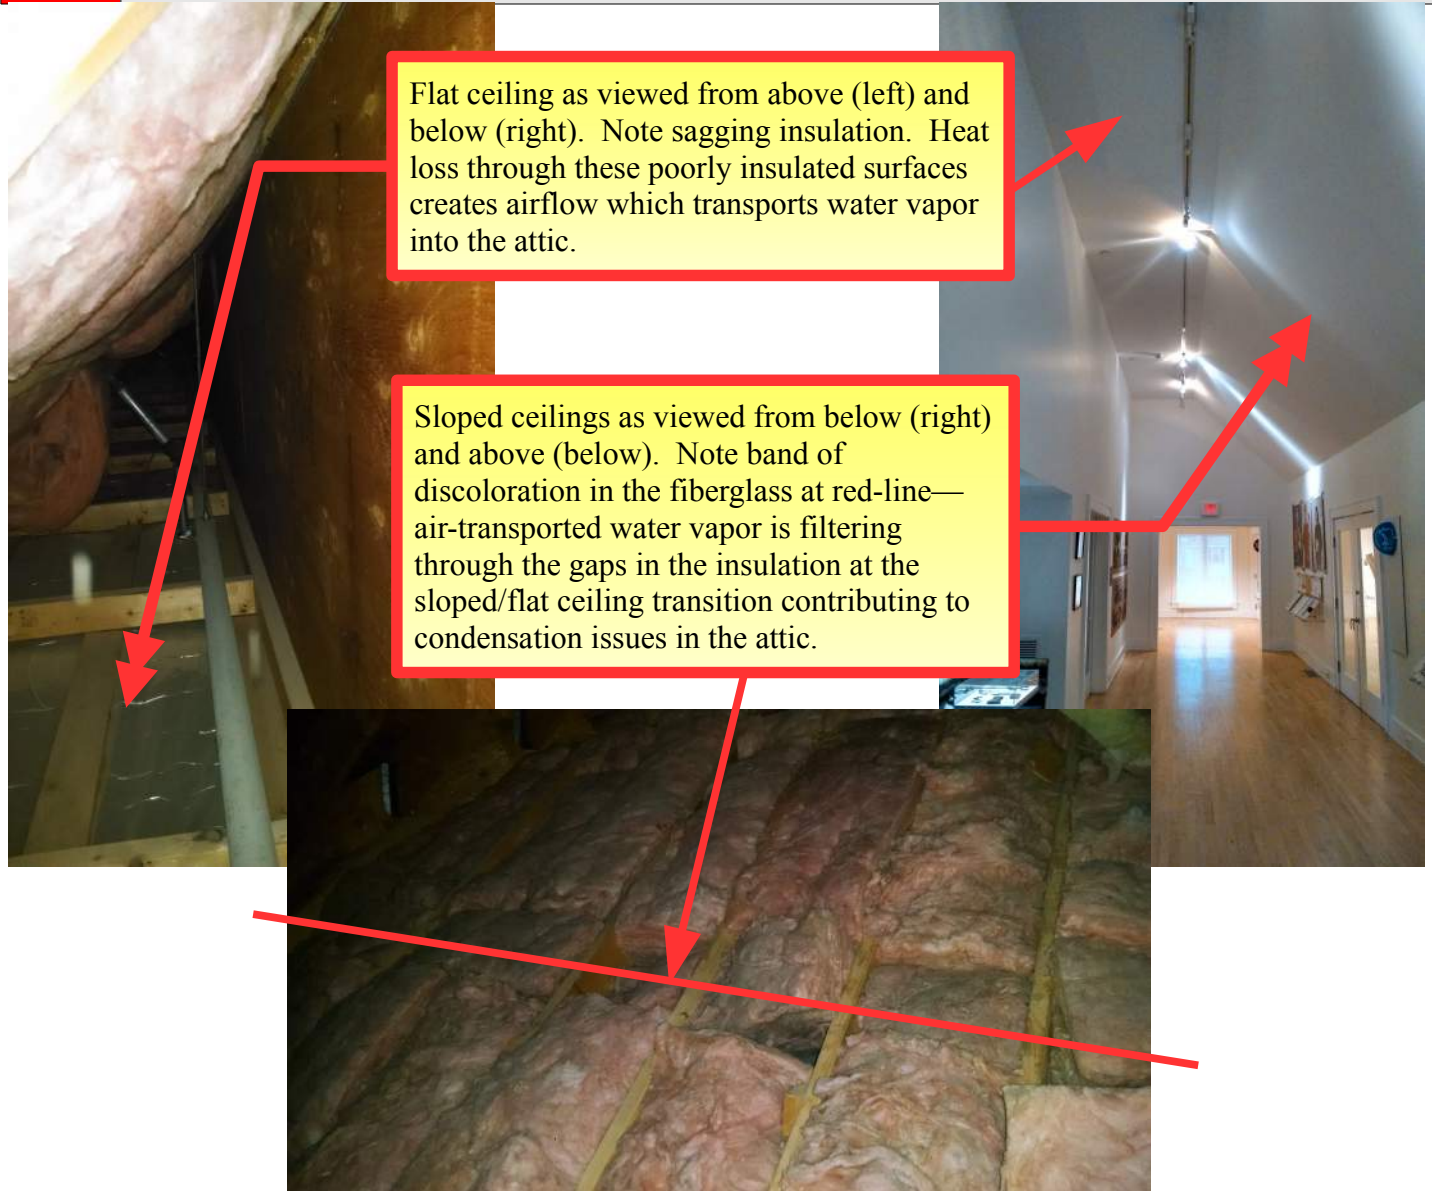
Priority	Retrofit/Air-sealing recommendations
<b>High</b>	<p><b>HALLWAY CEILINGS</b>--<i>In the attic, remove all existing fiberglass batt insulation from the sloped ceiling over the hallway. Note: this will expose a triangular space/void below created by the flat ceiling over a portion of the hallway. Because the existing fiberglass insulation has no air-barrier, air freely filters through the insulation, especially at gaps/edges. This improvement suggests maintaining the same thermal barrier, only creating an air and vapor barrier to the exterior using 2" Thermax foamboard.</i></p> <ul style="list-style-type: none"> <li>• <i>Air-seal sloped-ceiling framing intersections at the eave, at both flat ceiling intersections above the hall, and at the intersection with the computer room wall at the south.</i></li> <li>• <i>Install Insulweb netting to underside of sloped-ceiling/rafters,</i></li> <li>• <i>install 2" foamboard to attic-side of rafters, air-sealed with foil-tape and canfoam, secured with strapping,</i></li> <li>• <i>then install densepacked cellulose into the "rafter" cavities from the eave at the common-wall below to the intersection with the upper flat ceiling.</i></li> </ul>

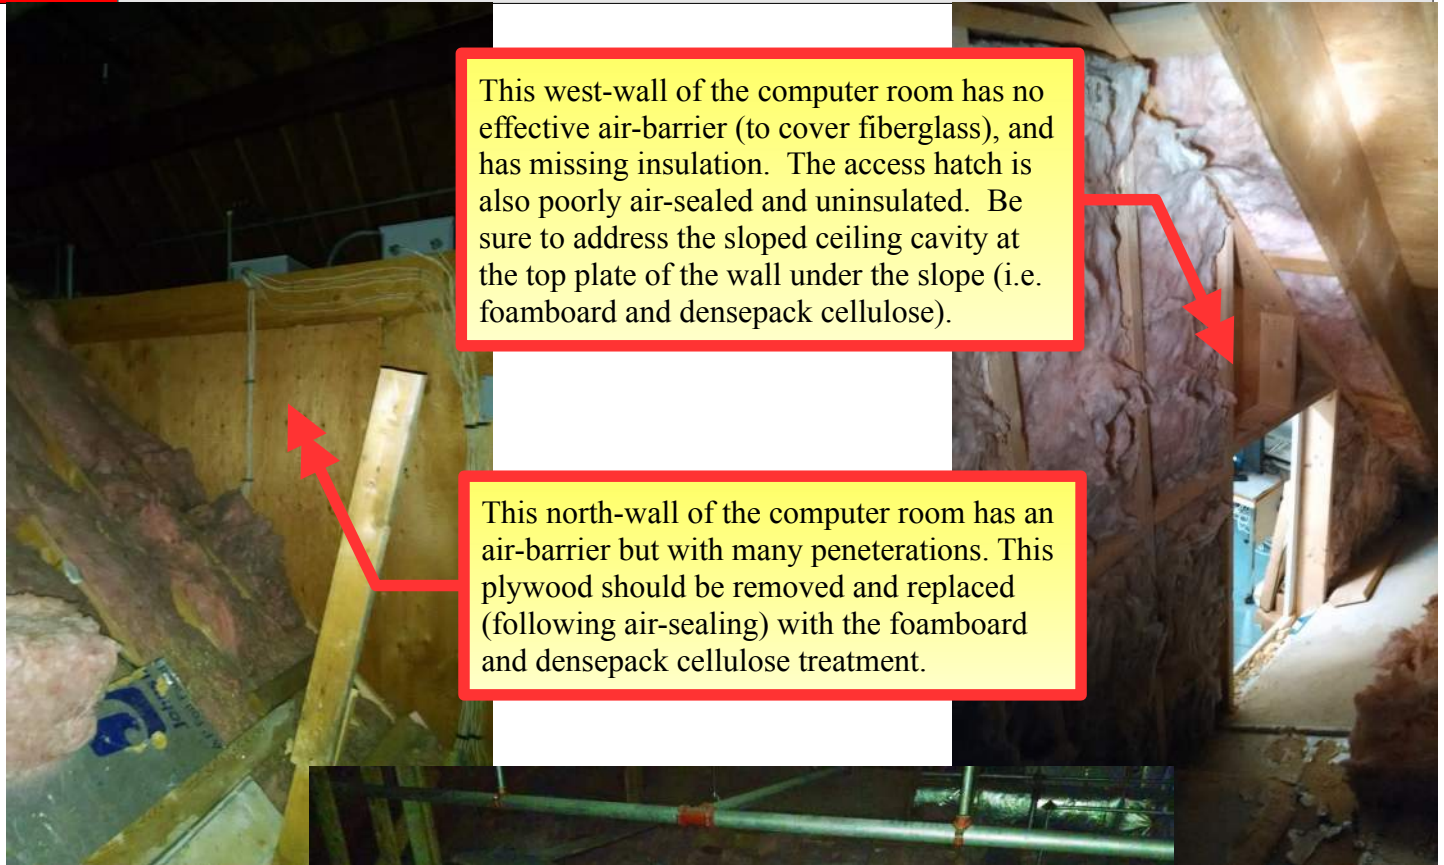
Priority	Retrofit/Air-sealing recommendations
<b>High</b>	<p><b>COMPUTER ROOM WALLS</b>—<i>These walls have many penetrations, poorly installed and incomplete insulation, and contribute to heat-loss to the adjacent attic space. In the attic, remove all existing fiberglass batt insulation from the west and north-facing wall cavities (north wall will require plywood-removal).</i></p> <ul style="list-style-type: none"> <li>• <i>Air-seal penetrations in the walls with canfoam/caulking,</i></li> <li>• <i>create insulation dam at tops of wall cavities (west-wall),</i></li> <li>• <i>air-seal seams at ceiling drywall above, exterior corner of room, and at the bottom of wall (if not completed already in above recommendation).</i></li> <li>• <i>Then, install 1" Thermax foamboard to the attic-side of wall cavities, with cap-nails/strapping to secure, and in-fill prepared wall cavities with densepacked cellulose (r-27).</i></li> </ul>

This west-wall of the computer room has no effective air-barrier (to cover fiberglass), and has missing insulation. The access hatch is also poorly air-sealed and uninsulated. Be sure to address the sloped ceiling cavity at the top plate of the wall under the slope (i.e. foamboard and densepack cellulose).

This north-wall of the computer room has an air-barrier but with many penetrations. This plywood should be removed and replaced (following air-sealing) with the foamboard and densepack cellulose treatment.

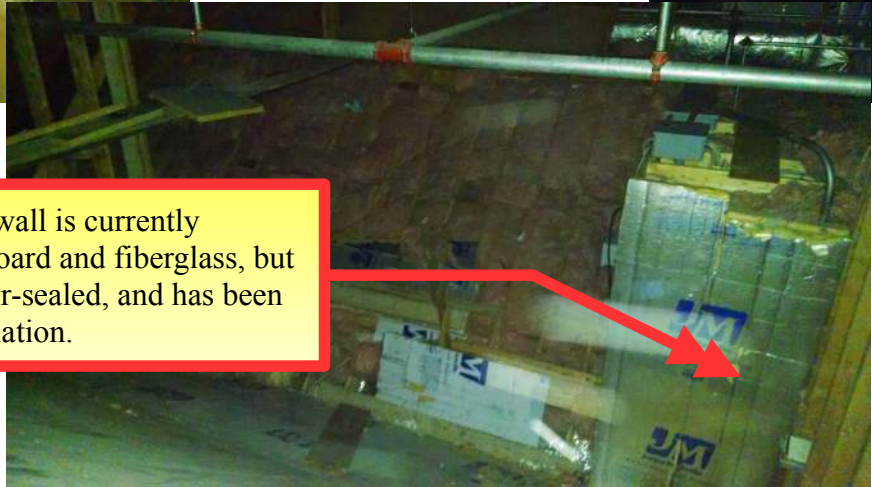
This section of west-wall is currently insulated with foamboard and fiberglass, but was never properly air-sealed, and has been impacted since installation.

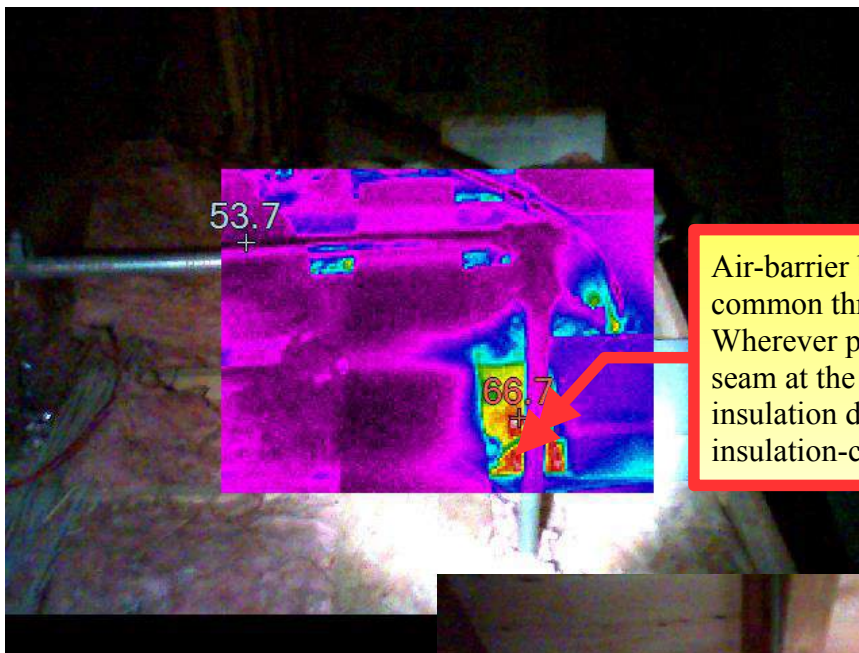
Priority	Retrofit/Air-sealing recommendations
<b>High</b>	<p><b>COMPUTER ROOM CEILING</b>—<i>The ceiling is barely insulated and riddled with air-barrier breaches. A comprehensive retrofit will reduce heat and vapor loss into the attic above the central part of the building. And due to the ceiling's proximity to the attic-exhaust fan (which tends to increase exfiltration), air-sealing will likely have a disproportionate improvement.</i></p> <ul style="list-style-type: none"> <li>• <i>Remove all existing fiberglass insulation and debris</i></li> <li>• <i>Air-seal all ceiling penetrations with canfoam and/or caulking</i></li> <li>• <i>Build foamboard or drywall boxes over recessed ceiling fixtures (fans/lights), sealed at edges and to the ceiling (convert light fixtures to LED).</i></li> <li>• <i>Install insulation dams at sloped ceiling intersection to south, and along the edge of ceiling to north and west to retain the proposed insulation.</i></li> <li>• <i>Install 16" loosefill cellulose over prepared ceiling surface (R-60).</i></li> </ul>

Air-barrier breaches such as this one are common throughout the entire attic. Wherever possible air-seal the penetration seam at the ceiling. If necessary create an insulation dam over the fixture to prevent insulation-contact.

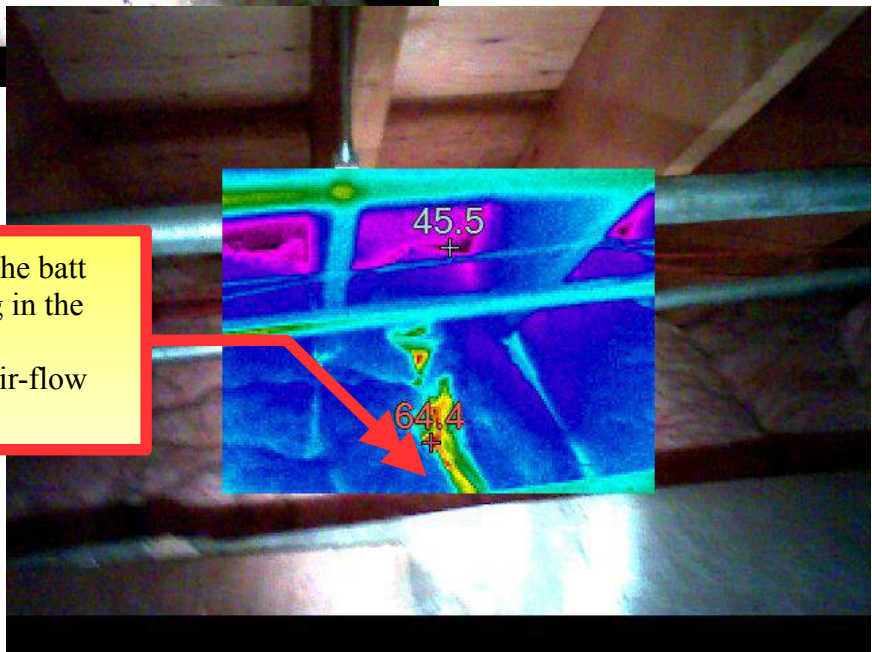
Gaps like these along the edges of the batt insulation allow convective looping in the air-space under the insulation—this accelerates heat-loss by increased air-flow through the insulation.

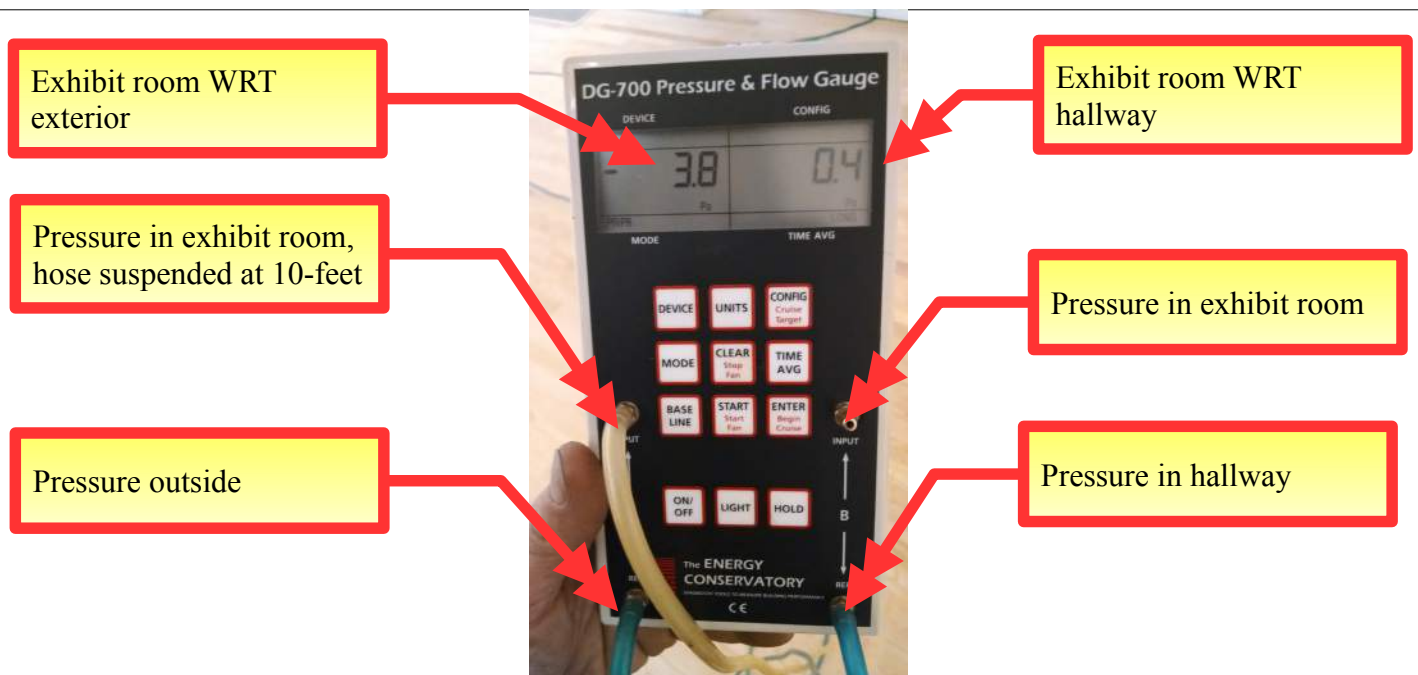
Zone Pressure Diagnostics—shows pressure in the exhibit room with reference to (WRT) adjacent spaces—exterior and hallway

- **Recommendations:**
  - *with the help of your licensed HVAC technician/company:*
    - *EITHER, greatly reduce return air from the exhibit hall to the central system with the goal to create a greater positive pressure in the exhibit hall WRT both interior and exterior spaces.*

- *AND/OR, greatly reduce return air in the ENTIRE BUILDING'S ventilation system, with the goal of raising the interior pressure WRT the exterior. AND/OR, complete comprehensive retrofit to attic spaces to reduce stack-effect throughout the entire building. AND/OR, SEE BELOW REGARDING ATTIC-EXHAUST FAN.*

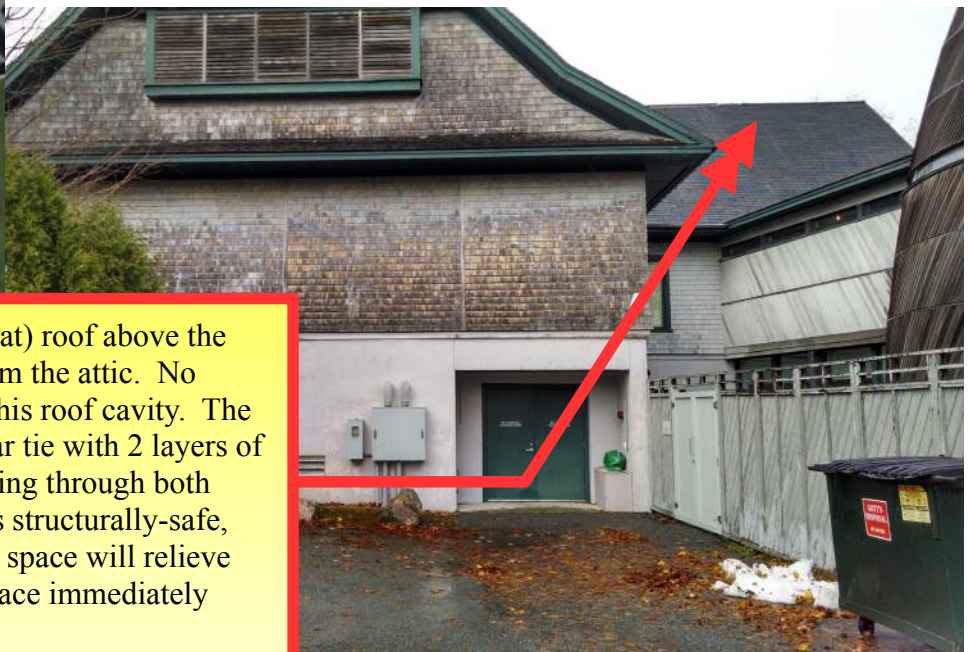
There is low-pitch (essentially flat) roof above the flat plywood deck as-viewed from the attic. No venting currently occurs out of this roof cavity. The deck is essentially a double collar tie with 2 layers of sandwiched 1/2" plywood. Cutting through both layers—with as large a hole as is structurally-safe, and connecting to the small attic space will relieve the vapor pressure in the attic space immediately above the exhibit room.

Type/ location	Recommendation
Attic	<ol style="list-style-type: none"> <li>1. <i>Attic ventilation should be achieved through passive means rather than mechanical. Though no pressure-testing was done in the attic, it is quite possible that the exhaust fan, as it's set up, will pull outside air into the attic via the path of least resistance—or the larger open vents-areas. This means most outside air is pulled in through the soffit venting (east-facing), and likely some inside conditioned air is pulled through the larger holes in the air-barrier (chimney chase, kneewall spaces of original building).</i></li> <li>2. <i>Unfortunately current attic ventilation, even with the exhaust fan doesn't likely pull enough air from the problem area (over the exhibit hall), mainly because there's no substantial supply of air to feed the exhaust fan.</i></li> <li>3. <i>Ideally passive attic ventilation is designed to allow for a greater area of open venting down low throughout the attic, and a lesser amount at the very top of the attic. In this case the bottommost venting occurs in spots around the roof...some places unintentionally. While the uppermost venting occurs at the east eaves.</i></li> <li>4. <i>Creating ventilation above the problem area is the ideal solution.</i></li> <li>5. <i>Cut holes through the flat plywood decking/framing at the top of the attic space over the exhibit hall to allow airflow into roof cavities. Then either engineer ridge venting at the south-facing section of east/west ridge, or engineer/install a roof vent, built up through a curb to allow proper sealing with existing rubber roofing.</i></li> </ol>
