Stability and consolidation of an ashlar barrel vault with great deformations: the church of Guimarei

S. Huerta, G. López

Departamento de Estructuras de Edificación, Escuela Técnica Superior de Arquitectura, Universidad Politécnica de Madrid, Spain

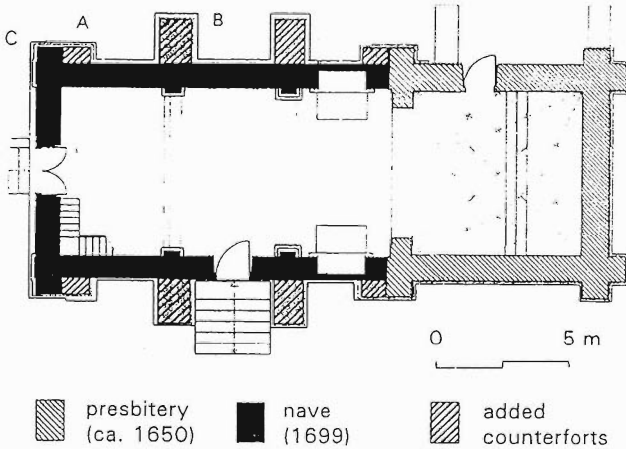
Figure 1: Plan of the church of Guimarei

and other four small, A, at the corners, were added after the completion of the church (see Fig. 1). Effectively, the horizontal stone courses present an evident discontinuity both in counterforts **A** and **B** (see Fig. 3); besides, the stones of the great buttresses in contact with the wall are not square, but present a slanted face just to fit with the wall's inclination. Moreover, the stone courses of the four great counterforts are perfectly horizontal. The conclusion is that counterforts **A** and **B** were added as a mean of consolidation after the lateral walls were already out of plumb.

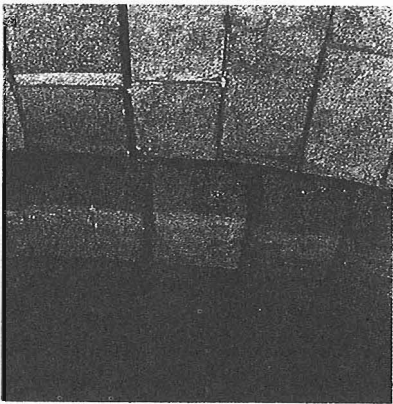
Figure 2: Vault cracking

In Guimarei the cracking was due to a leaning outwards of the abutment system (walls plus counterforts) of the nave. The vault adapted itself with a "classical" pattern: a crack in the crown, directed inward, and two cracks in the haunches, directed outwards (see Figs. 2 and 6).

However, the safety factor of 1.4 in relation to new movements, appears to be a little low. It seemed prudent, then, to recommend measures that will stabilize the geometry. Therefore it was suggested to add steel ties at approximately two thirds of the vault's height, below the cracks. The analysis of the presbytery arch yielded similar values and it was also recommended to add a steel tie, this time embedded in the masonry above the keystone.

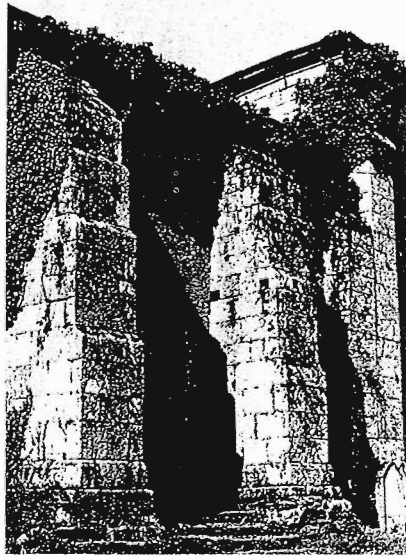
Figure 3: Added counterforts

From inspection of the external ashlar facing it could be deduced that the four great counterforts, **B**, that support the central zone of the nave,

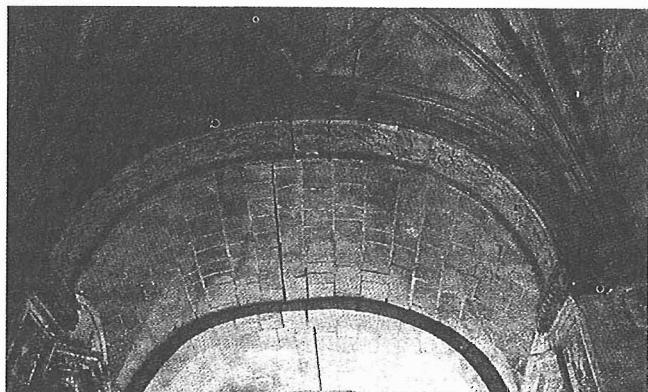
Figure 5

The presbytery wall, connected to the vault, tried to impede the movement and, not being able to resist the thrust, leaned also a little; the presbytery arch shows the corresponding cracking (the neighbouring zone of the ribbed vault was also slightly affected, see Fig. 5). In what follows we will concentrate only in the nave; in the original report a similar study was made also for the presbytery wall.

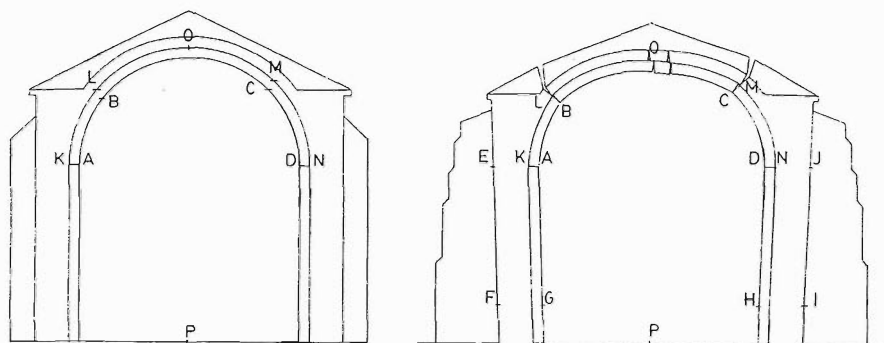
As said before, all the damages are concentrated in the nave and in the presbytery arch, and are a consequence of the leaning of the original walls and counterforts. In Fig. 8 are represented both the original (counterforts are hypothetical) and the actual distorted geometry. Table 1 summarized the measurements made to obtain the inclination of the walls. The values of Table 2 have been calculated from Table 1 supposing rigid body movements around the hinges. Some of them were checked and showed a good agreement with the actual state.

Figure 8: Original and actual deformed state (letters refer to the Tables)

It should be noted that the inclination of the walls is different inside and outside (greater). This difference of inclination have produced a separation of both faces (internal and external) of the wall, which afterwards moved independently.

When the new counterforts were added, the deformation remained. The inside inclination governs the vault deformation. This has been verified calculating the crack width in the crown (57 mm) and comparing this value with the actual width (55 mm).

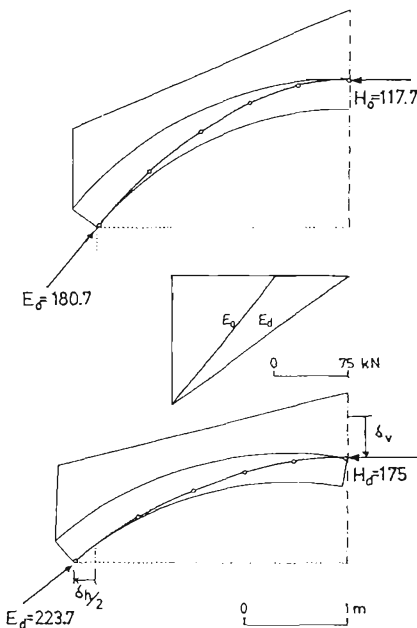
Figure 10 summarizes the result of the calculations. Due to an increase of span at the level of the hinges of 36 cm, the crown of the vault has sagged 32 cm. Note the notable the change of direction and the increase of the thrust at the inferior hinges.

Figure 10: Thrust line in the vault: (a) undeformed geometry; (b) actual geometry

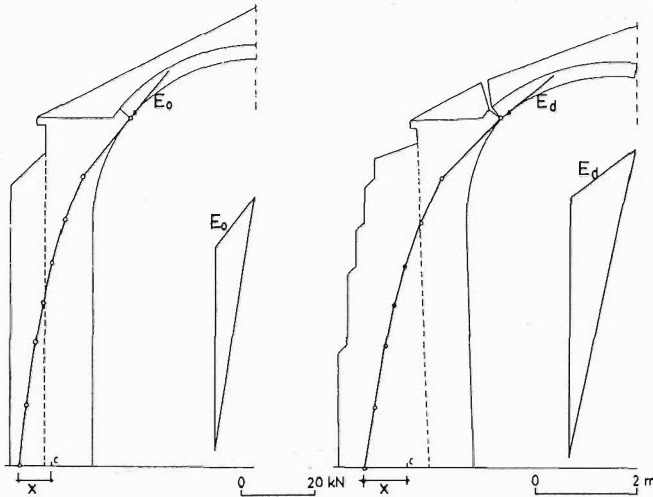
The stability in the lowest joint of the buttress was determined. The position of the thrust in this joint will give a measure of the safety of the buttress system. As before, we have made two analysis: one for the undistorted original geometry with hypothetical "gothic" counterforts; the other for the actual distorted geometry. Figure 11 summarizes the results. The geometrical factor of safety results of dividing the total width of the joint with two times the distance of the thrust to the middle of the joint (x , in Fig. 11).⁷

Figure 11: Stability of the abutment system: (a) undeformed geometry; (b) actual geometry

The safety factors are 1.2 for the "original" geometry and 1.58 for the actual geometry. It is evident that in the first case the stability was precarious and that a progressive inclination of the abutment system was likely to occur (indeed, that is precisely what happened).

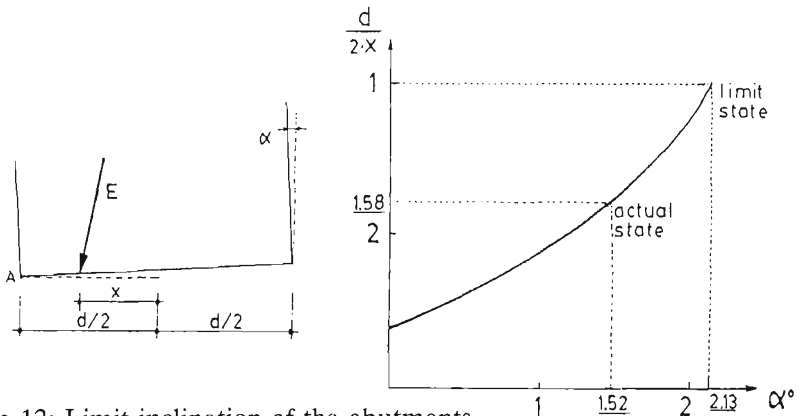
In Fig. 12 we have plotted the relative position of the thrust in the joint (the parameter $d/2x$ is precisely the geometrical factor of safety) against a growing inclination of the buttress, α . Supposing that sliding is impossible and that the deformation is fairly symmetrical, the only unknown is the centre of rotation. We have tried both extremes of the joint and the worst situation was the centre of rotation located at the outer border (A) of the joint. (In a more detailed study intermediate points should also be checked.)

Figure 12: Limit inclination of the abutments

Dividing the limit inclination by the actual inclination we obtain a measure of the safety against inclination. The relation between thrust position and buttress inclination is non-linear and it turns out that the inclination "governs"

the safety: we obtain a factor of 1.40, 15% lower than Heyman's geometrical factor.
