# Monitoring of “Zarzuela Racecourse” structure by means of non-destructive techniques for durability assessment

**ABSTRACT:** Present paper describes some aspects of the restoration project recently undertaken in La Zarzuela Racecourse, designed by E. Torroja and Domínguez in 1934. Despite the good mechanical work of steel, it has started a deterioration process which has caused the corrosion of reinforcement by carbonation. It has been detected corrosion attack in some places due to the breaking of the upper waterproofing membrane of the shell which enabled the water to remain long periods in the roof and therefore promoted corrosion of reinforcement. For the repair first an assessment of the degree of corrosion was made. The restoration project finally consisted in the injection of all the cracks in order to assure the joint work of the shell and the patching of the deteriorated zones. Profiting these works it was installed a monitoring system of corrosion sensors. Results of the recording are given in the paper.

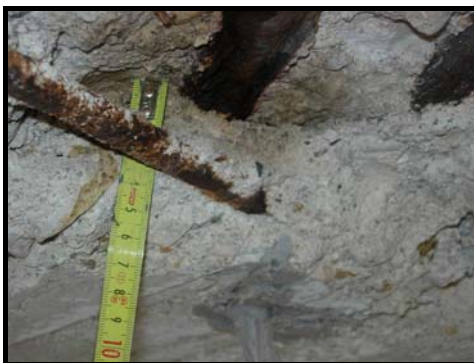
This Concrete carbonation has been studied and quantified on site, measuring a carbonation front (by the application of alcoholic phenolphthalein solution) higher than 60 mm in some points (Figure 2), reaching completely the shell thickness in some areas. In this way, it can be said that almost all the structure was affected by generalized corrosion, but no pitting or important localized lost of section in the rebars was detected.

Figure 2. Measurement of the carbonation front in the shell.

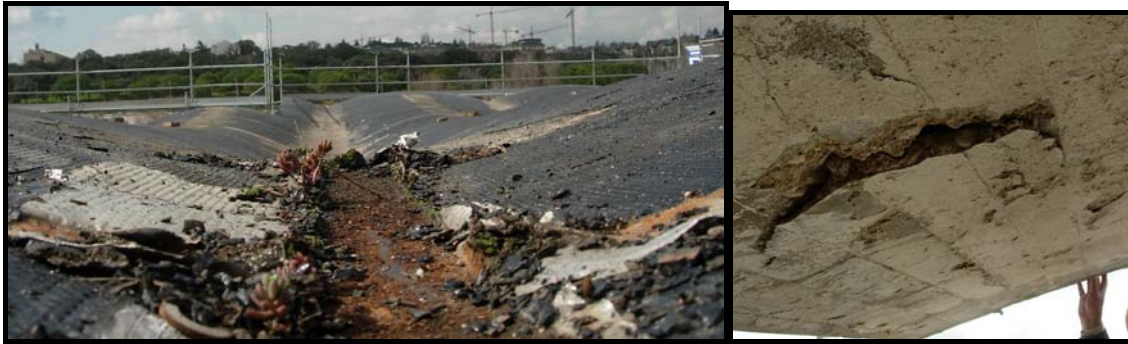
The corrosion attack has been accelerated in some places due the loss of the upper waterproofing foil of the shell which (Figure 3).

Figure 3. Deterioration observed before the restoration: Left: Lower part of one deck. Right: loss of upper waterproofing foil

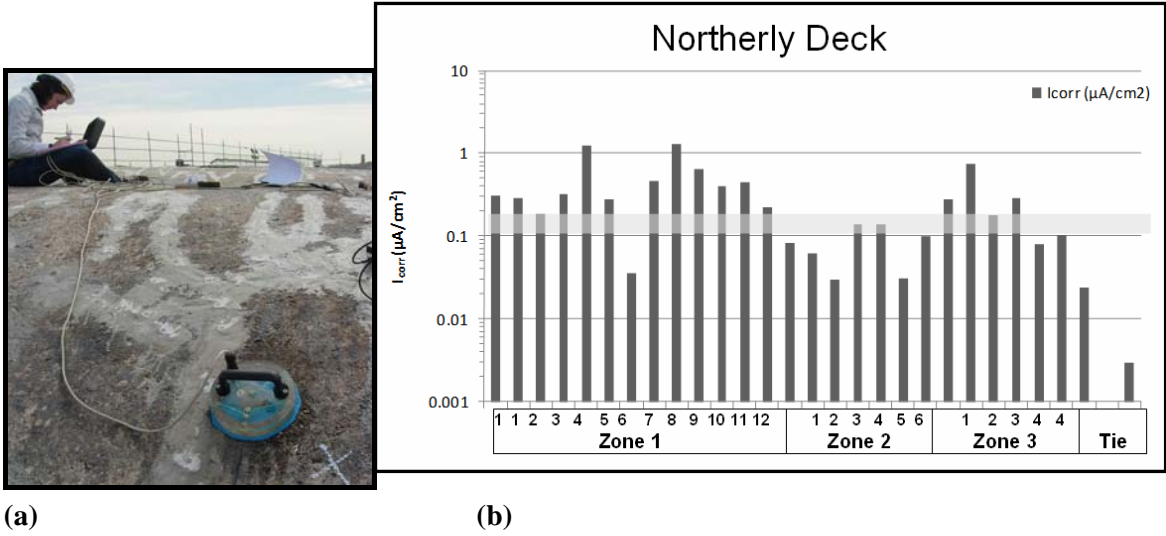
The corrosion rate (evaluated by the modulated confinement method by means of the corrosion rate meter Gecor 08) was quantified in different areas of the three decks (Figure 5). The results indicate that almost all the structure is corroding due to the concrete carbonation. The majority of the values registered are in the range of moderate corrosion rates (between 0.5 and 1  $\mu\text{A}/\text{cm}^2$ ), as is shown in the example of 04b (Feliú et al. 1990).

Figure 4. Left: Sensor and device used for the corrosion rate measurements. Right:  $I_{corr}$  values registered in the northerly deck.

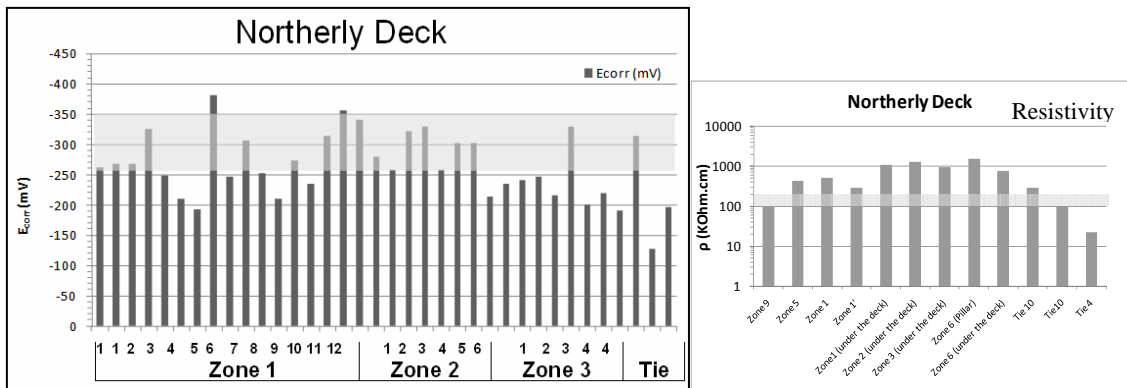
Other corrosion indicators, as are the corrosion potential and the resistivity, were also evaluated.  $E_{\text{corr}}$  was measured with a  $\text{Cu}/\text{CuSO}_4$  reference electrode. The majority of the values measured were in the range between -250 and -350 mV, what means an intermediate corrosion risk. Talking about concrete resistivity, very high values (higher than 200  $\text{K}\Omega\cdot\text{cm}$ ) were measured. These high values are due to the delaminations and voids present in the concrete, which do not allow a properly electrolytic contact for the measurement. For this reason, they do not correspond with the real concrete cover resistivity.

Figure 6.  $E_{corr}$  and resistivity results obtained in the northerly deck.

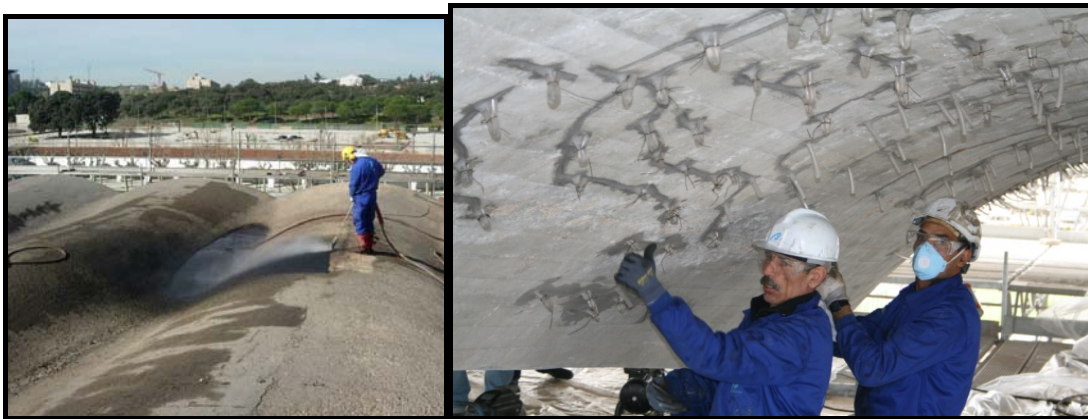
Figure 7. Restoration process

After the corrosion assessment, the concrete detached areas were removed and the rebars were cleaned and passivated. All the area was repaired with specific cement based mortar, and cracks were filled injecting resin and then sealed (Figure 7).

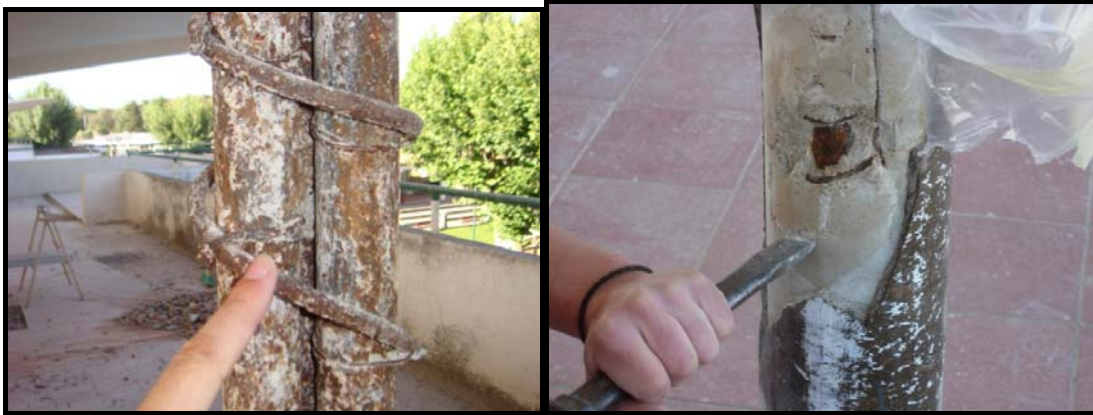
In this phase, the ties were also repaired. The ties are composed by three non corrugated steel bars (placed asymmetrically) embedded in cement mortar and waterproofed by a fibro-cement cover (Figure 8). Even when the waterproofing system seemed to be not the most suitable, the carbonation in these elements was very low, and the loss of section in the steels was not important.

Figure 8. Ties restoration.

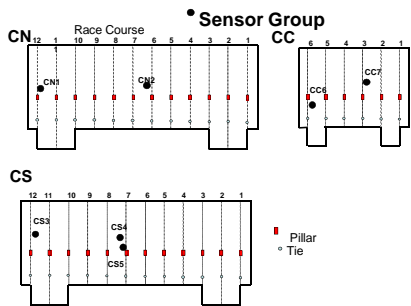
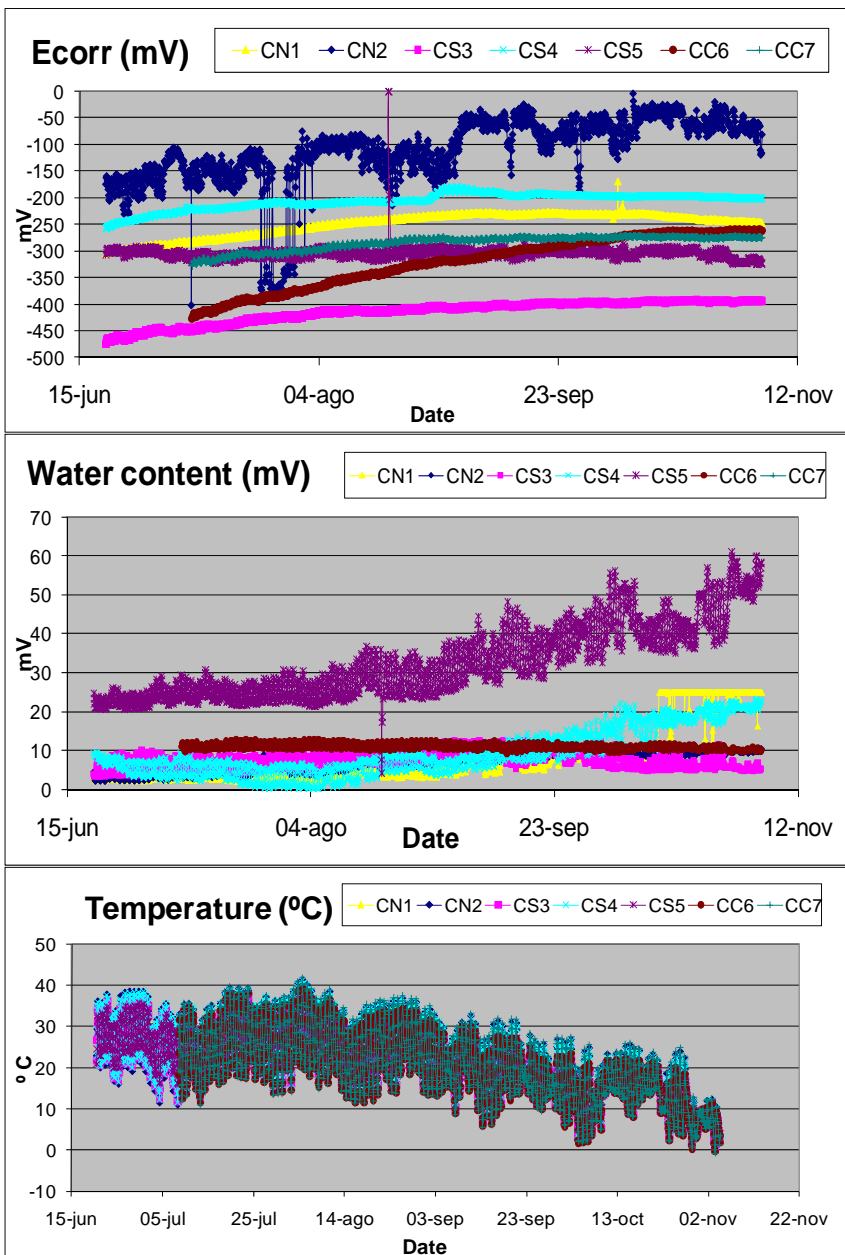
The  $E_{\text{corr}}$  tend to less negative values with time what means that the steel is being passivated. In the case of water content sensors, the response is measured in mV (difference of potential between two metals embedded in the sensor). Values around 0mV means no liquid water, so, the new waterproofing system is working properly

Figure 10. Some of the results obtained from the embedded sensors
