Pitting Corrosion in Austenitic Stainless Steel Water Tanks of Hotel Trains⁽¹⁾

D.A. Moreno*, Ana M. García*, Carlos Ranninger* and Belén Molina**

Abstract The water storage tanks of hotel trains suffered pitting corrosion. To identify the cause, the tanks were subjected to a detailed metallographic study and the chemical composition of the austenitic stainless steels used in their construction was determined. Both the tank water and the corrosion products were further examined by physicochemical and microbiological testing. Corrosion was shown to be related to an incompatibility between the chloride content of the water and the base and filler metals of the tanks. These findings formed the basis of recommendations aimed at the prevention and control of corrosion in such tanks.

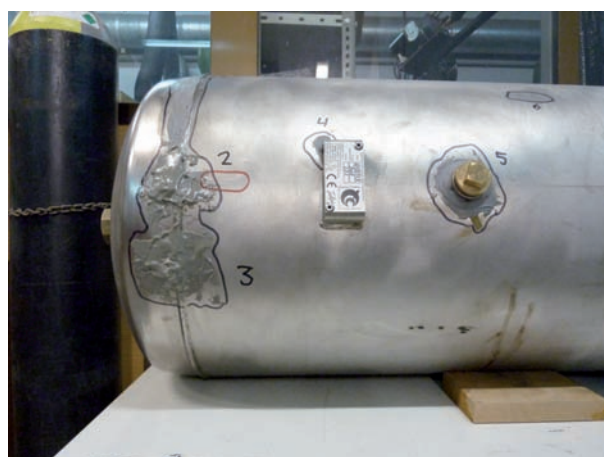
evidence of several subsequent repairs (Fig. 1). All the repairs involved the tank's lower zone, where most of the nozzles were located. The tank's upper zone was not corroded (Fig. 2).

Figure 1. Aspect of the 250-L water tank around the lower zone (head 1). The repairs, made with resin, are seen.

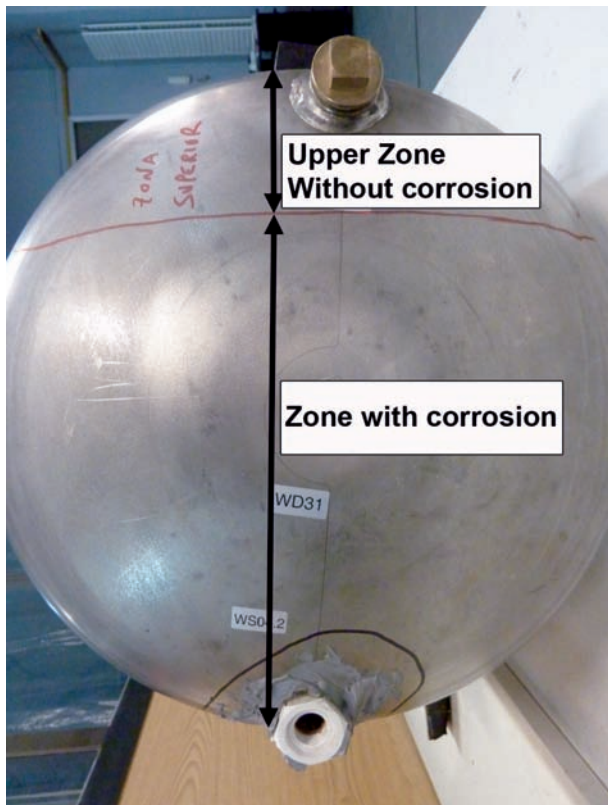
Figure 2. View of head 2 of the 250-L water tank, with corrosion and non-corrosion zones indicated.

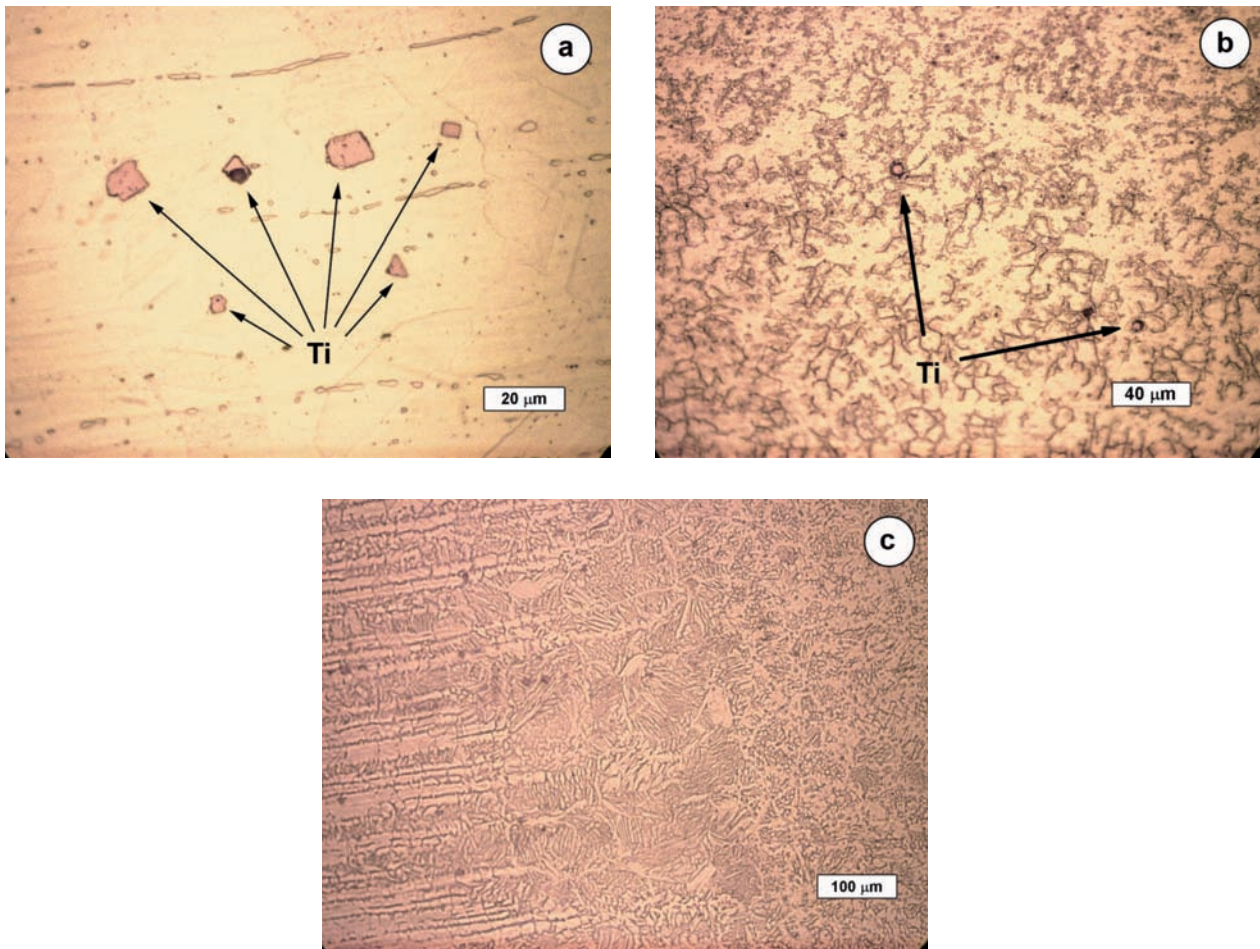
crystals were clearly distinguished by their pink colour and in some zones were aligned with the bands (Fig. 3a)). This material, from a metallographic point of view, has a microstructure consistent with its composition.

The weld metal had a dendritic structure with titanium crystals in its matrix (Fig. 3b)). The weld-metal zone close to the base metal showed a Widmanstätten microstructure, with embedded titanium crystals coming from the base metal (Fig. 3c)) since the filler metal, identified as niobium (Nb)-stabilized stainless steel ER347, lacks titanium (Ti) in its composition (Table II). The filler metal was ER347, which contains Nb and complies with the specifications of Patentes Talgo. The Ti crystals observed in the weld pool were smaller than those of the base metal and reflected the dilution of the filler metal during the welding process.

Figure 3. Microstructure of the stainless steel used to manufacture the 250-L water tank; a) Titanium crystals aligned according to lamination bands in the base material; b) Weld metal with titanium crystals visible in its matrix; c) Weld-metal zone close to the base metal showed a Widmanstätten microstructure.

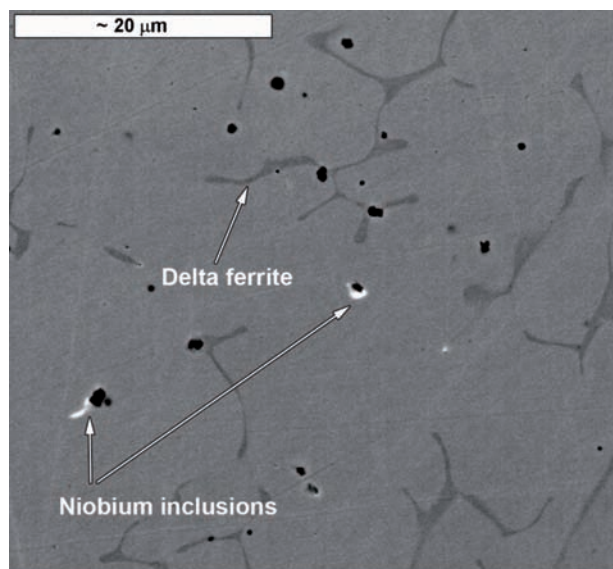
The metallographic study was completed with a detailed scanning electron microscopy analysis using X-ray dispersive energy. This was accomplished by a 3,500 - 5,000 \times magnification of the diverse phases observed in the microstructures. The weld metal thus observed showed an austenitic matrix containing islands of delta ferrite and Nb inclusions (Fig. 4).

Figure 4. Austenitic matrix containing islands of delta ferrite and Nb inclusions in the weld metal. Image obtained using scanning electron microscopy with back-scattering electron (2,000x).

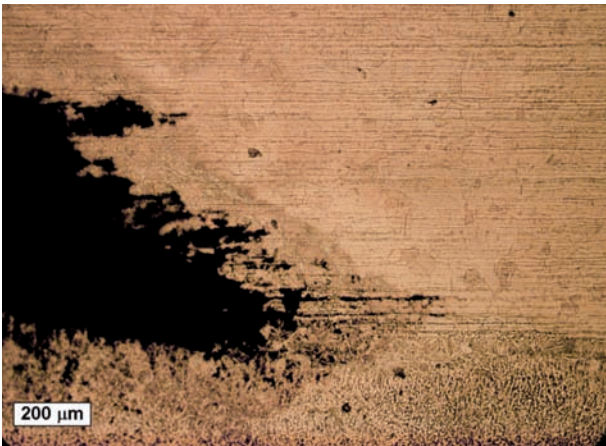
For the metallographic study, a series of cuts were made in the original test material to obtain specimens of the appropriate size for study. These were polished and then subjected to electrolytic etching. Optical microscopy showed that pitting had occurred completely within the weld seam, forming a line along the HAZ and barely entering the base metal through the lamination bands (Fig. 5). However, the corrosion then rapidly progressed towards the inside of the weld seam by following its dendritic structure (the interface between delta ferrite and austenite) (Fig. 6).

Figure 5. Pitting corrosion on the base-metal side. The corrosion has progressed along the lamination bands of the base metal.

Corrosion therefore initiated between the base metal and the weld metal, that is, in the HAZ, and progressed rapidly to the welding zone, which acted anodically, but it also involved the base metal, albeit more slowly.

AISI 321 stainless steel welded with ER347, while less expensive than AISI 316Ti, is inadequate as it is vulnerable to pitting corrosion.

For water tanks currently in use, we recommend magnesium anodes to protect the inside of the tanks.

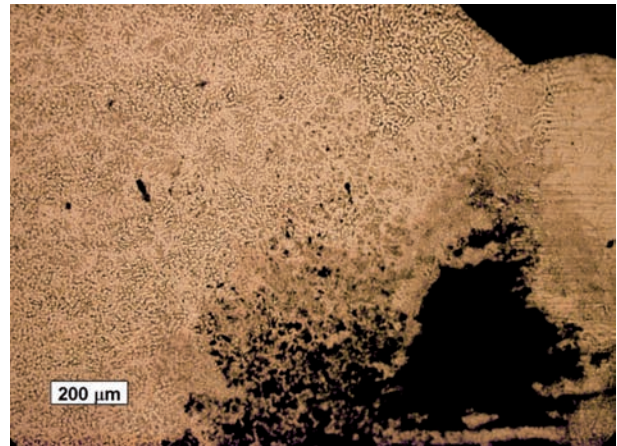
Figure 6. Pitting corrosion on the weld-metal side. The corrosion has progressed along the dendritic phase of the weld.

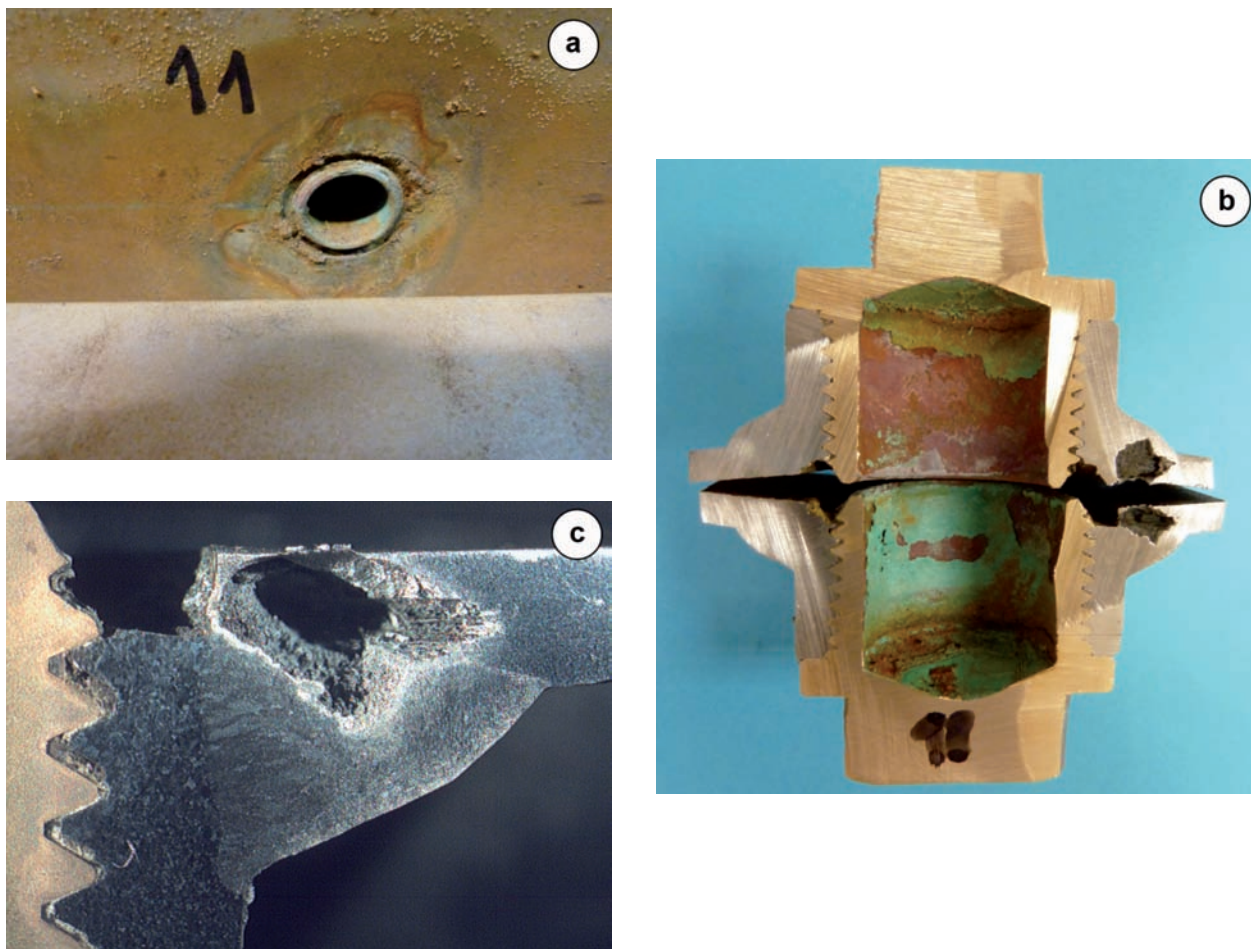
The interior of the corrosion site F - 11 is shown in figure 7a). F - 11 corresponds to a nozzle made of AISI 316 and was located in the lower zone of the tank. The nozzle was not welded on the inside and none of the welds between the nozzles and the shell plate had been made from the inside. Moreover, most of the nozzles, including the one involving F-11, were blind, with bronze plug pipes.

Observation of the F - 11 nozzle from the inside showed two small pitting on the external zone, where the weld metal and base metal met, which had been repaired. Cutting the nozzle in half revealed that the joint between the shell plate and the nozzle had almost completely disappeared due to extensive subsurface pitting. The resulting pits had filled with corrosion products (Fig. 7b) and 7c)).

Electrolytic etching of the polished test specimen showed that in the two pitting zones detected on the inside of the water tank, corrosion ran along the edge of the welding, progressing toward the interior but hardly towards the tank's base metal (Fig. 7c)). In no case did the corrosion involve nozzle material made of AISI 316. As noted above, this was due to the fact that AISI 316 contains Mo, which makes it resistant to pitting corrosion. The influence of alloyed Mo in

Figure 7. a) Interior of the F-11 specimen obtained from the 250-L water tank, corresponding to a nozzle welded only on the outside and fitted with a bronze plug pipe; b) Nozzle cut in two sections; c) Enlargement of b), showing subsurface pitting almost completely occupying the weld section.

Of the materials used in the construction of the water tanks, the best qualities were obtained with AISI 316Ti welded with Mo-containing ER-316L. The presence of Mo confers protection against pitting corrosion.

In the future, tank design can be improved by minimizing the immersion welds, moving some of them to the upper zone, and by eliminating unnecessary nozzles. An increase in the diameter of the nozzles would allow the addition of sacrificial anodes in the form of bars.
