# Performance analysis of a 7-kW crystalline silicon generator after 17 years of operation in Madrid

Eduardo Lorenzo , Roberto Zilles , Rodrigo Moretón , Trinidad Gómez and Ainhoa Martínez de Olcoz

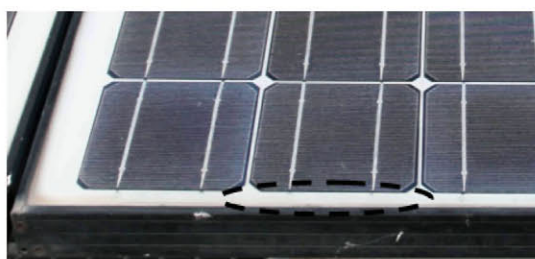
**Figure 1.** (a) General view of the installation. (b) Close-up view of a photovoltaic module. The 2-cm gap between the frame and the solar cells in the bottom part has effectively prevented soiling affecting the energy performance, as well as preserving the electrical insulation.

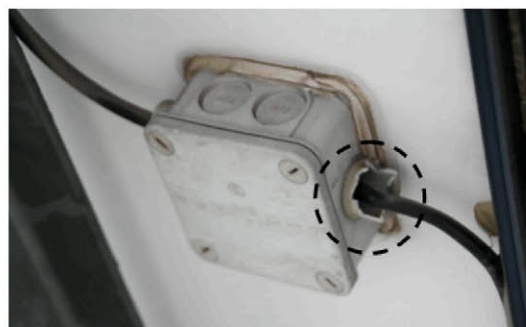
During the first 13 years of exposure to the elements, the only visual symptom of degradation appeared in the terminal boxes. In fact, although these boxes are IP65, they are not specifically designed for PV modules but for general electric installation purposes and they include several lateral holes with their corresponding cable grips. The degradation appeared in the form of cracks at these cable grips (Figure 2). However, it should be mentioned, on the one hand, that these pieces can be easily substituted by new ones and, on the other hand, that this kind of terminal box is not used any more in the PV industry, so that further in-depth comments are not required here.

**Figure 2.** Cracks in the terminal boxes appeared during the first 13 years of operation.

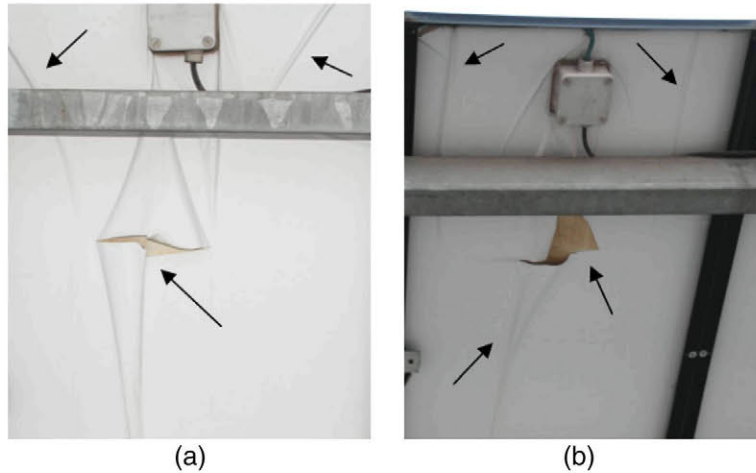
During the last 3 years, serious backsheet delamination has developed at the outer PET/PVF interface (Figure 3), affecting large areas of 62 modules, that is, 69% of the total. According to Reference [5], this indicates a stability problem in the corresponding adhesive used by the backsheet supplier. It is worth remembering that the adhesion between the polymer film (PVF) and the inorganic coating (PET) has been highlighted as a critical aspect of this technology [2,10]. Moreover, degradation symptoms also appeared in the joint between the laminate and the frame (Figure 4). Finally, many solar cells exhibit some colour darkening. Visual appearance suggests that this degradation is due to antireflective coating oxidation, as mentioned by other authors [5]. Table I summarises all the visual defects found and their incidence in the sample.

**Figure 3.** Visual defects appeared after the first 17 years of operation: backsheet delamination at the outer polyester/polyvinyl fluoride interface.

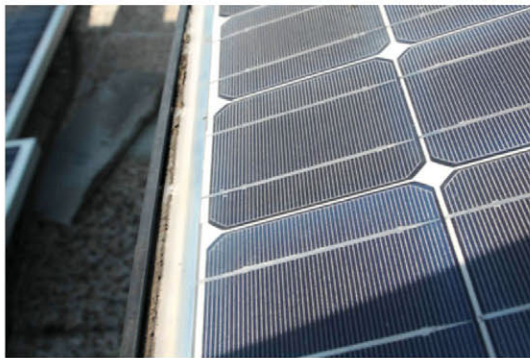
**Figure 4.** Visual defects appeared after the first 17 years of operation: (a) cracks and (b) moss in the joint between the laminate and the metallic frame. Solar cells darkening is also clearly visible in this picture.

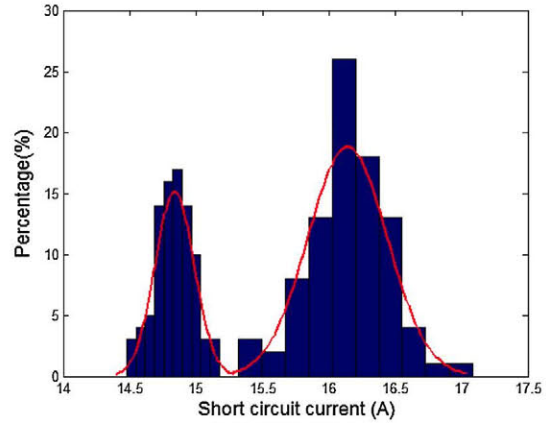
Figure 5. Short-circuit current distribution before (ranging from 15.3 to 17.1A) and after (ranging from 14.5 to 15.2A) the 17 years of outdoor exposition.

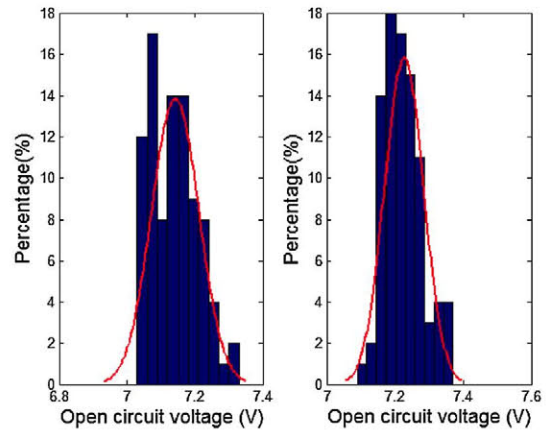
Figure 6. Open-circuit voltage distribution before (right) and after (left) the 17 years of outdoor exposition.

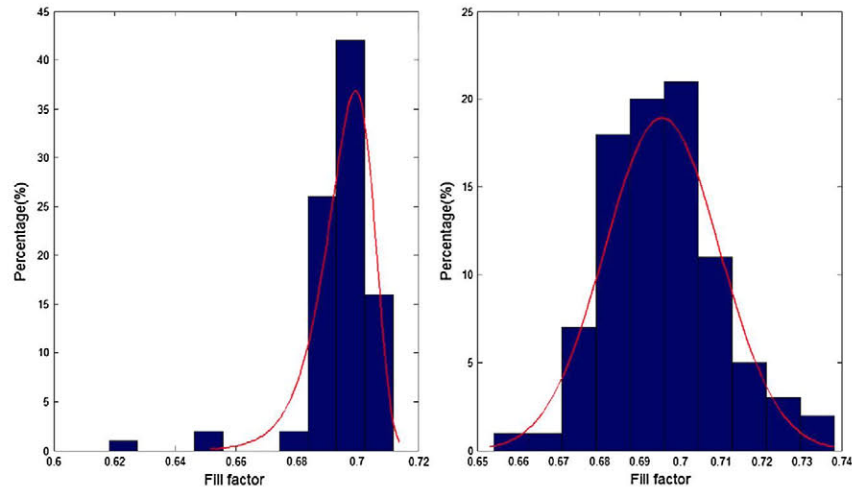
Figure 7. Fill factor distribution before (right) and after (left) the 17 years of outdoor exposition.

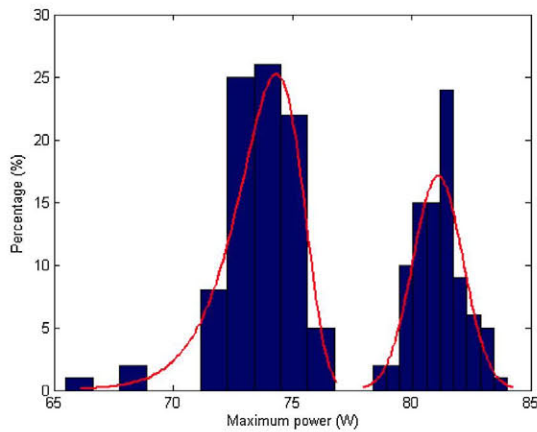
Figure 8. Maximum power distribution before (ranging from 78.4 to 84.0) and after (ranging from 65.5 to 76.8) the 17 years of outdoor exposition.

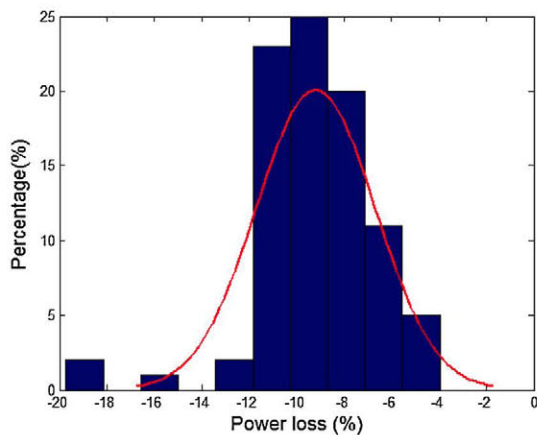
Figure 9. Degradation rate distribution, referred to the power loss.
