# Observed degradation in photovoltaic plants affected by hot-spots

Miguel García , Luis Marroyo , Eduardo Lorenzo , Javier Marcos and Miguel Pérez

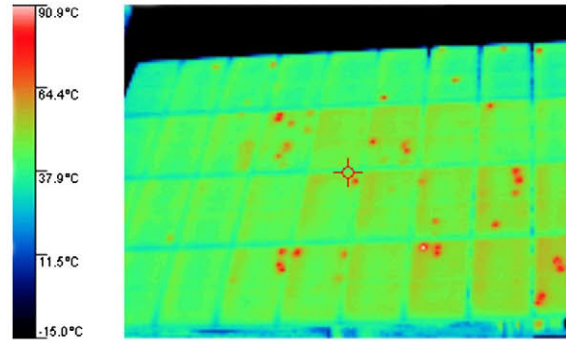
During the first year of operation, all the PV generators had an STC power of more than 90% of the nominal value. However, from 2008 onwards, a number of generators had power outputs of less than 90% of the nominal value. In 2009, the drop in production (i.e., in the STC power output) for the aforementioned generators became more pronounced and other cases also appeared. At the same time, a significant number of blackened points in the TEDLAR were observed on these PV generators, clearly due to a localized heating phenomenon. The presence of those blackened points appeared to be directly related to this lower power output (Figure 2).

**Figure 2.** Thermal image of the defective generator, April 2009.

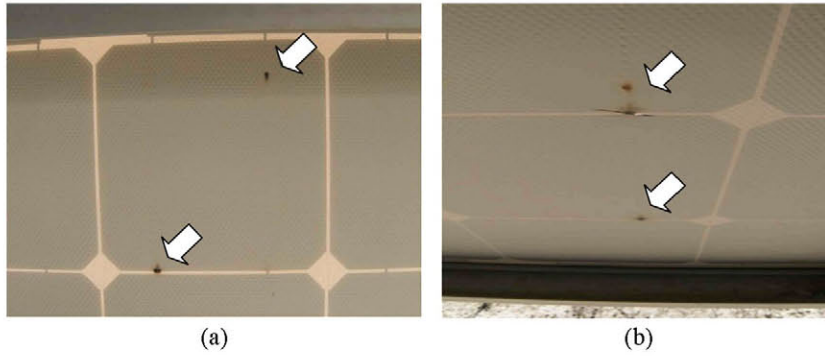
Contrary to former findings [6], the blackened points in this case were located over the two busbar tabs inside the cells (Figure 3). In some of these points, the TEDLAR backsheets were punctured, representing a risk of insulation failure (Figure 3.b).

**Figure 3.** Localized heating effects on the modules of the PV plant. The overheating were produced on the two busbar tabs inside each cell: (a) Blackened points in the TEDLAR and (b) Punctured TEDLAR.

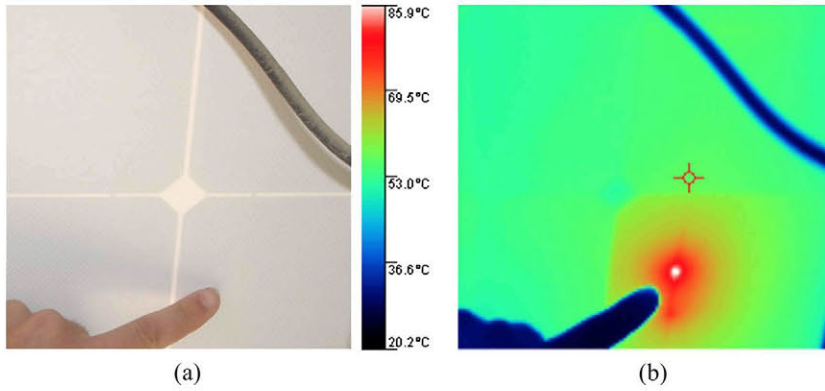
During an initial visual inspection of the modules, it was only possible to detect those localized heatings that had actually damaged the TEDLAR backsheet. However, a subsequent inspection of the plant using a thermal imaging camera made it possible to establish that there were some localized heatings that had reached temperatures close to 150 °C and also that there were a large number of localized heatings that had not yet damaged the TEDLAR. Figure 4 shows one of those localized heating not visible to the naked eye.

**Figure 4.** (a) Image of a module with a localized heating; (b) Thermal image of the module showing how it has a temperature over 85°C. The presence of the overheating is not yet visible to the naked eye.

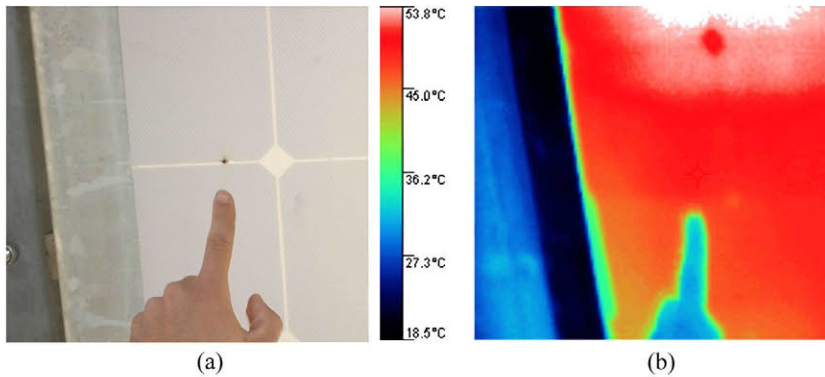
It was also observed how some of the blackened points in the TEDLAR, were no longer hot, as shown in Figure 5. In such cases, the corresponding bypass diode was frequently conducting.

**Figure 5.** (a) Image of the blackened point in the TEDLAR of one of the modules caused by a localized heating. The heat had punctured the TEDLAR. (b) Thermal image of the module in which the overheating does not show up.

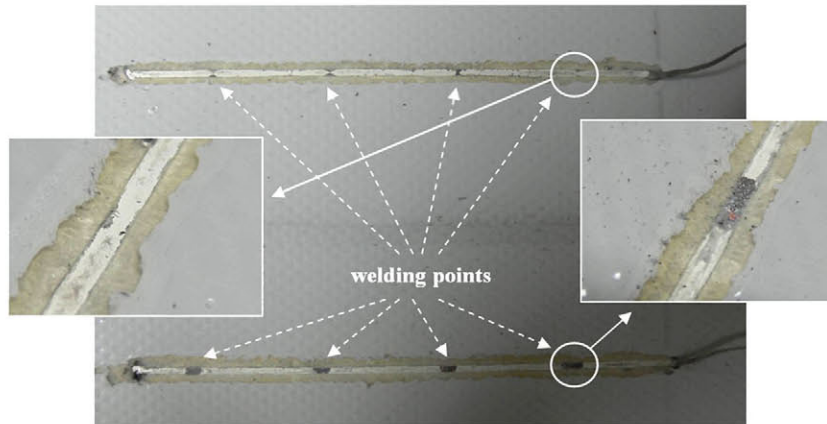
As a simple test to check the condition of the soldering in those cells affected by localized heatings, the busbar tabs were pulled out (once the TEDLAR and EVA layers had been removed). Figure 7 shows the analysis of the imprint left by the tabs: the only electrical contact between the tabs and the metal surface covering the back of the cells occurred at the solder joints. In these modules, there were four solder joints per tab. For the remaining points, the space between the tab and the conducting surface were filled by an encapsulant (electrical insulator). The solder joints for one of the two tabs pulled off (the upper tab) had a very small surface area, indicating a weak weld.

Interestingly, the overheating did not appear on the weakest solder joints but on those tabs that were better soldered (lower tab on Figure 7). To explain this fact, it should be borne in mind that the two collecting tabs are the only path for the current generated by the cell. If both tab solderings have the same electrical resistance, then the current will be divided equally between them. However, if one of these tabs has an abnormally high electrical resistance, then the current would tend to flow through the path with the lowest electrical resistance. The resistance of defective solder joints may be high enough to force almost all the current to pass through the strongest solder joints. This concentration of the current in small areas is responsible for the temperature increase in these areas and is therefore the cause of the hot-spots observed. This cause is different from the one found in other plants also experiencing soldering problems [6].

**Figure 7.** Imprints left by the busbar tab on the back of the cells after being pulled off by hand.

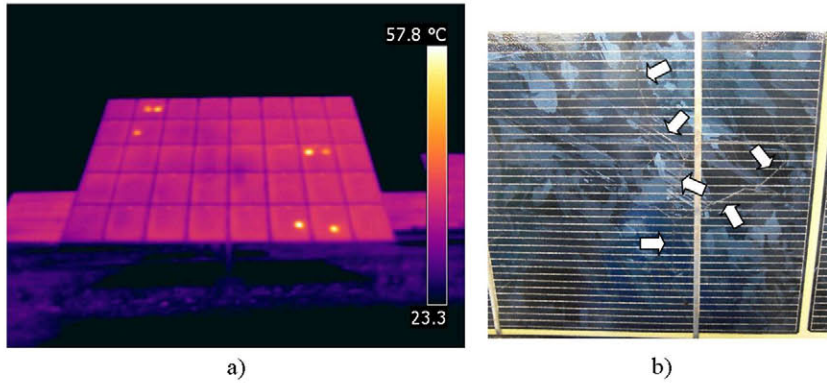
The plant was commissioned in 2007. A thermal imaging inspection carried out in 2010 showed a large number of cells with temperatures that were considerably higher than the rest

**Figure 9.** (a) Thermal image of a PV generator with five modules affected by hot cells and (b) Image of one of the hot cells (cracked cells).

(around 15 °C higher, with approximately 1000 W/m<sup>2</sup> irradiance), as shown in Figure 9.

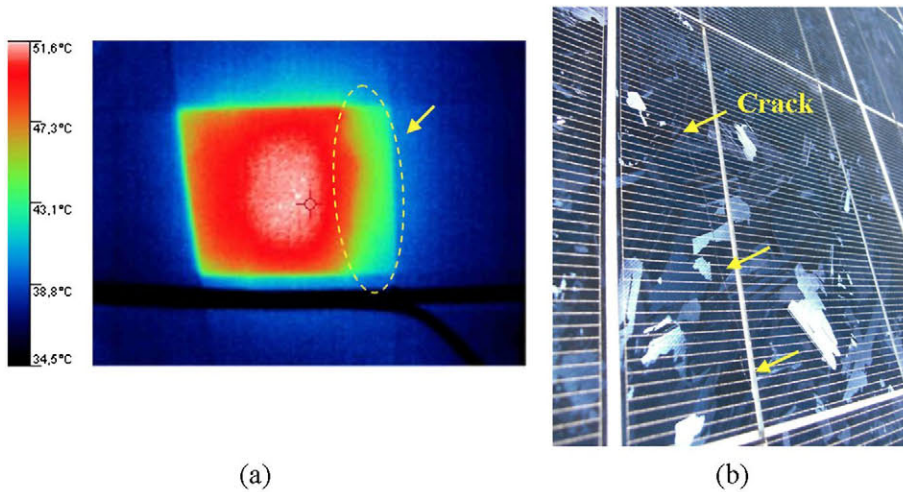
Given the fact that a thorough inspection revealed the presence of micro-cracks in a large number of hot cells (Figure 11b), it was decided to study the problem in greater detail.

**Figure 11.** (a) Thermal image and (b) Image of the front side of a cracked cell.
