# Case study in failure analysis of accelerated life tests (ALT) on III-V commercial triple-junction concentrator solar cells

**Abstract** — In this work the failure analysis carried out in III-V concentrator multijunction solar cells after a temperature accelerated life test is presented. All the failures appeared have been catastrophic since all the solar cells turned into low shunt resistances. A case study in failure analysis based on characterization by optical microscope, SEM, EDX, EQE and XPS is presented in this paper, revealing metal deterioration in the bus bar and fingers as well as cracks in the semiconductor structure beneath or next to the bus bar. In fact, in regions far from the bus bar the semiconductor structure seems not to be damaged. SEM images have dismissed the presence of metal spikes inside the solar cell structure. Therefore, we think that for these particular solar cells, failures appear mainly as a consequence of a deficient electrolytic growth of the front metallization which also results in failures in the semiconductor structure close to the bus bars.

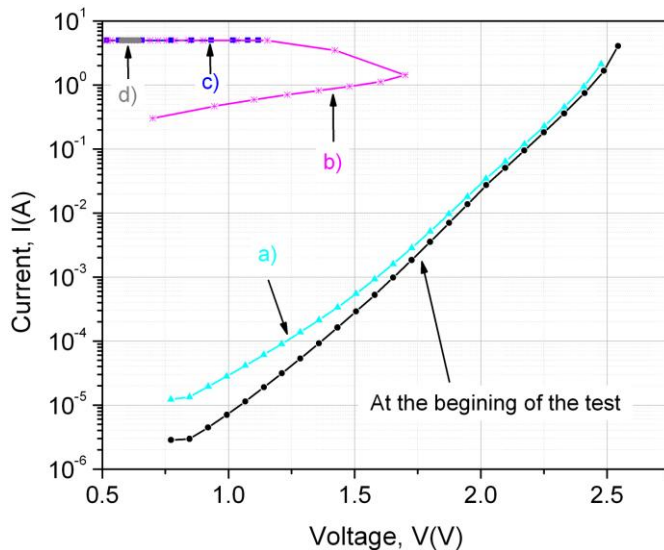
During the temperature ALT carried out, the dark I-V curves of the solar cells inside of the climatic chambers have been periodically measured. All the failures presented in the three climatic chambers have been catastrophic since all the solar cells turned into low shunt resistances (point d). In figure 1 the typical evolution of the dark I-V curve of the solar cell tested is depicted. It has to be pointed out that the source meter was limited to 5 A. Therefore, the flat region in the thyristor-like curve (point b) and in the low shunt resistance (points c and d) is due to the limitation of the current.

Figure 1. Typical evolution of the dark I-V curves of the solar cells tested inside of the climatic chambers.

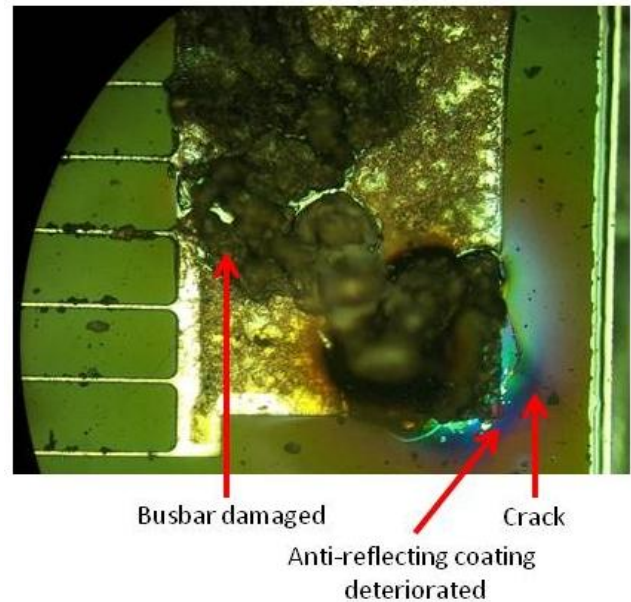
The first step has been to carry out a visual inspection by optical microscope. In figures 2, 3, and 4 we can observe the typical damage presented in the solar cells tested at low (119 °C), medium (126 °C) and high temperatures (164 °C).

In figures 2-4, we observe that for all the test temperatures, the bus bars have been damaged; we can clearly observe regions where the electrolytically grown silver has been detached from the evaporated metal. In fact, this effect is also observed in the fingers.

In all the solar cells, at any temperature, we observed cracks in the semiconductor surface next to the deteriorated region in the bus bar.

Figure 2. Microscope photograph of the typical evolution of the front metallization in a solar cell tested at low temperature (119°C).

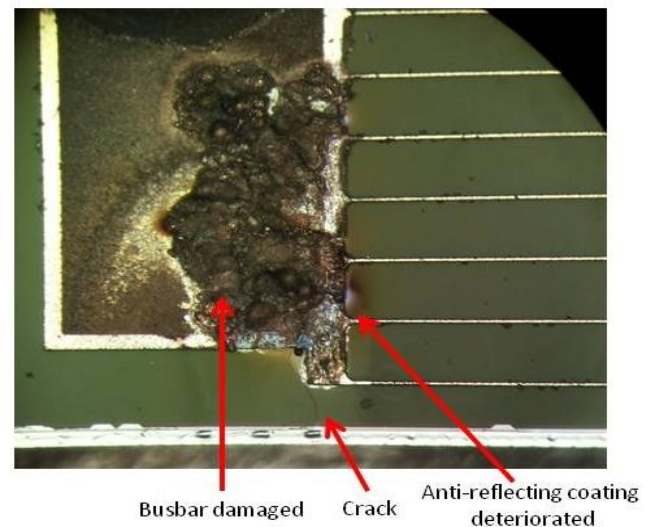
Figure 3. Microscope photograph of the typical evolution of the front metallization in a solar cell tested at medium temperature.

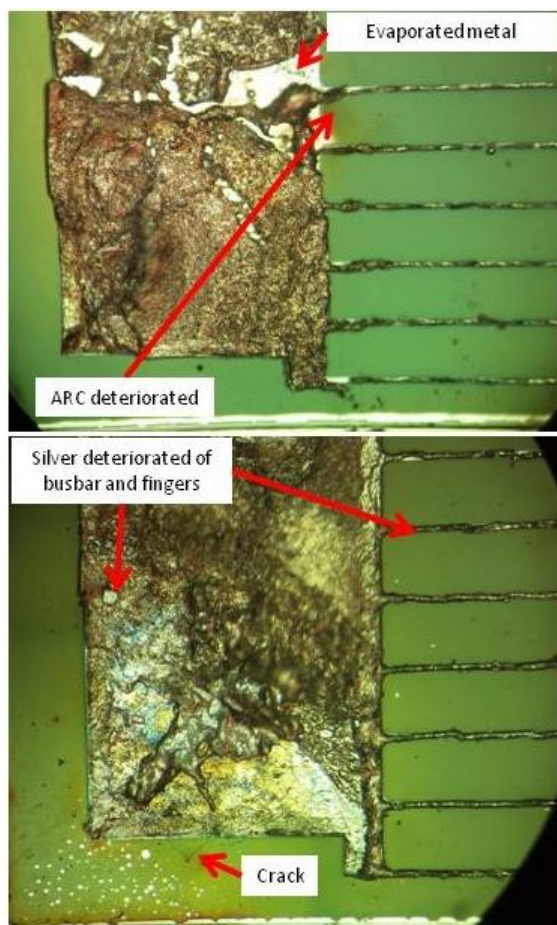
Figure 4. Microscope photograph of the typical evolution of the front metallization in a solar cell tested at high temperature (164 °C).

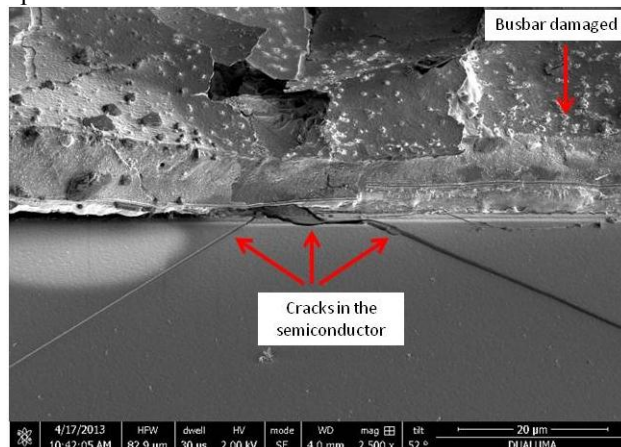
In order to better observe the evolution of the degraded bus bars and to evaluate their impact on the degradation of the semiconductor structure, SEM images have been taken. In figure 5, we can clearly observe how the bus bar is torn apart and it is raised up. Cracks in the semiconductor surface are observed and they could be due to a mechanical stress suffered by the different thermal expansion coefficients of metal and semiconductor. In figure 6 we observe that the cracks detected at the surface of the semiconductor also propagate inside the semiconductor structure. At this point, it is important to point out that we do not know if the cracks observed in the semiconductor are responsible of the failure in the solar cells (turning them into low shunt resistances) or if they appear after the failure. In order to clarify this doubt, in figure 7 we can discern that the part of the metal raised up corresponds to the electrolytically grown silver. The

Figure 5. Cross section SEM image of the front metallization in a solar cell tested at medium temperature.

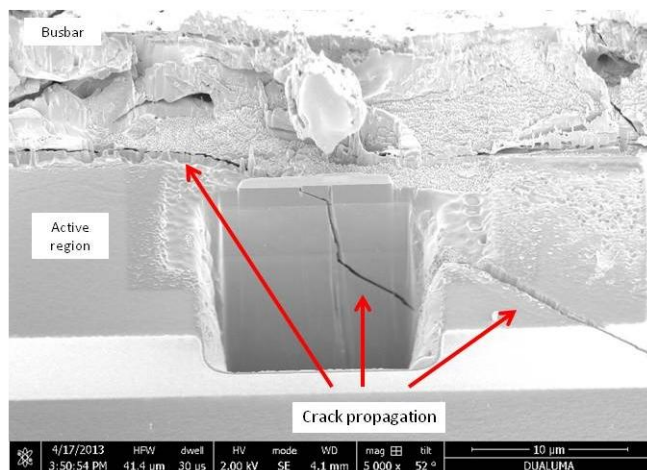
Figure 6. SEM image of a crack propagation.

cracks in the semiconductor structure. Two kinds of cracks can be discerned. Some of them are fractures which seem to be originated in the semiconductor surface close or beneath the bus bar and to propagate into the semiconductor structure as the ones shown in figure 6. As we pointed out above, these cracks seem to be due to the mechanical stress existing between the degraded metal and the semiconductor structure. The other kind of cracks seems to evolve in the opposite sense from the semiconductor structure towards the surface, as the one shown in figure 11. Finally, it has to be pointed out that no cracks were detected beneath or close to the bus bars of the reference solar cells what suggests that these cracks are promoted by current flow.

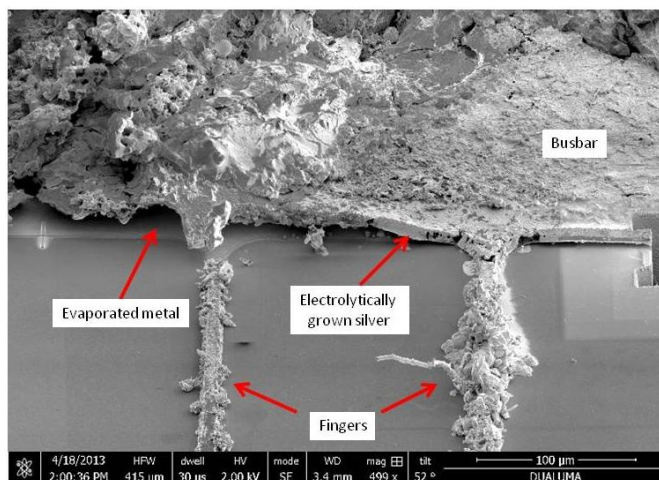
previously evaporated metal seems to be intact. It should be pointed out that the metal gap observed in figure 7 is about 20 microns. In figure 8 we detect that the electrolytically grown silver has also lift-off from the fingers, just remaining the evaporated metal.

Figure 7. SEM image of the evolution of the metallization.

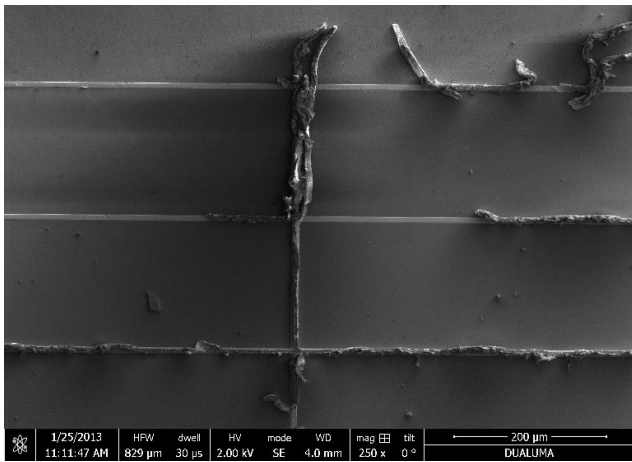
Figure 8. Upper view SEM image of the metallization of the fingers of a solar cell tested at low temperature

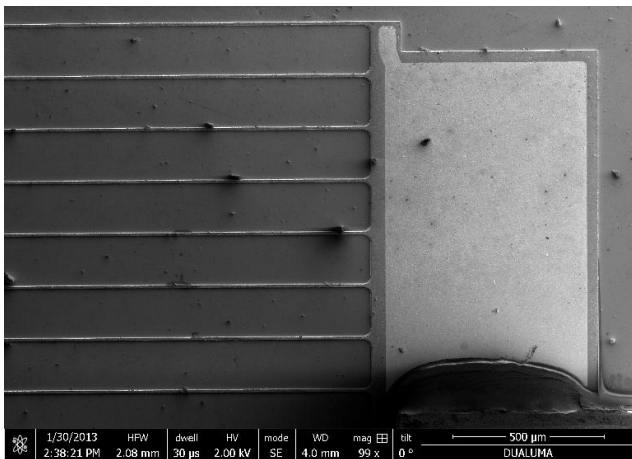
For comparison purposes, figure 9 present a solar cell which was inside the climatic chamber but current was not injected into it (reference solar cell). The cell presents the bus bar intact. Therefore, stressing with high temperatures but without the simultaneous current injection does not promote the degradation of the front metallization and the subsequent solar cell degradation resulting in a low shunt resistance.

Figure 9. Upper view SEM image of the intact front metal of a reference solar cell

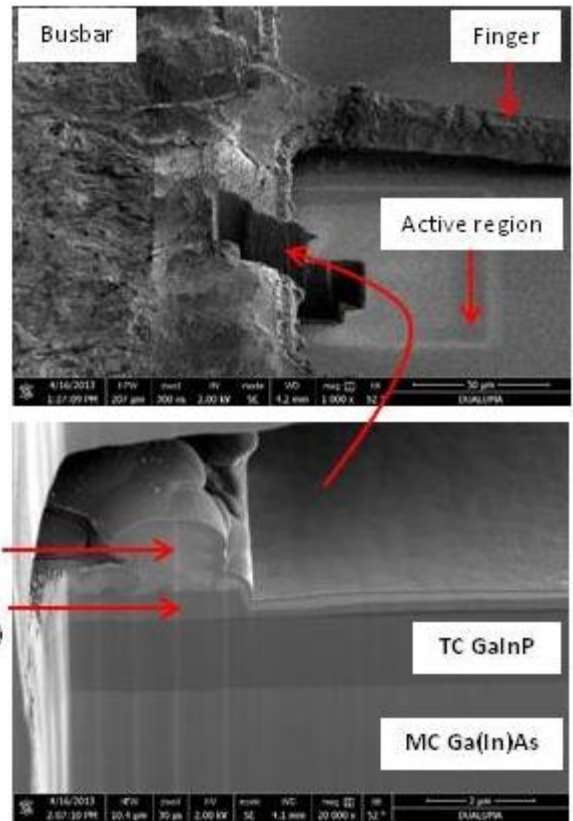
Figure 10. Cross section SEM image of a degraded solar cell. No metal spikes penetrating in the semiconductor structure beneath the bus bar are detected.

We have not detected any metal spike into the solar cell structure in none of the cross section SEM images. We can observe that the evaporated metal is undamaged (see figure 10). Therefore, there has not been electromigration into the semiconductor structure. However, again we have observed

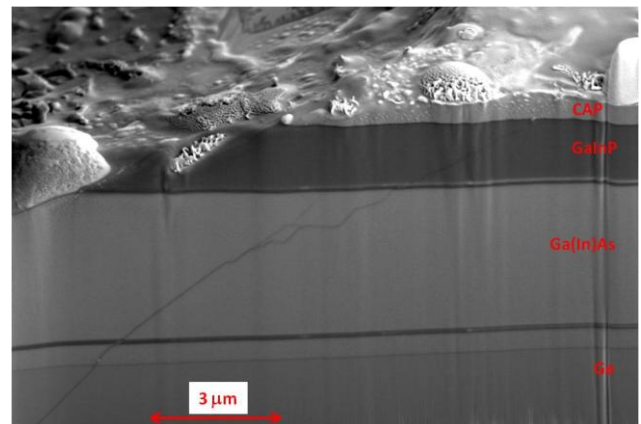
Figure 11. Cross section SEM image of the semiconductor structure beneath the degraded bus bar.

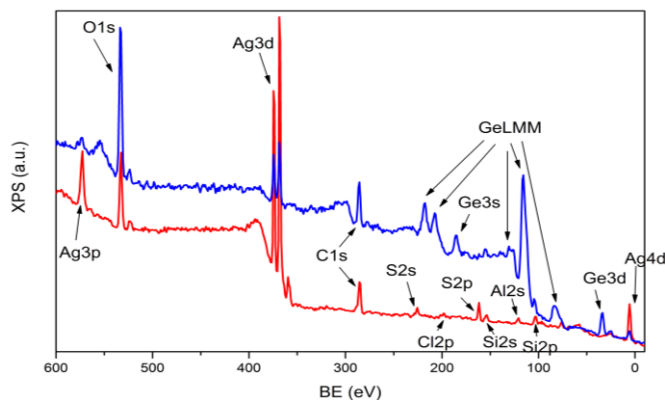
The chemical composition of the solar cell's bus bars has been investigated by using XPS. The X-ray photoelectron spectrometer used has been a Thermo Scientific Multilab 2000 system fitted with a dual-anode (MgK $\alpha$ , AlK $\alpha$ ) X-ray source and a 110 mm mean radius hemispherical sector analyzer with a seven-channeltron detector. As it can be observed in figure 12, there are remarkable differences between the composition of a degraded bus bar (blue line in figure 12) and that of a non-degraded one (red line in figure 12). In the surface of the last one, it should be noted the presence of sulfur, aluminum, silicon and chlorine, the last three elements in a very small quantity. In the surface of the damaged bus bar it is evident the apparition of germanium, - note the intensity of the core levels Ge3s, Ge3d and the Auger transition GeLMM-, together with an increase of the quantity of oxygen. Sulfur, aluminum and chlorine have disappeared. The intensity of the Ag signals has dramatically decreased in this bus bar spectrum.

Figure 12. XPS partial survey spectra of a non-degraded bus bar (down, red line) and of a degraded bus bar (up, blue line).

The germanium found in the surface of a degraded bus bar is strongly oxidized as it is demonstrated through the analysis of the Ge2p core level (not shown). This fact and the evolution of the silver to its oxidized form in this bus bar justify the observed increase of the O1s signal in the survey spectrum of the degraded bus bar.

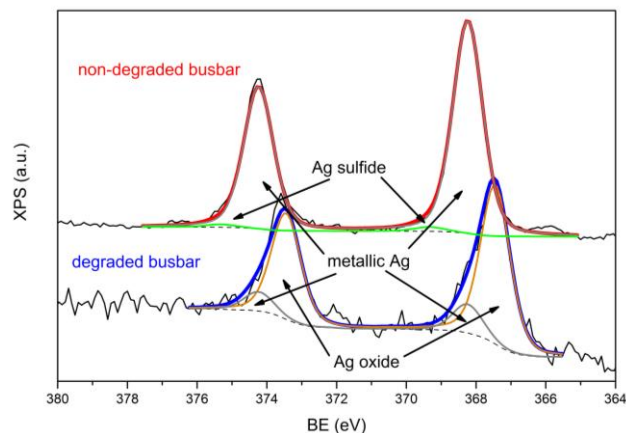
The analysis of the Ag3d doublet core level shown in figure 13 reveals that the main constituent of the non-damaged bus bar is metallic Ag while a very small quantity of silver is linked to sulfur, forming an Ag sulfide. The S2p spectrum analysis (not shown) confirms the presence of silver sulfide.

However, the deconvolution of the Ag3d core level for the degraded bus bar shows a very different composition. In this bus bar the quantity of metallic silver has decreased to 15% while the rest of the signal corresponds to silver oxide.

Figure 13. Deconvolution of the Ag3d core levels signal corresponding to a non-degraded bus bar (upper line) and to a degraded bus bar (lower line), showing the constituents of both signals.

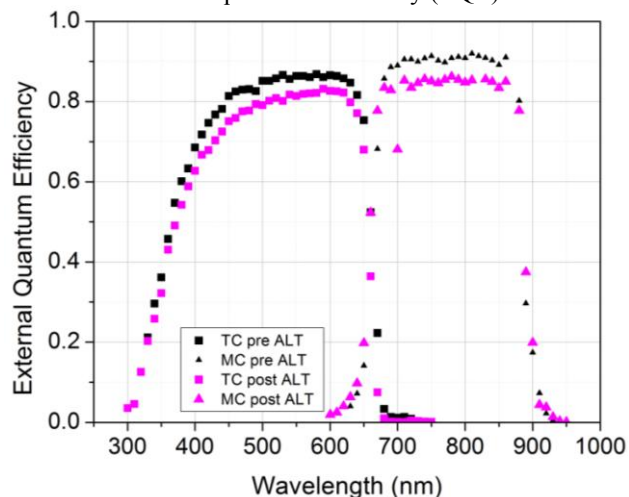
Figure 14. EQE of the top cell (TC) and middle cell (MC) before the ALT (black) and in a small piece in the center of the solar cell after the ALT (magenta) when the solar cells have turned into shunts.

In figure 14, the EQE of the top cell (TC) and middle cell (MC) before the ALT and in a small piece of the same solar cell after the ALT have been depicted. We do not observe significant differences. Therefore, we can conclude that the semiconductor structure has not been significantly degraded, at least far enough from the degraded bus bars.
