Construction of a high anchored wall at highway EX-A1 (Spain)

A. Gómez¹, A. Soriano², E. Carrera³ and A. Soriano-Martínez⁴

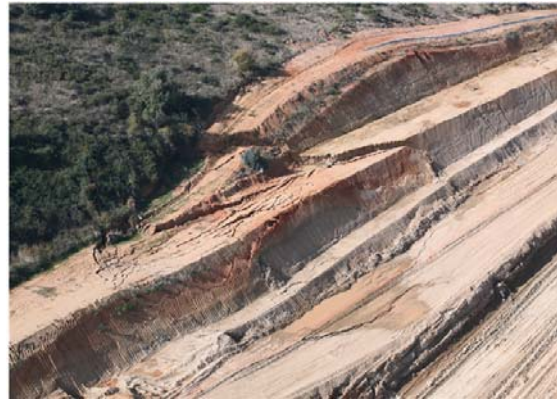
Figure 2.- Observed failure during construction

The excavation of this cut resulted unstable. A clear scarp appeared behind the upper part of the slope and the vertical movement of the sliding mass amounted to more than 1 m near the crest of the slide. The picture included in Figure 2 was taken a few months after the failure.

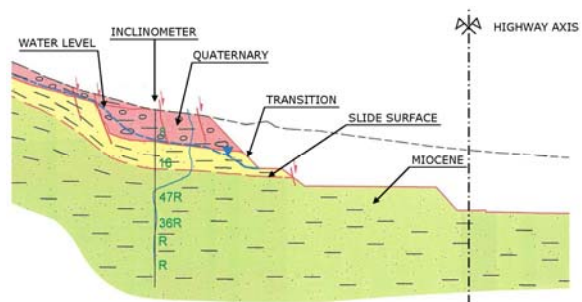
Figure 3.- Scheme of the observed failure surfaces. Geotechnical report after sliding. Translated from the original drawing made by Rodríguez Ortiz and Rodríguez Jurado, 2010

A scheme of the possible failure surfaces is indicated in Figure 3.

The angle of friction at the sliding surface (transition soft rock) was supposed to be about $\phi = 15^\circ$. For this strength value, the pore water pressures needed to explain the failure had to be as high as that indicated by a pore pressure factor $r_u = 0.25$. Some other combination of these two parameters (larger ϕ with larger r_u or lower ϕ with lower r_u) could also explain the failure but no easy way was found to measure pore pressure and no reasonable testing could be done on the actual strength at the failure surface due to the difficulty of testing soils at this particular location. The angle of friction used for this purposes seems reasonable for the residual strength of the low to medium plasticity clays that exist at this place.

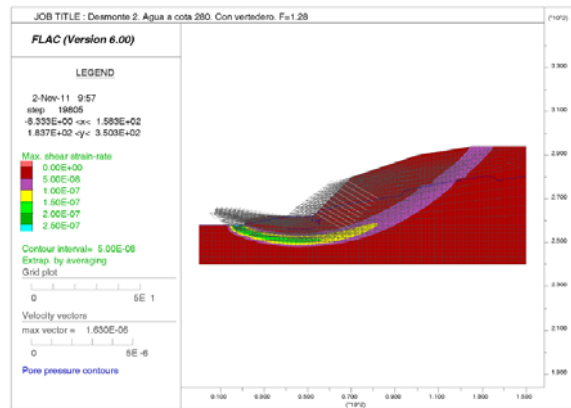
Figure 5.- Type of failure for a particular design situation

The type of expected failure, in case the ground strength is lower than that used for calculation is indicated in Figure 5. This particular situation corresponds to the phase of construction immediately before the placement of the final fill and with a water table situated at the medium expected level. For this situation, which is the more critical during construction, the resulting factor of safety, for the highest reasonable water table, is $F = 1.1$. For long term condition the expected factor of safety being $F \geq 1.3$.

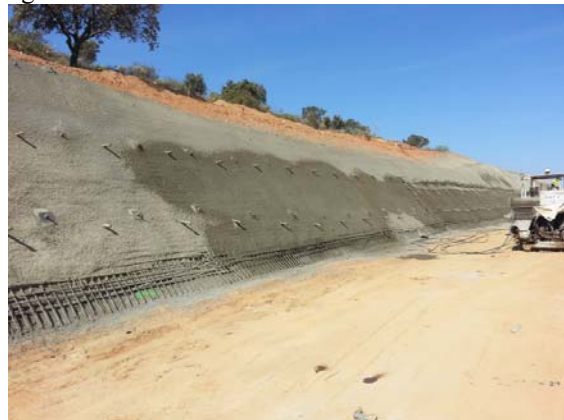
Figure 7.- Anchored wall wader execution

The photograph included as Figure 7 shows a view of the wall when it had a height of 4 m; that its two wall strips, each one 2 m high.

At this situation, when only the upper 4 m of the wall were finished, the excavation near the toe of the cut was initiated in order to reach the final explanation level for the highway. This was aimed to advance the general construction schedule. But this excavation reactivate the sliding of the ground between the anchored wall and the future highway as indicated in Figure 8.

- Increase the length of the anchors of the two lower rows of the wall from 12 m to 16 m.
- Substitution of the concrete wall that was to be built at the toe of the cut by a second anchored wall 4 m high built with the same procedure as the main anchored wall.

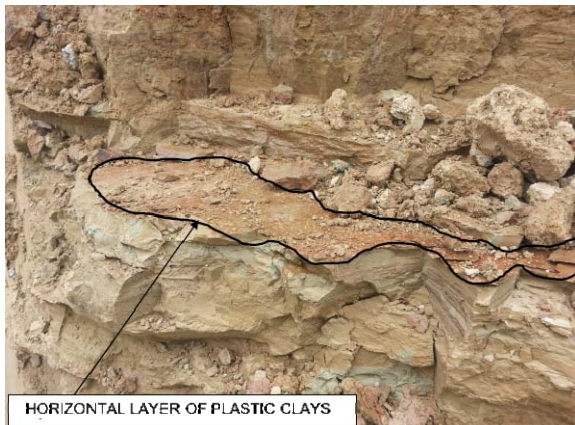
Figure 9.- Detail of a fossil sliding plane

During the construction of the lower part of the main wall and during the construction of the lower anchored wall, the structure of the soft Miocene marls was examined. Figure 9 indicates a fine layered clayey stratum near a separation surface (old sliding plane) where a few millimeters thick layer of clays exist and is thought to be the cause of the initial slide of this excavation as well as the second slide that took place during the execution of the solution, front of the upper anchored wall.

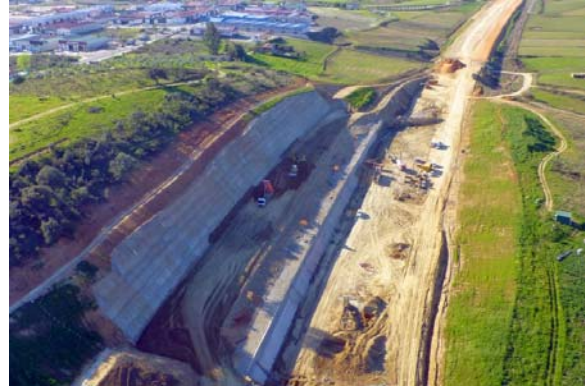
Figure 10.- View of upper and lower anchored walls

Excavations were completed with no other major incidents. Figure 10 includes a view of the situation of the walls (upper and lower anchored walls) when all excavations were finished and the final fill placement is under execution.

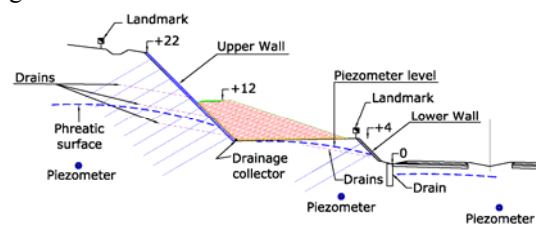
Figure 11.- Scheme of the observation of movements and pore pressures

Data of most interest in order to assess the stability of the cut were thought to be the movements of the anchored walls and the piezometric elevation of groundwater. In order to obtain this information, landmarks were placed along the crest of the upper and lower walls, at 20 m intervals. Some piezometers were placed within the marls, as indicated in Figure 11.

All piezometers used for this particular cut (a total of nine units) indicate pore-pressures much lower than those that could be obtained by other observations. Drains placed at the toe of the upper wall, as well as those of the lower wall, were draining some small flow of water. These observed facts indicate that the piezometric level, at the central section of the cut, should be at a position similar to the one indicated in Figure 11.

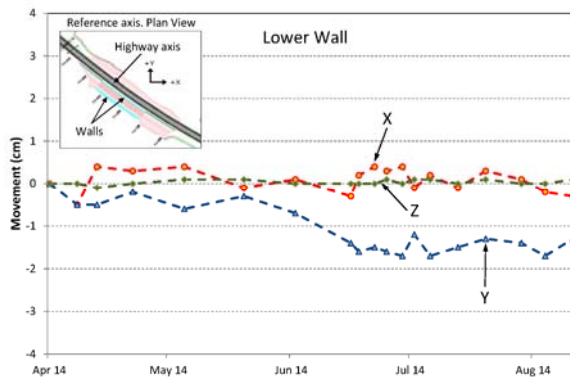
Figure 12.- Observed movements at the central section of the lower anchored wall

During the month of June 2014 and due to the final transitory excavations needed to prepare the highway platform, some movement took place at the crest of both walls as indicated in Figure 12, for the central section of the lower wall. For other sections movements were quite similar. The maximum observed movements are quite low and mainly due to the final excavation process.
