CHANSON, H. (2000). "A Review of Accidents and Failures of Stepped Spillways and Weirs." *Proc. Instn Civ. Engrs Water and Maritime Engrg*, UK, Vol. 142, Dec., pp. 177-188 (ISSN 0965-0946).

## A REVIEW OF ACCIDENTS AND FAILURES OF STEPPED SPILLWAYS AND WEIRS

by Hubert CHANSON

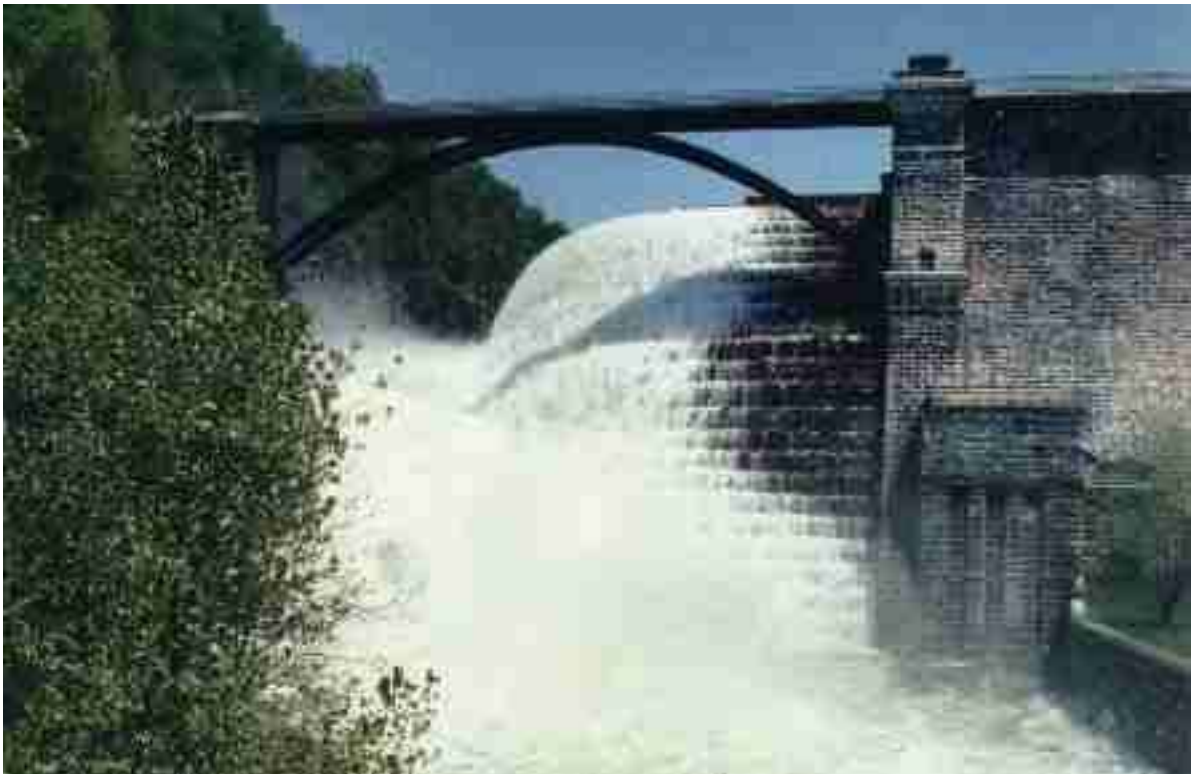
The spillway damage was caused by an improper spillway intake and, further, overflow conditions at the transition between nappe and skimming flow aggravated the severity of the damage (CHANSON 1995).

The spillway was heavily damaged in 1955 during flood release ( $650 \text{ m}^3/\text{s}$ ) less than the design capacity ( $1550 \text{ m}^3/\text{s}$ )

Fig. 3 - New Croton dam spillway (Courtesy of Matthew HILLER) - Recent photograph during a small overflow

In October 1955, the spillway was heavily damaged during a  $650 \text{ m}^3/\text{s}$  overflow. Extensive repairs were carried out between 1955 and 1957 (MARSH 1957), and the stepped chute is still used.

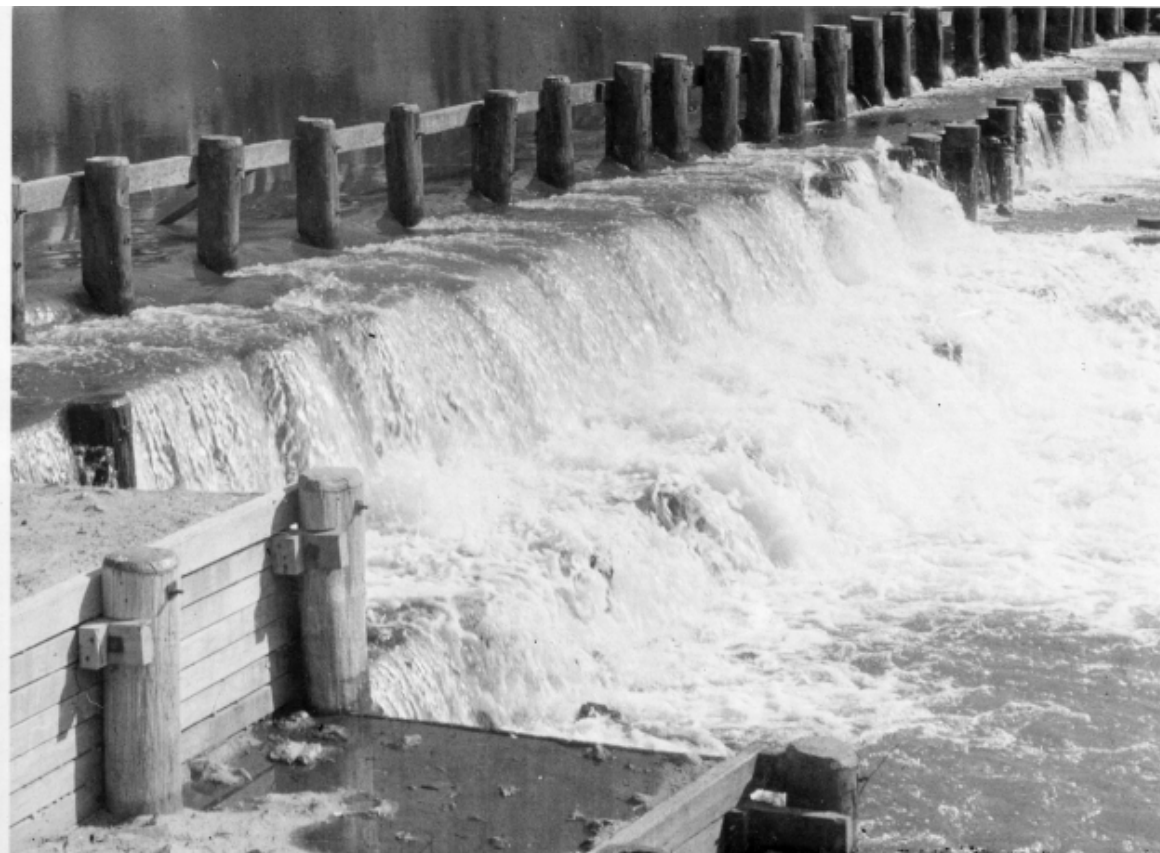
(B) Small overflow on 19 April 1955 (Courtesy of the Department of Natural Resources)

The failure of the Bonshaw weir occurred during the overflow event. Both abutments failed. The left abutment was bypassed and it was heavily scoured. The right abutment and a section of the weir were washed away. The failure resulted from an average quality of construction and poor abutment foundations.

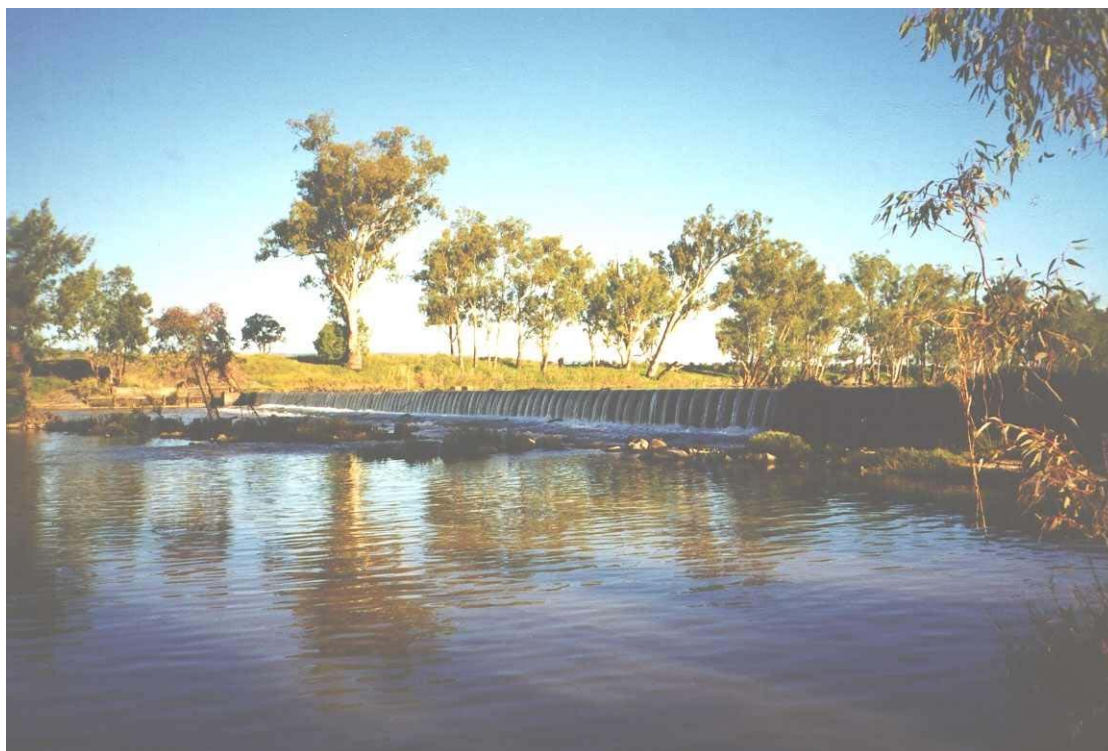
(C) View from the present weir from the left bank : note the ruins of the first weir in the foreground, downstream of the sheet-pile cascade (Photograph taken in February 1998)

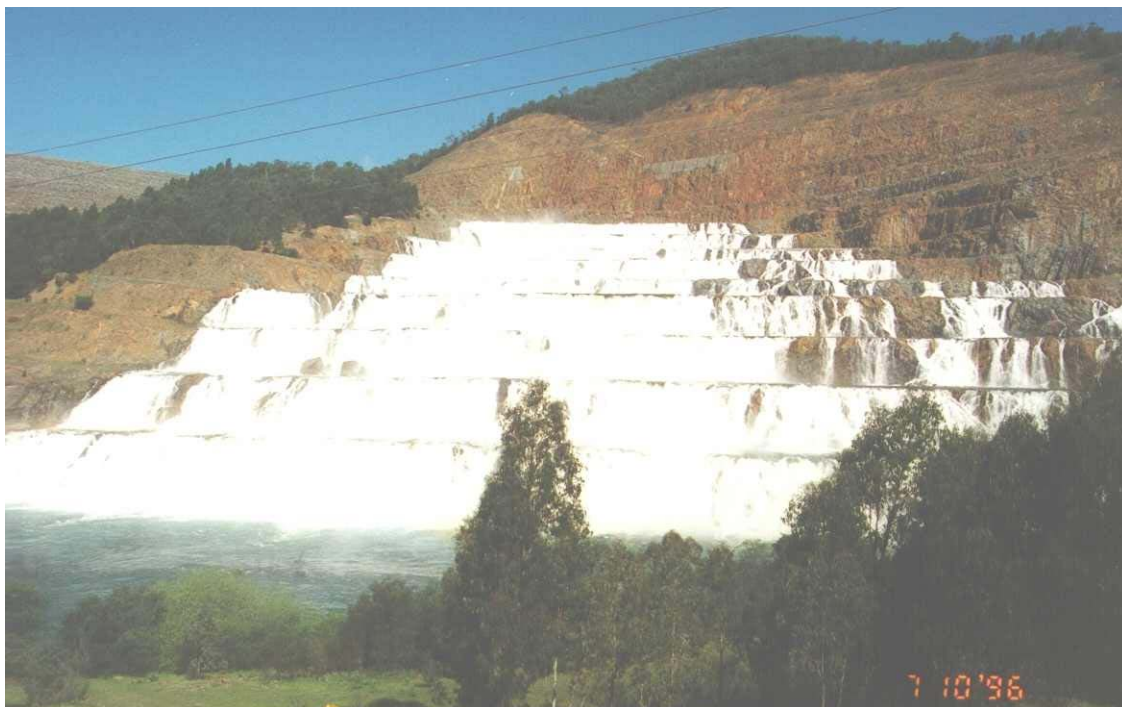
Fig. 6 - Dartmouth dam spillway during the 1996 overflow ( $Q_w \sim 225 \text{ m}^3/\text{s}$ ) (Courtesy of Mr JEFFERY, Goulburn-Murray Water)

During the 1996 flood ( $Q_W \approx 225 \text{ m}^3/\text{s}$ ), the unlined rock spillway was partially damaged. Although the discharge was much lower than the design flow rate, significant erosion was observed at several steps because of flow concentration in the right side of the cascade.

(A) Spillway view from downstream : note the flow concentration in the middle of the photograph and the absence of flow on the right edge of the photograph

Repairs were undertaken in 1996 and 1997 that included the provision of shotcrete protection and construction of anchored concrete retaining walls in the three upstream steps. Walls were built to prevent concentration of low-level flows in some areas.

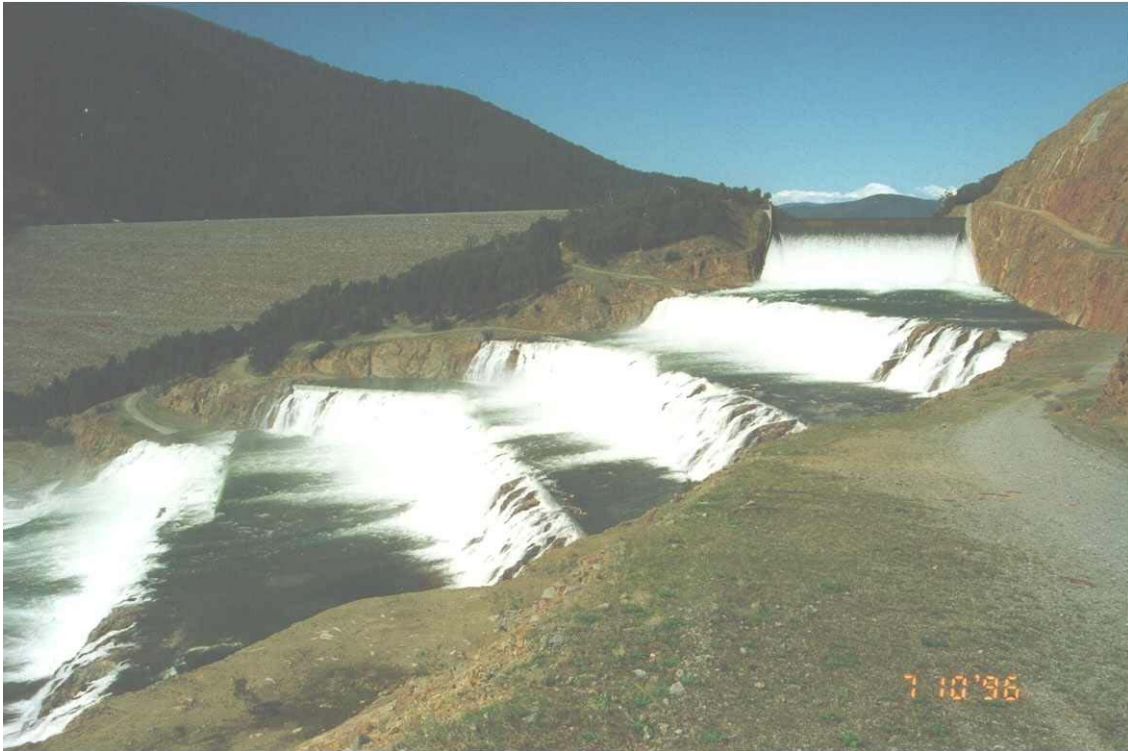
Fig. 6 - Dartmouth dam spillway during the 1996 overflow ( $Q_w \sim 225 \text{ m}^3/\text{s}$ ) (Courtesy of Mr JEFFERY, Goulburn-Murray Water) (B) Details of the cascading flow from the left bank, showing the concrete-lined chute and the first steps

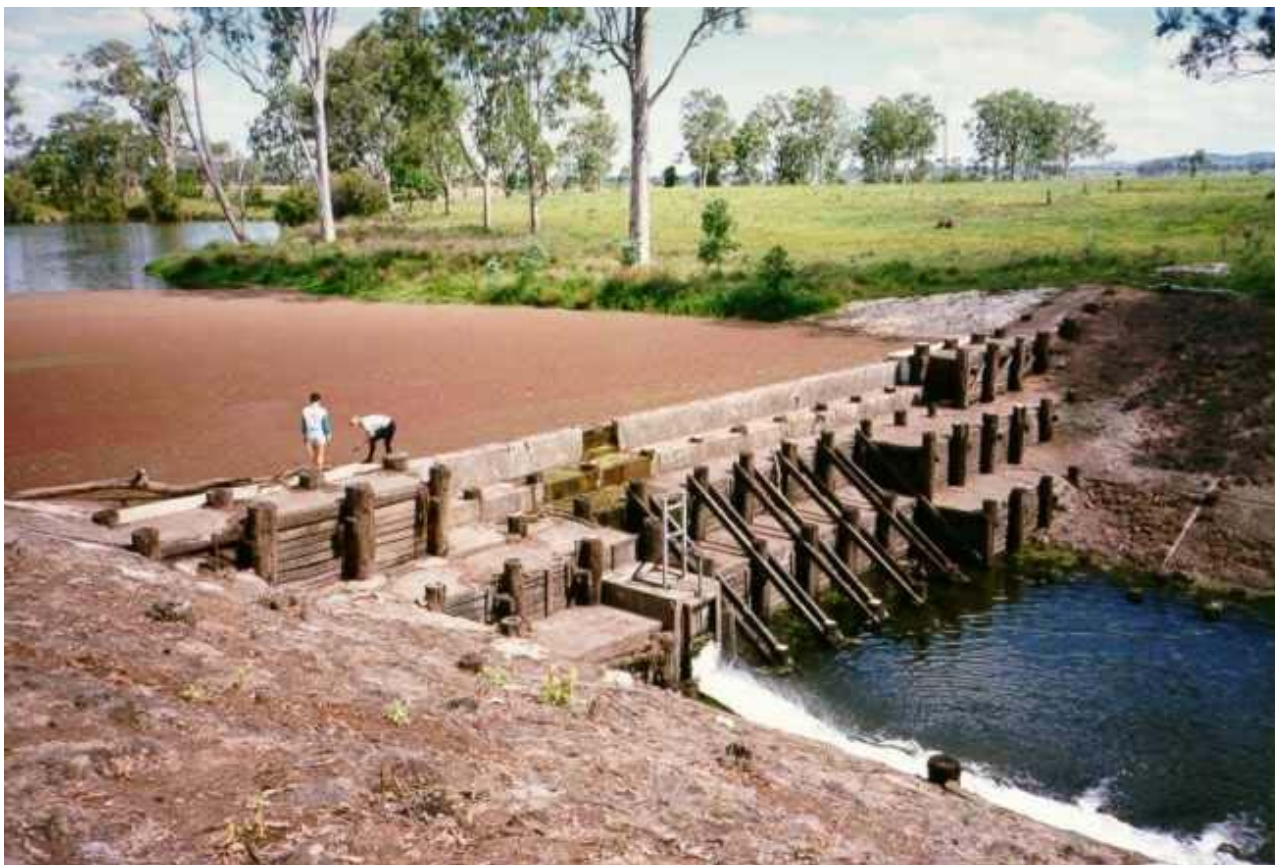
During the refurbishment, an earthfill cofferdam was built 20-m upstream to de-water the weir. A flood event took place while the weir was dry and the clayfill was removed. The cofferdam was overtopped on 7 February 1995 and the resulting flood wave submerged the weir. The weir was overtopped by over 1-m of water and overtopping lasted for 24 hours, with seepage through the timber cribs for a further 12 hours before repairs could start. After the event, inspections showed that the weir sustained the flood wave without major damage. The overtopping was filmed and the document highlighted the good stability of the structure, the significant energy dissipation during large overflow, and seepage through the rockfill material during the receding flood surge.

(C) Refurbished weir viewed from left bank : the upstream concrete wall is clearly visible (Photograph taken in November 1997)

The Silverleaf weir was built between 1951 and 1953 for stock water. The 5.1-m high weir was designed as a timber crib piled weir with concrete protection of the four steps (Fig. 7). The upstream wall was sealed with a clay embankment held by boulders set in mortar. The weir was refurbished in 1995 with the installation of a new outlet, construction of an upstream vertical concrete wall to replace the clay fill and to heighten the weir crest by an additional concrete step, and construction of a counterweir downstream.
