Fretting and Corrosion between a metal shell and metal liner may explain the high rate of failure of R3 modular metal on metal hips

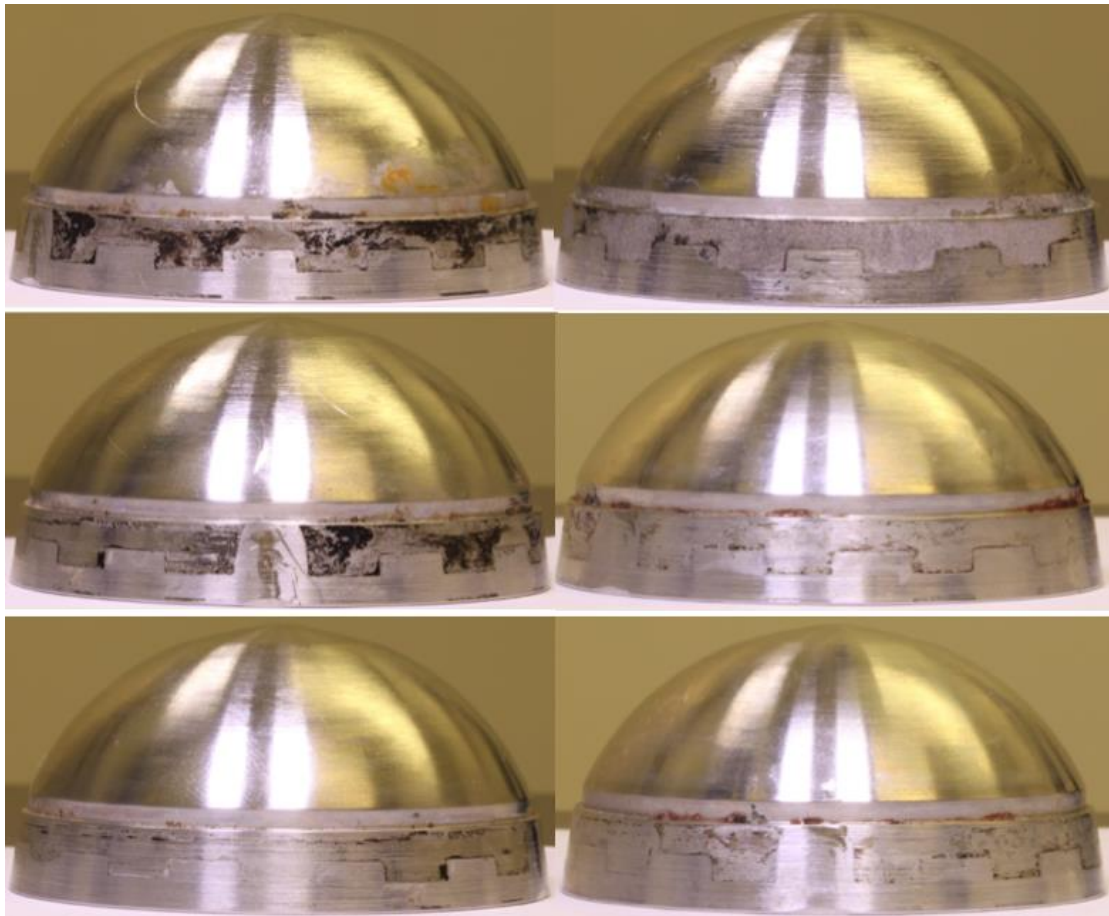
Visual analysis of each acetabular shell showed a band of debris on the inner surface, below the hard-bearing taper locking mechanism. The backside of the R3 metal liners illustrated evidence of surface damage and black debris in the same area. The areas of corrosion were clearly demarcated into a 'castle parapet' shape (figure 1). These areas of corrosion were found circumferentially at the equator of the metal liner. SEM micrographs of the backside of the liner illustrated evidence of pitting within the areas of corrosion and confirmed that the corrosive damage was clearly within the boundaries of the 'castle parapet' shape (figure 2). EDAX confirmed corrosive debris, rich in titanium (figure 3)

The corrosion on the backside of the retrieved metal liners in this study appears to have a clear pattern. Micrographs highlighted that there was a clear border as to which areas were corroded. These areas are exactly matched to corresponding areas on the inner surface of the shell illustrating that the geometry of the R3 acetabular shell does not fully conform to the metal liner. The R3 polyethylene liner is different to the ceramic and metal liners as it has anti-rotational tabs to prevent torque and allow a lock fit with the grooves on the acetabular shell. The insertions for the polyethylene tabs are visible on the inner surface of the R3 acetabular shell (figure 4). The metal liner does not have anti-rotation tabs therefore having intermittent areas of contact between the shell and liner at its equator. Where there is close contact between two different metals there is potential for corrosion. The acetabular shell is constructed from titanium, whereas the liner is constructed from a cobalt chromium alloy. The mixing of different metals permits galvanic corrosion and studies have shown that there is increased damage at taper junctions in mixed alloy implants[16-20]. When a metal liner is used in the R3 acetabular system, due to the anti-rotational tabs insertions on the equator of the shell it can permit joint fluid and debris to infiltrate the crevices between the liner and shell. This can cause an exacerbation of corrosion at this taper junction.

Figure 1: Photographs of 6 retrieved metal liners used in the R3 acetabular system illustrating a distinctive pattern of corrosion on the backside of the liners

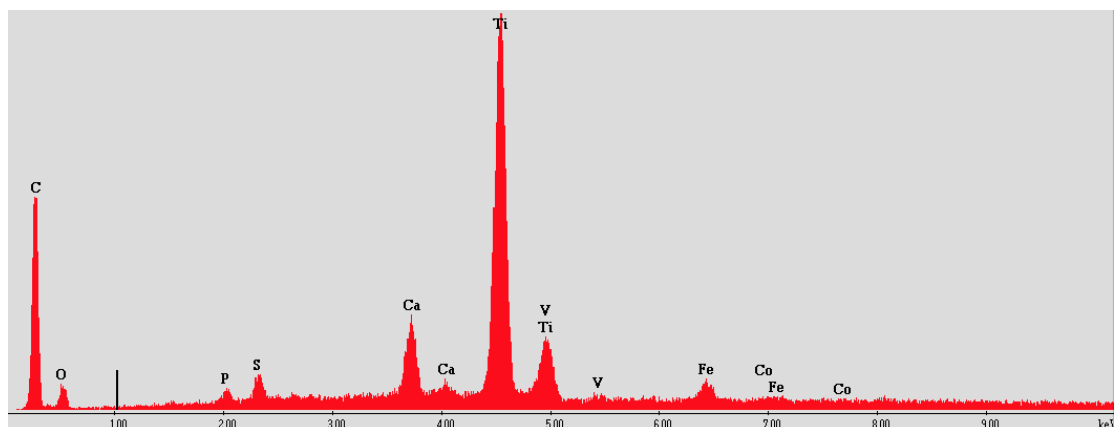
Figure 3: Energy dispersive X-ray spectroscopy of corrosive debris on the backside of the metal liner showing titanium rich deposits
