A Case Study For The Evaluation Of Total Quality Of Suburban Buildings In Turkey

Salih YILMAZ¹, Hayri Baytan ÖZMEN¹, Gulmustafa ŞEN²

¹Department of Civil Engineering, Pamukkale University, Denizli, Turkey

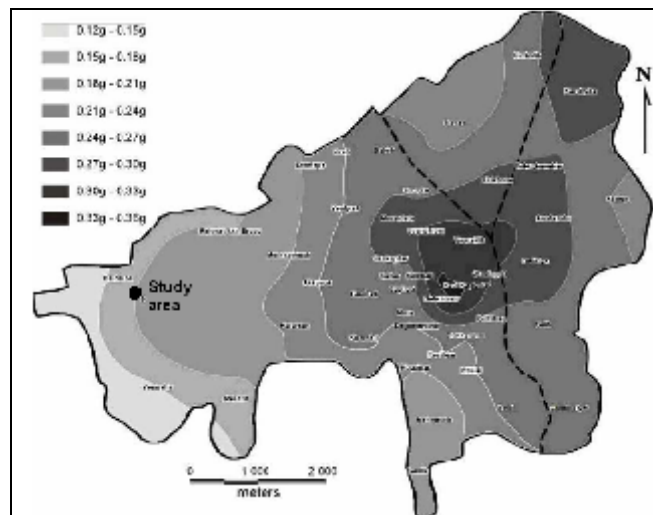
Earthquake is one of the major problems for many Turkish cities, like Denizli. City is on a region that is highest one of the 5 seismic zones of Turkey. Although, Adalet evleri is located on a hard soil layer, expected peak ground accelerations (PGA) at the area reaches up to 0.21g for a scenario earthquake of M6.9 as shown in the Fig. 2 [8].

Figure 2. Distribution of the expected PGA values for M 6.9 earthquake at Pamukkale Fault

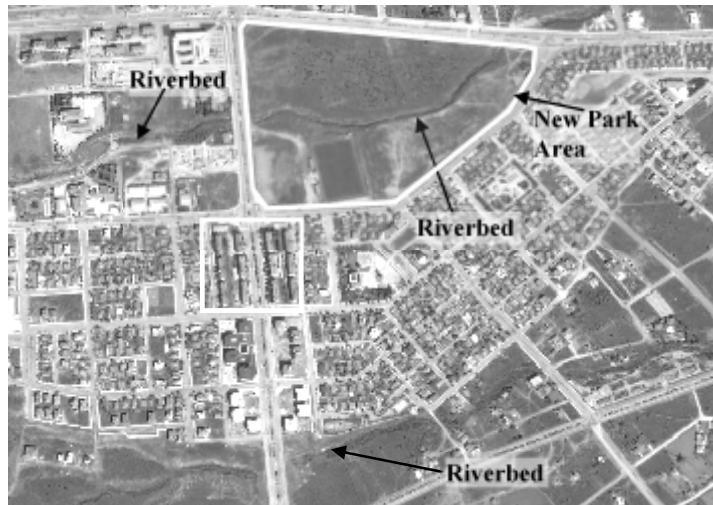
Another important possibility of natural disaster is flooding. The buildings in the region were constructed very near to the bed of two streams. These two stream beds can be seen on the Fig. 3. The rehabilitation of these streams is essential for the safety of the inhabitants.

Figure 3. Aerial view of the Adalet Evleri and surroundings.
