Repair the old concrete parts of the Hydro Plant

"LUMBARDHI" in Decan-Kosova

N.Kabashi¹, ; C. Krasniqi²,; R. Hadri³,; Q. Kadiri⁴,

University of Prishtina; Department of Civil Engineering, Prishtina, Kosova

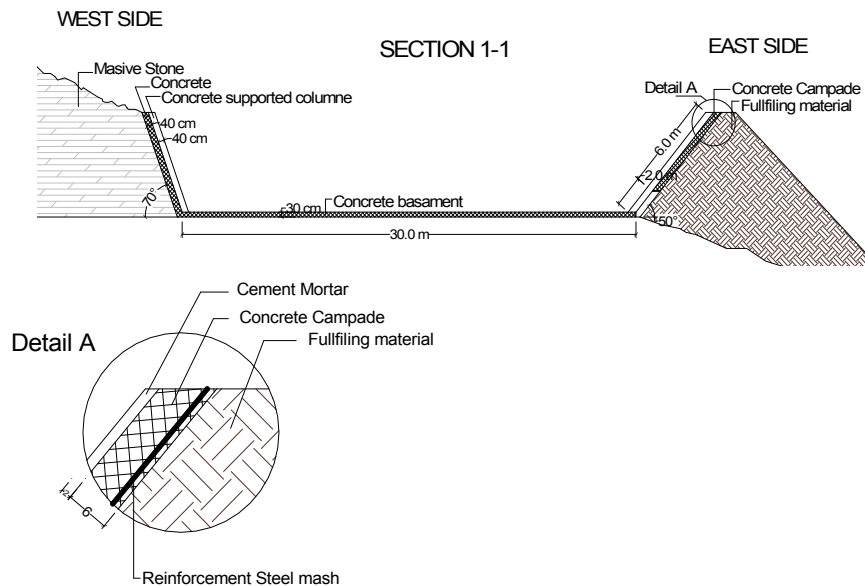
The constructions of accumulate water basin is based on the concrete campads with the dimensions 200x600x8 cm. Between the campades are the joints spall with the bituminous materials. The basement, especially on the east side is compacted soil and gravel and on the top is the con-

crete with the thick of 8 cm. The deterioration of concrete arrived not only on the top but on the depth and is evident the corrosion of the steel mesh. In general the degradations of concrete result on the east side. On the west side the basement is on the rock, and also on the top are concrete campades but supported with the columns concrete elements. The section of the constructions is present on the fig. 1.

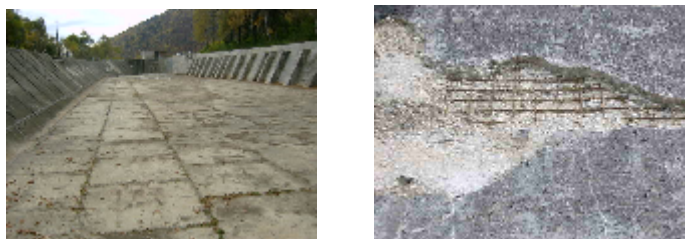
Fig.2. The view of the accumulations basin and degradation of concrete in concrete campades

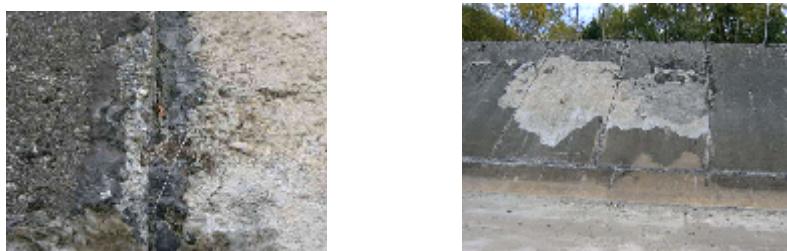
Fig.2. The joint connection between the floor and wall; joint between the concrete campades

The type of constructions is content from the part of concrete walls connection with joints. One of the major problem was the damage of existing joints and especially the joints material of bituminous materials. During the cast in place of grouts we prepare the edge of concrete elements very carefully and in this way to prepare the joint constructions. The existing materials which was used for fulfilling the joints was removed during the surface preparations. After the final preparations of joints we used the new material expanded to fulfill the joints and in same way to realize the requested parameters in this project.

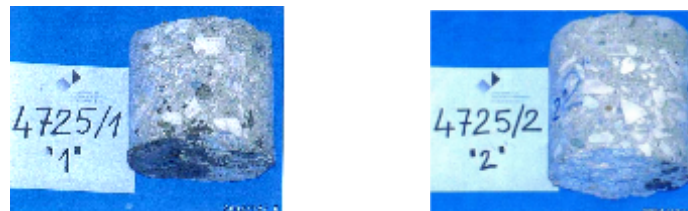
Fig.4 The samples taken from the east side “sample 1” and the west side “sample 2”

Most critical situations based on the results was the East Wall, and the next activities are concentrated on the repairing of this positions, but in some of small positions also the West wall and basement.

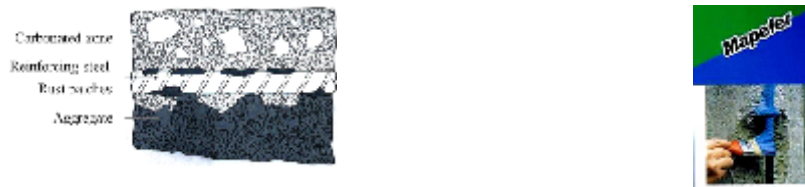
The cause of damage to reinforcement steel is corrosion for the long time of exposure under the different climate conditions. The first step in preparing the reinforcement steel for repairing is removing the deteriorated concrete surrounding the reinforcement. The damaged reinforcement is replacement and in some of areas is supplemented. For the other areas we used the cleaning with the wire brushing method to create the possibility for the coating of the reinforcement steel.

Fig 5; a/ Previous state of reinforcement steel; b/ Coating the cleaned reinforcement steel

The process of coating of existing cleaned reinforcement steel will apply to protect the steel on the future from the eventually corrosion and to improve the life time of steel. The previous state and the necessary coating is presented in fig.5 (a&b)

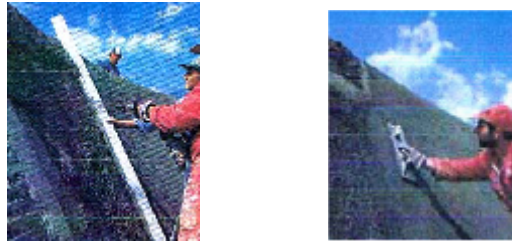
Fig.6. The cast in place and final smoothing the layer on the slope surface

The grout is cast in placed with compression in properly consistent for this kind of repairing works, especially but the surface was in slope position. In this case the applied grout is capable for excellent bond between existing concrete and grouts.

The thin layer was about 20 mm, in general. When we need for additional we apply the second layer.

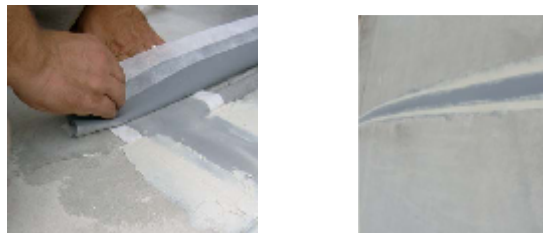
Fig.8: a/placing the PVC materials to protect the joints; b/the view of protected joints

The joints are protected with the polymer PVC materials , in this way this material are compatible for eventually joint movement in concrete. The methodology and placed this material is presented in fig. 8. a&b.

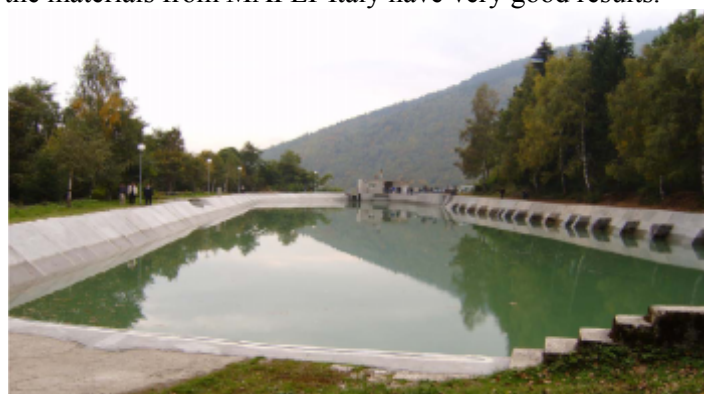
Fig.10. The actual situation after 5 years
