Damages of Masonry School Buildings on 2010 Karakocan - Elazig Earthquake

N. Cetinkaya¹, İ. Türkmen¹

¹Department of Civil Engineering, Inonu University, Turkey

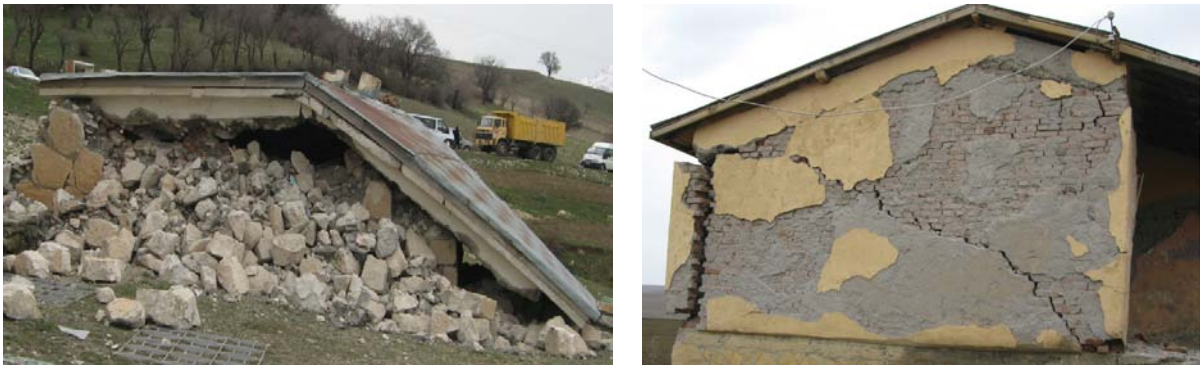
The masonry school buildings in the region affected by the earthquake were constructed by using stones collected from the river beds, soft natural stone blocks and lime hollow/solid blocks. Most of them were one-storey with a very heavy saddle shaped roof (Fig. 3). These buildings were not earthquake resistant according to previous or existing Turkish seismic codes [9]. Although the magnitude and spectral acceleration values of the Earthquake were not so high, many masonry school buildings were heavily damaged due to the above mentioned construction practice. The disaster area was surveyed and detailed studies were carried out on the damaged buildings to understand the reasons of the poor performance of the masonry school buildings. The main reasons are discussed in detail with the examples of damaged buildings.

Figure 3 Heavy -saddle shaped roofing systems

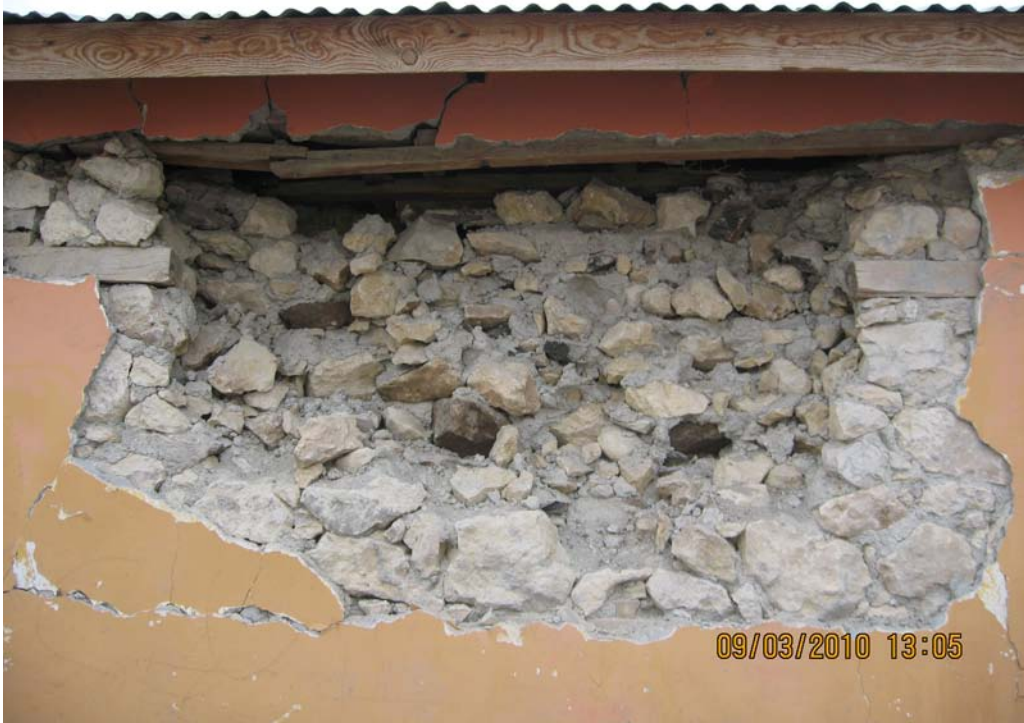
The stone masonry walls were constructed as inner and outer leaves with a total thickness of 50 cm in general. There was no interlocking element to connect the inner and outer leaves to each other (Fig.5). Because of this deficiency, the unsupported length of the outer leaf of the wall was doubled, but its effective thickness was decreased to the half of the wall thickness. So, the out of plane failure risk was increased considerably.

Figure 5 No interlocking element to connect the inner and outer leaves to each other

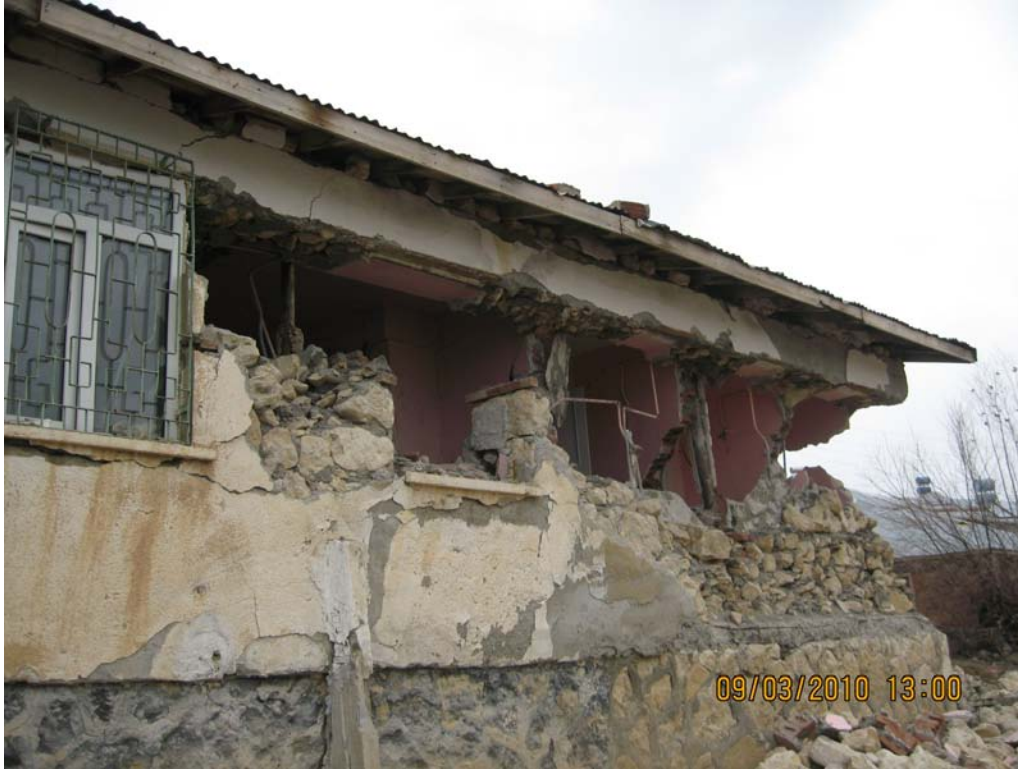
Another common reason of the damages was the insufficient connection of the walls to each other. There was either no connection or the connection was not constructed properly to transfer the loads. This kind of damage is shown in Fig. 6. The construction of the exterior walls was completed without any connection to partition walls. For this reason, the free span of the external wall was too much to resist against out of plane failure.

Figure 6 Damade due to the insufficient connection of the walls to each other

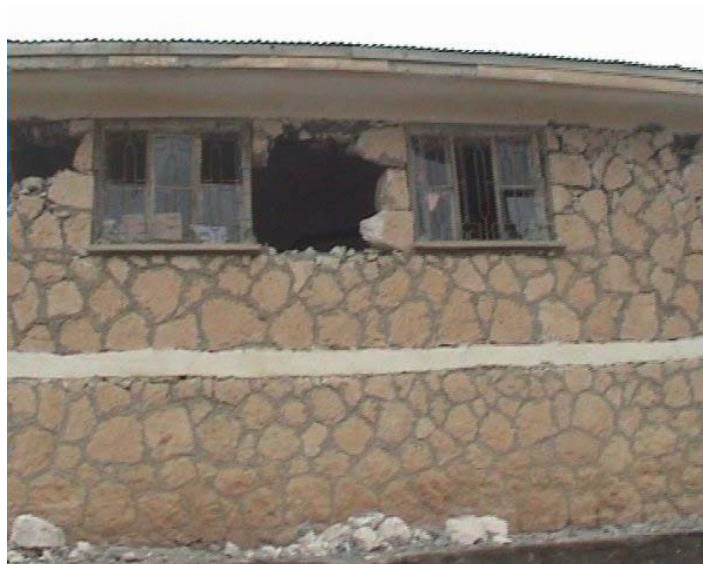
Wrong placement of the openings in the walls was among the most common damage reasons. Since the masonry walls are the only lateral load bearing structural elements of the masonry buildings, seismic design codes restrict the distance between the two openings and the distance between opening and corner of the walls [9]. The minimum distance between two openings should be 1 m and the minimum distance between an opening and a building corner should be 1.5 m. The damage due to the insufficient distance between two windows is shown in Fig. 7. Irregular shape of the masonry units in Fig. 7 is also as important as the insufficient wall length. Besides, it should be noted that the damage level in that wall could be higher if the bonding beams at the mid-height and the top of the walls were not. The damage shown in the Fig. 8 was due to the insufficient distance between the opening and the building corner.

Figure 7. Damage due to insufficient distance between two openings

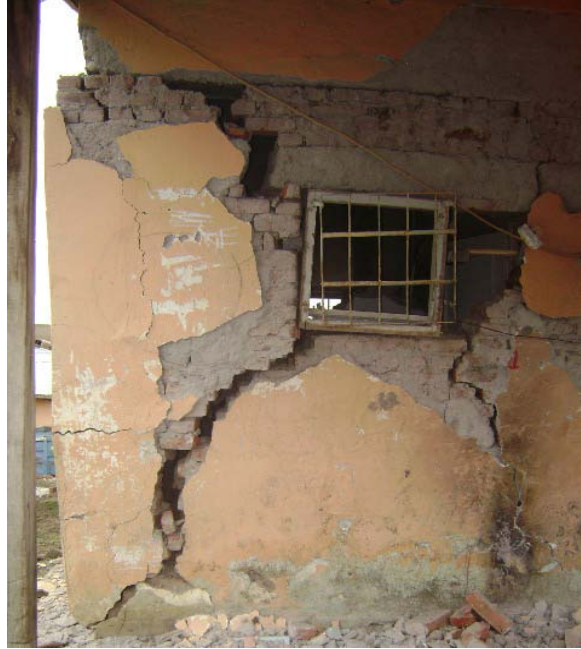
Figure 8 Wall opening close to the building corner

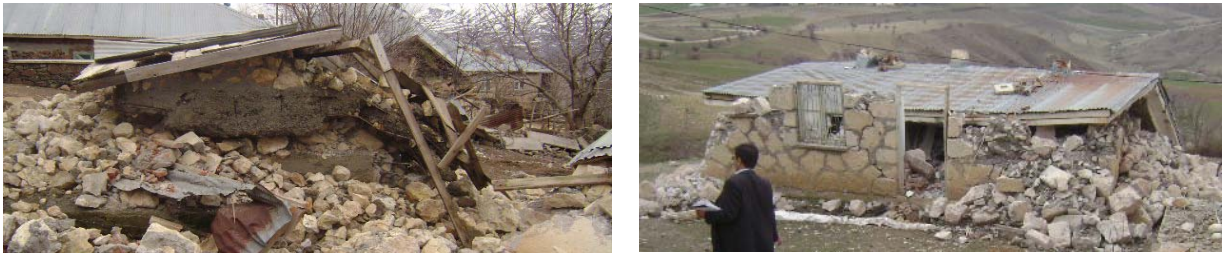
A heavy saddle shape roof which does not provide a proper rigid diaphragm effect is also important reason for the damages (Fig. 9). Interior walls and the walls in the inclined direction and the roof were not connected to each other to transfer the seismic loads. Therefore, the exterior long wall was subjected to the most of the seismic load coming from the heavy saddle type roof.

Figure 9 A heavy saddle shape roof

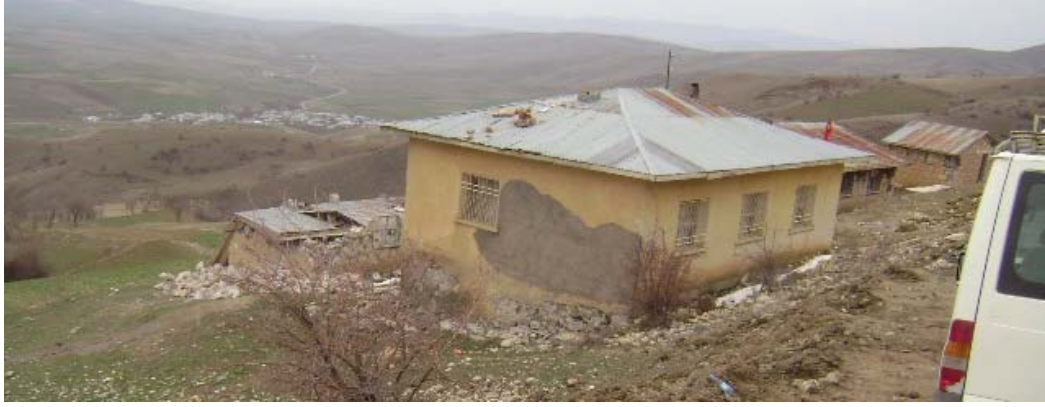
Topography of the region was also effective in the damages. Many of the damaged buildings were located on the hills with a high slope. According to Kramer topographical irregularities on ground surface may affect ground acceleration significantly [10]. Because of the amplified ground accelerations, the number of the damaged buildings increased significantly. The damages on the buildings located on a hill are shown in Fig. 10. Due to the concentration of seismic energy and amplification of the ground acceleration at the top of the hill, the damage level of the building becomes heavier than those located on the foot of the hill.

Figure 10 Many of the damaged buildings were located on the hills with a high slope
