*International Balkans Conference on Challenges of Civil Engineering, BCCCE,  
19-21 May 2011, EPOKA University, Tirana, ALBANIA.*

## **Deficiencies Of Some Important Bridges In Albania**

Over the past decades Albania has built many new bridges and roads. The construction of these bridges and roads has been done under different periods and characterized from different types of construction codes. The work reported on this paper was carried out to survey the present condition of three important bridges in national roads of Albania. Literature review was carried out to identify common defects on same type of bridges. Interviews were conducted with different engineers worked on similar type of bridges' design, construction and inspection in Albania. Site inspections of these three bridges were carried out to identify defects on the bridges. The study was extended to inspect all the members on the bridges to define causes of the defects. The main causes of the defects were classified as; lack of detailing in design, poor quality of construction, poor concrete quality, inadequate concrete cover, water leakage and last but not least lack of maintenance. These bridges are classified as

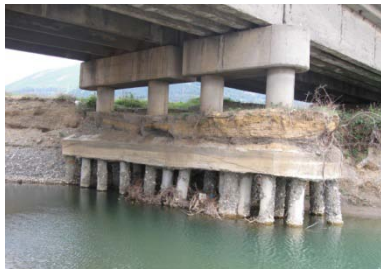
Albania rivers have mass flow rate so scouring is one of the main concern for bridge substructure. Mat bridge passes over Mat river and foundation consists on piles connected with a pile cap. Almost all piles exposed and have some problems. Scoring were recorded with different severity level. Sever scouring were observed at some part of the foundation as shown in [Fig.2(a)]. Reinforcements of pile cap were exposed and rusted because of lack of concrete cover and poor workmanship. Moreover, considerable amount of soil was found in pile cap concrete as an evidence of poor construction supervision [Fig.2(b)]. The piles have concrete deterioration defects and very often steel bars are exposed to environment [Fig.2(c)].

(a) *Pile erosion*

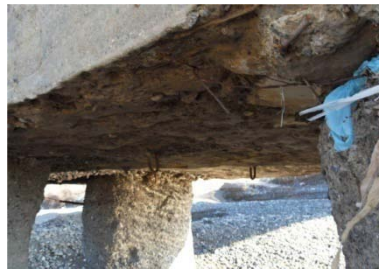
(b) *Pile cap bad workmanship*

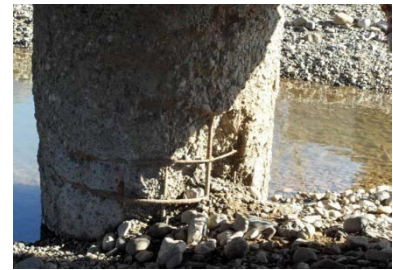
(c) *Pile concrete deterioration*

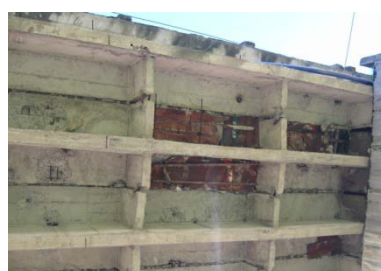
Bridge superstructure defects were seen in all three bridges. because of aging factor, more serious defects were seen on Mat and Vora Bridge compare to Sukth Bridge which was built after 1990. Workmanship problems such as improper frame work and inadequate concrete cover are very obvious in three bridges [Fig.3(a), Fig.4(f)]. Diaphragms that are very sensitive parts must align beams on correctly position. However the most of the diaphragms in these bridges were found out of position. The miss alignment were measured more than 5 cm on some of the diaphragms [Fig.3(b)]. Because of poor workmanship and design detail, reinforcement were placed so closely that does not allow the concrete enter between them so exposed reinforcement are widely seen [Fig.3(c)]. This problem was associated with improper concrete cover and water leakage and result with heavily rust on the reinforcement all over the bridges' structural members [Fig.4(a),(e)]. The reinforcement diameter was around 4mm at some rusty place. Chemical attack is widely seen on every superstructure element [Fig.4(b)]. Spalling and delamination were other two commonly defects seen all over the bridges' superstructures [Fig.4(c),(d)].

(a) *Improper framework*

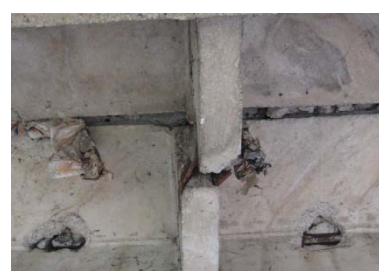
(b) *Diaphragm misalignment*

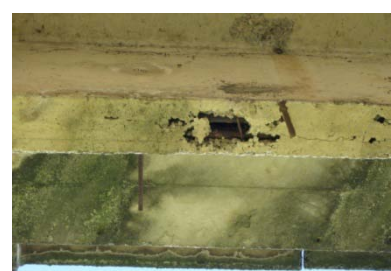
(c) *Dense bars, concrete gap*

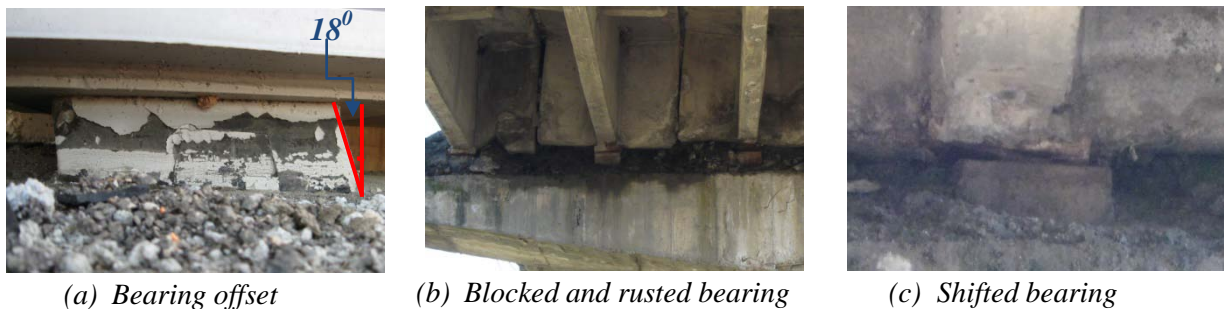
Figure 5 Bearing defects

Mainly there are four types of bearings used on Albanian bridges; Roller bearing, linear rocker bearing, plane sliding bearing and elastomeric laminated bearing. Any defects on bearings prevent the structure to move as originally designed, therefore high stresses observed on beams. This high stress may cause individual span or entire bridge failure. Therefore routine inspection and replacement of bearings is extremely important. Metal bearings on the bridges were corroded and clogged with debris as shown in [Fig.5(b)]. Some of the plane sliding bearing have misaligned and lost its functionality at all. As it is shown in [Fig.5(c)], bearings sliding plates does not touch each other and they totally have lost originally design

purpose. Most of the elastomeric laminated bearings have offset problems that vary from one to some centimetres. The angle of offset on elastomeric bearings varies from 15° to 20° [Fig.5(a)]. A common defect of all bearing is locking with debris [Fig.5(a),(b),(c)].

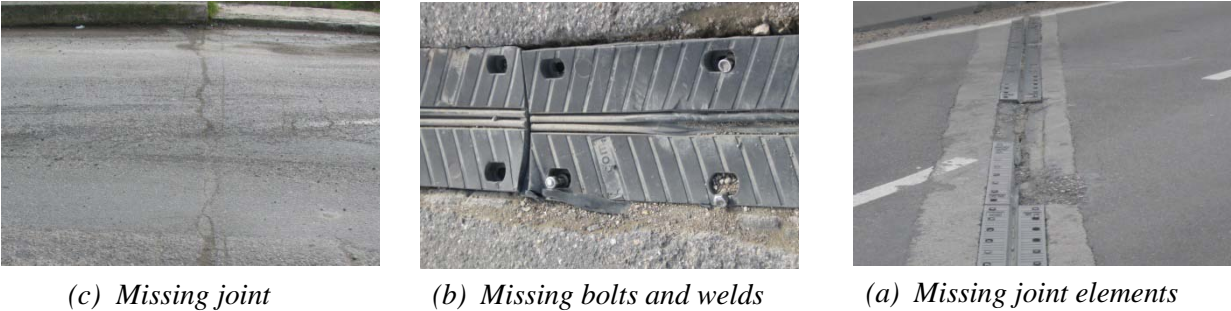
Figure 6 Expansion joint defects

Abnormal noise is made almost in every expansion joint mostly caused from difference in level. As matter of workmanship sometimes the expansion joints are not put at all [Fig.6(a)]. Seal and sealant are generally out of function so they allow water to pass throw. Components like bolts and welds are mostly out of function [Fig.6(b)]. Concrete or asphalt adjacent to the joints supports of faces has generally spalls or cracks. Missing elements of the expansion joints are often seen [Fig.6(c)]. This missing elements cause problems to other elements such as bearings. The undersides of the expansions were not constructed properly. This leads water leakage and failure of entire expansion joints.

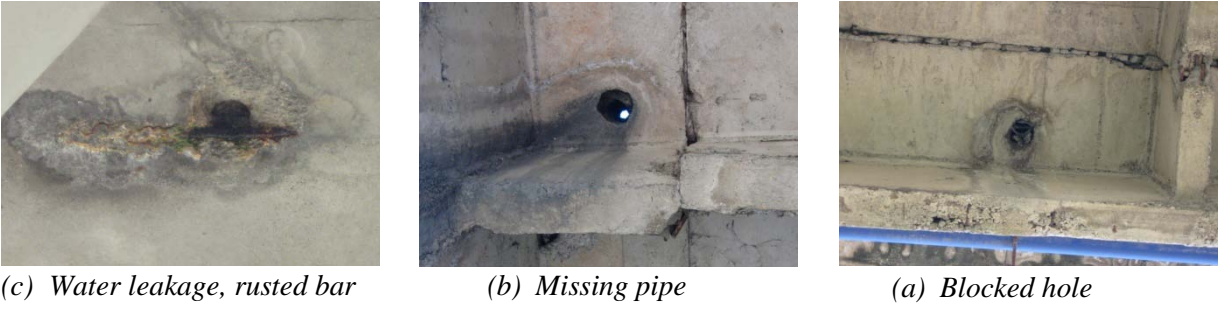
Figure 7 Drainage system defects

Drainage system inspection is one of the most important part all types of inspections. The lack of maintenance on the system will definitely lead durability problem on concrete and steel structure. Condition of the system in all three bridges is seriously defected. The drainage holes were created after construction of deck by destroying some part of structure member [Fig.7(a)]. Drainage pipes were not found and the structure directly exposed to rain water. As a result, the decks under surface have problems like chemical attack, moss and wetness [Fig.7(b),(c)].
