Sextos, A., De Risi, R., Pagliaroli, A., Foti, S., Passeri, F., Ausilio, E., ... Zimmaro, P. (2018). Local site effects and incremental damage of buildings during the 2016 Central Italy earthquake sequence. *Earthquake Spectra*, 34(4), 1639-1669. <https://doi.org/10.1193/100317EQS194M>

# Local site effects and incremental damage of buildings during the 2016 Central Italy earthquake sequence

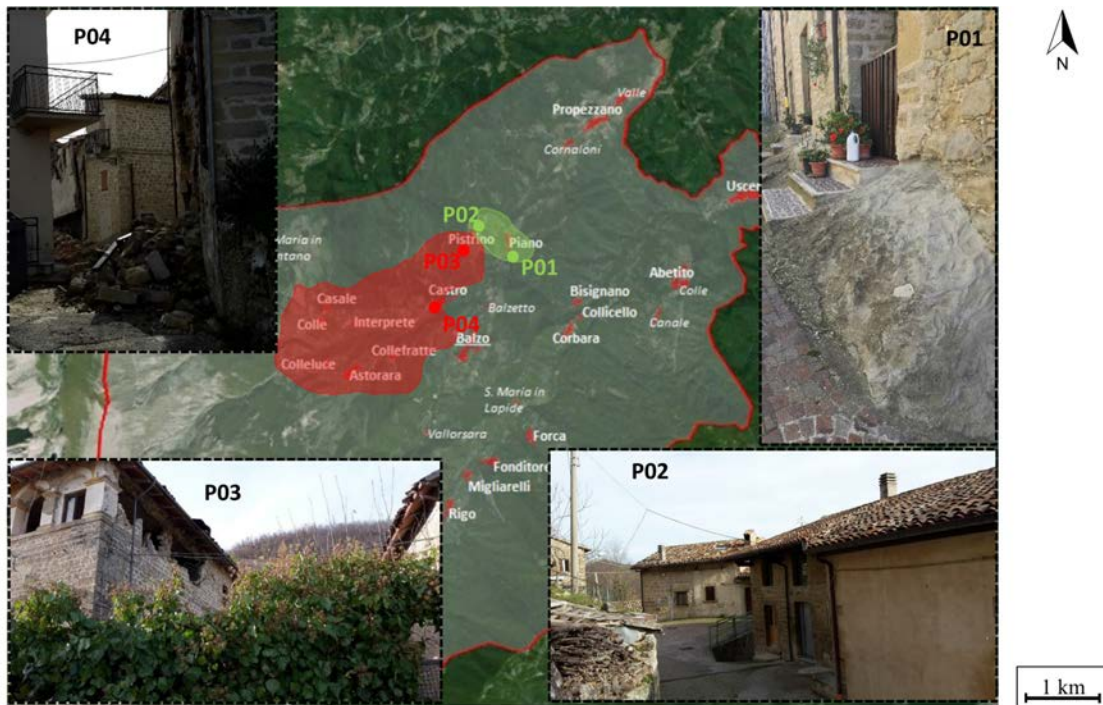
222 Other Montegallos hamlets, such as Astorara, Castro, and Colleluce in the southwestern  
223 part of the area at a distance of 1.5 to 2.5km from Piano, located on quaternary deposits  
224 resting on rock, experienced high levels of damage and several cases of total collapse (D5).  
225 For example, Figure 3-P04 shows a street in Castro that was blocked by the debris of a  
226 damaged building. Given the proximity between Castro (highly damaged) and Piano  
227 (practically undamaged), and the very similar structural systems and construction standards,  
228 it is probable that Castro experienced stronger ground motions than Piano, due to significant  
229 topographic amplification. A view of the 3D model obtained with a drone survey over the  
230 entire area can also be found in BYU-PRISM (2016). It shows the typical crest configuration  
231 of the zone, leading to possible 2D topographical effects.

**Figure 3.** Spatial distribution of building damage across the municipality of Montegallo.

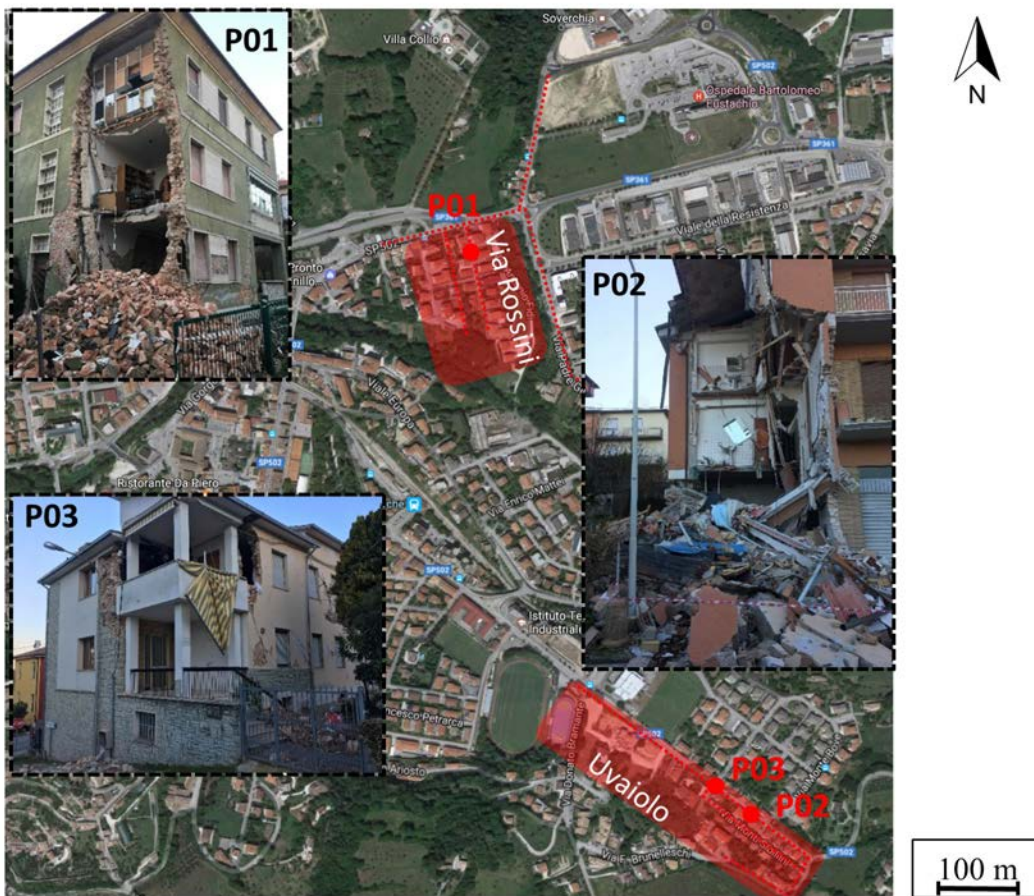
Other examples of local site effects were identified in some areas of San Severino Marche (number 11 in Figure 2). San Severino Marche is a town in the Province of Macerata, in the Marche region, located about 50 kilometers south-west of Ancona and about 25 kilometers south-west of Macerata. It has about 12,000 inhabitants, and it comprises more than 40 hamlets. Unlike Montegallo, San Severino has districts where most of the buildings are of reinforced concrete, built in the 1960s and the 1970s. Within San Severino Marche, two neighborhoods along Via Mazzini and Via Rossini attracted most of the GEER reconnaissance team attention due to the evident and quite localized damage observed (Figure 4). Via Mazzini is located uphill while buildings along Via Rossini are constructed on the ancient riverbed of the Potenza River. It is deemed that stratigraphic amplification is likely to have taken place due to the presence of soft shallow sediments resulted from the river artificial channeling operations. Similar damage patterns and site effects have been observed in Tolentino (number 10 in Figure 2), as described in GEER (2017).

**Figure 4.** Characteristic building damage within the town of San Severino Marche.

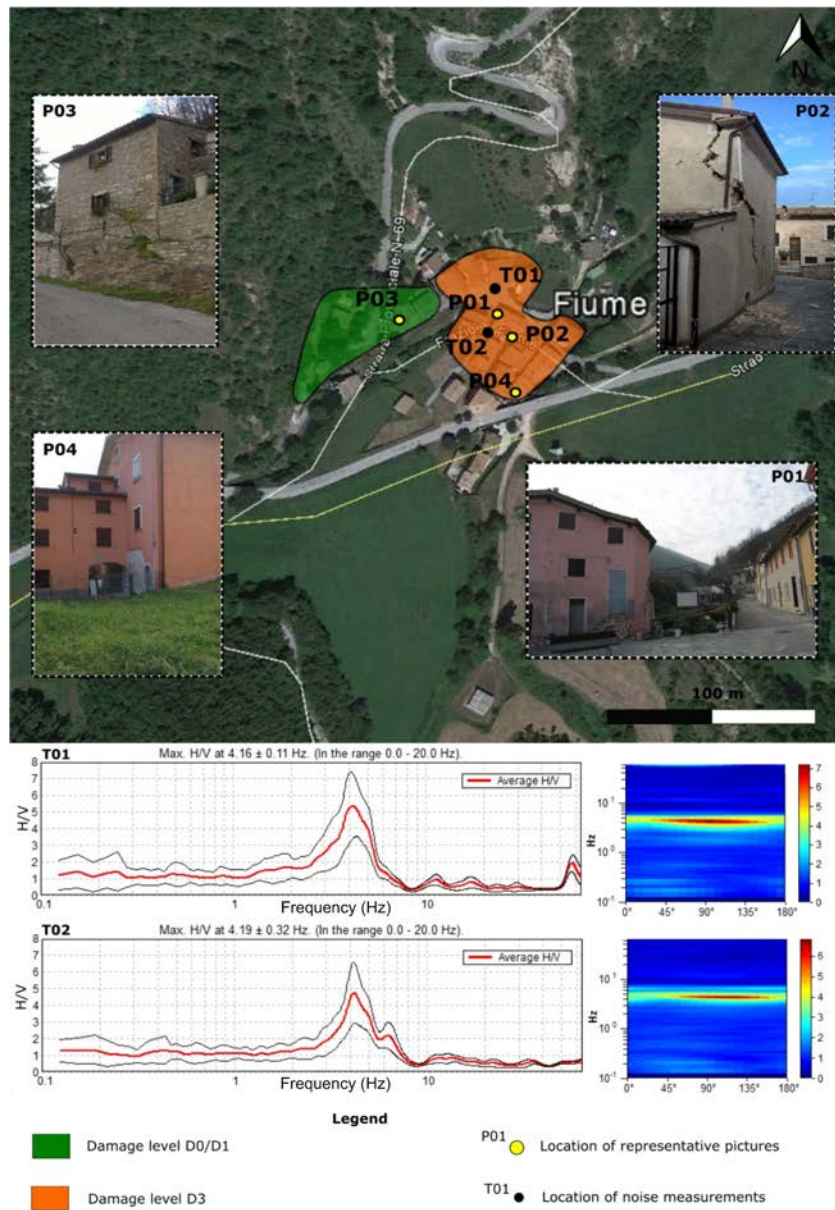
265 eastern part of the hamlet, founded on colluvial and alluvial deposits resting on bedrock,  
266 suffered high levels of damage (D3) as shown in reference pictures P01-P02-P04, whereas  
267 the western part, built on travertine rock, had only negligible damage (D0/D1, P03).

268 Two noise measurements (T01-T02 in Figure 5) were performed in the damaged zone  
269 (east side of the hamlet) during the GEER mission. A portable Tromino tomograph was  
270 employed and the total duration of each measurement was approximately 15 minutes.  
271 Horizontal-to-Vertical (H/V) spectral ratios were computed by using the geometrical mean of  
272 horizontal components. In addition, H/V ratios were computed by rotating the horizontal  
273 component between  $0^\circ$  and  $180^\circ$  (directional or polar HVSR), in order to investigate  
274 preferential directions of site amplification (i.e., the polarization of ground motion). Both  
275 H/V and polar H/V are reported in Figure 5 showing a large H/V peak around 4 Hz, which  
276 shows significant stiffness contrast between the upper soil layers and the underlying bedrock,  
277 i.e. a typical proxy of local site amplification.

293 **Figure 5.** Damage zonation within the village of Fiume (up). Location and results of noise  
 294 measurements in terms of H/V spectral ratio (bottom left) and polar plot (bottom right).

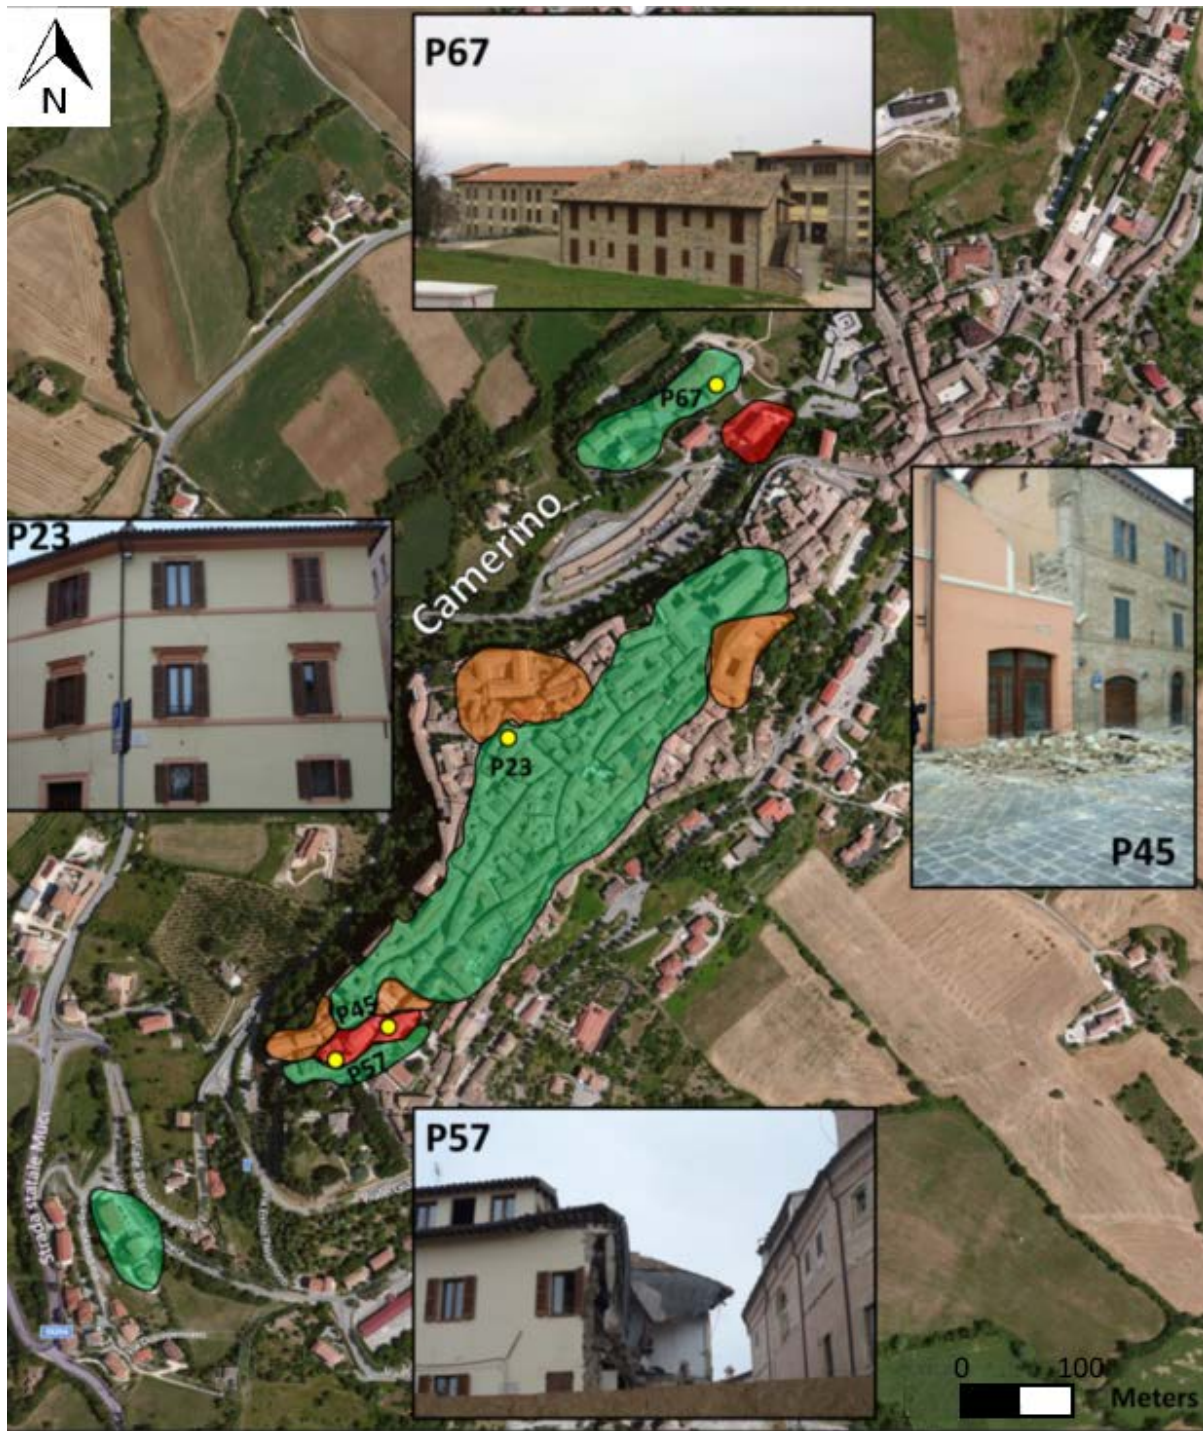
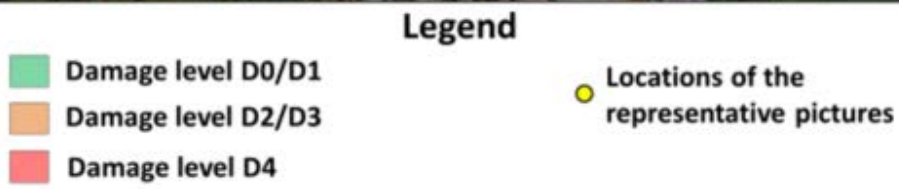
320 Figure 6 depicts the damage distribution across the main village, as inspected after the 30  
321 October event. Relatively low damage (D0 or D1) were observed within the inner part of the  
322 ridge characterized by local bedrock (GRS) outcrops. Higher damage levels (D2-D3) were  
323 observed for many of the low rise (2-3 stories) unreinforced masonry buildings, even if some  
324 of them were partially retrofitted. The damage is mainly localized on the hillside, where  
325 potential topographic amplifications and permanent deformation (due to slope instability)  
326 may be occurred. The highest damage level (D4) was observed at the SW side of the historic  
327 center and at the bottom of the Camerino hill, where several masonry structures collapsed.  
328 The observed damage distribution pattern in Camerino is consistent with site effects that  
329 could be inferred from the geological map shown in Figure S5. Strong amplification of

330 earthquake ground motions is highly probable given the thin soft layers of eluvio-colluvial  
331 soils (ML) overlying the bedrock.

**Figure 6.** Damage zonation within the historic center of Camerino with pictures of the representative structures inspected.

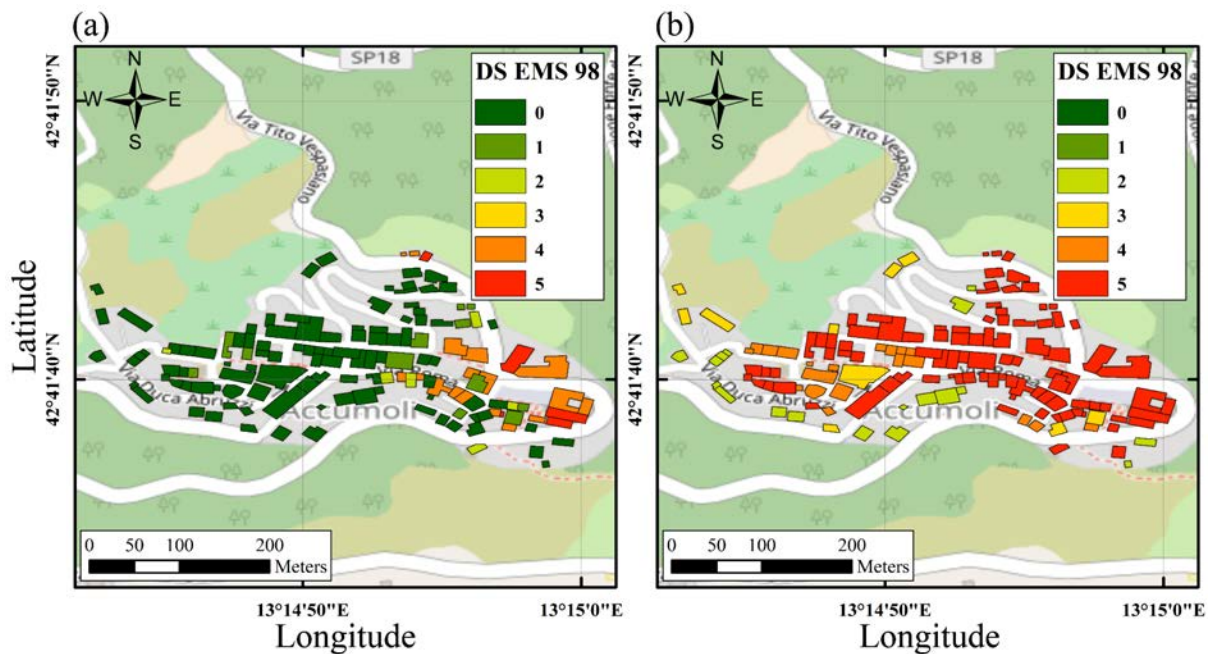
357 Figure 7 illustrates the structural damage levels observed during the two surveys, after the  
358 24 August (left) and the October events (right). After the August 24th event, the most severe  
359 damage was observed at the eastern side of the village, while the vast majority of the building  
360 stock retained its structural integrity null or with minor damage (D0-D1). However, at the  
361 end of the seismic sequence, Accumoli was almost completely destroyed. Few buildings, in  
362 the south end of the village survived the sequence of events with limited damage (D2).

364 **Figure 7.** Damage levels in the main village of Accumoli (a) after the first earthquake and (b) at the  
 365 end of the entire sequence.

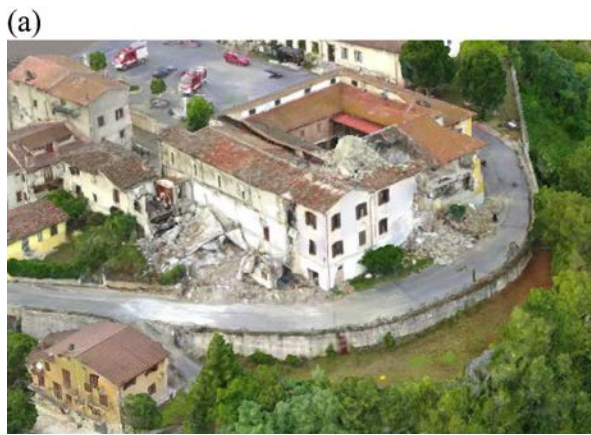
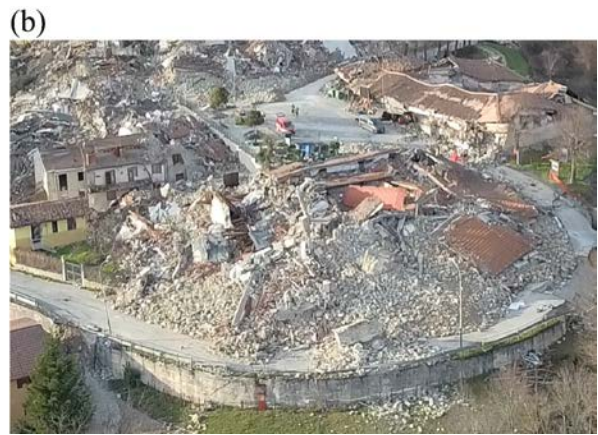
372 Figures 8a and 8b show an aerial view of the east part of the village during the first and  
 373 the second surveys, respectively, including the local church and the police station, which  
 374 eventually collapsed because of multiple earthquake excitations. **Figures 9, 10 and 11**  
 375 illustrate characteristic cases of minor-to-moderate shear and out-of-plane damage after the  
 376 August event that **led** to abrupt collapse because of the earthquake sequence. Age of  
 377 construction, high spectral accelerations for periods lower than 0.3s (which match the natural  
 378 periods of low-rise buildings) and the variation of spectral polarization across several events  
 379 were likely the main contributors to the observed catastrophic damage patterns. Given the  
 380 location of Accumoli, topographic effects may also have contributed to the observed damage.

382 **Figure 8.** Aerial photos of the east side of Accumoli after (a) the first earthquake and (b) the entire  
383 earthquake sequence.

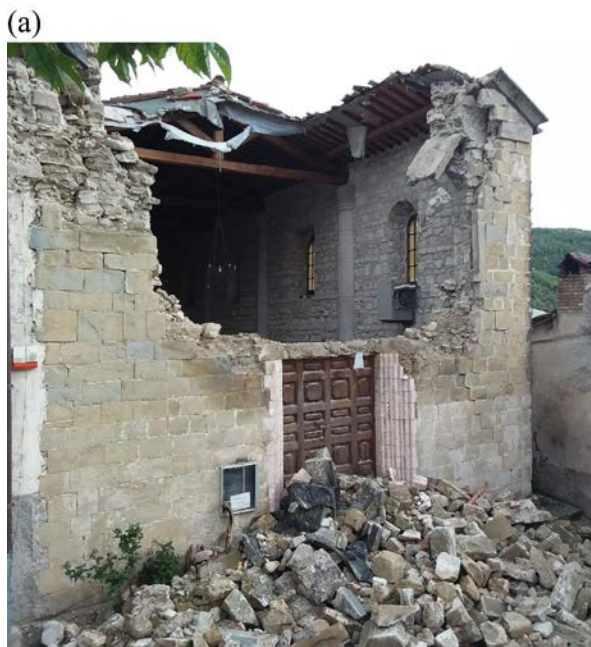
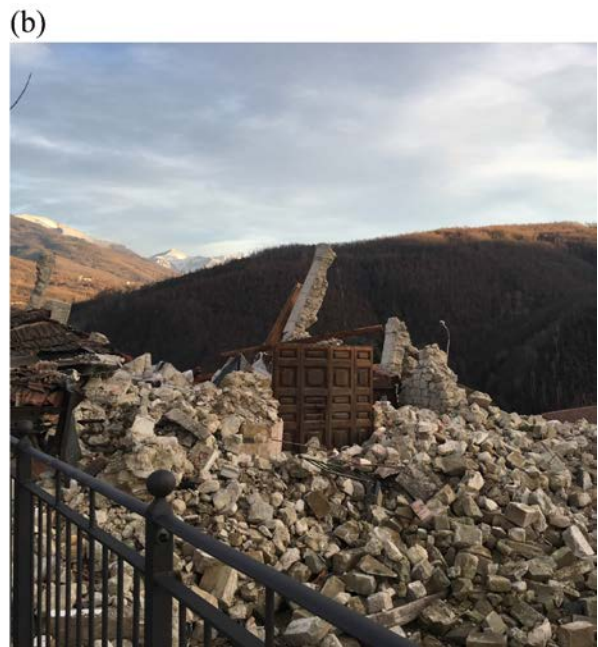
**Figure 9.** The local church: (a) after the first earthquake; and (b) after the entire sequence.

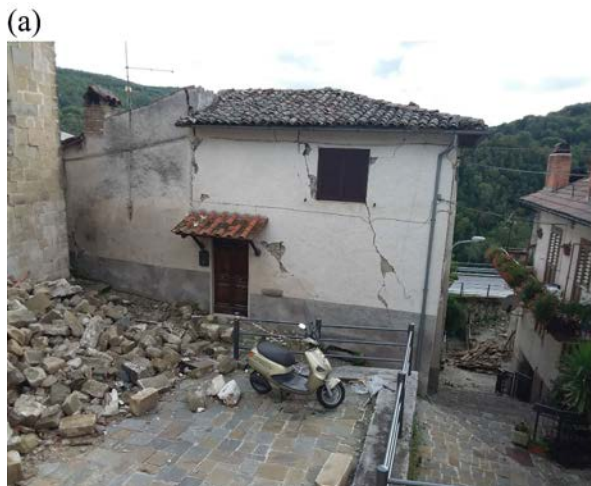
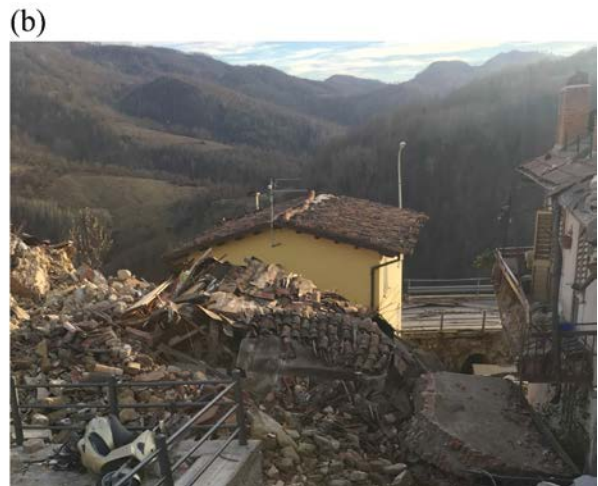
**Figure 10.** Masonry residential building: (a) after the first earthquake; and (b) after the sequence.

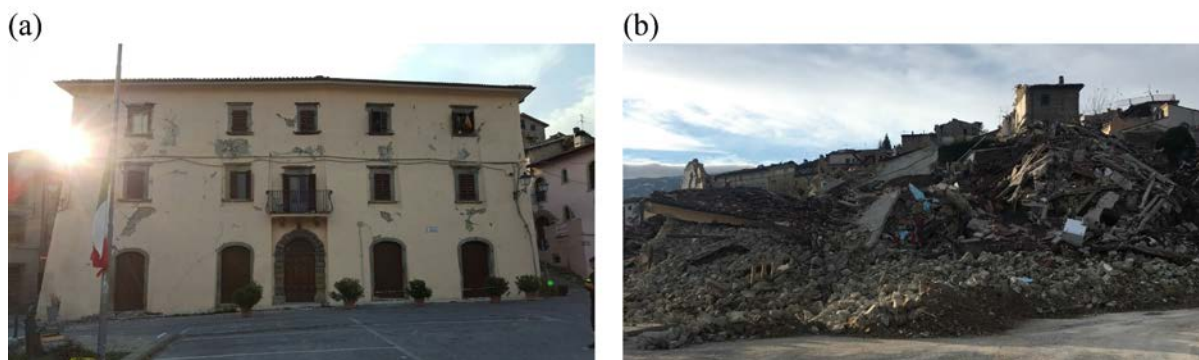
389 **Figure 11.** The town hall: (a) after the first earthquake; and (b) after the entire sequence.

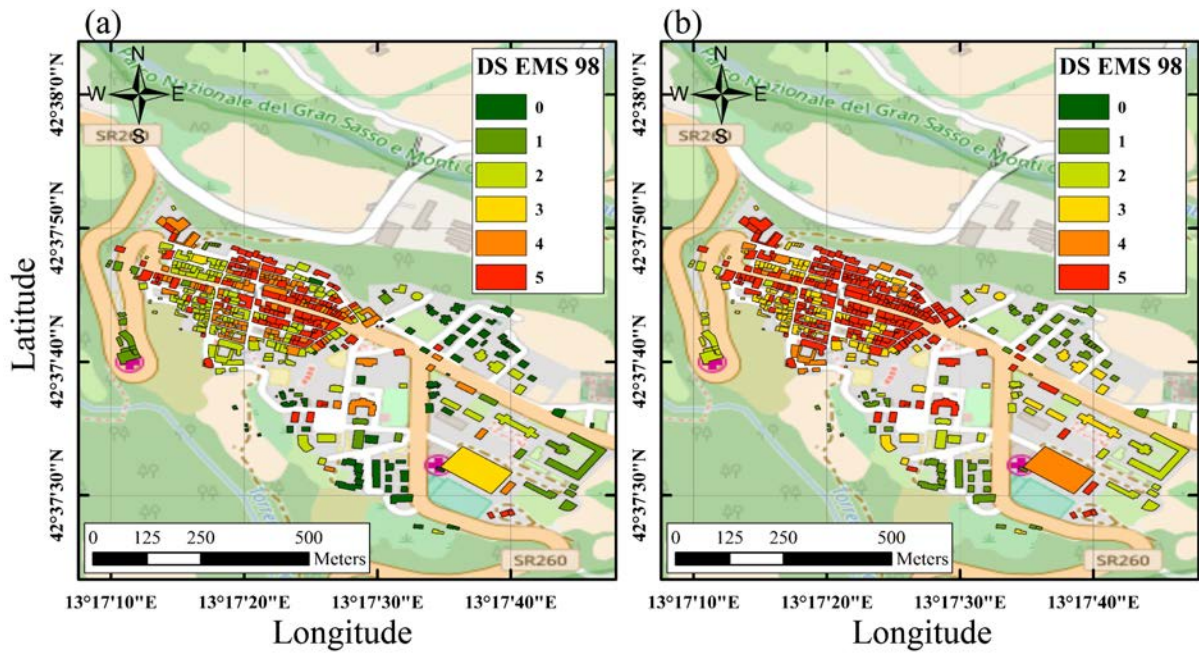
408 Figure 12 shows the structural damage levels observed during the two surveys. The 24  
409 August event caused severe damage to the south-east part of the historical city center along  
410 the main avenue (Corso Umberto I). As observed in the case of Accumoli, many buildings  
411 that were still standing after the first event with only a small residual capacity to additional  
412 horizontal actions, fully collapsed because of the subsequent September and October events.  
413 The **shifting** of damage states between the aftermath of the first event and the end of the

414 entire sequence is reflected in the following inspection results clearly indicating a major shift  
 415 to most critical damage states: intact buildings (D0) were reduced from 30% to 18%,  
 416 buildings with minor damage (D1) were increased from 5% to 10%, moderate damage (D2)  
 417 was reduced from 24% to 6%, D3 increased from 1% to 21%, D4 decreased from 17% to 3%,  
 418 and collapsed buildings (D5) had a significant increase from 23% to 42%.

419  
 420 **Figure 12.** Damage levels observed in the center of Amatrice (a) after the 24 August earthquake  
 421 (during the first survey), and (b) after the entire sequence (during the second survey).

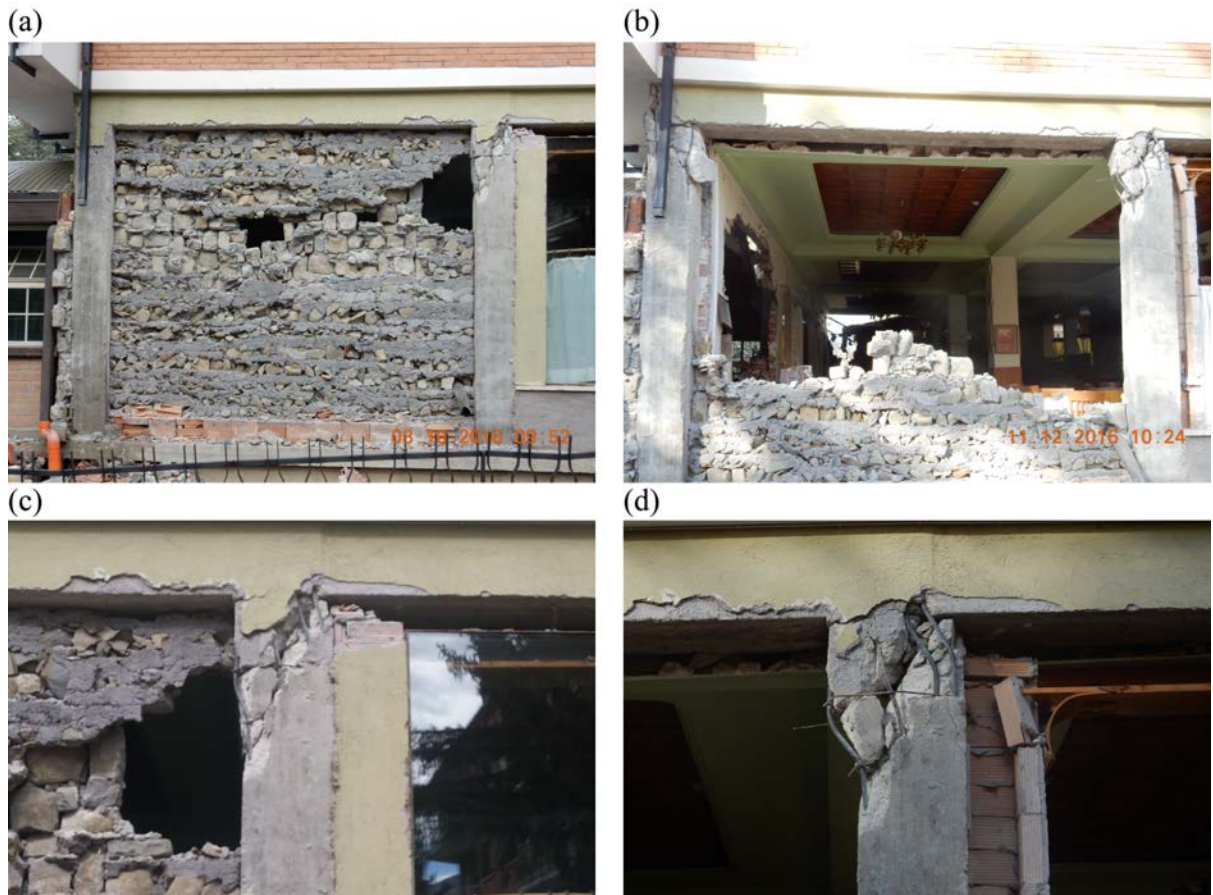
422 Even though the statistical sample of the reinforced concrete buildings was not adequate  
 423 to quantify how damage accumulates for different structural systems under multiple  
 424 earthquakes, an effort was made to compare characteristic cases at least qualitatively. An  
 425 example of a reinforced concrete building is illustrated in Figure 13. The partial out-of-plane  
 426 collapse of an external infill panel after the first event was followed by complete failure at the  
 427 end of the entire seismic sequence. A closer inspection of the top right beam-column joint  
 428 further reveals shear damage that was magnified, though not considerably, under multiple  
 429 excitations, i.e. the reinforced concrete structure retained some of its capacity thus avoiding  
 430 collapse. A similar example is shown in Figure 14. Cyclic degradation, concrete spalling and  
 431 minor longitudinal rebar buckling were indeed observed in the absence of adequate

432 transverse reinforcement, however, **global** damage state remained constantly moderate  
 433 despite the multiple earthquake events. In some cases, damage accumulation was more  
 434 significant, as for instance, in the building depicted in Figure 15, where minor damage after

446 **Figure 13.** Reinforced concrete residential building (a,c) after the 24 August earthquake and (b,d)  
447 after the entire sequence. (a,b) External infill failure and (c,d) shear failure at the column top.

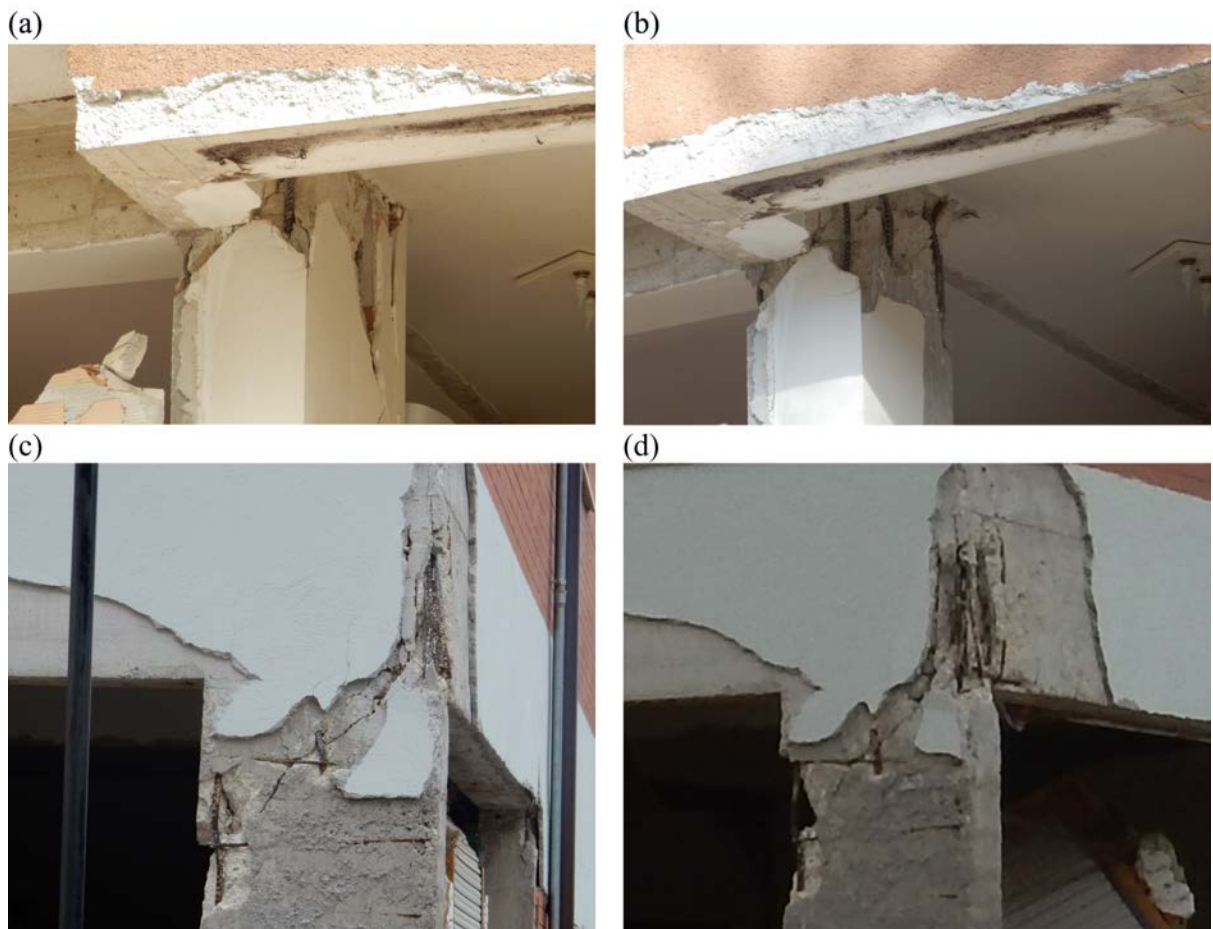
449 **Figure 14.** Beam-column joints. Concrete spalling and local bar buckling due to lack of transversal  
 450 reinforcement after the 24 August event (a,c) and after the earthquake sequence (b,d).

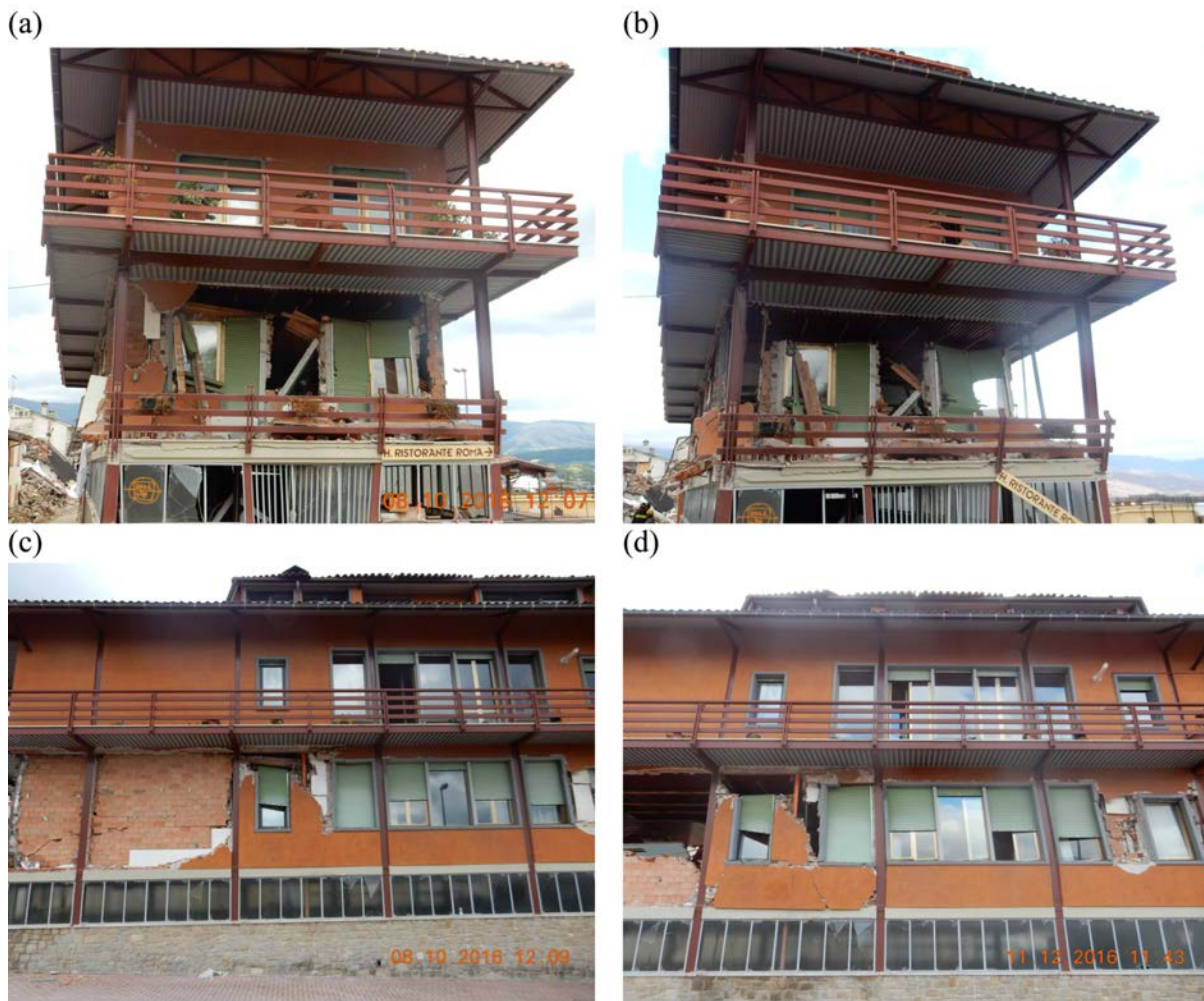
456 **Figure 16.** Steel residential building. (a,c) Limited damage after the 24 August earthquake and (b,d)  
 457 extensive damage of the infill panels at ground level with evident residual drift after the entire  
 458 sequence.

459 **Such a steel structure** consists of a basement, a ground floor, and two upper stories  
 460 alongside a shorter top story that serves as a penthouse. After the 24 August event, the  
 461 damage was mainly confined to the infill panels, with only small local flange instabilities  
 462 observed at the top of two front columns of the ground floor. At the end of the entire seismic  
 463 sequence, the building experienced permanent deformation along its longer direction, as  
 464 shown in Figure 16. Such permanent deformation was localized at the second level of the  
 465 building with a visible residual inter-story drift due to the relative positions of infills and  
 466 openings. Preliminary finite element analyses of the building confirmed that the fundamental  
 467 period of the structure is approximately equal to 0.75 sec. This was an uncoupled  
 468 translational mode along the long side, which was mainly attributed to the orientation of the

469 steel columns with their strong axes aligned with the short side of the building. Naturally,  
 470 residual drift developed along the longitudinal (weak) axis. Evolution of structural damage is

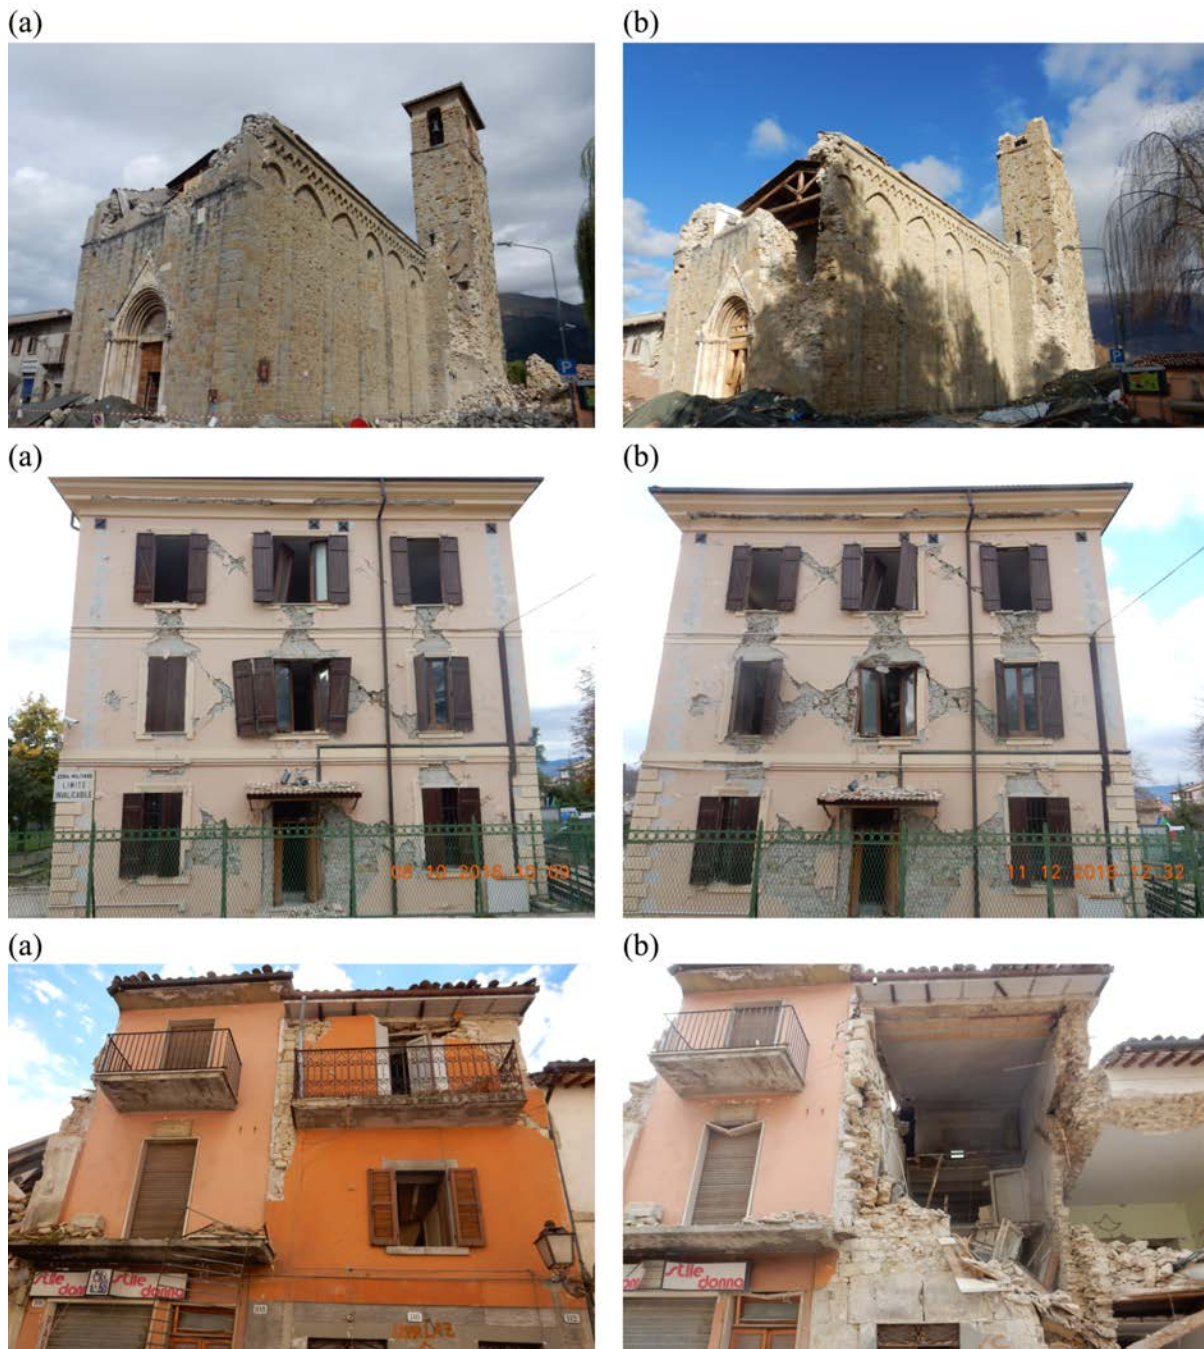
471 also clearly seen in several characteristic masonry structures, such as the church of  
472 Sant’Agostino (Figure 17, top), the local police (“Carabinieri”) station (Fig. 17, middle) and  
473 typical residential buildings (Fig. 17 bottom and Fig. 18).

475 **Figure 17.** Incremental structural damage of the church of Sant’Agostino (top), the local police  
476 station (middle) and one of the several masonry buildings collapsed after (a) the event of 24 August  
477 earthquake and (b) the entire sequence.

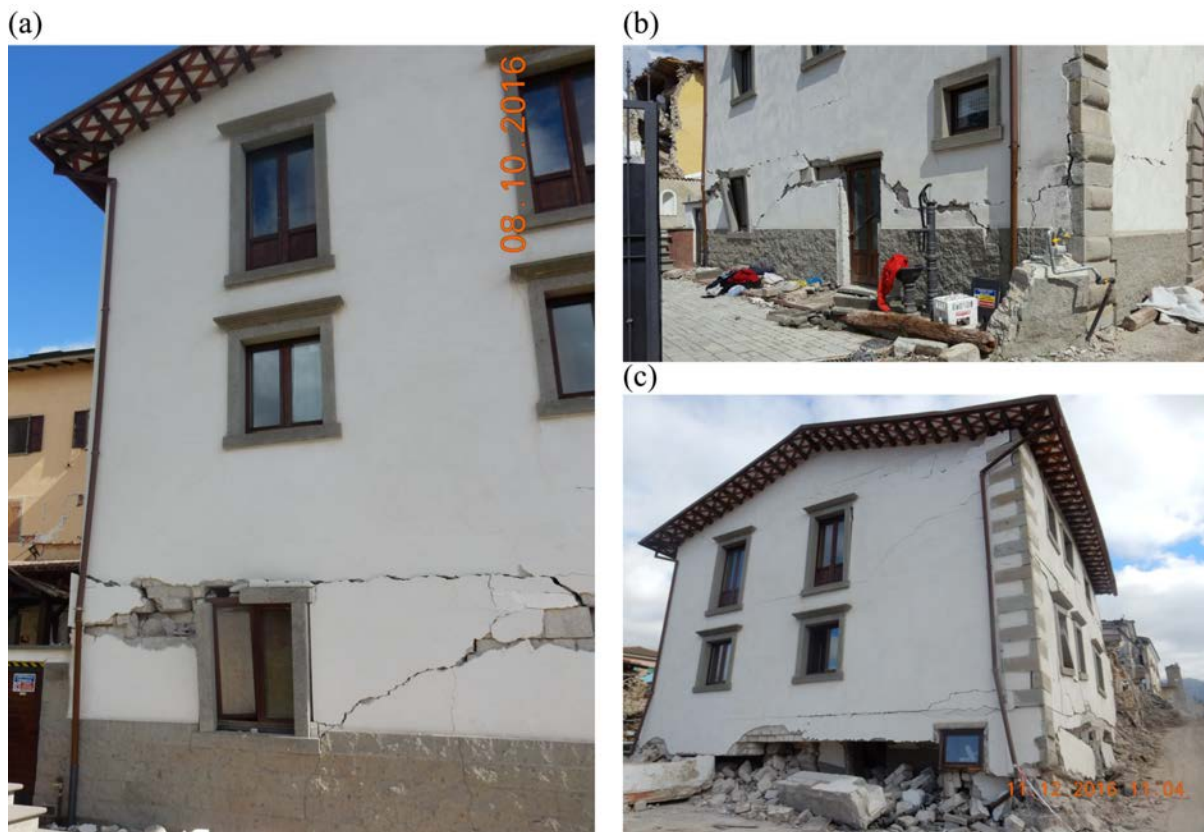
479 **Figure 18.** Residential masonry residential building after the 24 August earthquake (a, b) and (c) after  
 480 the entire sequence. Shear failure of the ground floor bearing wall leads to soft story collapse at the  
 481 end of the third event.

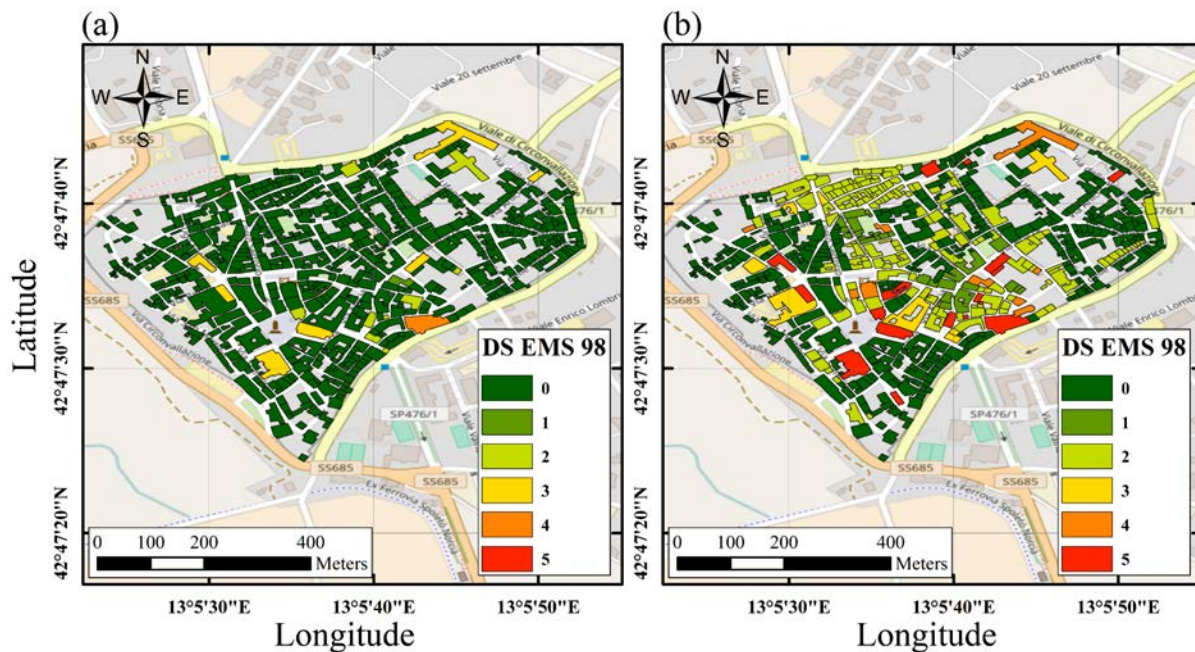
514 Figure 19 shows the structural damage levels observed during the two inspection  
515 campaigns. Following the 24 August earthquake, only a small number of buildings  
516 experienced medium or severe damage, located mainly in the historical center of the town.  
517 This good performance can be primarily attributed to two reasons. First, after the 1859  
518 earthquake, the reconstruction of Norcia was based on a set of new practical rules of thumb  
519 prescribing a minimum wall thickness, the use of buttresses, the reduction of building height,  
520 the use of vaults only at ground floor and the mandatory presence of good wall-to-wall  
521 connections. The increased wall thickness is still visible in many structures, and in several  
522 buildings, the wall thickness varies linearly along the height of the first story. Secondly, a  
523 series of repair and strengthening works followed the 1997 Umbria-Marche event, **which**

528 observed at the end of the seismic sequence, mainly in heritage construction such as churches  
 529 and monasteries. The following variation of cumulative damage was reflected in the  
 530 statistical distribution of the different damage states: intact buildings (DS0) were reduced  
 531 from 97% after the first earthquake to 67%, which was a substantial change in structural  
 532 behavior. Minor damage (DS1) also increased at the end of the entire sequence to 4% from  
 533 almost 0% after the first event. The same applies to moderate damage (DS2), it increased  
 534 from 1% to 24%, previously, and to DS5 increased from 0% to 3% in the first event, DS3 and  
 535 DS4 remaining practically constant.

536  
 537 **Figure 19.** Damage distribution in the historical center of Norcia (a) after the 24 August event and (b)  
 538 at the end of the entire seismic sequence.

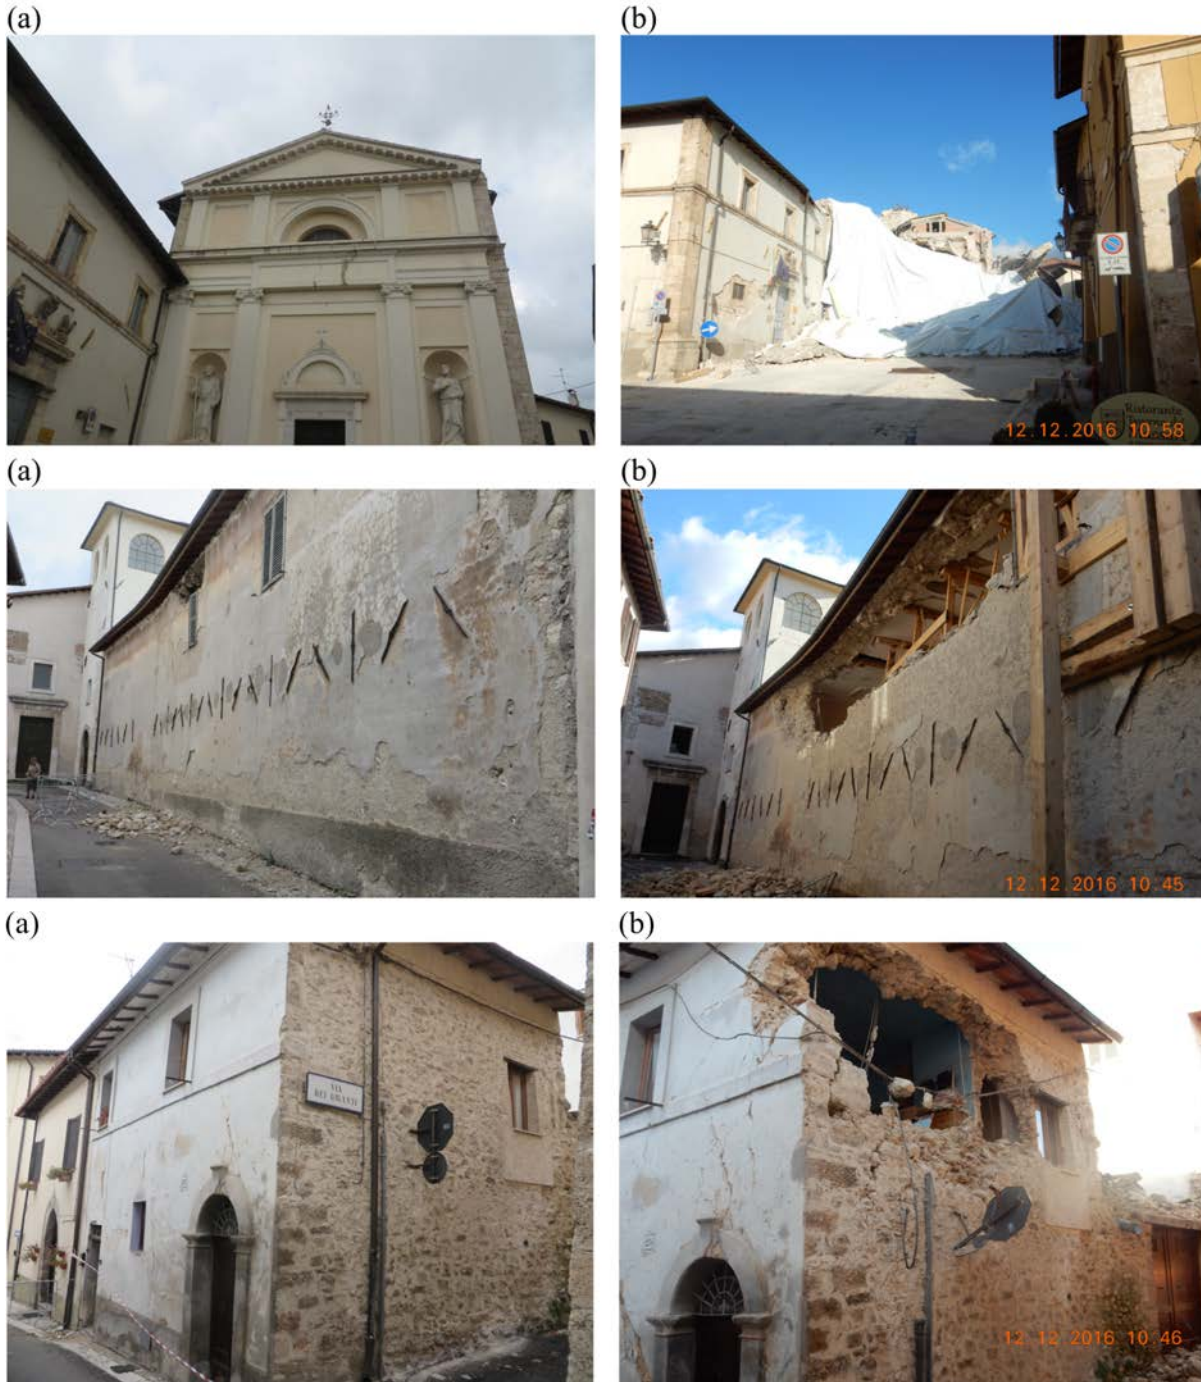
539 Figure 20 (top) shows one of the churches that was slightly damaged by the M6.1 24  
 540 August seismic event but collapsed following the M6.5 30 October event. Many historical  
 541 churches in Norcia experienced similar damage evolution, as shown for instance in Figure 20  
 542 (middle), where the out-of-plane failure of a historic monastery and the partial loss of support  
 543 of the roof is depicted. Notably, the wall failure was concentrated at a level higher to that of  
 544 the seismic retrofit, thus highlighting that the retrofit shall not be only localized on the  
 545 ground level but also take into consideration the reduced axial load and weak diaphragm  
 546 action of the masonry walls at the higher level. Figure 20 (bottom) shows two masonry  
 547 residential buildings with irregular masonry construction that experienced only minor  
 548 cracking during the first earthquake, but significant out-of-plane and in-plane wall failure

549 under subsequent events.

551 **Figure 20.** Seismic damage observed in characteristic masonry buildings (a) after the 24 August  
 552 earthquake and (b) at the end of the entire seismic sequence.
