Sextos, A., De Risi, R., Pagliaroli, A., Foti, S., Passeri, F., Ausilio, E., ... Zimmaro, P. (2018). Local site effects and incremental damage of buildings during the 2016 Central Italy earthquake sequence. *Earthquake Spectra*, 34(4), 1639-1669. <https://doi.org/10.1193/100317EQS194M>

# Local site effects and incremental damage of buildings during the 2016 Central Italy earthquake sequence

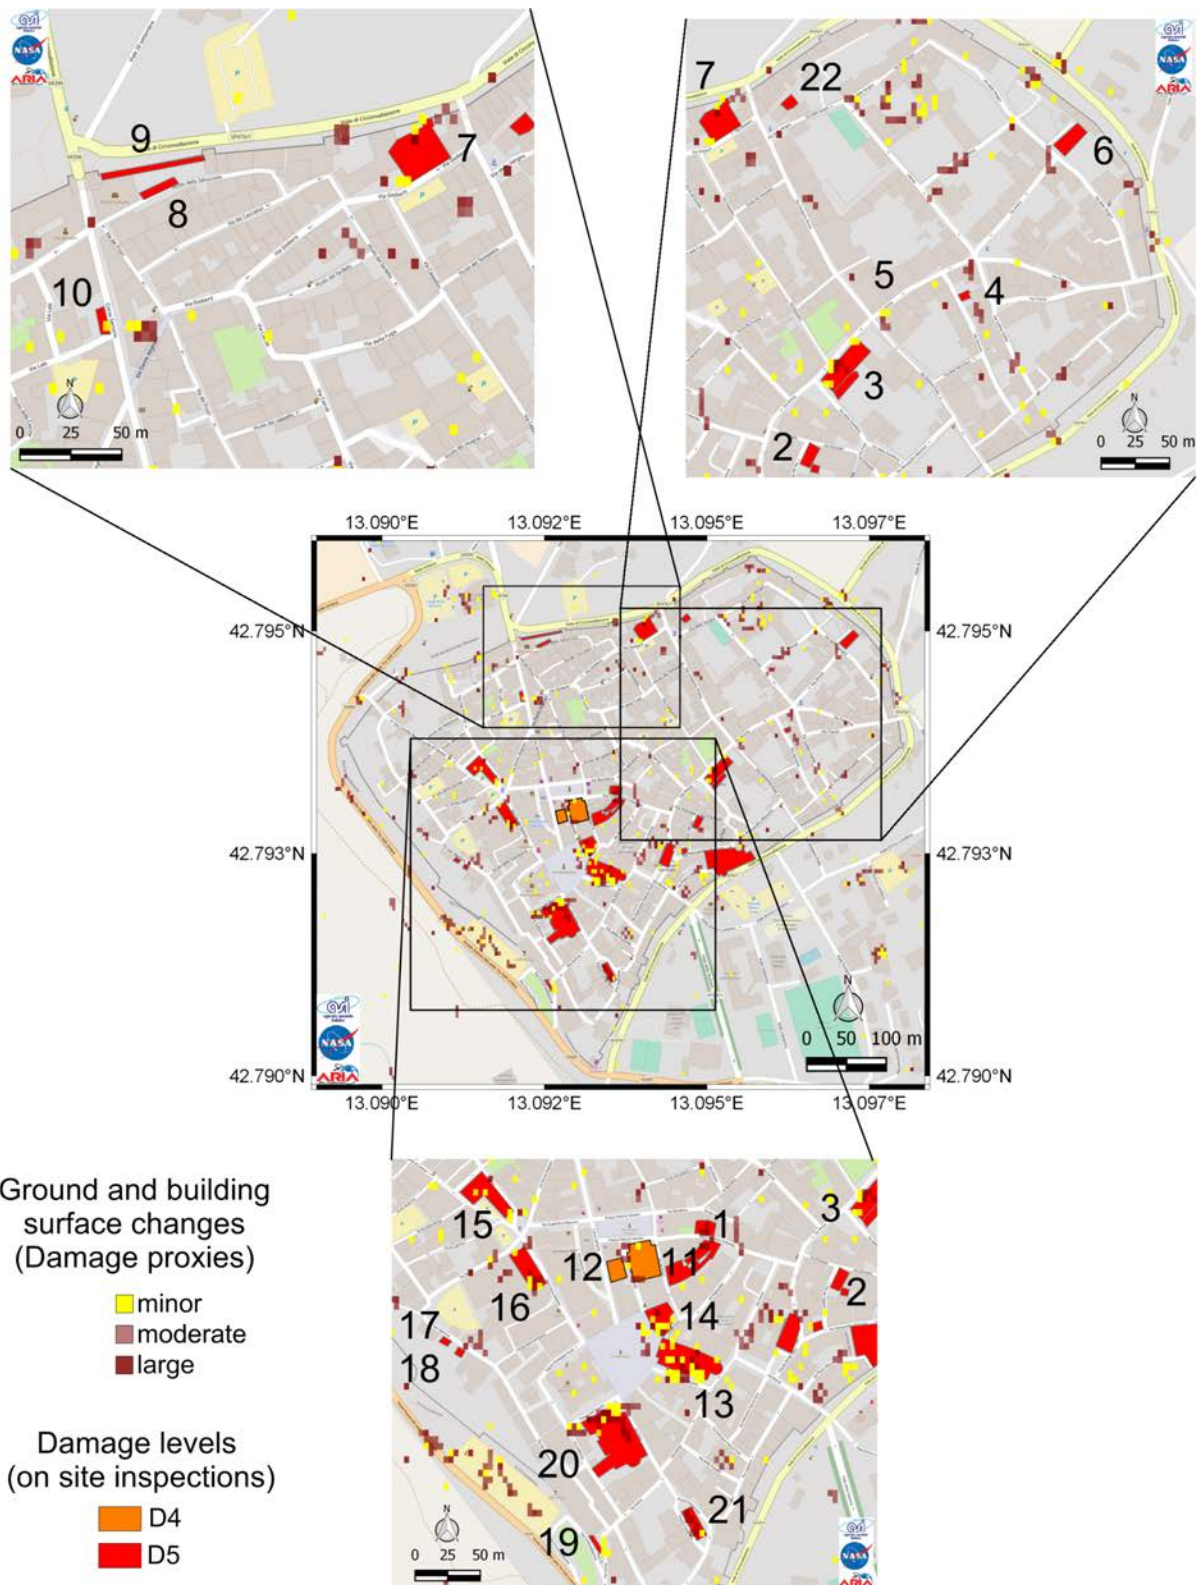
579 Figure 21 shows the DPM produced for the historical center of Norcia after the **M6.5** 30  
580 October event, that is, the end of the earthquake sequence, superimposed with 22 structures  
581 that were classified visually as completely collapsed (D5), and selected D4 structures.

582 By comparing the locations of these mapped structures and the damage zones from ARIA  
583 imaging, a good agreement was observed. In particular, for all structures with an assigned  
584 damage level of collapse (D5), the DPM accurately showed a concentration of red and dark  
585 red zones, representing areas in which substantial deformations occurred.

587 **Figure 21.** Damage proxy map of Norcia, along with the identification numbers of all structures with  
 588 assigned damage level D5 and selected structures with assigned damage level D4, from field  
 589 inspections and available high-quality on-site information and photos.
