HIGH ENERGY BEAM IMPACT TESTS ON A LHC TERTIARY COLLIMATOR AT CERN HIRADMAT FACILITY*

M. Cauchi[†], CERN, Geneva, Switzerland and University of Malta, Msida, Malta
 O. Aberle, R.W. Assmann[‡], A. Bertarelli, F. Carra, A. Dalocchio, D. Deboy, S. Redaelli, A. Rossi,
 B. Salvachua, CERN, Geneva, Switzerland
 L. Lari, CERN, Geneva, Switzerland and IFIC (CSIC-UV), Valencia, Spain
 P. Mollicone, N. Sammut, University of Malta, Msida, Malta

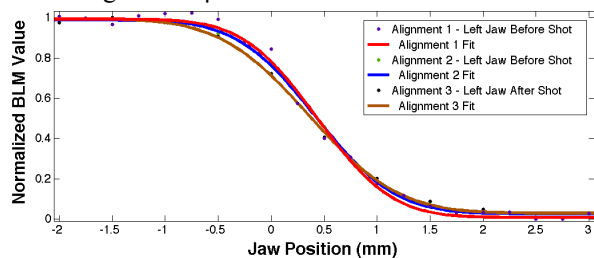
A beam-based setup was performed after Test 1 and Test 2 as an attempt to check the surface integrity of the jaws and the collimator mechanics following the beam shots. As can be observed from Fig. 4, there are no large variations between the beam positions before and after the shot, indicating that there is no critical damage of the

jaw surface. It is however difficult to conclude on errors in the range of 100 μ m

Figure 4: Beam-based alignment of left jaw. Alignment 1 and Alignment 2 are performed before Test 1 while Alignment 3 represents the check after Test 1.

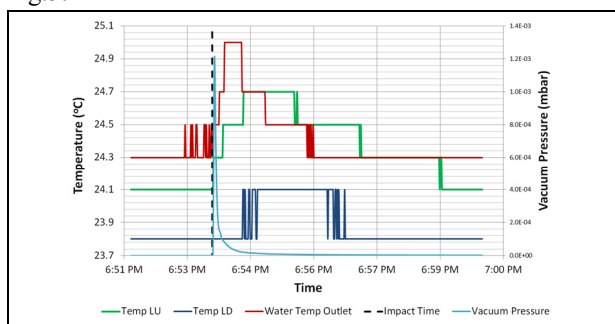
Figure 5: Test 1 temperature profiles captured by the upstream (LU) and downstream (LD) left jaw temperature sensors and by the water outlet temperature sensor. Also, vacuum pressure profile for Test 1. Impact at 6.53.51 PM.

The profiles in Fig. 5 show a temperature rise following the impact, which although small, is clearly observable. The temperature increases recorded are lower than expected and are not really compatible with post-mortem observations presented later. Thus these results have to be handled with care as there are potential issues under investigation. One of the reasons for these discrepancies might be the high thermal resistance (low contact pressure) between the temperature probe and the support to which it is attached, leading to an incorrect temperature recording. A peak in vacuum pressure for Test 1 is observed in Fig. 5 at the moment of impact.

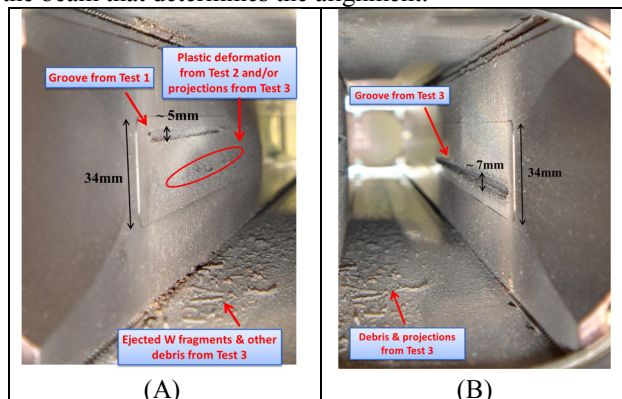
After the necessary cool-down of the irradiated collimator, a preliminary visual inspection (Fig. 6) was carried out to give a qualitative damage evaluation before further analysis. Grooves from Test 1 and Test 3 can clearly be identified, showing that there was a local temperature rise exceeding the melting point of the CuNi phase of the jaw insert material ($\sim 1343^{\circ}\text{C}$). Various fragments and projections of tungsten can be also observed between the jaws. Vaporisation deposit around the molten region is visible, indicating the extent of the damage caused by the beam impacts. The reason why the

alignment checks in Fig. 4 did not indicate the presence of such grooves might be because the grooves do not cover the full length of the jaw and the unperturbed part at the end of the jaw still determines the closest point to the beam that determines the alignment.

Figure 6: Preliminary visual inspection. (A) Damage on the left jaw caused mainly by Test 1 beam impact. (B) Damage on the right jaw caused by Test 3 beam impact.
