CHARACTERIZATION OF ASR PRODUCTS IN A 40-YEAR-OLD HIGHWAY. PROVINCE OF CÓRDOBA, ARGENTINA

Francisco Locati^{1*}, Silvina Marfil², Pedro Maiza³, Edgardo Baldo⁴

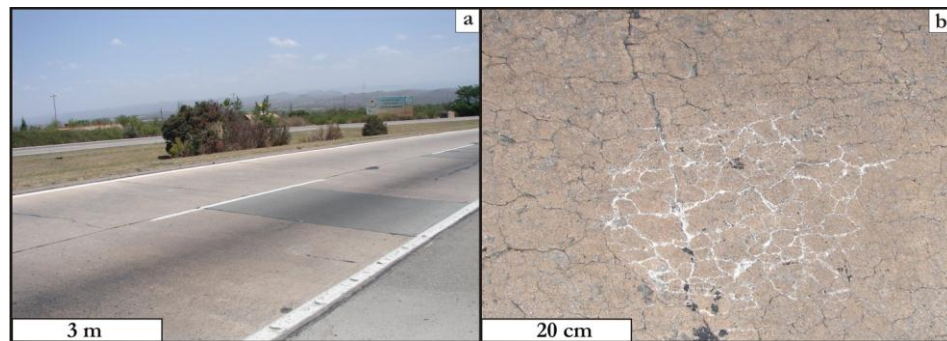
The second sector shows more deterioration. Concrete slabs show transverse joint faulting, broken areas next to transverse and longitudinal joints, longitudinal and transverse cracking, broken corners, intense cracking in transverse joints (in dowel bars), map cracking and areas with polished aggregates due to loss of the superficial mortar. Different works were made in these sectors involving partial or total replacement of slabs (Figure 2a) and localized areas repaired with asphalt mixtures.

In severely cracked areas such as the middle zone of slabs and next to transverse joints, white materials filling cracks 2 to 3 mm thick are seen (Figure 2b). In other sectors of the highway, the slabs present color variations, with a whitish central zone and boundaries with a yellowish color of lustrous shine.

FIGURE 2: Photographs of the structure. a) Sector of the highway without asphalt cover with partial slab replacement. b) Map cracking with white material filling fissures.

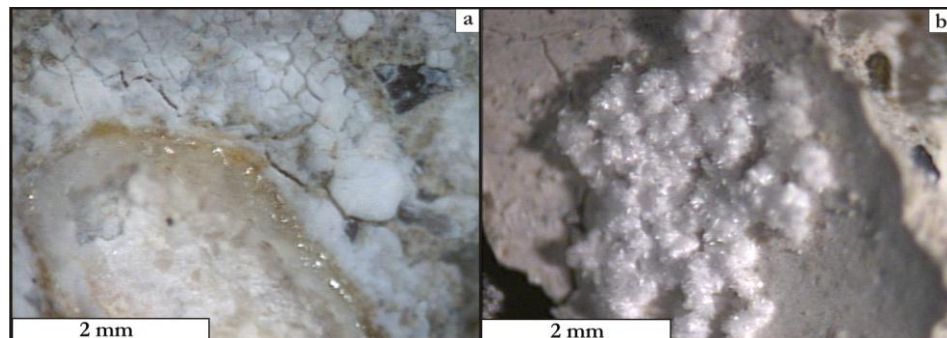
In Figure 3a an aggregate totally covered by a massive and white material can be seen. It turns shiny at the boundary of the aggregate and translucent and brown at the mortar-aggregate interface. Finally, a massive, white and cracked material covers the surface of the surrounding mortar. In Figure 3b a white and crystalline material of needle habit can be seen.

FIGURE 3: Photographs of concrete samples under the stereomicroscope. a) Aggregate covered and surrounded by reaction products. b) Air void partially filled with a white and crystalline material forming groups of radial crystals of needle habit.

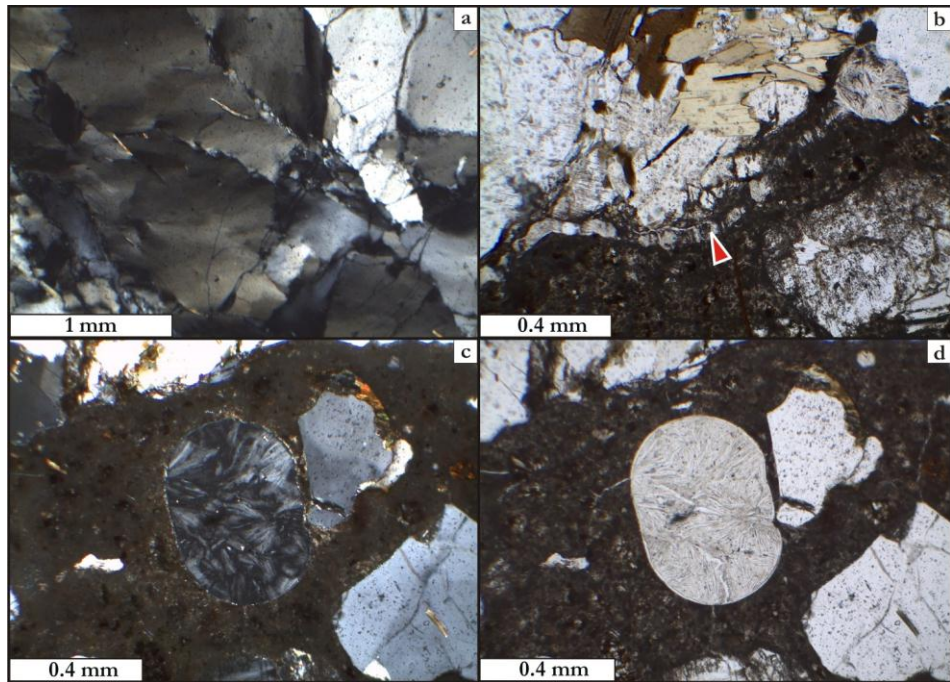
Concrete aggregates are mainly composed of biotitic gneisses with minor quantities of migmatites, amphibolites, granitic intrusives and marbles. The first group shows marked sin-metamorphic foliation and evidence of posterior deformation. The content of quartz is above 50% and presents a lot of microstructures associated with brittle deformation (small particles due to cataclasis) and brittle-ductile deformation (undulating extinction, deformation bands and subgrains, Figure 4a). The grain size ranges from a few millimeters to some dozen micrometers.

The mortar shows intense microcracking. A fibrous material crystallized perpendicular to fissure walls can be seen and it becomes bigger in air voids crystallizing radially to the interior of the cavities (Figure 4b).

Some materials in the cavities show fissures like “mud cracks” possibly due to dehydration and contraction processes. Air voids are partially or totally filled with ettringite (Figures 4c and 4d).

FIGURE 4: Photomicrographs. a) Gneissic aggregate showing quartz crystals with undulating extinction, deformation bands and incipient subgraining. Crossed nichols. b) Microfissure in the mortar-aggregate interface (red arrow) filled with a fibrous material. At the end of the fissure the material crystallizes in an air void of larger size. Parallel nichols. c) Air void filled with ettringite. Crossed nichols. d) The same picture with parallel nichols.

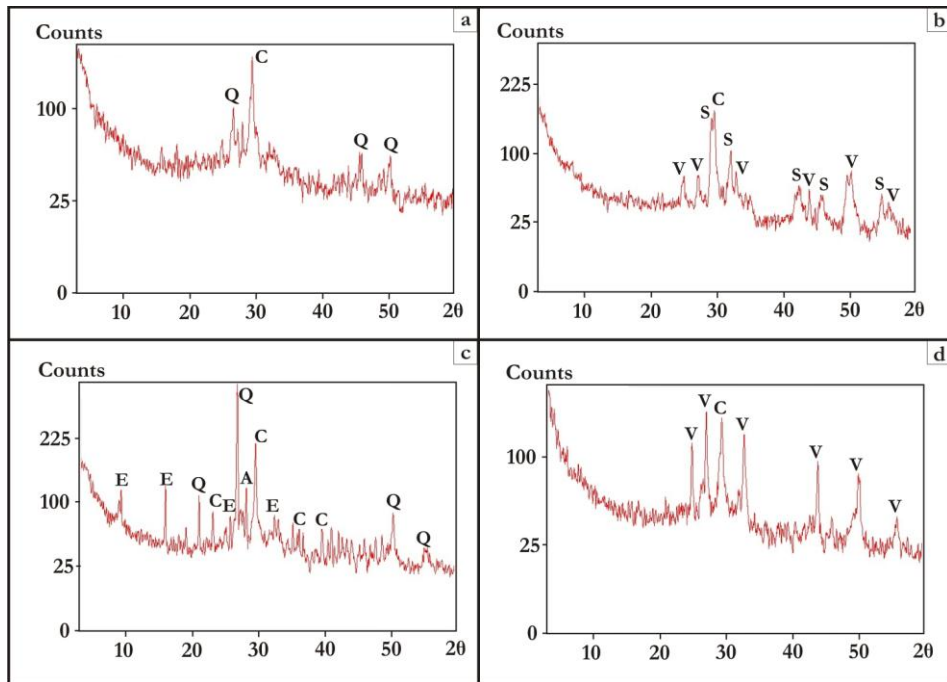
The massive and white material of low hardness and cracked, which covers air voids and the mortar, was identified as calcite (C) (Figure 5a). Another massive and white material of low hardness filling air voids was identified as a mixture of vaterite (V) (CaCO_3), calcite and a calcium silicate hydrate (S) with reflections coincident with tobermorite mineral (Figure 5b). The white material of low hardness but more compact in the mortar-aggregate interface was identified as a mixture of calcite and ettringite (E) (Figure 5c). In this sample, there are some reflections coincident with a calcium aluminum silicate hydrate (A) with zeolitic structure (gismondine). In the diagram there is only one reflection that is not superimposed with the other phases. The translucent and shiny material was identified as vaterite (Figure 5d).

were identified through XRD as a mixture of ettringite, calcite and a calcium aluminum silicate hydrate that possibly corresponds to a phase with zeolitic structure (Figure 5c).

FIGURE 5: XRD diffractograms. a) Material that covers air voids and mortar. b) Material filling air voids. c) Material in the mortar-aggregate interface. d) Translucent and shiny material in the mortar-aggregate interface. Calcite (C), quartz (Q), vaterite (V), calcium silicate hydrate (S), ettringite (E), calcium aluminum silicate hydrate (A).

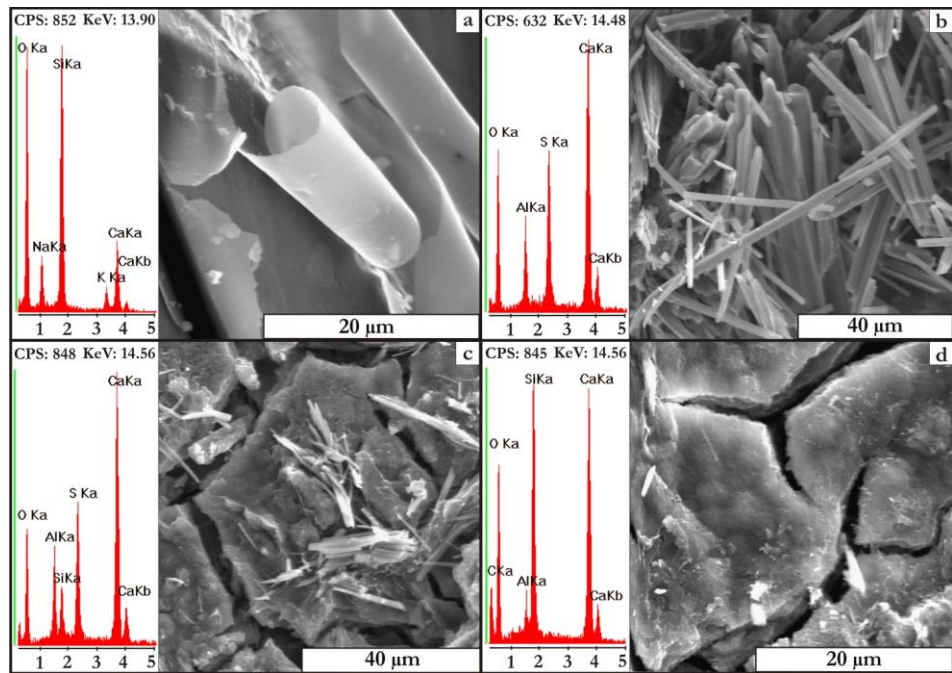
A laminar material that is detached from the concrete surface and forms tubes is observed (Figure 7a). It is composed of Si, O, Ca, Na and K. Due to its low percentage in the sample, XRD determination was not possible.

Filling cavities and on the mortar surface, prismatic crystals of needle habit were observed. They are composed of S, Al, Ca and O (Figure 6b). This material was identified as ettringite through XRD analysis.

A massive and cracked material at the mortar-aggregate interface and in the mortar was observed (Figures 6c and 6d). Over this material some prismatic crystals forming radiated groups were also identified. This prismatic material is composed of S, Al, Ca, O and Si (the latter possibly being a contribution from the massive material in the background). The massive product consists of Si, Ca, O, Al and C. All these materials

FIGURE 6: SEM-EDS determinations. a) Laminar material that is detached from mortar forming tubes. b) Prismatic crystals of ettringite in air void. c and d) Massive and cracked material on the mortar surface. Radiated groups of prismatic crystals over the massive and cracked material are also observed (c).
