Int. Conference on Sustainable Structural Concrete, 15–18 Sept 2015, La Plata, Argentina.

PETROGRAPHIC EVALUATION OF A 50-YEAR-OLD CONCRETE PAVEMENT MADE WITH QUARTZITIC AGGREGATE

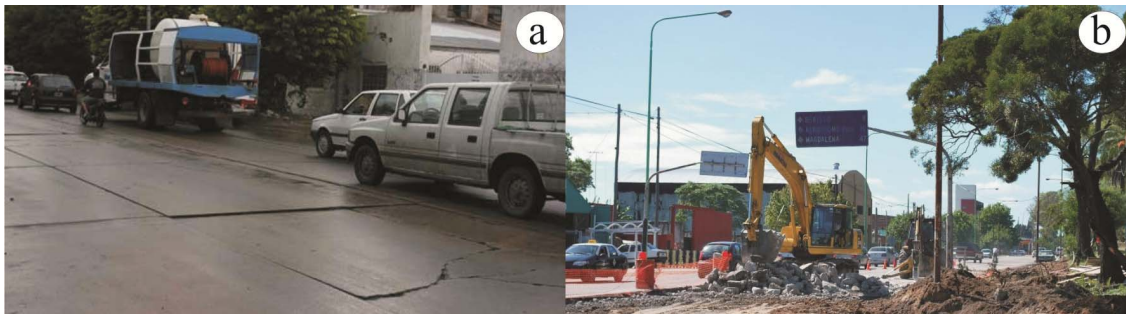
slab. Before its removal, the surface slab was affected by transverse and longitudinal cracks, erosion at joints and edges, and faulting (Fig. 1a).

Figure 1: (a) Pavement affected by longitudinal and transverse cracks, slab sinking and joint faulting. (b) Removal of concrete slabs (sampling area).

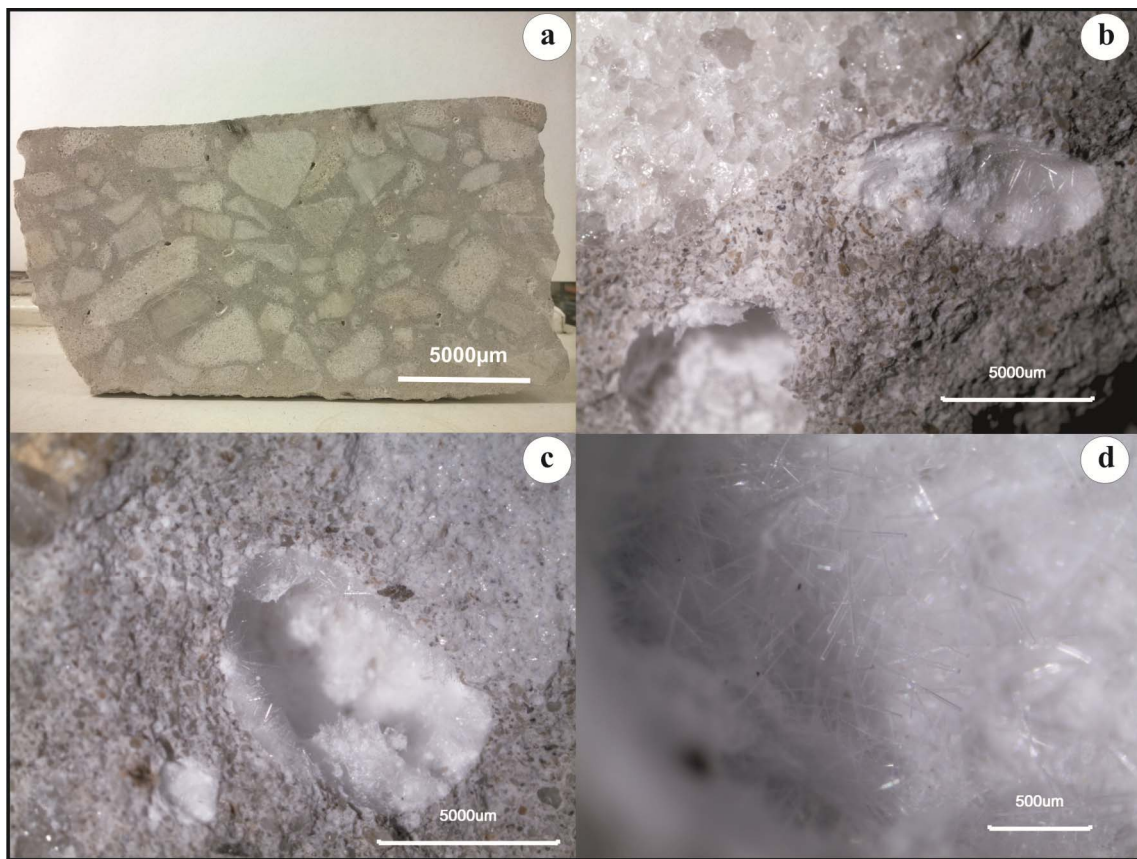
The samples taken from the base slab contained no reinforcements and their average thickness was 13 cm (Fig. 2a). The concrete from the surface slab contained remnants of dowels and tie bars, and was about 20 cm thick (Fig. 3a).

The mortar characteristics are very good, although it may be partly affected by cracks, which sometimes may also affect the interfaces with the coarse aggregate. Although the cracks are cohesive and in good condition, voids or irregular pores many millimetres in size and circular pores less than 1 mm in diameter, mostly filled with whitish products, are commonly seen (Fig. 2b and 2c). Such products occur as masses or fibrous crystals of pearly lustre that would be associated with ettringite (Fig. 2d).

Figure 2: Base slab concrete. (a) Mesoscale image showing the total slab thickness where the quartzitic coarse aggregate and the mortar with entrained air voids can be seen. Images (b), (c) and (d) taken with a binocular magnifier. (b–c) Detail of mortar pores, close to the interface with the quartzitic coarse aggregate, filled with a reaction material. (d) Detail of the reaction material, which is crystalline and of acicular habit.

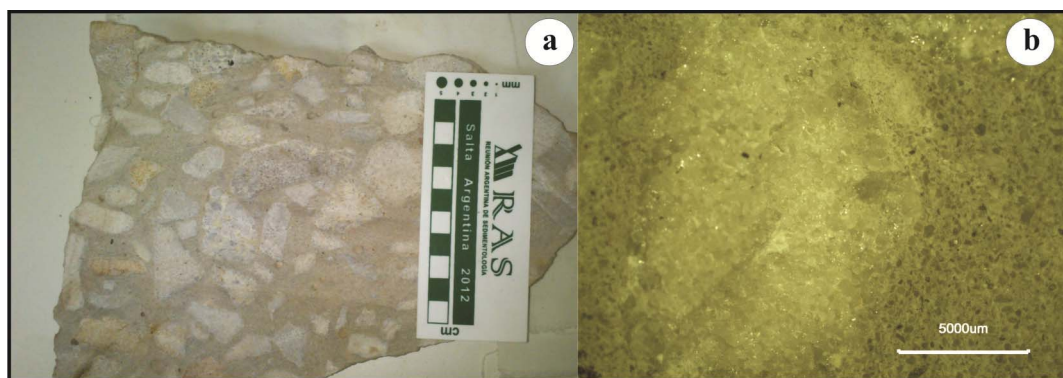
Surface slab concrete: it has similar characteristics to those of the base slab. The coarse aggregate is composed of the same quartzite and the mortar has similar proportions of fine aggregate and cement paste. Differences were found at this scale, namely that almost all the cement paste is yellowish grey due to the carbonation process (Fig. 3a) and the pores and entrained air voids are not filled or their walls are visibly lined. The coarse aggregate–paste interface is in good condition, with no cracks.

Figure 3: Surface slab concrete. (a) Mesoscale image. The total thickness cannot be seen. (b) Binocular magnifier image showing a whitish quartzitic coarse aggregate, the yellowish grey mortar and the interface, which are in good condition.

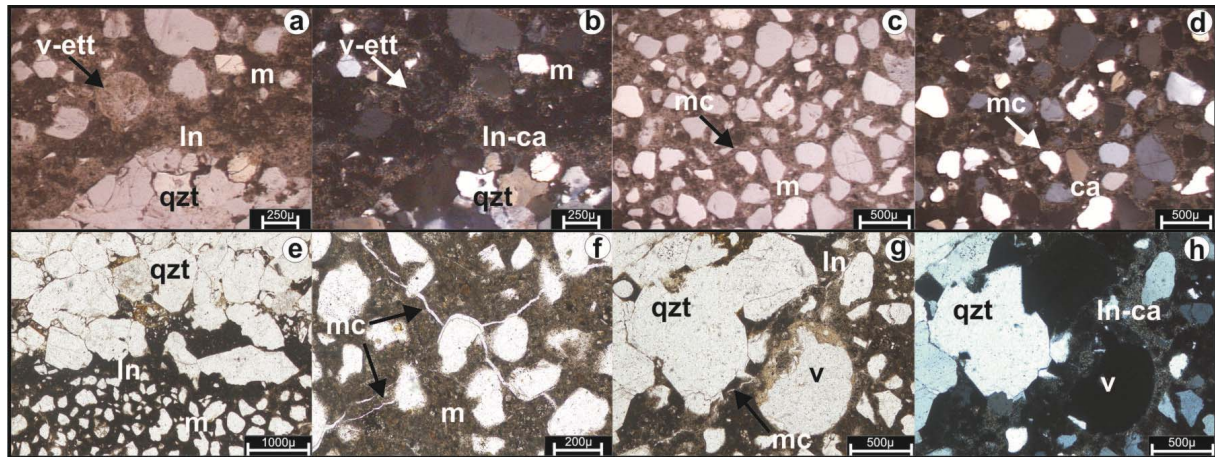
The surface slab concrete is similar to that of the base slab. As shown in Fig. 4e and 4f, the coarse aggregate–cement paste interface is in good condition, cohesive and with good adhesion, but in some cases microcracking and carbonation were observed in the area of the coarse aggregate–mortar interface, as well as some entrained air voids partially filled with calcite, portlandite and/or ettringite, as shown in Fig. 4g and 4h. Close to the microcracks and voids, the mortar is carbonated, and portlandite crystals that may form a kind of halo around the aggregates, mainly the fine aggregate, are common.

Figure 4: Polarizing microscope images of thin sections. a–d Images of base slab concrete. (a–b) Under parallel light and crossed nicols, respectively. Orthoquartzite making up the coarse aggregate (qzt); the mortar is sound and the interface is partially carbonated (In-ca). Entrained air void filled with ettringite (v-ett). (c) Under parallel light, mortar (m) where very fine microcracks (mc) have developed. (d) The same image under crossed nicols; the mortar is carbonated (ca). e–h Images of the surface slab concrete. (e) Under parallel light, area of the quartzitic aggregate (qzt)–mortar (m) interface in good condition, with no cracks. (f) Unfilled microcracks (mc) affecting the mortar (m) and some interfaces with the fine aggregate. (g) Under parallel light and (h) under crossed nicols; area of the interface with the quartzitic aggregate (qzt) that is partially carbonated (In-ca) and affected by a microcrack (mc) and an entrained air void (v) partially filled with calcite and/or portlandite. In short, the microstructure of the concretes examined does not show reaction phenomena or deterioration processes affecting the coarse or fine aggregate. The aggregate–mortar contacts are clear, with no reaction rims or cracked particles. Microcracking and carbonation in the paste are rare. The main material filling mortar voids is ettringite, which also appears on the mortar surface.

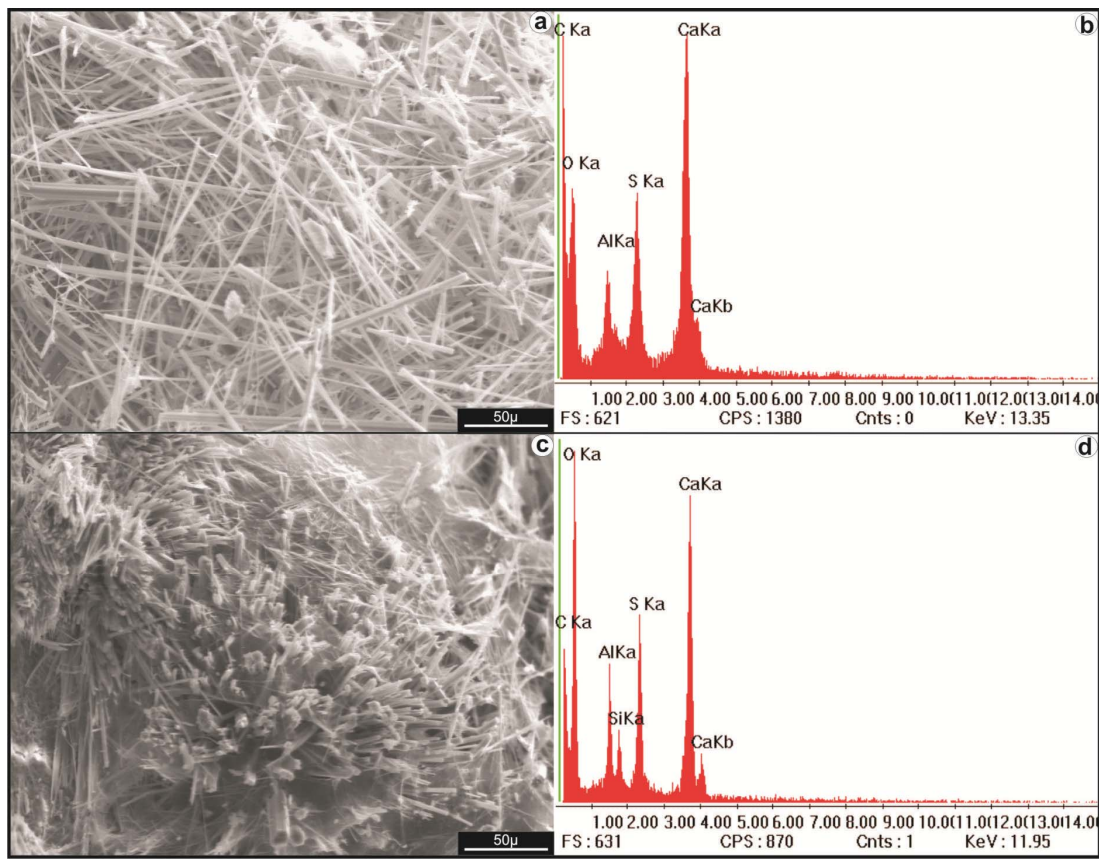
A larger quantity of material could be obtained from the base slab concrete for the analyses. Figure 5a shows crystals of fibrous habit characteristic of primary ettringite and Fig. 5b the chemical analysis of the material by EDS, where S, Al, O and Ca attributed to ettringite were identified.

Figure 5c shows ettringite crystal growth inside an entrained air void and Fig. 5d the corresponding EDS spectrum, where the low-intensity Si peak was assigned to quartz from the aggregate.

Although the C peaks observed in both spectra are partly due to the material used to metallise the samples, the high intensity (especially in Fig. 5b) associated with the Ca peak intensity is assigned to calcite.

Figure 5: SEM–EDS. (a) Fibrous habit typical of primary ettringite. (b) Composition of the material shown in Fig. 5a. S, Al, O and Ca attributed to ettringite. (c) Ettringite crystal growth inside an entrained air void. (d) EDS spectrum of the material shown in Fig. 5c.

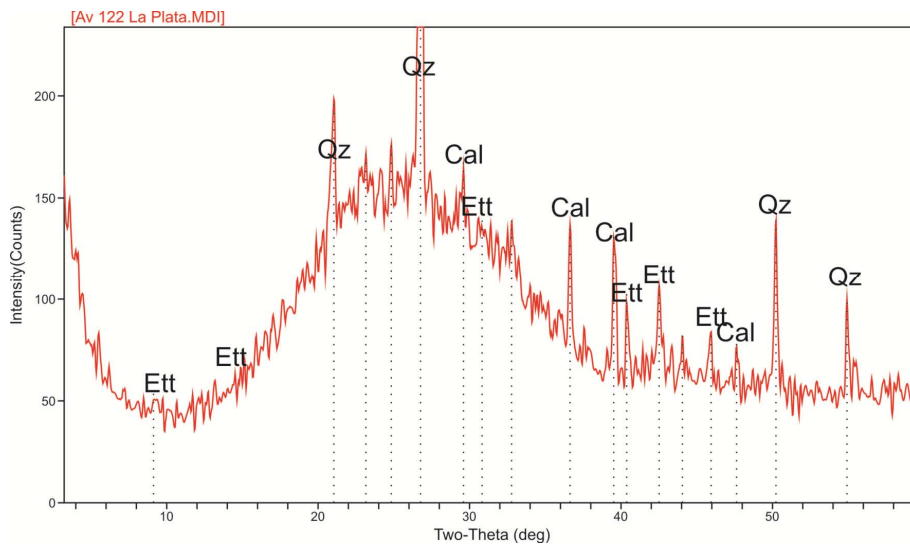
The products collected from the base slab concrete voids were analysed by XRD. The reaction material developed inside the pores and on the mortar surface was separated under a stereomicroscope to be examined by XRD in order to identify the species present. As scarce material had developed, it was difficult to concentrate a large enough quantity for the analysis, which was also difficult due to the low crystallinity of the products related to the quartz from the fine and coarse aggregates. Figure 6 shows the XRD patterns indicating that the main reflections correspond to quartz with subordinate calcite. A very low intensity reflection peak at 9.70 Å, attributed to ettringite, was identified.

Figure 6: XRD pattern of the reaction material developed inside entrained air voids and on the mortar surface. Ett: ettringite, Qz: quartz, Cal: calcite.
