The importance of structural monitoring as a diagnosis and control tool in the restoration process of heritage structures: a case-study in Portugal

Maria-Giovanna Masciotta^a, Luís F. Ramos^b, Paulo B. Lourenço^c

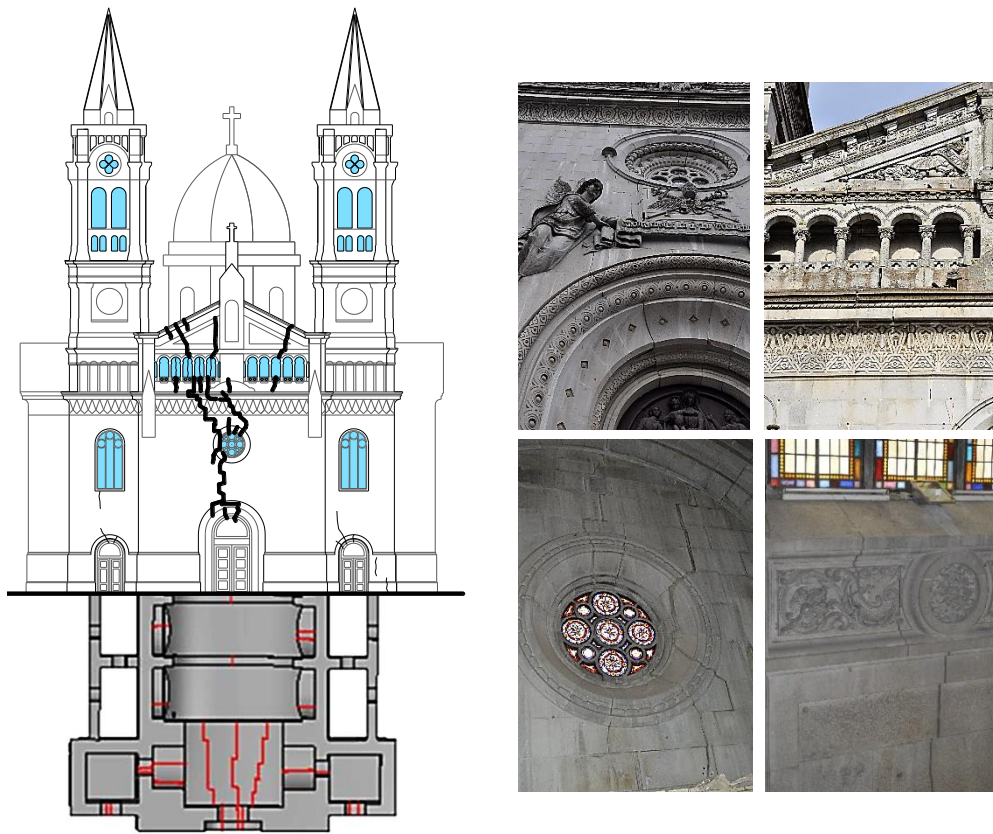
The church exhibited moderate to severe structural damage (Figure 2). The most affected part was the façade where a V-cracking pattern arising from the keystone of the portal was observed. The major of the two cracks split the façade into two macro-blocks, being as deep as the thickness of the wall and reaching over 50 mm width at the tympanum level. Five vertical cracks of about 5 mm width were also present on the outer wall of the left side of the gallery. Inside the building, beyond the major crack crossing the façade, several cracks were visible in the vault beneath the choir and additional cracks were detectable along the weakest links of the sidewalls of nave and transept. Besides the cracking pattern, the last laser scanning [18] highlighted that the towers of the church were leaning forward in longitudinal direction and moving apart in transversal direction. Little hair cracks, probably due to the high compressive stresses caused by the load eccentricity associated with the tilting, were observed at the base of each tower.

west but with different inclination ratios. Merging this information with the outcome of the geotechnical survey, it was concluded that the main cause triggering the cracks and the separation movements of the towers was the differential soil settlement in the strata underneath towers and façade. Although the digging of two pits uncovered the presence of good quality foundation made of large-size granite blocks under the towers, the soil profile surveyed during the investigations showed heterogeneity and variability of the layers along the longitudinal section of the church [19]. The temple stands on a slope which is levelled by a landfills bank, thus the steady bedrock layer is very close to the foundation in the apsis and transept areas, but it goes deeper and deeper while proceeding towards the front of the temple. Here the soil is mostly composed of sands and non-cohesive layers, whose poor mechanical characteristics get worse when approaching the western area. This explains why the floor of the church was sinking from the transept towards the front façade and why this phenomenon was accentuated under the western tower.

Figure 2 – Structural damage in the church: (a) crack pattern of the façade and choir vault; (b) details of the cracks; and (c) possible collapse mechanism [18].

Once the analysis of the ‘symptoms’ shed light on the root causes of the damage affecting the church, *ad hoc* strengthening measures were planned and executed (04/2014 – 07/2015) [20]. The strengthening design focused on three main aspects, viz.: (1) elimination of differential soil settlements; (2) restraint of towers leaning and attenuation of tensile stresses responsible for the cracking of the façade; and (3) restore of material continuity. To this end, the consolidation measures involved the installation of micro-piles along the foundation sides of both towers, the placement of post-stressed tie rods to link the towers, and the injection of cracks. The works schedule is summarized in Table 1. Given the importance to evaluate the effects of the works on the global behaviour of the system, a continuous dynamic monitoring was carried out during and after the structural intervention. The outcome of the dynamic

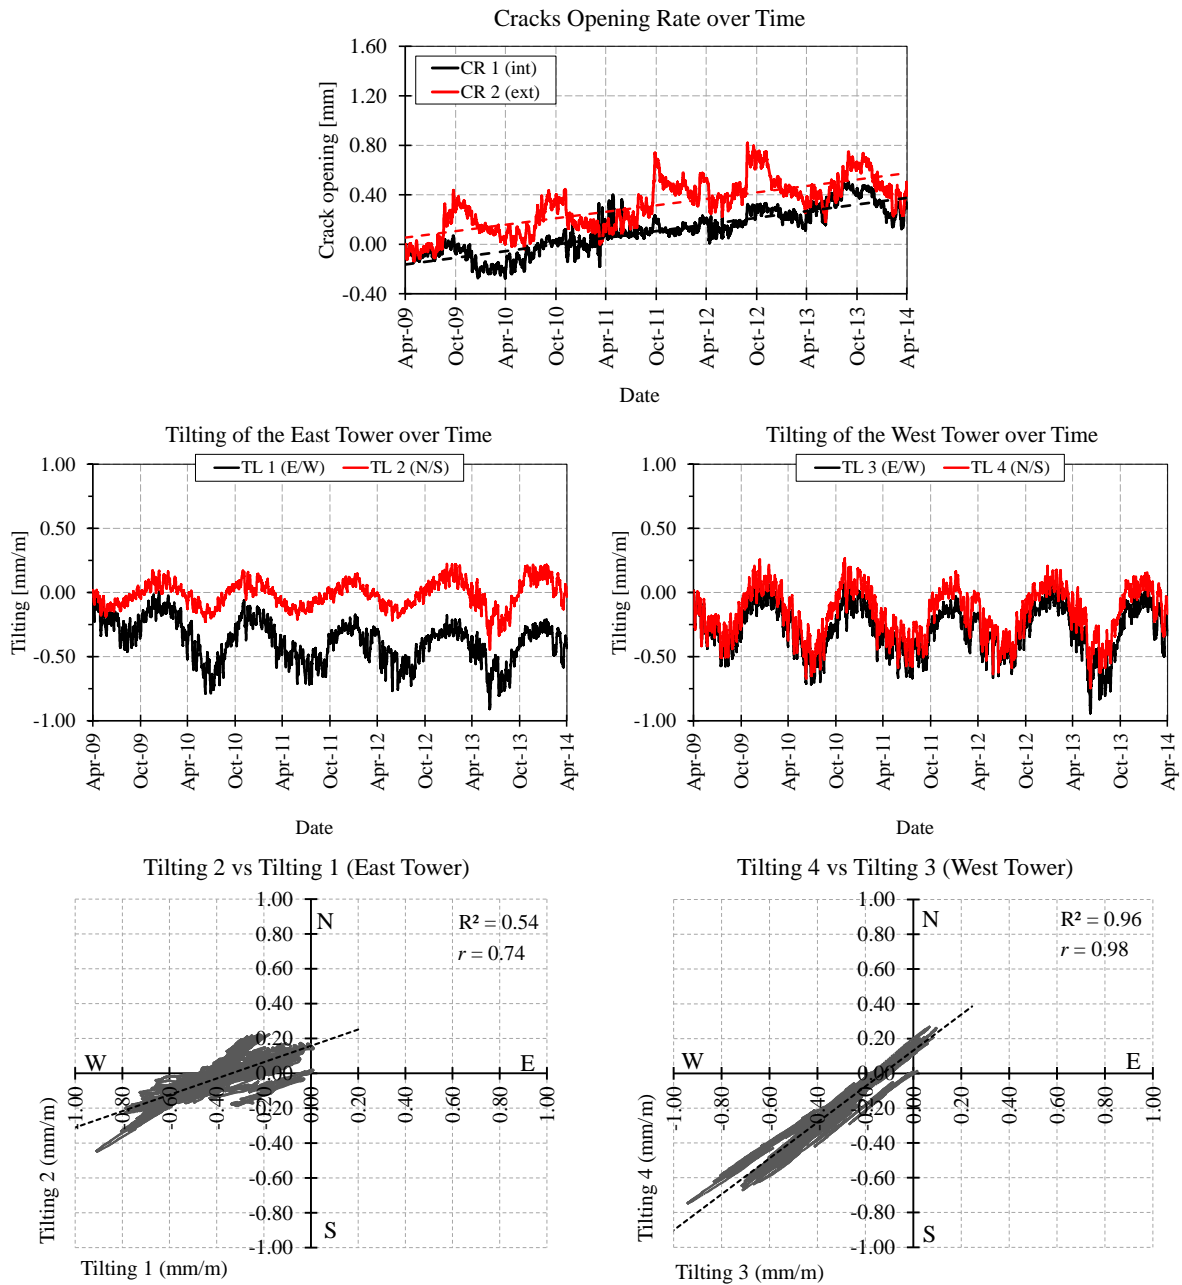
Figure 4 shows the evolution of cracks opening and towers tilting before the works execution (04/2009 – 04/2014). As it can be seen, the cracks behaviour features a positive linear trend over years, meaning that the cracking pattern has not recovered but worsened with time, pointing out the need for corrective measures. The cracks width keeps increasing with an average opening rate of 0.1 mm/year, reading a higher growth rate for the exterior crack (CR2). Regarding the tilt data, it is noticed that both towers feature in-phase cyclic oscillations either in longitudinal (N/S) and transversal (E/W) directions with a common trend in leaning towards West-South. Greater oscillation amplitudes (responsible for the separation movements of the façade) are found for the western tower, reading maximum tilting values of 0.94 mm/m in West direction and 0.75 mm/m in South direction. These values describe relative displacements as the original inclination of the tower is unknown, but, assuming that the towers had no initial imperfection in verticality, the actual displacements can be derived from the 3D laser scanning conducted in 2014 [18]. Based on the surveyed points cloud, the tower featuring greater inclinations is always the western one, with tilting values of 5 mm/m in West direction and 3

mm/m in South direction. Considering the towers as rigid bodies undergoing pure rotation about a fixed axis at the bottom of the foundation, the top displacements result equal to 0.26 m and 0.15 m in transversal and longitudinal directions, respectively, with rotation angles of 0.29° and 0.17° . Being these values within the threshold limits identified through the stability analysis of the tower [22], no alarm was issued but the visual appearance of the monument resulted compromised, calling for remedial measures.

Figure 4 – Static monitoring of cracks opening and towers tilting before the works execution (r and R^2 indicate the coefficients of correlation and determination, respectively).

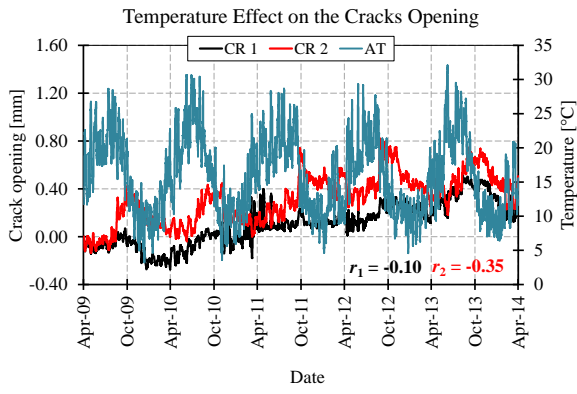
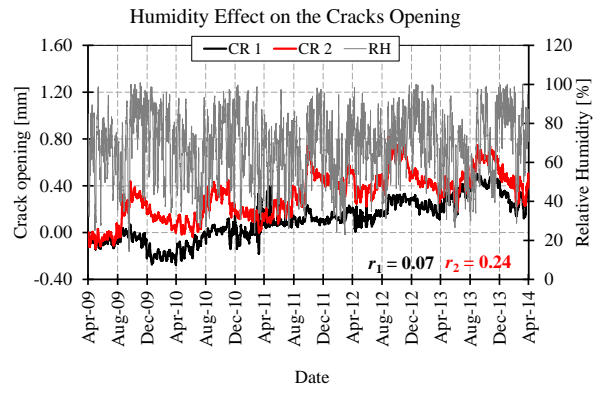
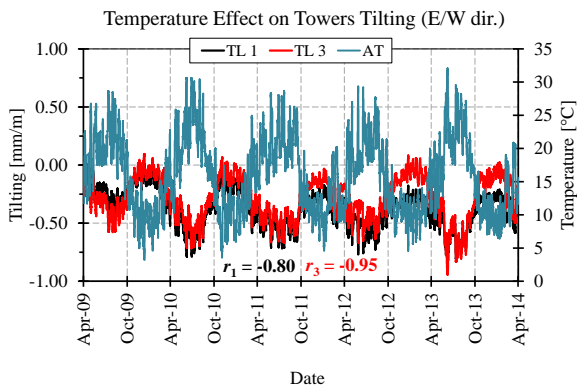
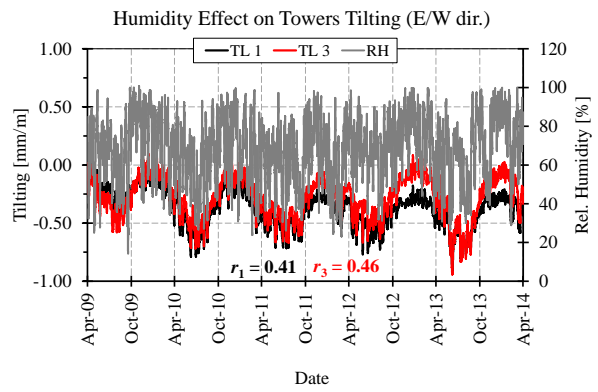
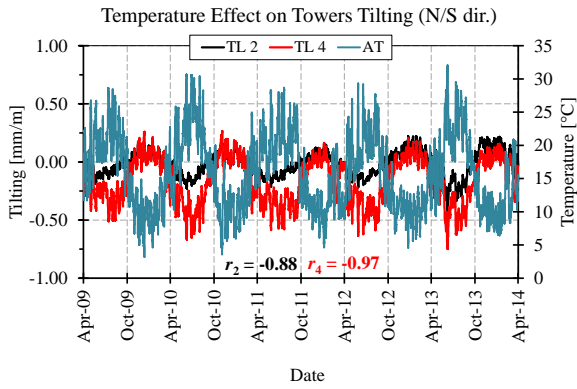
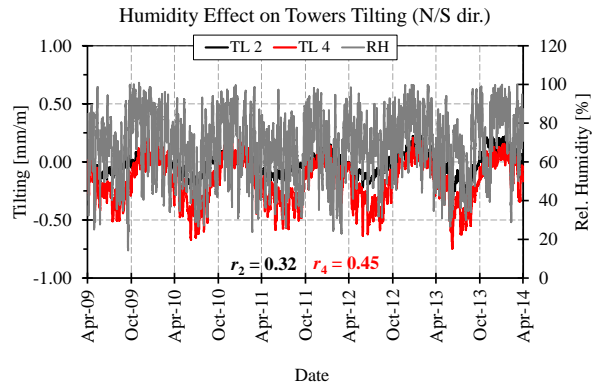
It is stressed that the structural performance of historic buildings can also be adversely affected by environmental conditions [23], [24]. As a rule, masonry expands when temperature rises and contracts when temperature falls. Thermal contraction on the material surface without a corresponding change in its interior temperature can cause a thermal differential and potentially lead to cracking. If cracks already exist, temperature fluctuations cause the cracks to open and close accordingly. In order to comprehend whether ambient variables may influence the damage scenario of the church, crack and tilt data are plotted along with temperature and relative humidity. The results are displayed in Figure 5, where the relationship between monitored quantities is expressed through the coefficient of correlation r . Unlike crack CR1, crack CR2 shows a higher environmental variability (Figure 5a-b), being located on the exterior side of the façade and therefore directly exposed to seasonal fluctuations of temperature and relative humidity. As the temperature goes down (warm-cold cycles), the crack width increases; as the temperature goes up (cold-warm cycles), the crack width decreases. From a physical viewpoint, this phenomenon is due to the cracks closure/opening associated with the thermal expansion/contraction of the masonry material with rising/decreasing temperature. Owing to the thermal inertia of the masonry walls, small phase shifts are also observed between temperature variation and CR2 trend. On the contrary, no correlation is found between crack growth rate and relative humidity. Concerning the towers oscillation (Figure 5c-f), a direct relationship with temperature fluctuations is remarked. The towers rotate towards North/East

when temperature decreases and lean towards South/West when temperature increases. This phenomenon affects both towers, but the western tower is the one featuring a stronger temperature influence, reading values of r nearly equal to the unit. Although less strong ($r < 0.50$), a direct correlation between towers tilting and relative humidity is found as well.

Figure 5 – Variation of cracks opening and towers tilting versus temperature (AT) and relative humidity (RH) before the works execution (the coefficient r indicates the correlation between crack or tilt data and ambient variables).

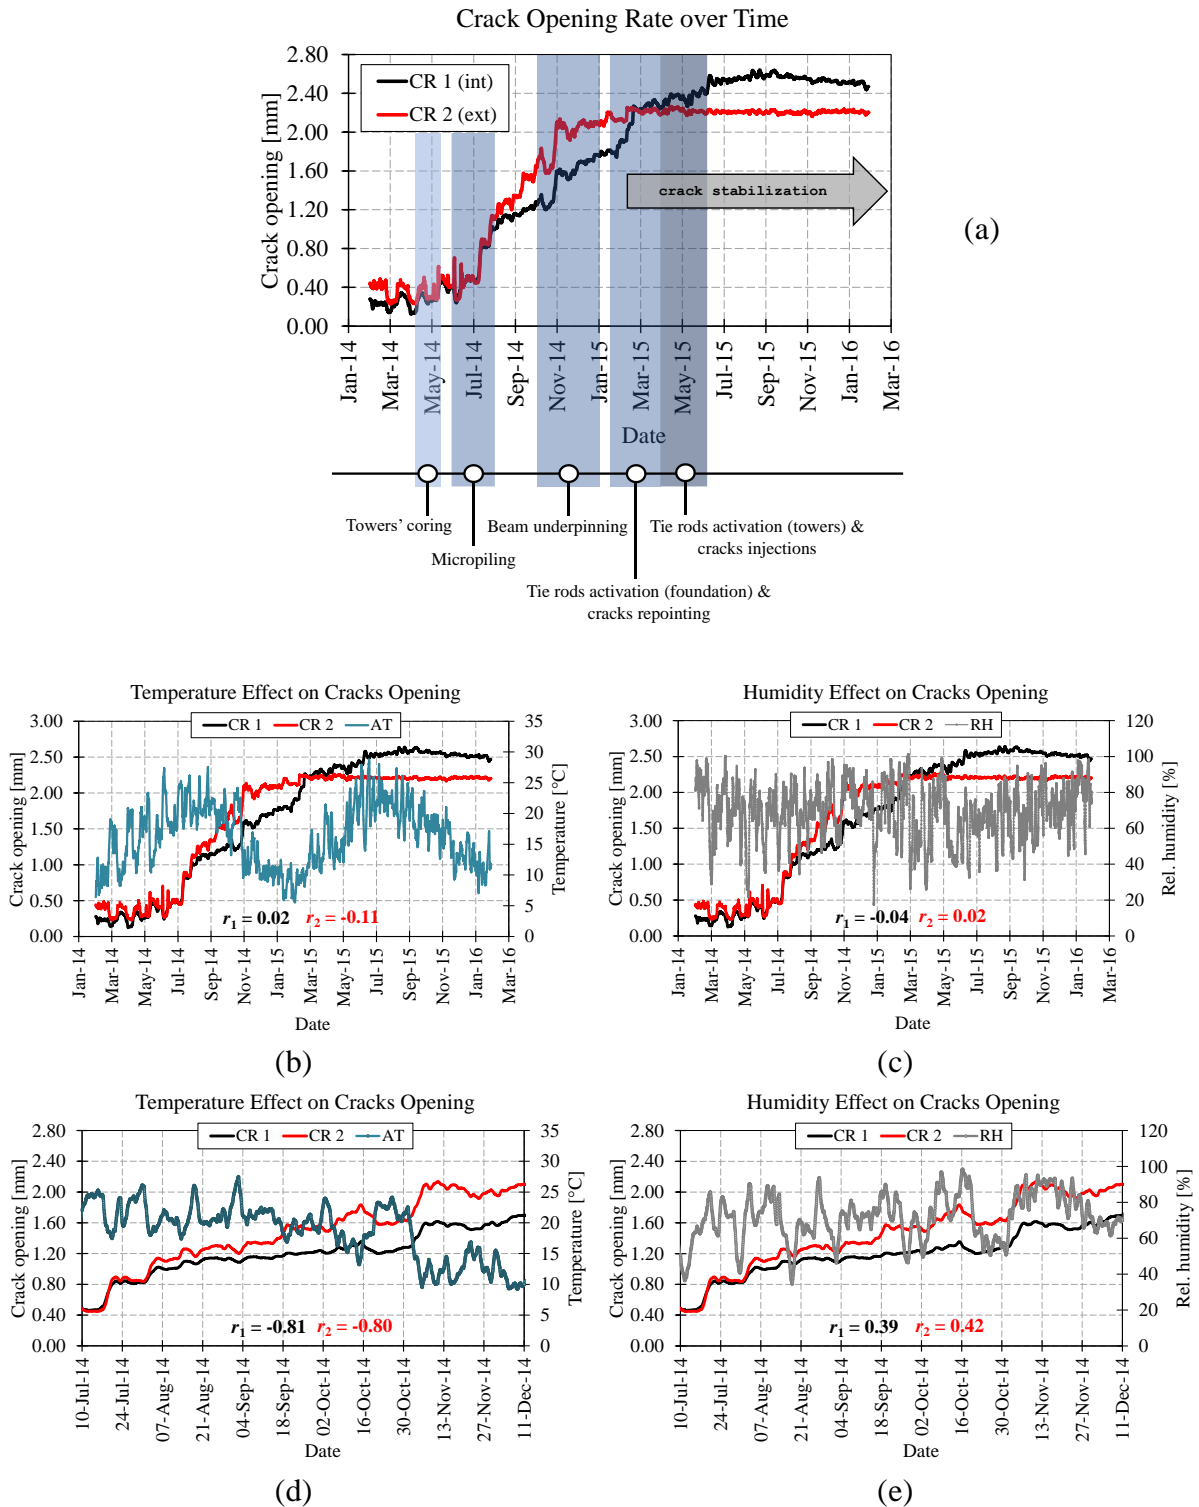
The evolution of cracks opening during and after the strengthening works is illustrated in Figure 6. It is highlighted that in the period ranging between the micro piling (June/July) and the beam underpinning (November/December) the crack meters record abrupt jumps, reading an increase of crack width of about 1.7 mm for CR2 and of nearly 1.4 mm for CR1. Although modern drilling techniques used for micro piling are very neat and do not produce any harm to structures, excessive vibrations in cohesionless soils can induce overall ground movements and propagate to the surface and adjacent areas. In the present case, the substantial cracks opening monitored during drilling operations is ascribed to the soil loosening originated from excessive ground disturbance. In fact, as the piling works stop and both towers and foundation anchoring systems become operating through the tie rods activation, the trend stabilises and the crack growth is arrested (Figure 6a).

In what concerns the environmental effects on the damage pattern associated with the cracks, no relation is found with respect to seasonal variations of ambient parameters (Figure 6b-c). Yet, quite a strong correlation is registered between cracks opening and daily variations of environmental conditions (Figure 6d-e), especially in terms of temperature ($r \approx -0.81$): when the temperature drops off, the material shrinks and the cracks width increases, whereas when the temperature rises, the material expands and the cracks width decreases. As expected, the ambient fluctuations sensibly affect the damage pattern of the church during the works, being the cracks still active. On the contrary, after the activation of the anchoring systems and the injections of cracks, no further influence of ambient conditions on the cracking pattern is found.

Figure 6 – Static monitoring during and after the structural intervention: (a) evolution of cracks opening rate; variation of cracks width with respect to (b-c) seasonal and (d-e) daily fluctuations of temperature and relative humidity.

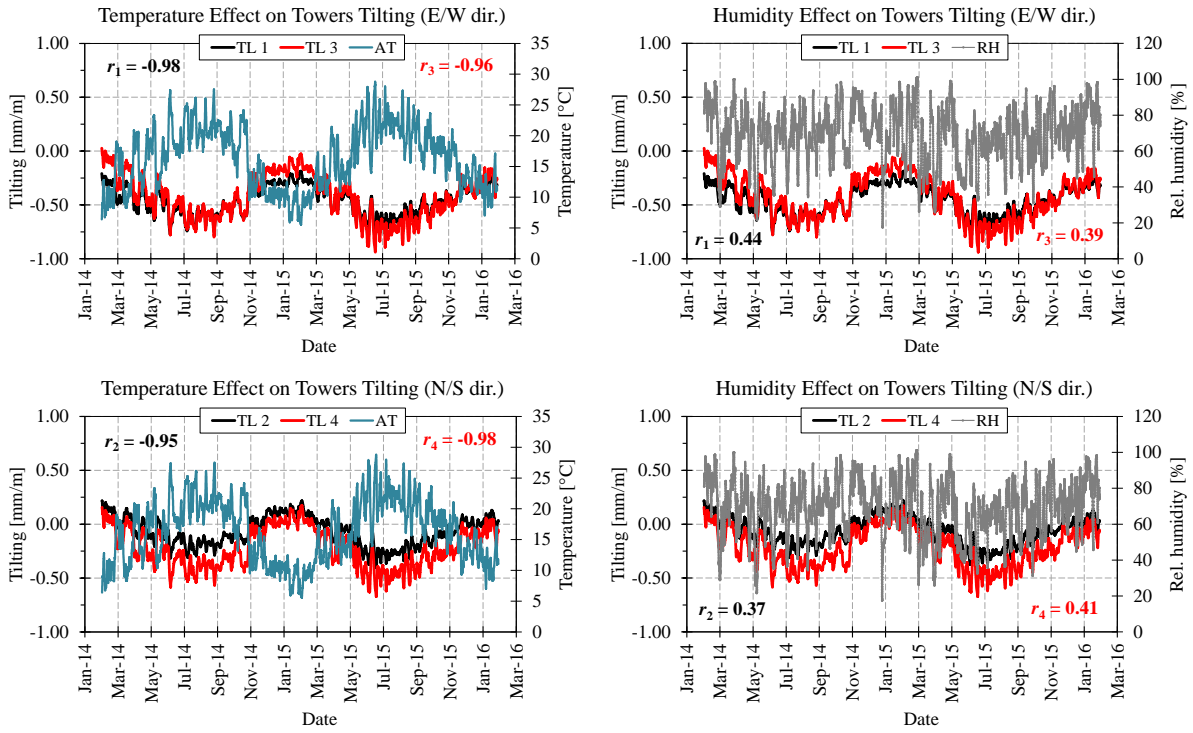
Analysing the tilt data (Figure 7), it is deduced that the towers movements do not feature any significant change of trend during the works execution, being the tilting rate steady throughout the intervention. Although the monitored time span was likely not enough to catch the tilting turnabout expected after the activation of the anchoring system, it is plausible that towers oscillations suffered much more from varying environmental conditions rather than other phenomena. This is confirmed by the plots in Figure 7 which show a significant correlation between towers tilting and air temperature ($r > -0.95$), much stronger than the one with relative humidity ($r < 0.45$).

Figure 7 – Variation of towers tilting versus temperature (AT) and relative humidity (RH) during and after the works execution (the coefficient r indicates the correlation between tilt data and ambient variables).

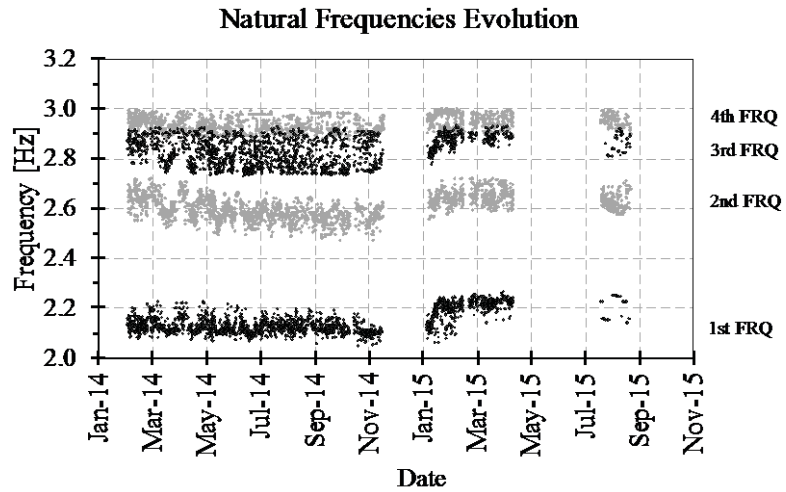
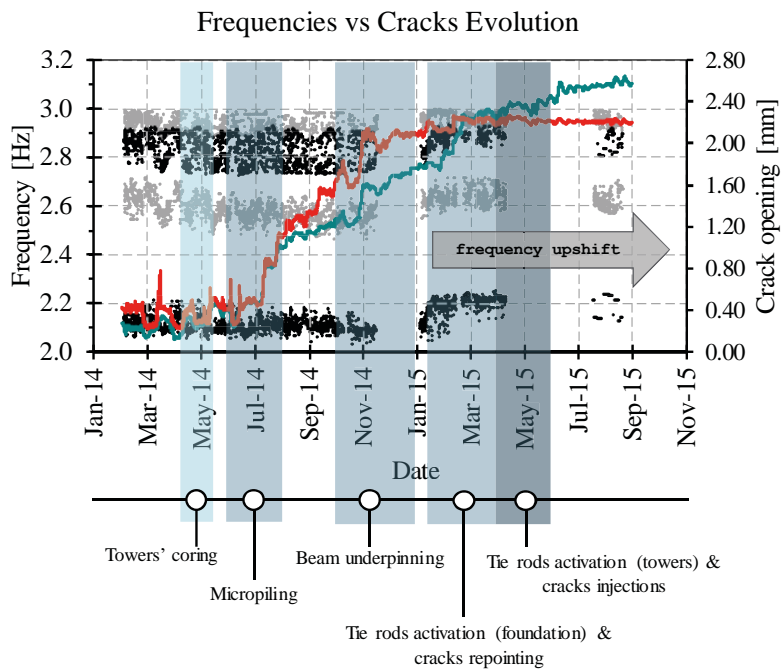
Figure 8a presents the evolution of the four identified natural frequencies from February 2014, two months before the works began, till August 2015, one month after the works were over. Although all data were pre-processed to improve the outcome of the modal estimation, the frequencies result quite scattered. In the authors' opinion this might be the consequence of a low SNR due to the inadequacy of some of the dynamic system's components, which unfortunately could not be upgraded. Notwithstanding that, there are a few aspects that can still be caught in the chart and are worth exposing. To help the interpretation of the results, the chart is repeated by overlapping both frequency and crack evolution and marking the main phases of the structural intervention (Figure 8b). It is observed that during the first monitoring campaign, which lasts till the casting of the reinforced concrete beams for the foundation underpinning (11/02/2014 – 21/11/2014), all natural frequencies feature a decreasing trend. As the structure was damaged and the cracks width was increasing, frequency downshifts are evident at this stage. But, when the anchoring system becomes operational, the structural stiffness begins to increase leading in turn to an increase of the frequency values, as evidenced by the results from the second (09/01/2015–15/04/2015) and third (21/07/2015–23/08/2015) monitoring campaigns. This outcome visibly reflects the structural improvement obtained with the adopted strengthening measures. Table 5 summarizes the average frequency values estimated before and after the activation of the anchoring system. The most significant changes concern the first

two modes, whose frequencies increase up to 3.3% and 1.7%, respectively, after the intervention. A sample of two-month evolution of the natural frequencies relevant to these two modes is presented in Figure 9, together with the variations of ambient noise, temperature and relative humidity for the same period. Both modal frequencies show a moderate correlation with the daily variations of temperature and humidity, whereas no direct relationship is found with ambient noise during the works execution. Still, it cannot be excluded that the dependence of natural frequencies on air humidity is only apparent and mainly originates from the inverse correlation between humidity and temperature, which turns out to be the main driver behind the changes in the structural features. As cracks tend to close with rising temperature, the system results stiffer and this is ultimately reflected into the increase of the frequency values, being modal and physical parameters directly related.

Figure 8 – Evolution of (a) the identified natural frequencies during the structural intervention and (b) comparison with the cracks evolution.

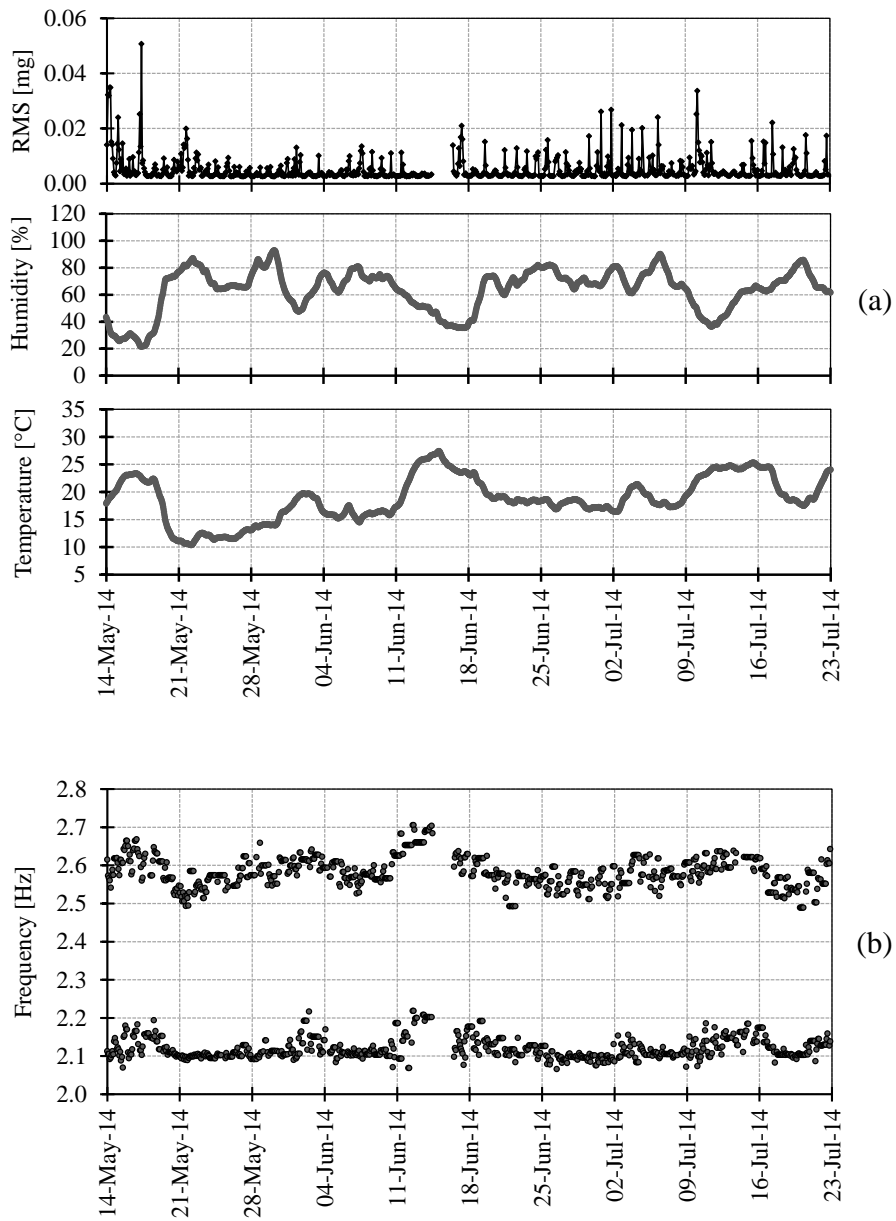
Figure 9 – Close-up of the time evolution of (a) ambient noise, relative humidity and air temperature with respect to (b) the natural frequencies of the first two modes of the church from 12/05/2014 till 23/07/2014.

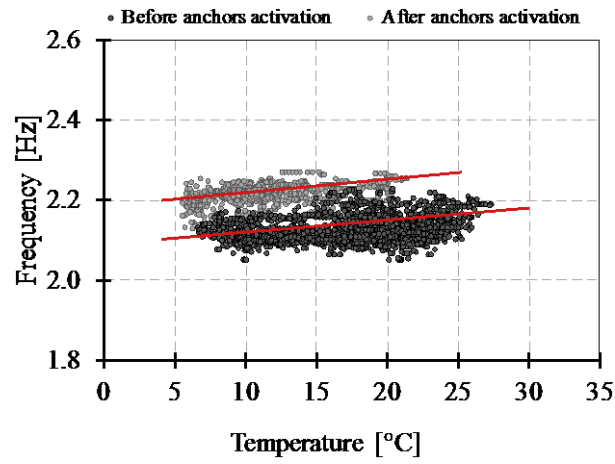
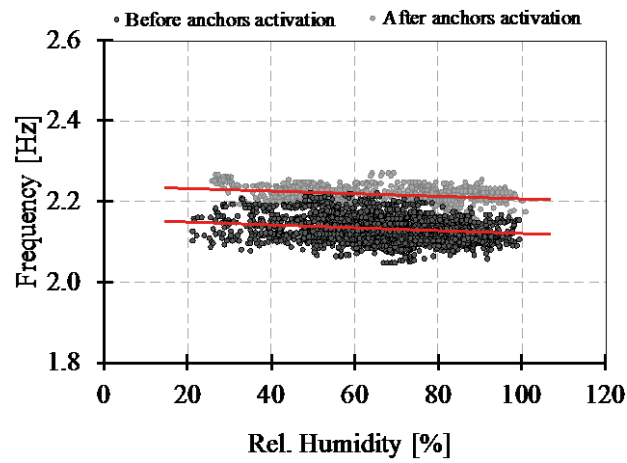
As mentioned before, the high level of background noise in the dynamic data combined with the low amplitude of the signals led to scattered frequencies, thus an accurate analysis of the ambient variability of the system's frequencies over the entire monitoring period could not be performed but for the first frequency, being the one with the highest percentage upshift. Indeed, the plot of the frequency-temperature relationship for the first mode (Figure 10a) exhibits a clear variation of the regression line following the activation of the anchoring system, with the range of temperature variation being almost the same. Analogous considerations can be made concerning the frequency-humidity relationship (Figure 10b), even though the correlation between the two quantities is lower. Despite the scatter in the modal parameters estimation caused by the low SNR, the distinction between frequency values associated with damage and no-damage scenarios is appreciable. Both the arrangement of the frequency-temperature and frequency-humidity points before and after the anchors activation and the variation of the regression lines indicate that the observed frequency shifts are permanent, confirming that the

adopted strengthening measures have been effective in restoring the sound condition of the church.

Figure 10 – Variation of (a) frequency-temperature correlation and (b) frequency-humidity correlation for the first mode before and after the activation of the anchoring system.
