Evaluation of the masonry and timber structures of San Francisco Church in Santiago de Cuba through nondestructive diagnostic methods

Riccardo D. De Ponti¹ | Lorenzo Cantini² | Laura Bolondi¹

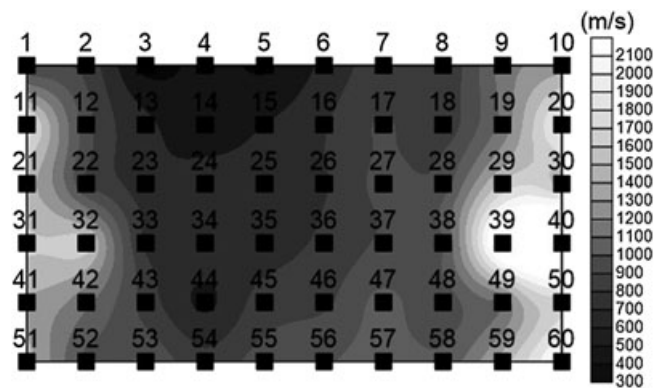
As shown in Figure 14 and Figure 15, higher velocities (around 2,000 m/s) are concentrated along the edges of the

FIGURE 14 Velocity map indicating the distribution of the velocities obtained on pillar P3b. Path direction: north-south

pillar, composed by a sequence of compact materials, and the central columns of the grid of points present lower values (between 400 and 900 m/s). These quality results offer limited information: in this case, the low velocities can be associated with the supposed organization of the masonry section, presenting a brickwork with several mortar joints that can mitigate the sonic waves velocity.

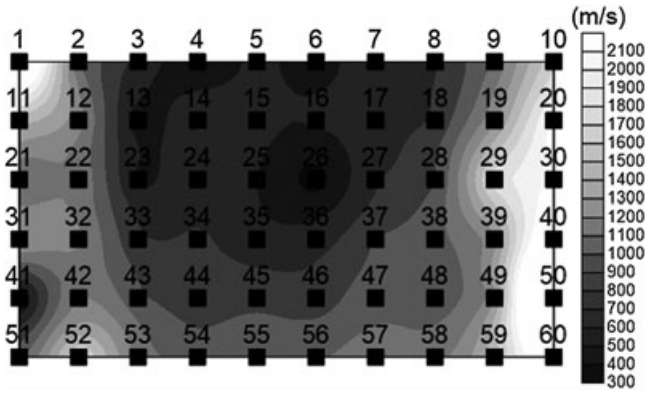
FIGURE 15 Velocity map indicating the distribution of the velocities obtained on pillar P3b. Path direction: east–west

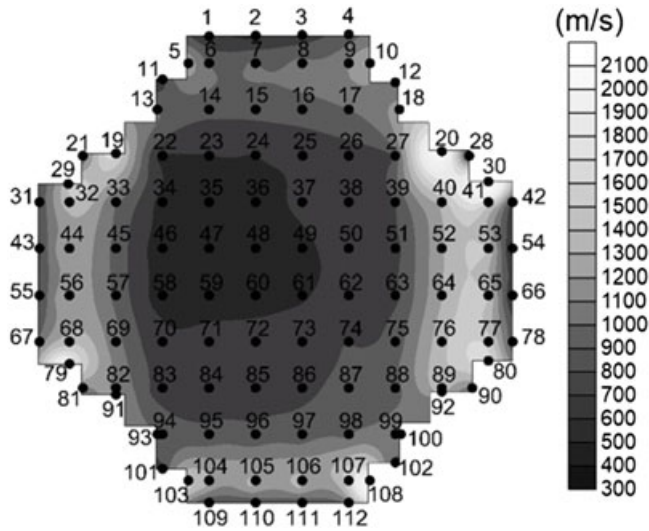
FIGURE 17 Distribution of the velocities obtained by the cross-path computation on the horizontal section of the pillar at 110 cm from the floor

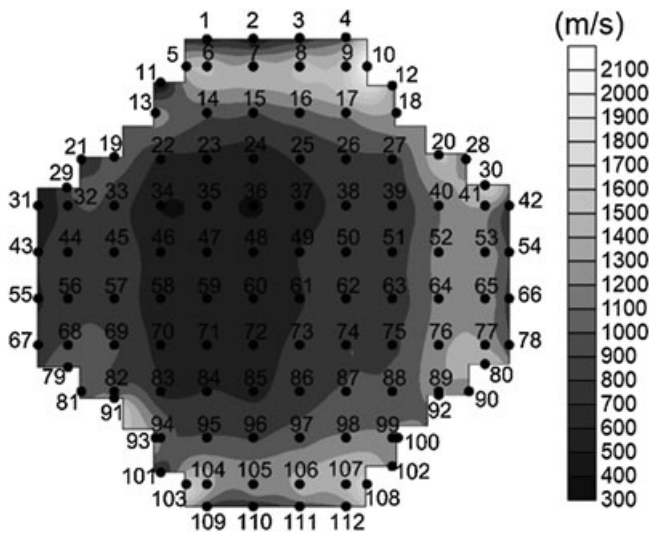
FIGURE 18 Distribution of the velocities obtained by the cross path computation on the horizontal section of the pillar at 154 cm from the floor

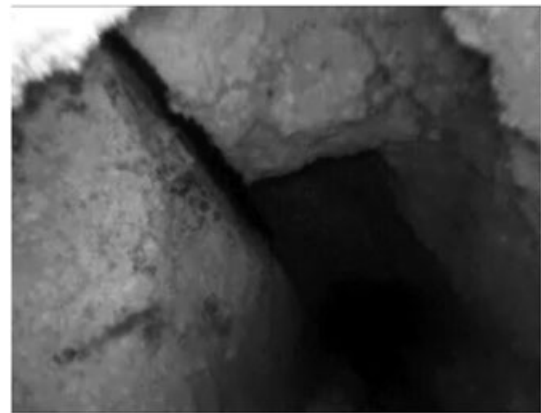
to low density of the structure). After carrying out a 70 cm drill in the area corresponding to low sonic velocity range, the video endoscope allows observing the masonry section stratigraphy (Figures 19). The pillars are formed by a brickwork structure containing a cavity (Figures 20) hosting a timber element (Figures 21). According to the historical analysis, the pillars contain timber columns.

FIGURE 20 The cavity observed inside the pillar

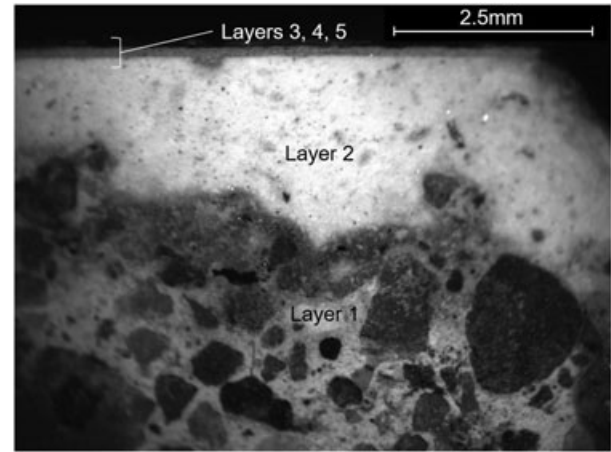
FIGURE 23 Stereomicroscope analysis of sample SF_r (render)

PFM analysis shows a partial disconnection between layers 1 and 2, separated by a thin and continuous crack. They are also different in binder: layer 1 has an air-lime based binder, very dense and coarse grained. Layer 2 is characterized by a fine-grained air-lime binder, with several pores and no aggregate. Layers 3, 4, and 5 are modern, synthetic materials. Aggregates are, in layer 1, homogeneous in shape and nature: metamorphic and volcanic rocks and a few quartz are present. In the binders, no hydraulic reaction was observed.

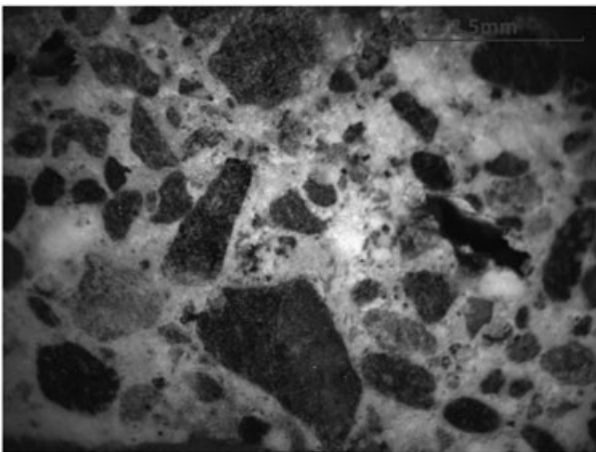
Sample SF_b is a single layer fragment of lime-based bedding mortar, homogeneous in binder and aggregate (Figure 22). At the stereomicroscope analysis, a very good adhesion between aggregate and binder is detected. In the binder, a few lime lumps are visible, max diameter: 1 mm. Aggregate has a fluvial origin; fragments are rounded and homogeneous in characters and shape, average diameter: 1 mm, max diameter: 4 mm. Pores are mainly present in the binder, not numerous and with a max diameter of 1.5 mm. No fibers or inclusions were detected.

PFM analysis shows Sample SF_b to be air-lime based, with a high binder-aggregate ratio (about 1:2.5). Binder is coarse grained and not homogeneous in distribution. Aggregates are mainly quartz, volcanic, and meta-

FIGURE 22 Stereomicroscope analysis of sample SF_b (bedding mortar)

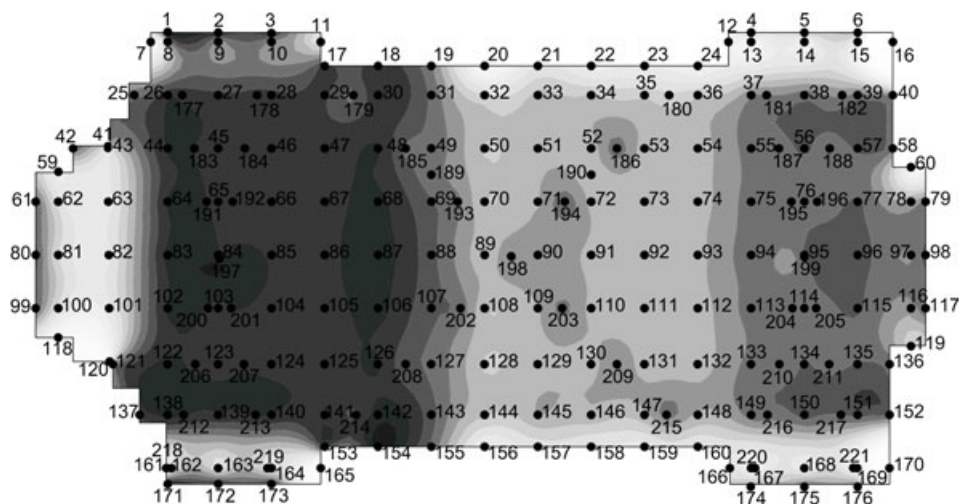
FIGURE 25 Velocity map on the horizontal section of the large pillar

a more refined interpretation of the presence of discontinuities in the masonry structure. The distribution velocity map (Figure 25) reveals the influence of the cavities hosting the timber columns in two separate areas of the horizontal section. The large area characterized by a sonic average velocity of about 700 m/s indicates a relevant part of the supposed load-bearing structure that is subjected to low density in the section morphology. Thanks to historical analysis, the low velocity range can be associated to the presence of the vertical timber elements and the result suggests the utility of an in-depth study of this area through MD tests.
