# INVESTIGATION OF RISING DAMP AND SALT ATTACK PROBLEMS OF HERITAGE BUILDINGS

**Md Azree Othuman Mydin<sup>1</sup>, Mohd Nasrun Mohd Nawi<sup>2</sup>, Muhammad Arkam Che Munaaim<sup>3</sup>**

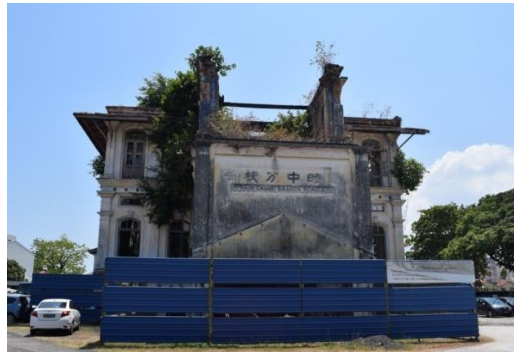
**Figure 6.** Shih Chung School

Figure 6 shows the Shih Chung School which is situated at No. 11, Jalan Sultan Ahmad Shah, 10050 Georgetown, Penang. It is built in year 1880 by Cheah Tek Soon. This building has been unoccupied since 1994. In early year, this building is functioning as a shelter for the family of Cheah Tek Soon. Then, it was once become as Chinese Consulate. Later, this building was function as a school which known as Shih Chung School until year 1994. After Shih Chung School, this building was left unoccupied until now. Now, this building is being fenced up and no entry is allowed as the building is deteriorated severely and might danger the visitor.

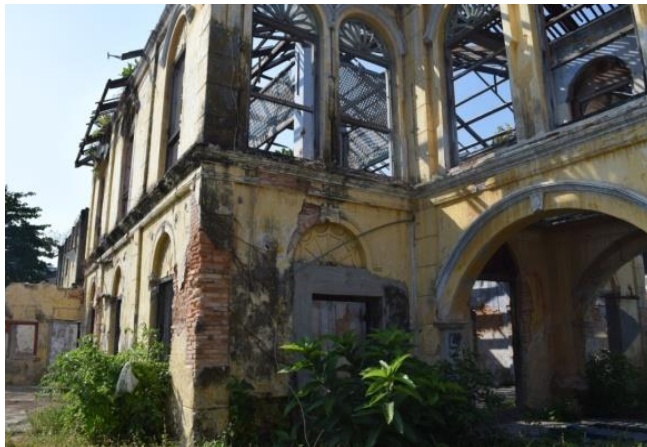
**Figure 8.** Doubled-storey Mansion at Jalan Dato Koyah

There are plenty of plants growing and even the roof of the building is no more. The condition of the building is not safe for use, thus it has been fenced up to prohibit any entry. This building did not undergo any repairing work before that. However, conservation work of this building will be begun soon by a conservator architect in Penang.

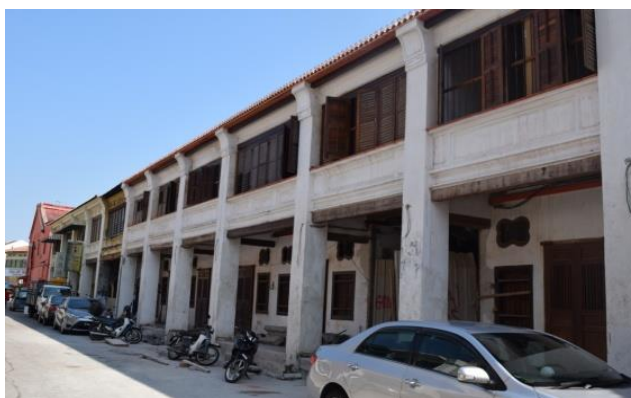
**Figure 9.** Double-storey old house at Lebuah Carnarvon

The case study is situated at No. 11-21, Lebuah Carnarvon, 10100 Georgetown, Penang (Figure 9). It was built in early 19<sup>th</sup> century. It is a doubled-storey old house. There is several building defects occurred in the building included decay of timber on the ceiling and staircase, peeling paints, dampness problem and salt attack problem. Thus, currently these houses are undergoing conservation and renovation work in order to repair the building defects in the building.

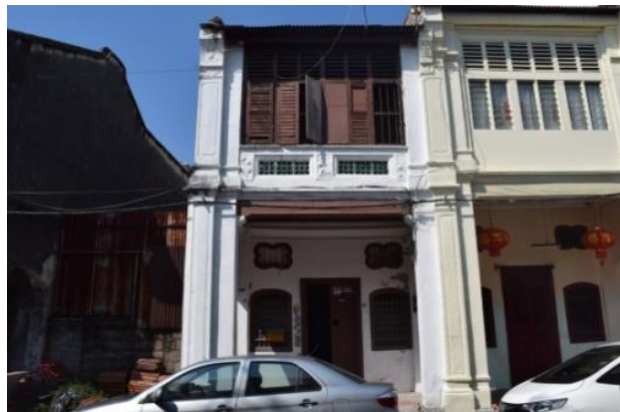
Figure 10. Double-storey house at Lorong Prangin

This case study is situated at No. 69, Lorong Prangin 10100 Georgetown, Penang has been shown in Figure 10. It is built in early 19<sup>th</sup> century as well. It is a doubled storey house which is previously occupied by a family. However, this house has been unoccupied since year 1996. There are many defects occurred in the house such as bird damage, salt attack, dampness, decay of timber and so on. Due to unoccupied, birds take this house as their own shelter and bird droppings can be found scattered everywhere in the house. The health of the occupants might be affected. Conservation work will be begun soon by a conservator architect in Penang.

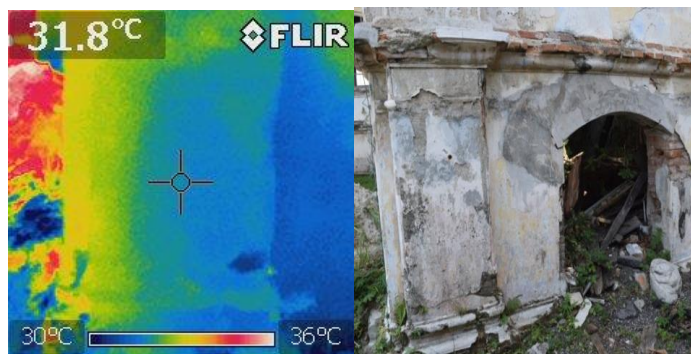
Figure 11. Infrared thermograph of Shih Chung School

From the Table 1, it can be told that, rising dampness contributed to the dampness problem on the wall. Generally, moisture comes from the ground and travel up to the wall. As can be seen, the moisture content at the lower ground level has quite high percentage in moisture content. The capillary action is decelerating as the height is increasing, thus the moisture content is decreasing. However, in Shih Chung School, the dampness occurred not only contributed by rising damp but falling damp as well. Due to the deterioration of the roof of the building, rainwater is directly entered the building. This can be told by the reading of moisture content at the height of 2.0m. From Figure 11, it can be clearly seen that the temperature of the wall is low. Rising damp occurred in this building might be due to the location of the sa is near to this building which is less than 20 metres.

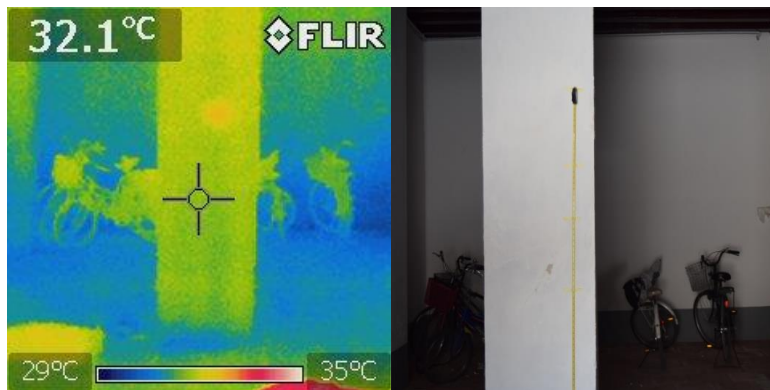
Figure 12. Infrared thermograph of Boon San Tong Khoo Kongsi

From Table 3 above, the lower area of the affected column have very high moisture content until the reading is exceeding the scale. From Figure 12 above, the thermograph has captured that the temperature of the column is low. The moisture content in the wall is decreasing while further up to the column. However, the moisture content is still very high which is recorded as 5.0%. This shows the indications of rising damp. The possible cause of such high moisture content might be the location of the building which is previously a sea. Thus, the moisture of the ground is comparing high than others and the building is more susceptible to moisture.

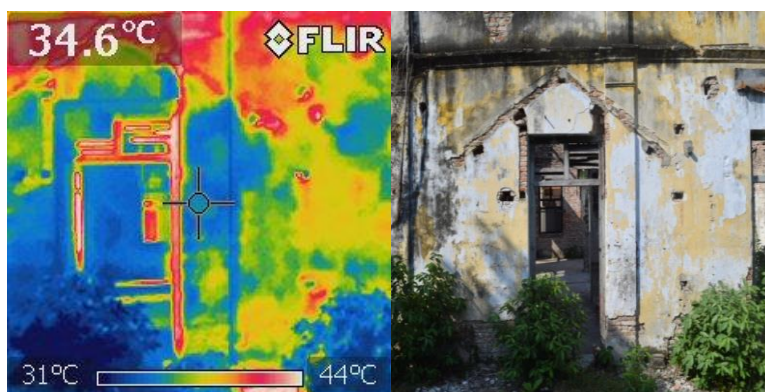
**Figure 13.** Infrared thermograph of No.38 Jalan Dato Koyah

From Table 5 above, the moisture content recorded has depicted the indication of rising damp problem. The moisture content recorded is increasing from 0.5m, 1.0m to 1.5m. From the Figure 13, the temperature captured on the wall is low at the lower area of the wall. The moisture content is recorded 2.0% at height of 2.0m. This might be caused by the rainwater enters the building because the roof of the building is deteriorated and currently the building is roofless and direct exposure to sunlight or rainwater.

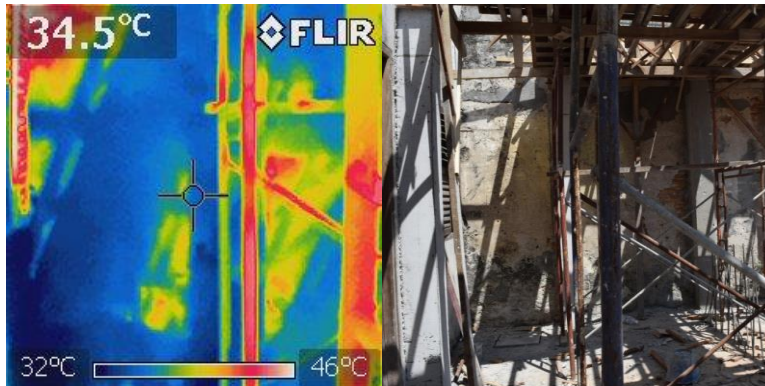
**Figure 14.** Infrared thermograph of No.11-21 Jalan Carnarvon

From the Table 7 and Figure 14 above, they depicts that the dampness problem in this case study is severe. The moisture content in the wall at the height of 0.5m, 1.0m and 1.5m are exceeding the scale of moisture metre. At the height of 2.0m, the moisture content has recorded at 5.6 %. The moisture content recorded portrays the indication of rising damp. The possible factor causing the rising damp problem might be the location of the building is close to the sea and the lack of exposure of sunlight on the wall. Thus, the evaporation rate is slower especially at the bottom part of the wall, it seems barely evaporates.

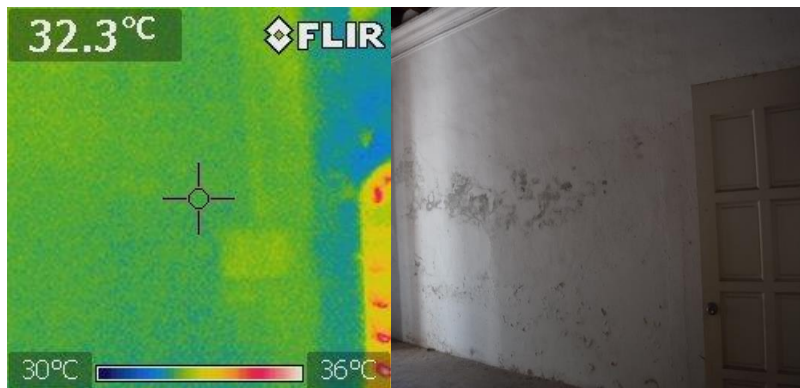
Figure 15. Infrared thermograph of No.69 Lorong Prangin

From the Table 9 and Figure 15, the average moisture content recorded shows a gradual decrease as the height of the wall increases. This implies that the dampness occurred is rising dampness. However, as from the data obtained, the average moisture content increase and

reach to 4.4% at the height of 1.5m. This dramatically changes can be seen on the wall in the building as there is a severe and significant spalling paint at the height of 1.5m on the wall which can be vividly seen by naked eyes. The possible factor causing to the rising damp and salt contamination in this case study might be the location of the building close to the sea. This case study is located not far from the case study located at Lebuh Carnarvon. Moreover, less exposure to sunlight which lead to low evaporation rate of the moisture from the wall which has lead to accumulation of moisture and salt deposits on the wall.
