## MONITORING PROCESS OF THE RE-CONSTRUCTION OF AN ANCIENT STRUCTURE: THE BALUARTE DO CAVALEIRO

Jorge Pinto<sup>1</sup>, Humberto Varum<sup>2</sup>, João Guedes<sup>3</sup> and Anibal Costa<sup>4</sup>

Received 9 October 2009

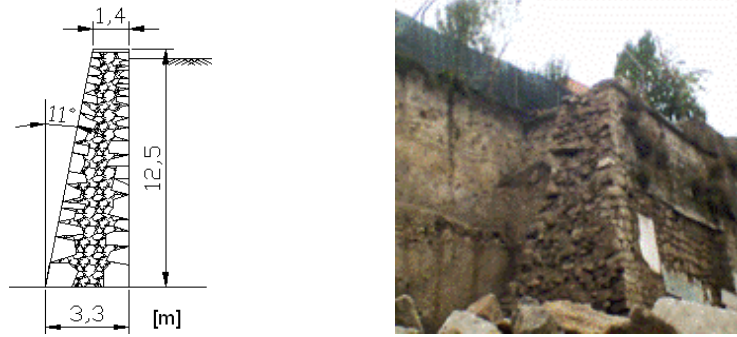
Figure 3. Cross-section of the Baluarte do Cavaleiro wall (December 2005)

The Baluarte do Cavaleiro is a typical stone masonry wall. The real geometry and dimensions of its cross section is shown in Figure 3. The building technique detail adopted in the construction of the wall that consists of using large granite stone pieces in the inner and the outer faces and filling the gap between them using small and irregularly shaped granite stone pieces is also illustrated in Figure 3.

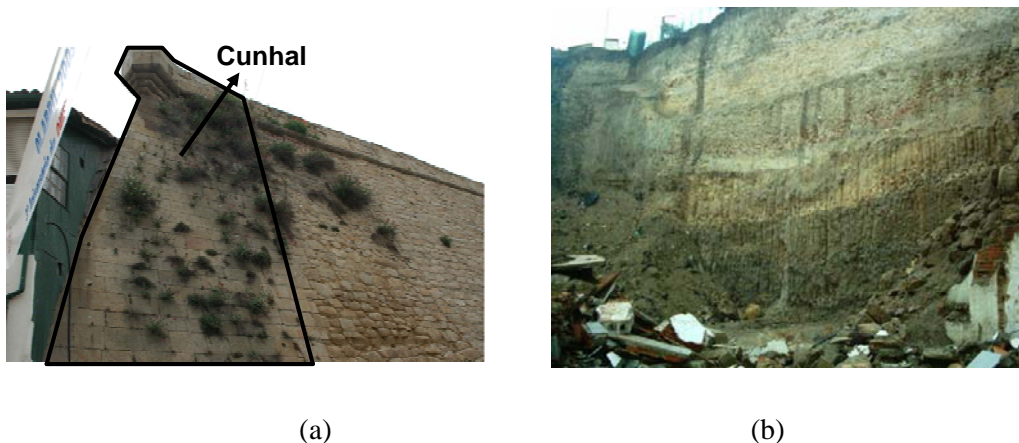
Figure 4. a) *Cunhal* that connects the SE and SW walls; b) Soil profile supported by the wall (December 2005)

The connection between walls is materialized by junction element which is designated here by *cunhal*, Figure 4(a). These elements were built up using dry cut stone masonry. On the other hand, the walls have filled joints, Figure 4(a).

Figure 4(b) shows the soil that has been supported by the wall (December 2005). This soil has the following constitution: 1.0 m thick organic soil as the first layer; 11.5 m thick of embankment type of soil as the second layer. This soil is extremely consolidated because it allowed an almost vertical cut, Figure 4(b). Exploration drilling tests were done in the downstream side of the SE wall in order to identify the foundation soil. The results of these tests concluded that the foundation soil has the following typology (see Figure 5): the first layer is a 1.0 m thick of silt; the second layer is a 2.0 m thick of thin sand; the third layer goes down to until the bedrock and is formed by saturated sand which varies in terms of granulometry from thin to thick. The bedrock depth is around 5.4 m near the *cunhal* that connects the SE and SW walls (test S1), 10.8 m in the middle span of the SE wall (test S2) and 7.4 m near the *cunhal* that connects the SE and NE walls (test S3).

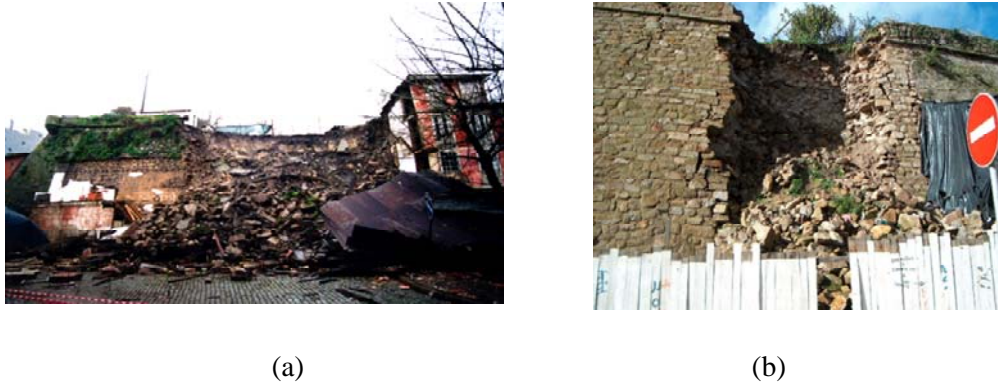
Figure 7. Scale of destruction of the SE wall of the Baluarte do Cavaleiro after the two collapses: a) First collapse (March 2001); b) Second collapse (April 2002)

The first collapse culminated in the loss of a substantial part of SE wall and also in the loss of some of the attached building, Figure 7(a). From this figure and from Figure 3 it is noticeable that parts (related to the contact area of wall and attached buildings) of the outer face of this wall had cement coat and in the other ones there was vegetation. These facts prove that the wall did not have a regular maintenance process and had faced changes in its original drainage system. Some structural instability signals gave evidence of occurrence of the first collapse. These signals were an impressive crack that was formed in the top of the soil that was supported by the SE wall and a significant slope of the front façade of the buildings that collapsed.

After the first collapse, the SE wall was rebuilt and this reconstruction process took about 1 year to finalise. The attached buildings that had suffered partial or total collapse were completely demolished, Figure 7(a). Just after the conclusion of the above reconstruction process (April 2002), the SE wall faced the second collapse which resulted in a smaller scale of destruction, Figure 7(b). This situation required another reconstruction process of the SE wall of the Baluarte do Cavaleiro that ended in February 2007. The monitoring process described in this work is related to this last reconstruction process.

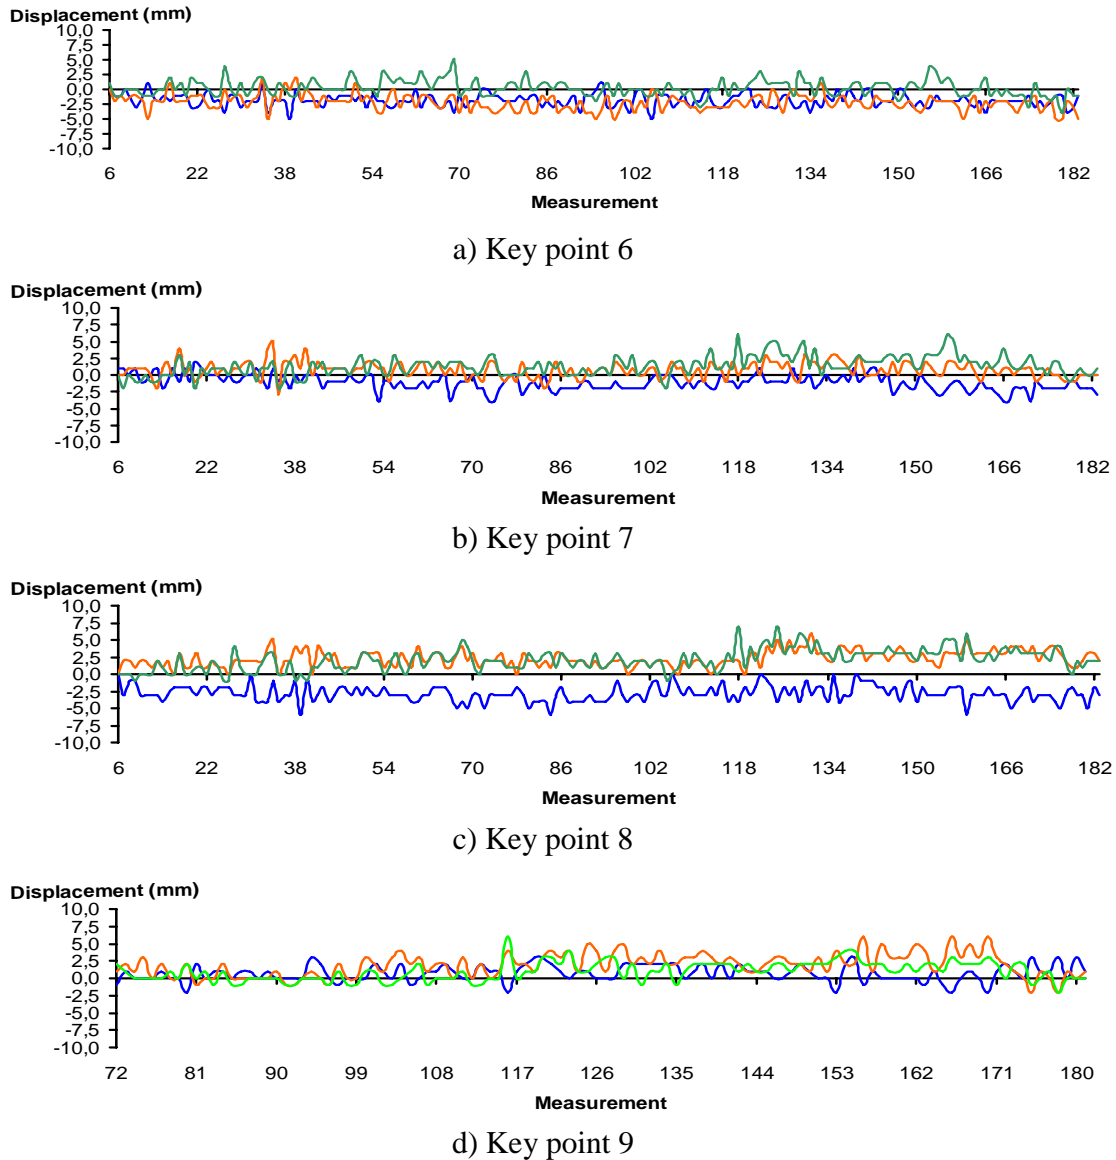
Figure 11. Displacement evolution of the key points of the NE wall (6, 7, 8 and 9)

The displacement components evolution of the key-points of the NE wall (6, 7, 8 and 9) throughout the reconstruction process of the SE wall is shown in Figure 11. None of these points had an increasing displacement evolution. In fact, the evolution was an oscillatory function type, having in general maximum values less than 6.0 mm in terms of absolute value. The average value of the displacement components of these key points was in general less than 2.0 mm. Only the perpendicular displacement component of the key point 8 showed an average value of 2.7 mm. In fact, if the error associated to the surveying process was taken into account in the quantification of the coordinates of the key-points then the above displacement values could be assumed as being smaller. This error is a function of: (1) the instrument accuracy, which can be quantified using the expression presented next; (2) the precision of the measurement, associated to a human error; (3) the temperature correction.

Figure 11(d) only includes the displacement evolution of the key-point 9 from the 72<sup>nd</sup> measurement because the reflector (that materialised this key-point) fell down in December of 2005. It was only possible to define one key-point (key-point 37) in the SW wall of the wall because the attached buildings did not allow sticking other reflectors on this wall. This key-point was located approximately at the half length of this wall, Figure 8-d), and consequently a bit far from the zone affected by the demolition/reconstruction of the SE wall. The displacement evolution of the key-point 37 is illustrated in Figure 12 where we can realise that there was no significant displacement of this point throughout the reconstruction process of the SE wall. This

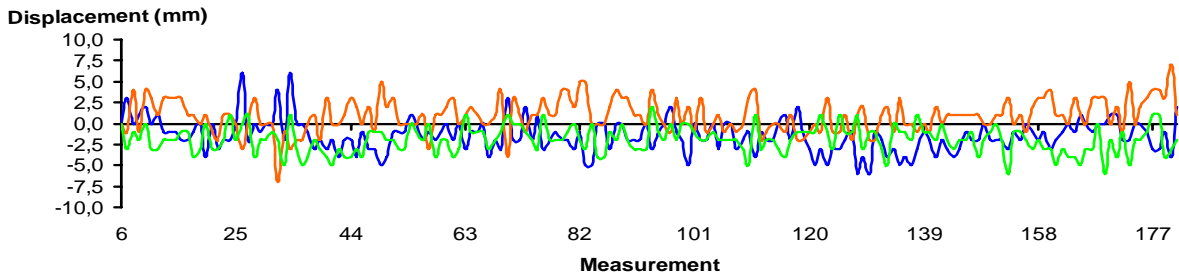
Figure 12. Displacement evolution of the key point 37 that was defined in the SW wall

evolution was not increasing type and the displacement component that had shown higher average value (equal to 1.8 mm) was the vertical one.

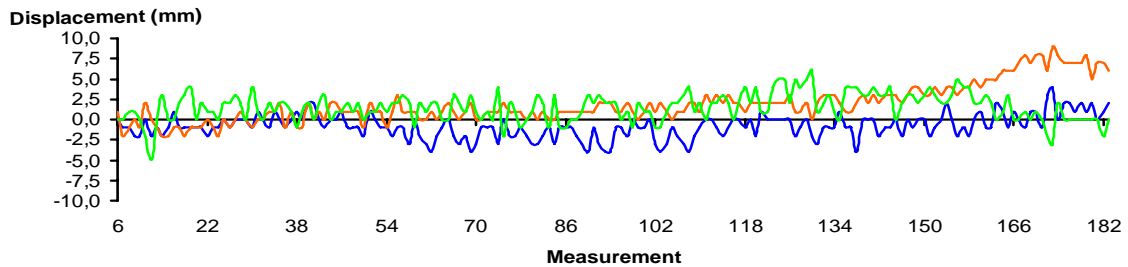
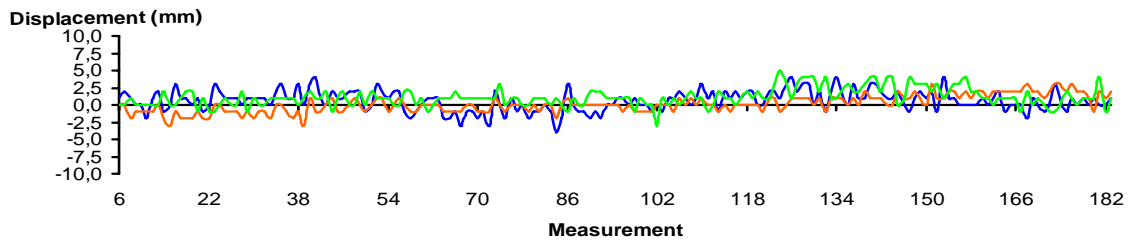
Figure 13. Displacement evolution of the key points 12 and 13 related to the cunhal that connects the SE and SW walls

The key-points 12 and 13, Figure 8(c), were defined to monitor the cunhal that connects the SW and SE walls. Their displacement evolution is shown in Figure 13. In this case, there was not a generalised increasing trend on the component displacement of these key-points either; the average value of these components was less than 2.0 mm. These facts indicate that this structural element was not affected by the reconstruction process of the SE wall.

However, it is noticed in Figure 13(a) that the parallel displacement component of the key-point 12 had suffered an increasing evolution between the measurements 141 and 167 (September and December 2006). This behaviour was related to the fact that this key-point had been defined in a piece of stone of the top course of stone (Figure 14) and this piece of stone had suffered movements resulting from the working process. This parallel displacement component evolution had stabilised from the measurement 167.

This is an example of an instability signal detected through the proposed monitoring process in this work. In this particular case, it was possible to detect an instability signal (increasing evolution of a displacement component of a key point), to identify its cause (movement of a piece of stone resulted from the working process), to evaluate the scale of that instability signal (circumscribed to a piece of stone, the visual inspection did not find significant movements in the area surrounding that piece of stone, the key point 13 (near the key point 12) did not have an increasing displacement evolution during that period of time), to decide if the planned working process should continue (the working tasks related to the reconstruction process had run as planned because the instability signal did not give evidence indicating risk of collapse of the cunhal or other construction).

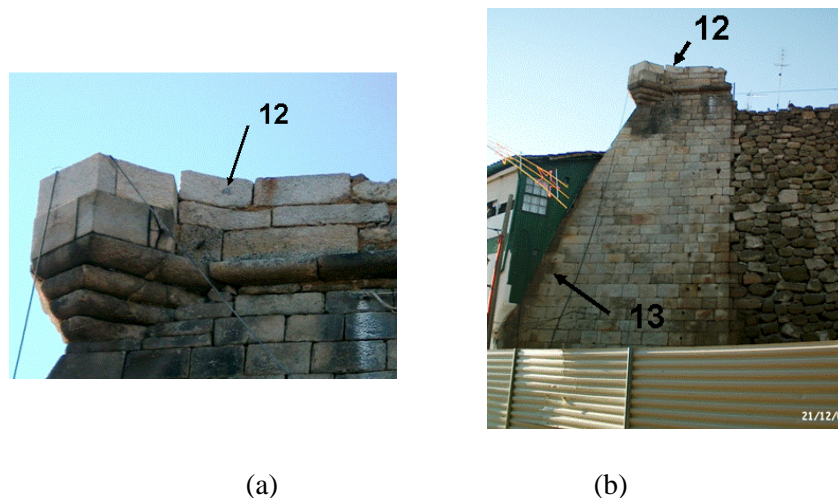
Figure 14. Key point 12: a) Location of the key point 12; b) Location of the key points and 13

The key points 12 and 13 also had shown a similar displacement evolution trend, Figure 14, as the one described for the key points 4 and 5 being though less expressive. Figure 15 also shows that the key-point 4 of the NE wall had had an increasing evolution of the perpendicular displacement component that started from the 138<sup>th</sup> measurement. By the time in which the 138<sup>th</sup> measurement was done the reconstruction process of the SE wall was in progress. Since the values of this displacement component were negative, the piece of stone on which the reflector (that materialized the key point 4) was glued had moved in the direction of the embankment.

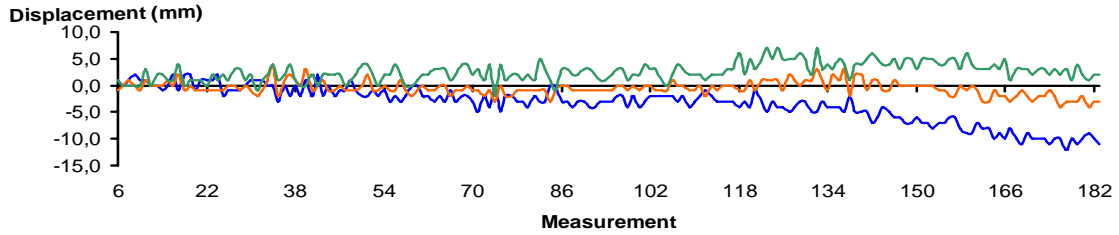
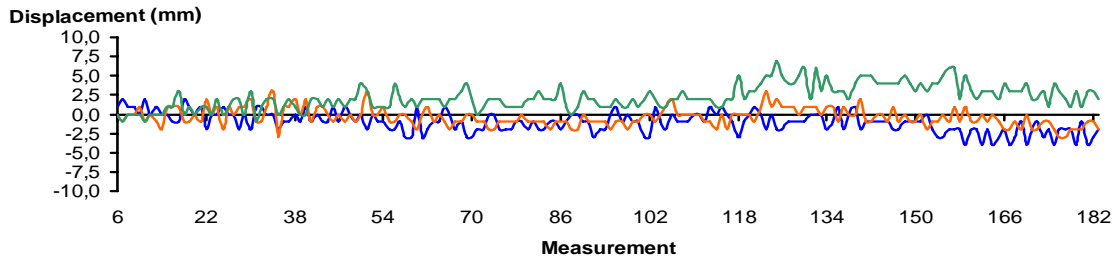
Figure 15. Displacement evolution of the key points 4 and 5 related to the cunhal that connects the SE and NE walls

A similar situation had happened for the cunhal that connects the SE and NE walls for which the related key points were 4 and 5, Figure 8(b). The displacement component evolution of these key points is described in Figure 15 where we can notice that until the 116<sup>th</sup> measurement (June 2006) there were not expressive value of displacement. However, from this measurement, the vertical component of displacement of both key points had increased which indicates that these key points went up. This evolution had inverted from the 158<sup>th</sup> measurement (November 2006) and the vertical component of displacement evolution converged to 0 mm, Figure 15.

Through Figure 10, it is possible to realize that the 116<sup>th</sup> measurement was done when the demolition of the SE wall was taking place and, more precisely, this demolition task (Task 1, Figure 10) was taking place next to the cunhais. Simultaneously, the work task related to the excavation for the execution of the drainage system (Task 2, Figure 10) was also in progress by that time. Based upon these facts, the ascendant displacement of the key points 4 and 5 may be related to the above work tasks. As the reconstruction process was progressing (after the 116<sup>th</sup> measurement) the key points 4 and 5 had shown a displacement components evolution trend similar to the initial one (before the 116<sup>th</sup> measurement).

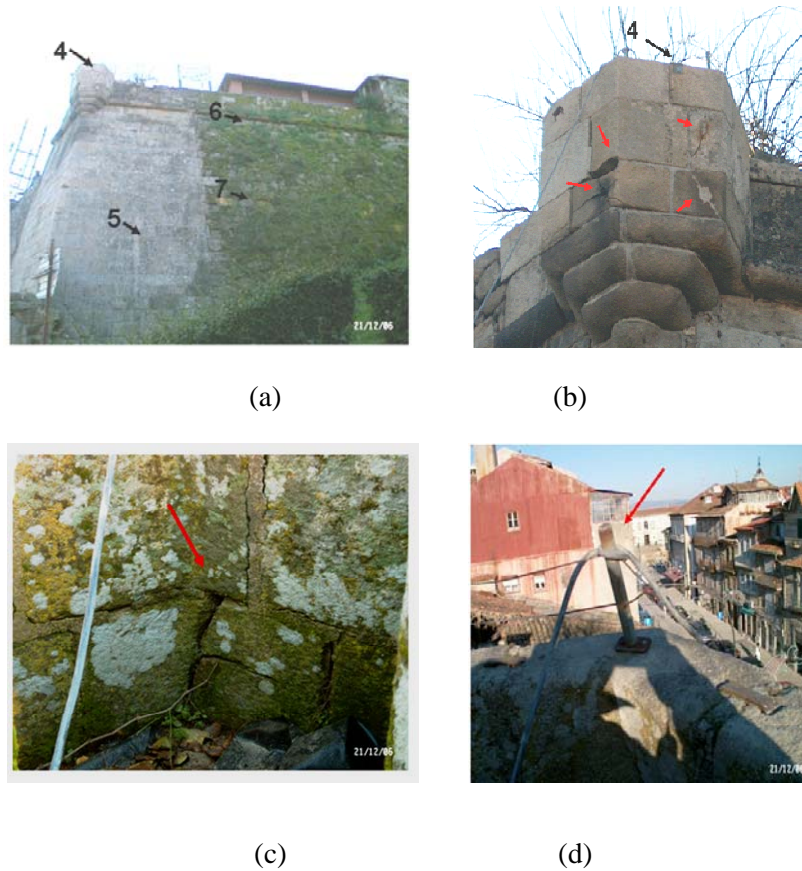
Figure 16. Key point 4: Some pathologies existing around the key point 4 and resulted from the working tasks related to the reconstruction process: a) Location of the key points 4, 5, 6 and 7; b) Existing pathologies surrounding the key point 4; c) Existing pathologies surrounding the key point 4; d) Existing steel bar next to the key point 4

As it was described for the key-point 12, the cause of the above displacement evolution of key point 4 was related to the working task that was in progress by the time in which the measurement 138<sup>th</sup> was taken. Figures 16(b) and 16(c) illustrate that some pieces of stone located near the key point 4 had cracks. Meanwhile, Figure 16(d) shows the existence of a steel bar fixed to the wall and also near the key point 4. This steel bar had been under an action, resulted from the working tasks of the reconstruction process, which resulted in a permanent deformed shape of this bar in the direction of the embankment.

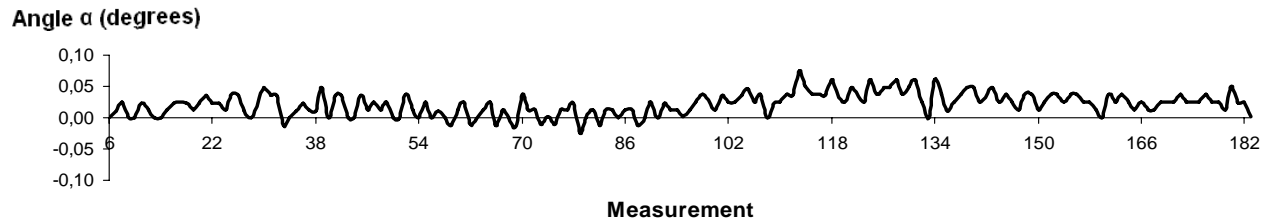
Figure 17. Evolution of  $\alpha$  for the alignment defined by the key points 6 and 7 of the NE wall

This is another example case that validates the applicability of the adopted monitoring process described in this work. At the same time, graphs that describe the evolution of the angle  $\alpha$  throughout the reconstruction process of the SE wall of the Baluarte do Cavaleiro were also defined in order to control the verticality of the constructions under the monitoring process. Figure 17 illustrates, as an example, the evolution of  $\alpha$  for the alignment defined by the key-points 6 and 7 related to the NE wall. As it can be seen, the area of the wall surrounding this

alignment had kept the same slope (i.e.  $\alpha$  remained almost constant) throughout the reconstruction process and this is another indication that the reconstruction process did not affect the stability of the NE wall.

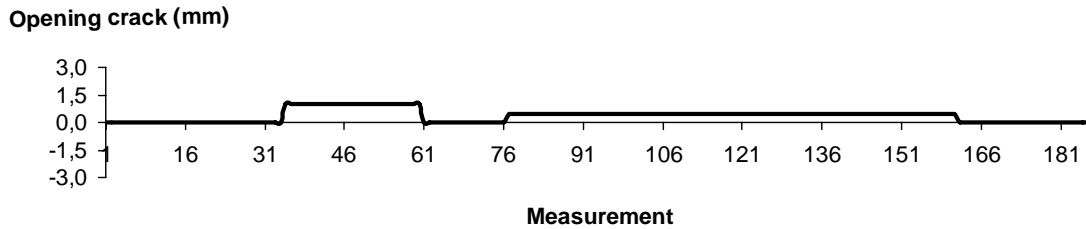
Figure 18. Opening crack evolution of the crack D-1-36

The opening crack evolution was studied during the reconstruction process. Those cracks did not have an expressive opening crack evolution. In general, the quantified opening crack evolution was the expected and resulted from the normal temperature changing through the year. Figure 18 illustrates the opening crack evolution graph of the crack D-1-36 (i.e. localized in the building D (Figures 8(a) and 8(d)), in the 1<sup>st</sup> floor and is the 36<sup>th</sup> pathology identified in that building) as an example. As it can be noticed from Figure 18, the crack opening evolution at this point is almost constant having the maximum value of 1.0 mm. This small oscillation of values was related to the normal temperature variation during the year even taking into account that all the cracks that were controlled were inside of a building.
