Survey on the main defects in ancient buildings constructed mainly with natural raw materials

In this context an early 19th century Portuguese watermill building is used as a study case to show how a roof leaking may lead to a progressive building collapse.

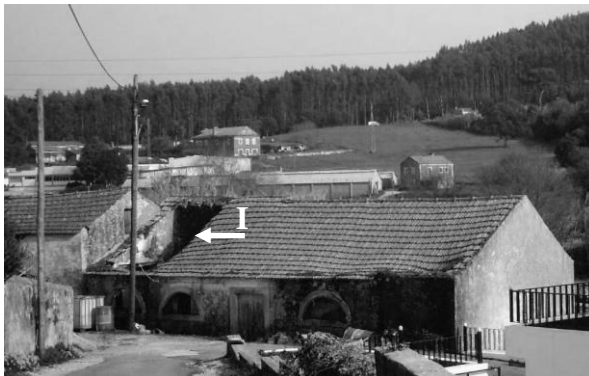
In this research work, the building adopted as a study case is an early 19th century watermill which its main function was to provide the neighborhood and the surrounding villages of flour. Its activity ended by the mid 70's with the boom of the supermarket networks which started to offer pre-packed cereals and flour. The death of the owner plus the above described situation were the main reasons why the watermill building has been without any use and maintenance from that time. The Fig. 1 shows the watermill building in 2000 in which it is evident that a partial roof collapse has occurred (Fig. 1, detail D).

Figure 1. Watermill building's condition in 2000

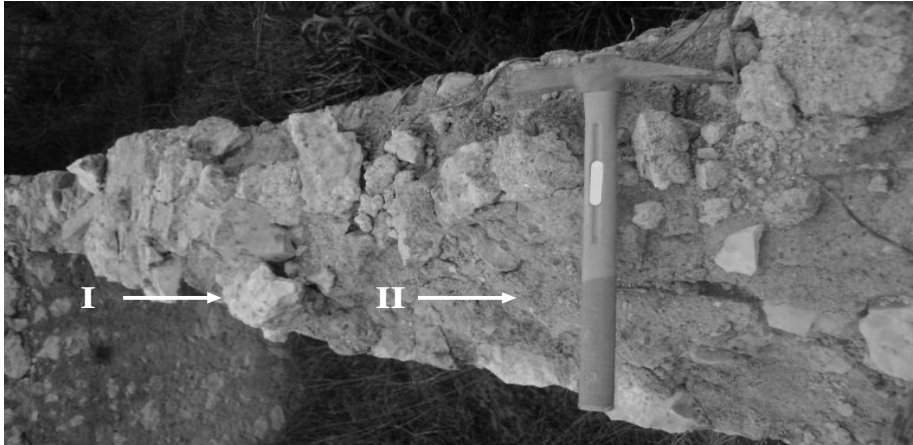
Figure 5. Detail of the structural stone masonries walls

Since this region is sparse in stones, the structural stone masonries walls (exterior and interior) had been built up using irregular and small sized limestone pieces (Fig. 5, detail I) agglutinated by a structural mortar (Fig. 5, detail II). The average thickness of these walls is 0.40 m.

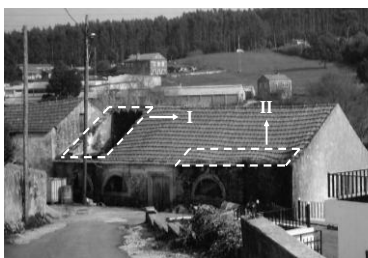
a. 1st Collapse (2000)

The roof timber structure has been facing partial collapses throughout the last 9 years. The first partial collapse occurred in 2000, in which part of the roof of the storage room was lost (Fig. 8-a, detail I). It is important to underline that the main structural timber elements which are trusses did not get damaged.

Figure 8-a in its detail II shows a local permanent deformation of the roof system of the grindstone room in its connection to the frontal wall. Some ceramic tiles were also missing there.

Meanwhile, Figure 8-a illustrates the roof's condition of the grindstone room before the above described third roof's structural collapse occurred in 2009 (Fig. 8-c). Some purling and timbers boards showed an advance stage of deterioration in the contact zone with the structural wall. Through Figure 6-a, detail I, it is also possible to notice that these timber elements had a darker shade than the similar ones located outside of the damaged zone which indicated a leaking problem. By doing a similar analysis, Figure 6-a, details VII, VIII and IX indicated that there were some cracked ceramic tiles or the ceramic tiles/timber board direct contact solution was not the appropriated one because may increase an undesirable water moisture in the timber structural elements.

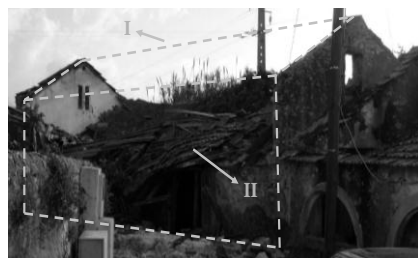
b. 2nd Collapse (2007)

The second structural failure of the roof occurred in 2007 resulting in the completely loss of the roof of the storage room (Fig. 8-b, detail I) and part of the frontal limestone based masonry wall (Fig. 8-b, detail II).

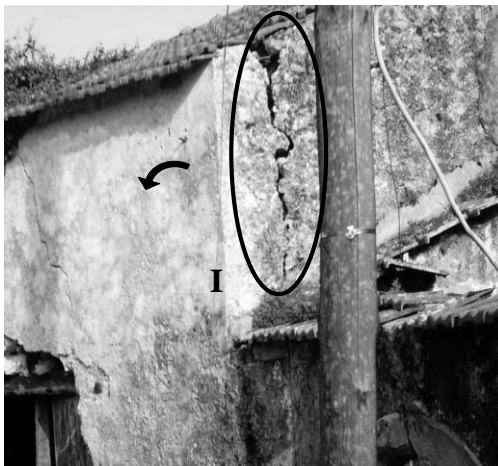
Figure 9. Vertical crack, 2007

An expressive vertical crack located in the junction of two limestone based masonry wall of the storage room (Fig. 9, detail I) was formed just before the occurrence of the second roof's structural collapse occurred in 2007. The thickness of this vertical crack decreases from the top to the bottom.
