## INSPECTION AND DIAGNOSIS TESTS FOR STRUCTURAL SAFETY EVALUATION – A CASE STUDY

The investigation was requested to assess the degree of deterioration of the parking lot of a commercial area at ground level (foundations) and on first floor (beams and slabs). The referred parking lot is a mixed structure (steel-concrete) constituted by encased metallic beams, pre-cast concrete elements and reinforced concrete "in situ". The parking building was built in the 90's, presenting to the date visible signs of deterioration and excessive deflection of transverse supporting beams that evidenced structural stability problems. To stop the transversal beams deformation, the steel channels were applied as a correction measure immediately after the conclusion of the structure construction. To fulfill this aim, several destructive and non-destructive evaluation tests were performed at the ground and first level for several constructive elements. All testing results were gathered in a final report with the contribution of expert entities in the different areas which were involved, to guide the owner decision in the eventual demolition or rehabilitation of the structure. It should be noted that th

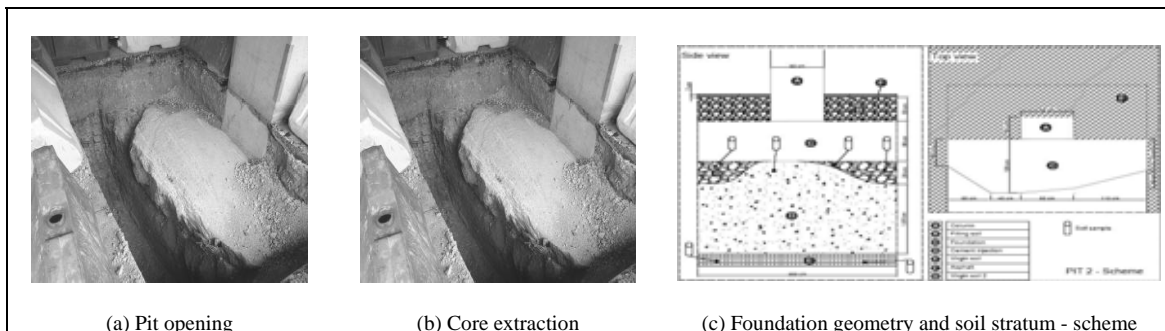
Figure 1: Trial pits

Two pits were carried out to inspect the foundations and soil stratum. Excavation was performed through an area of approximately  $2 \times 3 \text{ m}^2$ . In a first phase, the excavation of both pits was done until 1.6 m depth, from the top of the foundation. In a second stage, one of the pits was excavated until 3.6m depth. In both pits no water was found and the soil stratum was dry. Before extracting the cores on the top surface of the foundation (Figure 1) and from the buried part of the column, a reinforcement cover survey was done. However, the cover meter did not detect the presence of reinforcement on the top surface of the foundations in either pits.

collected at the borders. Additionally two more samples in PIT\_2 were collected at an approximately 3.6 m depth. The locations of the samples taken are represented in Figure 1.

The nature of the soil stratum was described in a specific report (sulphate attack and chemical composition), supported by the analysis of the soil specimens taken out. At first sight, the soil stratum seems compact and does not reveal any kind of contamination or significant changes that could produce a noteworthy decrease on the load capacity bearing of the structure. Concrete foundation does not have regular dimension and is not in accordance with the design drawings.

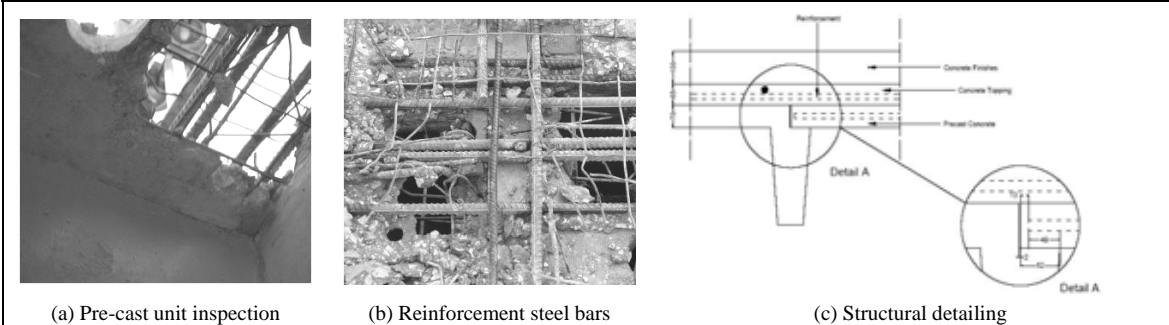
Figure 2: Semi-destructive tests on slabs

The concrete pavement covering was removed on an area of 1.0m<sup>2</sup>, on the suspended slabs in four locations. Cores into the top of the reinforced concrete pre-cast unit below the reinforced concrete topping were taken off and the test results for compressive strength, petrographic analysis, ion-chloride carbonation of the concrete removed in each location, present a range of results that did not suggest any serious problem. No signs of damage, cracking or corrosion were found in the “in situ” topping concrete and pre-cast slab unit or in the supporting pre-cast concrete rib. The thickness of the in situ structural concrete topping is 65 mm (see Figure 2) and is constant in all the other four locations. However, the concrete finishes vary in the four locations ranging from 100 mm to 140 mm. An existent gap between the pre-cast slab units has been observed, which is empty and has a constant thickness of 2 mm (see Figure 2c).

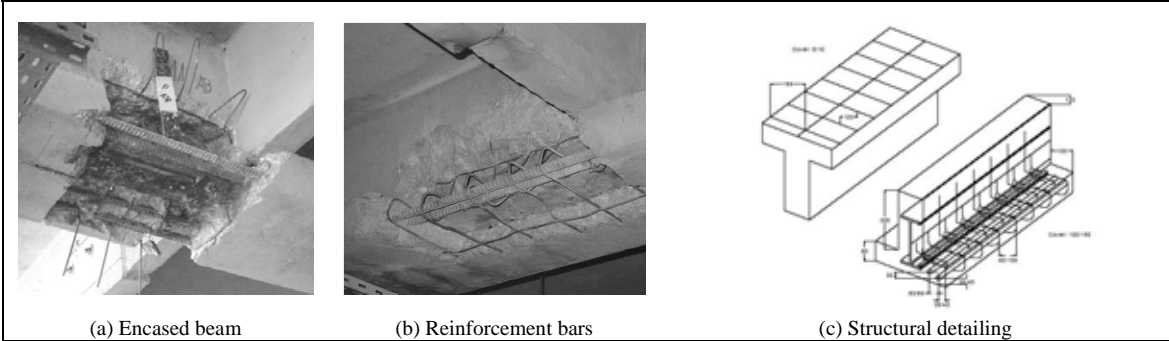
Figure 3: Destructive testing on encased beams

Based on the “in situ” inspection the geometric characteristics of the encased beams could also be defined as represented in Figure 3. No relevant damages or cracking were found in the supporting concrete flange or in the in situ topping and pre-cast unit. On the other hand some signs of corrosion were found in the wrapping mesh at the bottom of the beams. No signs of damage or corrosion were found in the reinforcements or in the flange of the steel beam. As represented in Figure 3 the cover at the bottom of the steel beam (supporting concrete flange) is sometimes inexistent. The observations “in situ” of the construction details are not in accordance with the available design drawings and schemes.

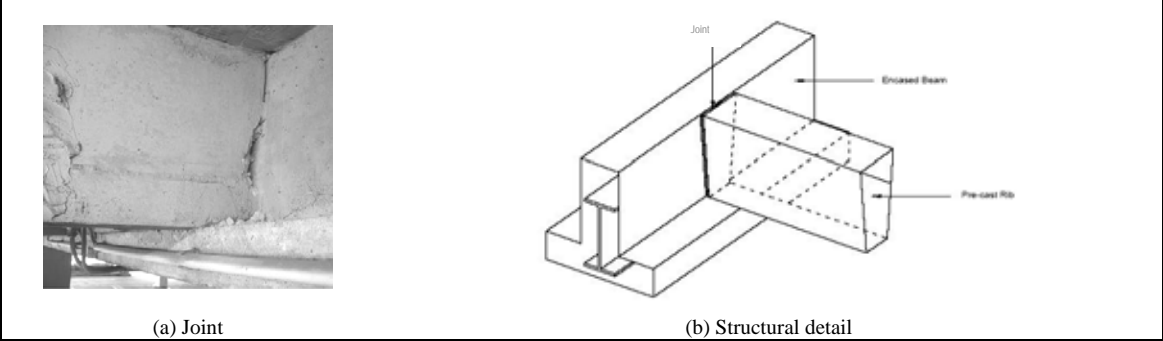
Figure 4: Joint between encased beam and transverse pre-cast ribs

After removing the concrete in some elements, an existent gap between the encased beams and the pre-cast ribs was found (see Figure 4). At first sight this gap (thickness ranging between 7 and 12 mm) seems to be filled. However, only the borders are “covered” by some mortar and sometimes the interior has some cement paste that was drained when the topping concrete was cast “in situ”. A more effective connection should be guaranteed in order to obtain a monolithic behaviour.

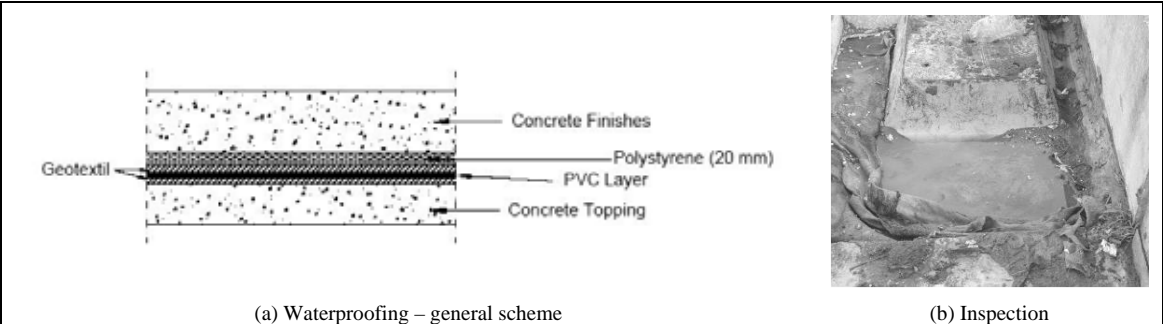
Figure 5: Waterproofing

On the edge between the concrete finishes and the concrete topping, a waterproofing PVC layers was found. The scheme in Figure 5 shows the details. The presence of large quantities of water was also observed, which exist due to the geometric irregularities of the slabs which allow the accumulation of water in some points and also due to the physical separation between the concrete finishes and the concrete topping. In some locations the PVC layer was damaged allowing the presence of water in the structural concrete topping.

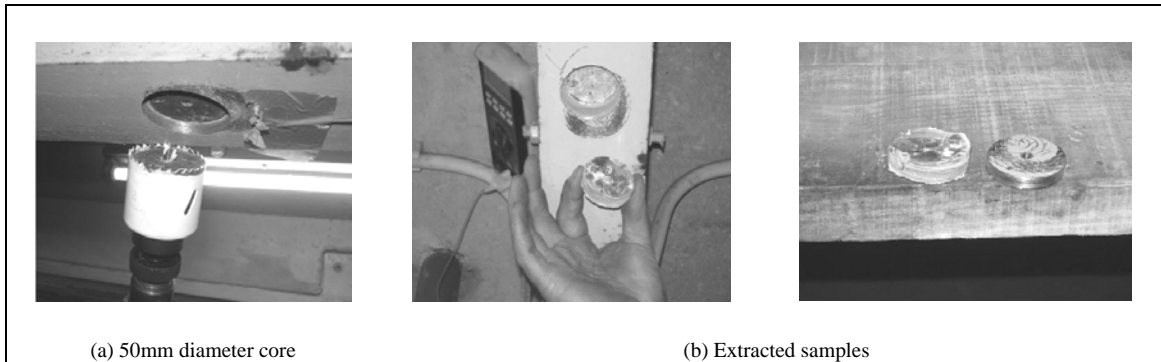
Figure 6: Pull-Off Tests

In situ pull-off tests were carried out in ten locations to determine bonding strength. The locations were chosen to be representative of bond conditions. The proposed locations for the tests were calibrated using the ultrasonic tests. Taking into account the pull-off and the ultrasonic test results it can be concluded that, in general, epoxy bonding of the steel channels to the pre-cast concrete ribs is defective (see Figure 6).

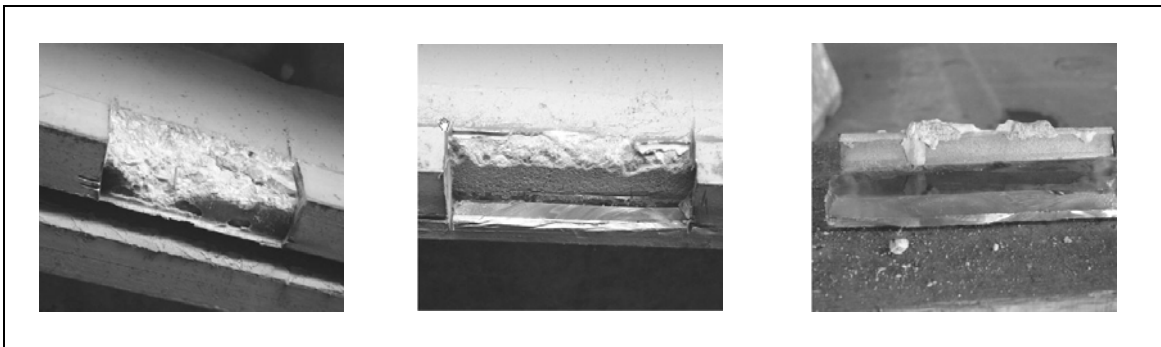
Figure 7: Bond sampling

Samples of the material used to bond and of the steel channels were extracted to carry out the following tests (see Figure 7): FTIR analysis samples, TGA analysis, X-ray spectroscopy and Shear strength. However, from the extraction operation it was concluded that the epoxy adhesive was not bonded to the pre-cast concrete elements. Therefore these tests were not carried out, because they would not lead to relevant conclusions.

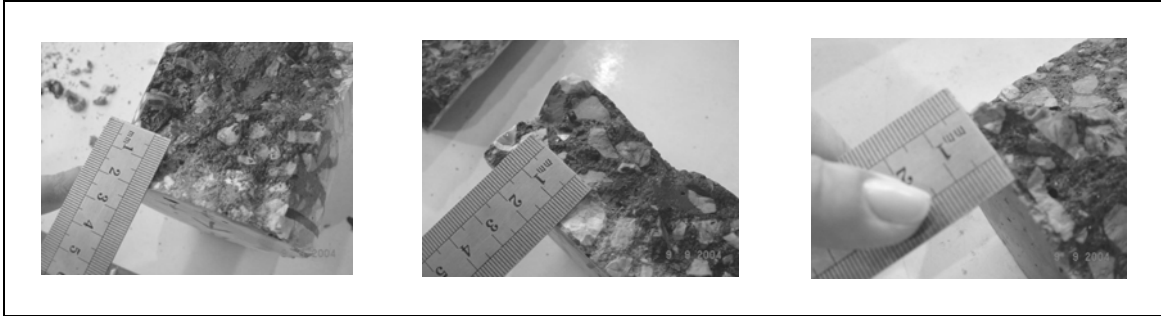
Figure 8: Carbonation results - Concrete from columns

The carbonation depth assessment in concrete elements was carried out on specimens drilled out of the structure from the points indicated by the contractor. The fresh fractured concrete samples were treated with an alcoholic solution of phenolphthalein indicator in accordance with the procedure established in the Portuguese Standard LNEC E391 [1]. The column samples present a carbonation depth of about 20mm but still very distant from the reinforcement (see Figure 8). The samples drilled from covered concrete elements have no carbonation signs. In relation to corrosion problems, it also seems insufficient to want to assess the corrosive state of the concrete without any measurement of its resistivity or of the electrochemical potentials of the armour or even a measurement of corrosion speeds.

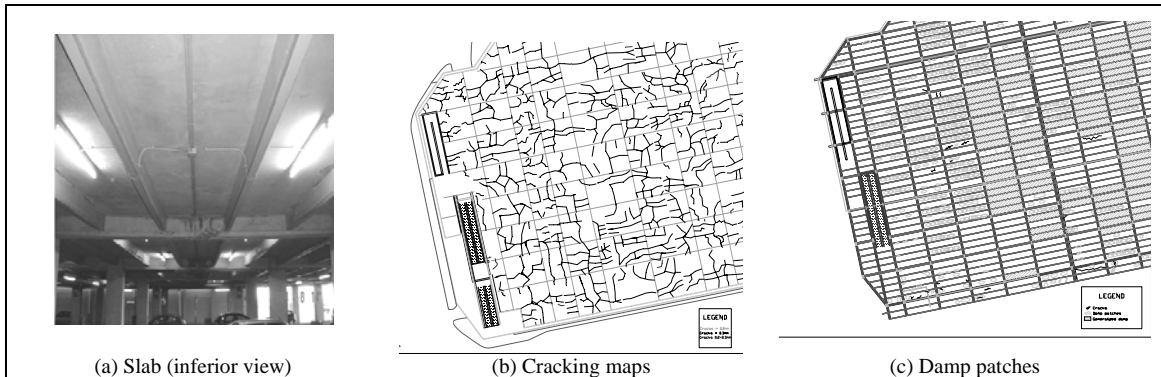
Figure 9: Visual grading results

This is the most simple and oldest NDT. The visual evaluation consists of examining directly, and at a relatively short distance, the elements along their length, checking and registering all the signs of alterations, global position, structural function, dimensions, accessibility, cleanliness of the element surfaces, luminosity conditions, existence of graphical and topographical elements and if they are in accordance with the actual structural conditions, type of repair or reinforcement, localization of the problems related with the loading conditions; cracking evaluation (see Figure 9), etc. However, the estimation of the serviceability properties of new and/or rehabilitated constructions, by visual grading is not entirely reliable with respect to a series of factors influencing the mechanical properties and, further, with respect to the influence of the human factor in the grading proper. Based on visual inspection to the structure, no iron oxide stains were found, nor drippings or any other kind of bleaching worth noticing.

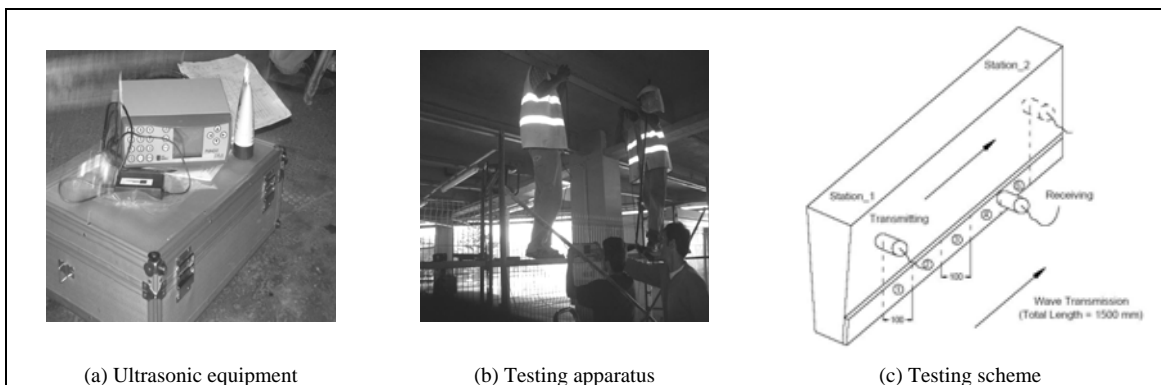
Figure 10: Ultrasonic tests

Coupled with a thorough visual examination, this test can add significantly to the quality of an inspector's evaluation. The ultrasonic method is used in homogeneous, non-porous materials to evaluate the elastic properties [7]. 31 pre-cast ribs were tested. The values of the velocity of propagation range between 956.7 and 2531.7 m/s. The results were not very consistent, in part due to the difficulties in carrying out the tests: great moisture content and temperature variations, problems in calibrating the measurements with confidence (difficulties in finding a well bonded channel) and high wave attenuation due to the energy consumption by the reflection of the waves as a result of the significant existent gaps. The ultrasonic transmission shows low sensibility to areas where debond has occurred. A clear difference in terms of velocity of propagation in locations where debond occurred versus locations where the epoxy was (apparently) glued to the steel channels was not observed.

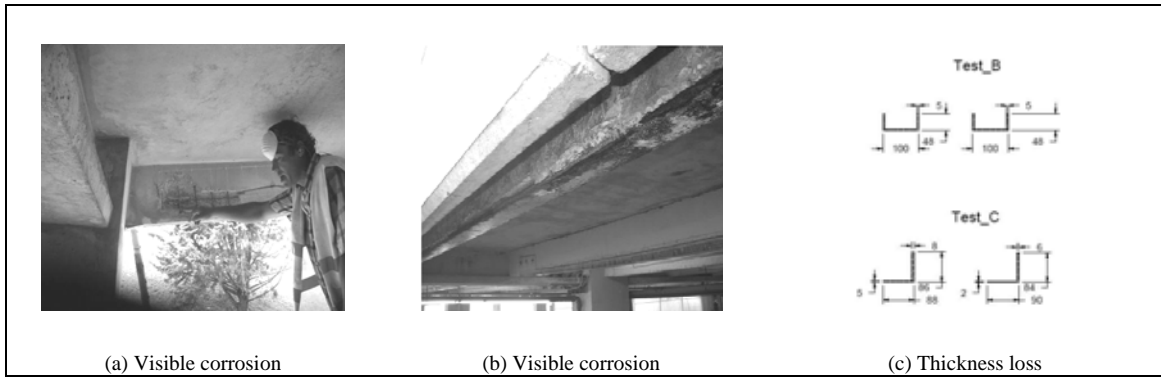
Figure 11: Cover meter survey and corrosion of steel members

Concrete cover thickness, diameter and location of reinforcement bars were evaluated as shown in Figure 11. Results indicate that concrete cover and reinforcement bars arrangement are thoroughly in accordance with the project drawings. The recovering thicknesses vary between 3,5 cm to 4 cm, which is quite acceptable for this kind of structure. The rust was totally removed with a metal brush from three steel channel sections. Corrosion is uniform in the most external steel channels. Thickness loss is worrying (only on the external ones), loss of more than 50% real thickness (see Figure 11c). From the samples extracted with reinforcement (two) and the zones with exposed for examination (five), it has been observed that the steel has no apparent section loss and is possibly in the passive state.
