# The use of FRPs in seismic repair and retrofit: Experimental verification

A. Pinto, P. Negro, A. Colombo & H. Varum

*ELSA Laboratory, Joint Research Centre, EC, 21020 Ispra (VA), Italy*

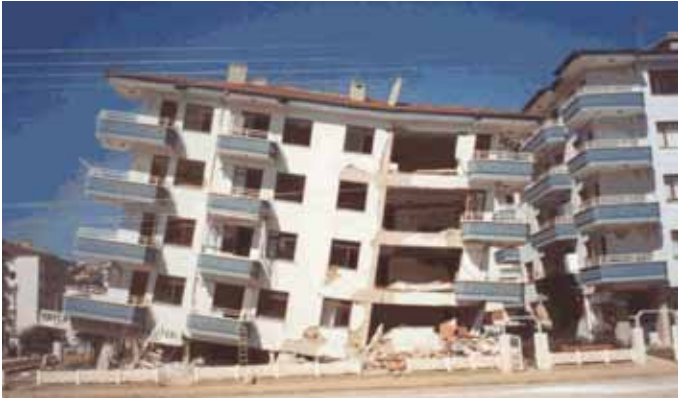
Figure 1. Failure of a building during the 1999 Turkish earthquakes (Elnashai 2000)

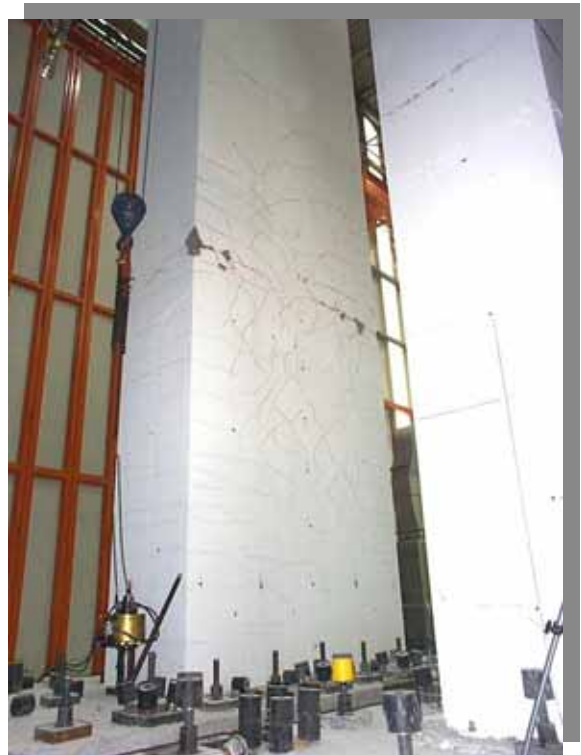
Figure 2. Bridge pier model (scale 1:2.5 - hollow box cross-section) of an existing highway-bridge in Austria tested at ELSA. Failure at 3.5 m from the base (Pinto & Tsionis 2001, Flesch et al. 2000)

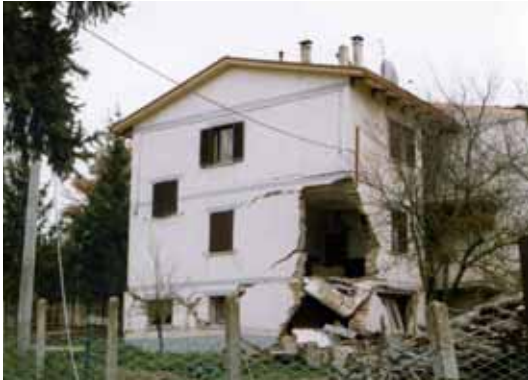
Figure 3. Failure (collapse of a corner) of a masonry house during the Umbria-Marche earthquakes, September 1997, Italy

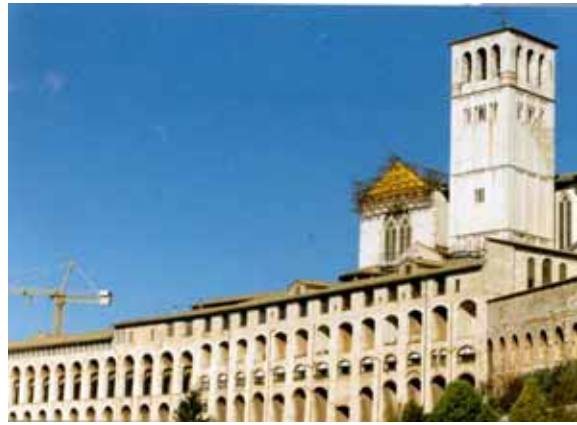
Figure 4. Repair and strengthening works at the Basilica of St Francis of Assisi (Tympanum) after the 1997 earthquakes, Italy

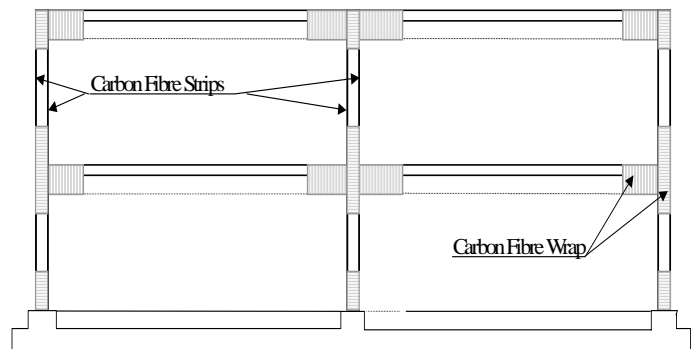
Figure 5. General layout of the REEDS frame location and type of strengthening

intervention to leave the structure with its original dimensions and to avoid the use of pneumatic hammer or other mechanical means, the activity included positioning unidirectionally oriented carbon fibre mats at all member ends. These were expected to increase the local ductility capacity in the member ends –mainly those of the columns- by means of the confinement effect exerted by the carbon fibre mats. In fact, the action accomplished by the membrane was to hold the layers of cover in their position, preventing them from spalling apart. The intervention is schematically shown in Figure 5.

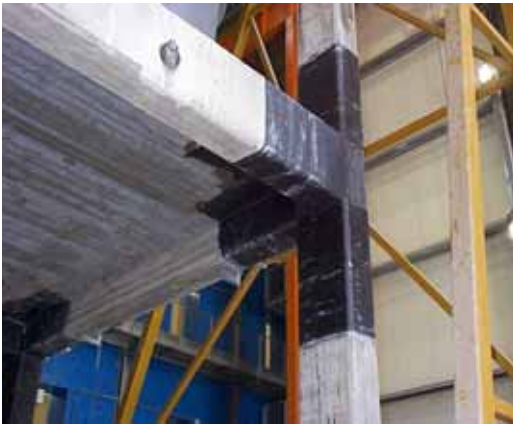
Figure 9. Member ends wrapped with CFRP

The structure was then used to investigate the effectiveness of CFRP as a repairing technique. After the injection of all cracks with epoxy resin, monodirectional carbon fibre wraps have been glued around all the member (beams and columns) ends (see Figure 9). The shear walls have been wrapped throughout the height of the building (Figure 8). Being the damage in the two frames of the structure

caused by different phenomena, it has been decided to intervene in a different way in the walls of the two frames. In particular, four-directionally-oriented wraps have been applied to the shear walls of the deformation-based designed frame in order to recover the loss in shear resistance. In the other frame, the intervention has been limited to the increase of the confinement effects by using monodirectional oriented fibre wraps.

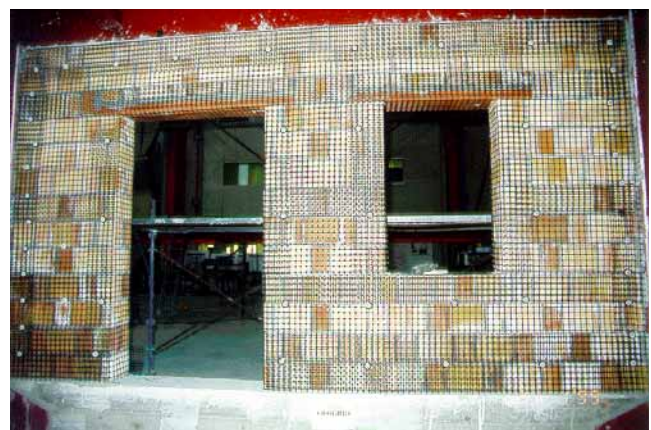
Figure 11. Application of the plastic nets for the wall with openings

A research program, funded by the European Commission, aimed at investigating the possibility to increase the intrinsic ductility and energy dissipation capacity of panels, has been recently concluded at the European Laboratory for Structural Assessment (ELSA) of the European Commission. The problem has been focussed on the possibility of confining the panels by using polymeric grids.

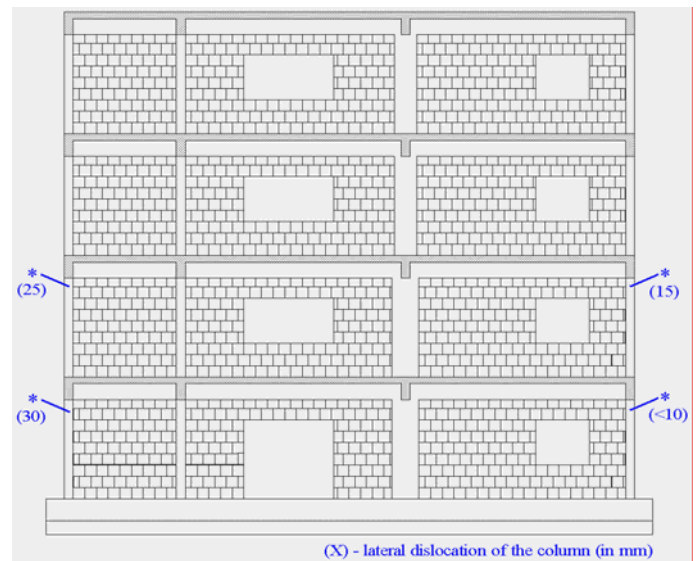
the infill panels) of a few columns (top part) with lateral dislocations of the external columns of 50 mm (~25% of the column cross-section characteristic height) (see Figure 14). Relocation, repair and strengthening of the column/joint parts were required to carry out the final collapse tests.

Figure 13. Layout of the RC frame with indication of the damaged columns/joints

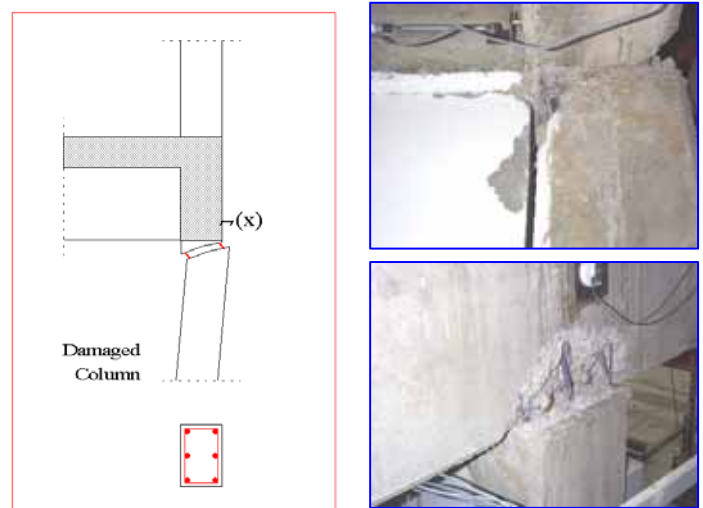
*Joints* - As already explained, a few joints were seriously damaged and dislocated from their original positions due to the cut-off effect caused by the infill panels. They were forced back to their original position and partially reconstructed. It is however known that reconstruction processes do not provide lateral resistance for horizontal or even vertical loads. It was therefore necessary to provide confinement to the joint and anchoring top-columns to the adjacent

Figure 14. Failure (shear-out) of the column/joint interface: Schematic representation (left), photographic documentation (right)

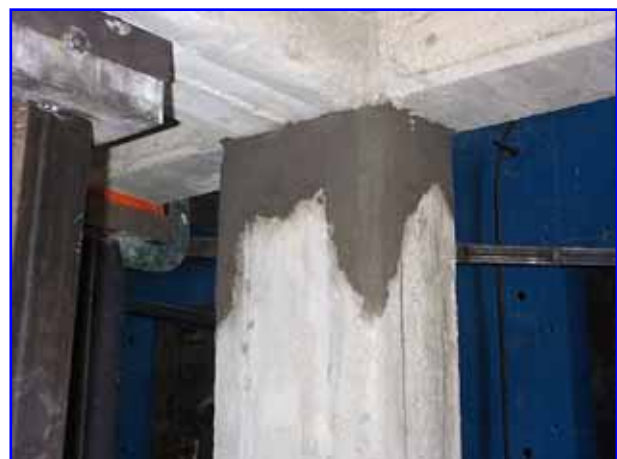
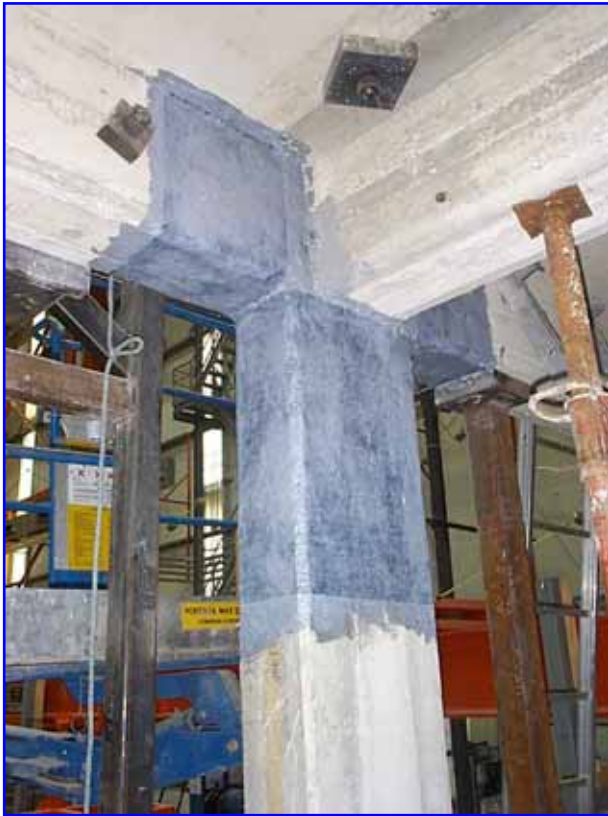
Figure 15. Reconstruction of the column/joint and strengthening with carbon fiber fabrics with epoxy based impregnation resin

The preparation and execution of the repair/strengthening works for six columns/joints and for one column was carried-out in four working days; the time elapsed being a period of 2 weeks between the application of the first repair products and when the final operation was carried out. They comprised: a) Removal of concrete at the top of the damaged column (20 cm); b) Positioning of columns to its original vertical position; c) Concreting of the external heavy damaged joints and column (1<sup>st</sup> storey, strong column) (see Figure 15); d) Injection of cracks in beams (with epoxy resin); e) Roughening of the external superficies (column and joints) for application of carbon fiber system; f) External carbon fiber repair system of the heavy damaged joints (see Figure 15).

A single layer of carbon fiber was used in all strengthening interventions. Furthermore, the carbon fiber fabrics are unidirectional, which requires control during their application. In fact, they must be oriented along the direction requiring strengthening. For required bi-directional strengthening two superposed carbon orthogonally oriented fiber fabrics must be used and, for shear-controlled situations, inclined carbon fiber fabrics are required, unless multi-oriented fabrics are used.

*Column* - the first floor strong column suffered heavy damage at the base and top extremities. Shear failure at the bars termination zone (0.70 m from the column base) was particularly evident. Therefore, it was necessary to increase strength and to provide sufficient confinement in the critical zones, including the bars termination zone. According to these requirements, confinement was continuously provided from the base up to 0.90 m, and the top column confinement was limited to 0.30 m.
