Seismic vulnerability of churches in Faial and Pico islands, Azores

J. M. Magalhães, R. Vicente, T. Ferreira, A. Costa & H. Varum

SUMMARY:

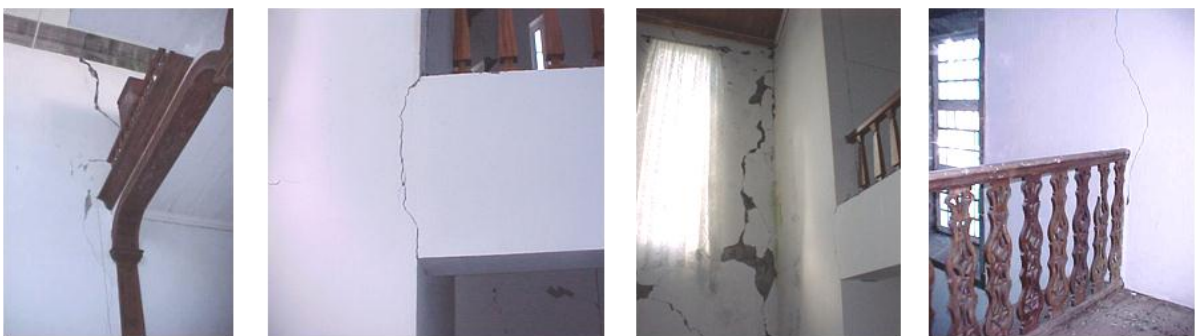
However, during evaluation of the photographic register and inspection reports made by Costa and Vasconcelos (1999), it was detected that all these churches contain a high choir and, most of them had damages related to the seismic behavior of this macro-element (Figure 3). This structure constitutes a second floor of the church, which normally includes access to the bell towers, and is a typical macro-element in Portuguese churches.

Figure 3. Consequential damages of the interaction between high choir and sidewalls of Azores churches [Costa and Vasconcelos, 1999]

The study of this macro-element is extremely important due the register of serious damages (Figure 3) that may result from its interaction with other parts of the structure, for example, the sidewalls, arches that support the structure or the façade. For this reason it was introduced as the 29th damage mechanism on the methodology corresponding to this macro-element. Figure 4 presents all the damage mechanisms considered in this work.

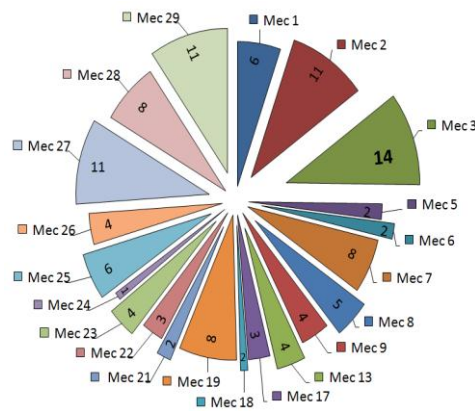
Figure 6 represents the damage mechanisms identified in the sixteen studied churches. This figure indicates that the cracking caused by shear effort in the façade wall (mechanism 3), the overturning of the top of the façade (mechanism 2), damages in the high choir (mechanism 29) and the cracking in bell towers (mechanism 27), have been identified in a large number of the study cases. Analysis of this figure allows an indirect perception of the main weaknesses in these buildings.

Figure 6. Pie chart of the identified damage to the 16 churches of Azores after the July, 9th 1998 earthquake

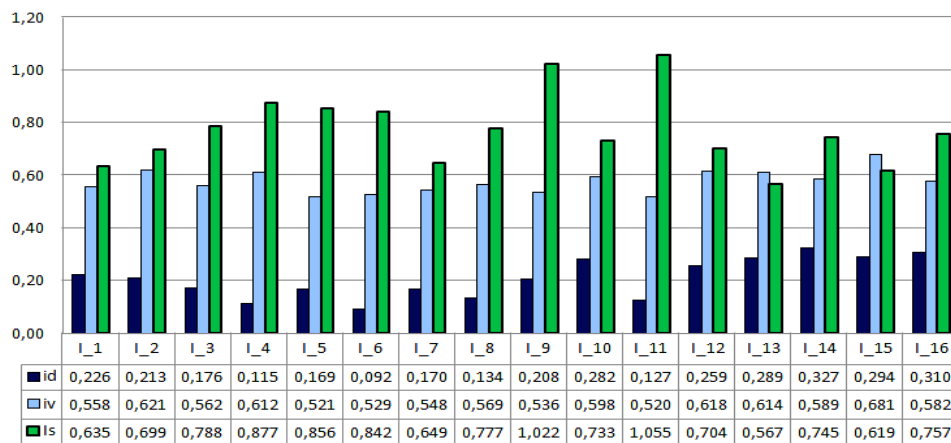
Figure 7. Values of i_d , i_v and I_s obtained for the 16 studied churches

As discussed previously, according to the reference document, churches with a damage index higher than 0.3, do not gather the necessary conditions for normal use. In this study, the value of this index was typically quite low, being equal to or greater than 0.3 in only in two of the sixteen churches.

The global seismic behavior of these buildings is statistically represented by the vulnerability index (i_v) (variable between 0 and 1), which is an average of the behavior of different parts of the church (Linee Guida, 2006). As shown in figure 7, all of the churches examined have a high vulnerability index (i_v) between 0.5 and 0.7

Regarding the seismic security index (I_s), in most cases the values achieved were less than one (Figure7), which, according to Linee Guida (2006), means that these churches are not able to support an earthquake with the reference ground acceleration considered for this region ($a_{gR} = 2,5 \text{ m/s}^2$) (NA, 2008). It is important to stress that the results obtained for the seismic security index (I_s) concern the reference acceleration (a_{gR}) off the seismic region and depends also of the assumed values of ground amplification factor ($S=1$) and importance factor ($\gamma_1=0.80$).

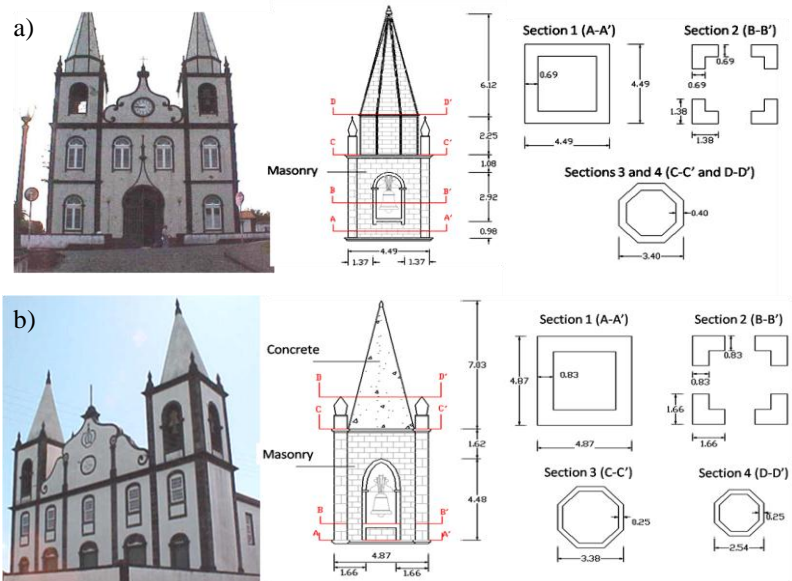
Figure 8. a) Church and belfry of Madalena – Pico; b) Church and belfry of Bandeiras – Pico

In both cases it was verified that the critical section corresponds to the base of the columns on the belfry, easily explainable by the reduced dimensions in plant of the elements besides of the reduced axial load at this level. Comparing the resistant bending moment (M_{RES}) with the bending moment corresponding to the reference acceleration (M_u) of the critical section (Table 1), it was concluded that this condition was verified. In addition, the results obtained by the critical ground acceleration corresponding to the ultimate limit state (a_{ELU}) are lower than the reference ground acceleration (a_{gR}) for this region ($a_{gR} = 2,5m/s^2$) indicating their high vulnerability.

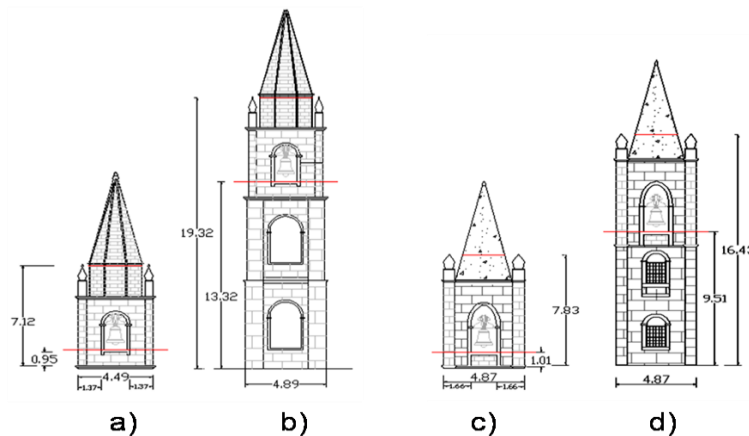
Figure 9. Critical sections in the two considered situations: a) Church of Madalena only considering the belfry; b) Church of Madalena considering the isolated tower; c) Church of Bandeiras only considering the belfry; d) Church of Bandeiras considering the isolated tower.

The results obtained for the critical ground acceleration showed that both the belfries have high vulnerability to seismic action, and the ground acceleration corresponding to the collapse in the critical section diminishes when the real altitude of the belfry is considered. This increase in vulnerability is caused by the amplification of ground acceleration at the real altitude of the belfry.

The biggest increase of vulnerability corresponds to the church of Bandeiras (lower tower). These results are justified by the number and dimensions of considered openings providing to this tower a higher seismic vulnerability, and to the fact of its lower fundamental vibration period, being in this case the response spectrum more severe.
