## **HMS VANGUARD 100**

*Citation for published version (APA):*  
Rowland, C., & Hyttinen, K. (2018). HMS VANGUARD 100: Survey 2016-2017. HUSKYAN.

HMS VANGUARD 100  
SURVEY 2016-2017  
Survey Report

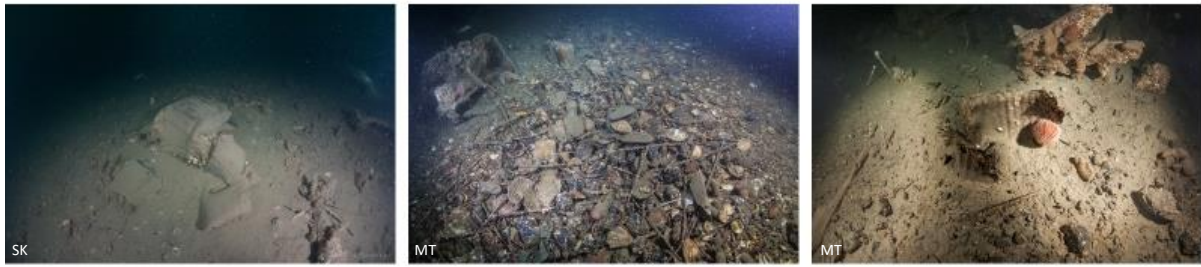
- A slight depression in the seabed of depth  $\cong 1\text{m}$ , absent of substantial pieces of wreckage.
- Randomly scattered sticks of cordite and small pieces of coal and shoe soles.
- 4-inch cordite cases heavily deformed and turned inside out by the effects of explosion, clearly identifiable by their corrugated case-form.
- 12-inch Clarkson cases empty of cordite, split open and with heat damage.

Figure 29: Explosively formed Clarkson Case; example section of the "gap" detailing shoe soles, coal and cordite; deformed 4-inch cordite case

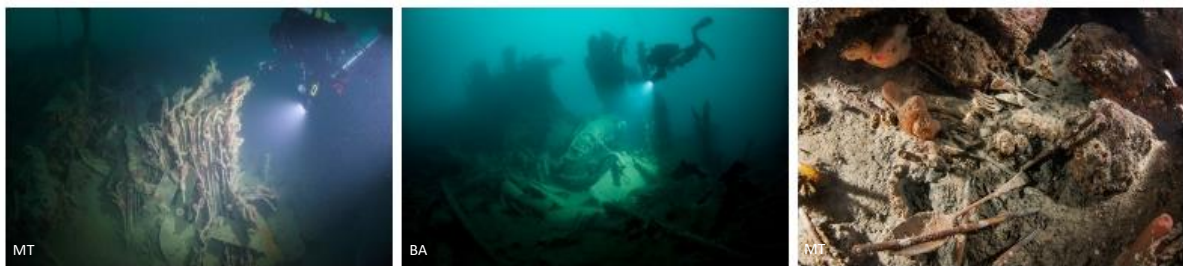
The forward Engine Room bulkhead (frame 148) is intact, along with associated machinery on the aft side. The longitudinal bulkhead between the port and starboard Engine Rooms is also partially present. The port Engine Room inner turbines, the cruising turbine and low pressure ahead & astern turbine are in place and almost intact. The two portside outer high pressure turbines were not located. These may be buried below the low pressure turbine or they may have been salvaged. The starboard Engine Room is much more broken, with only splintered turbine blades visible and no sign of intact turbines. Anecdotal evidence refers to salvaged condensers from VANGUARD having quantities of cutlery concreted to the condenser casings. Cutlery was also located in the Engine Room wreckage. This may have originated from the Main Deck above the Engine Rooms where the Petty Officers Mess and Seamen's Galley and Admirals Galley were located.

Figure 34: Starboard Turbine Room splintered turbine blades; port turbines; cutlery

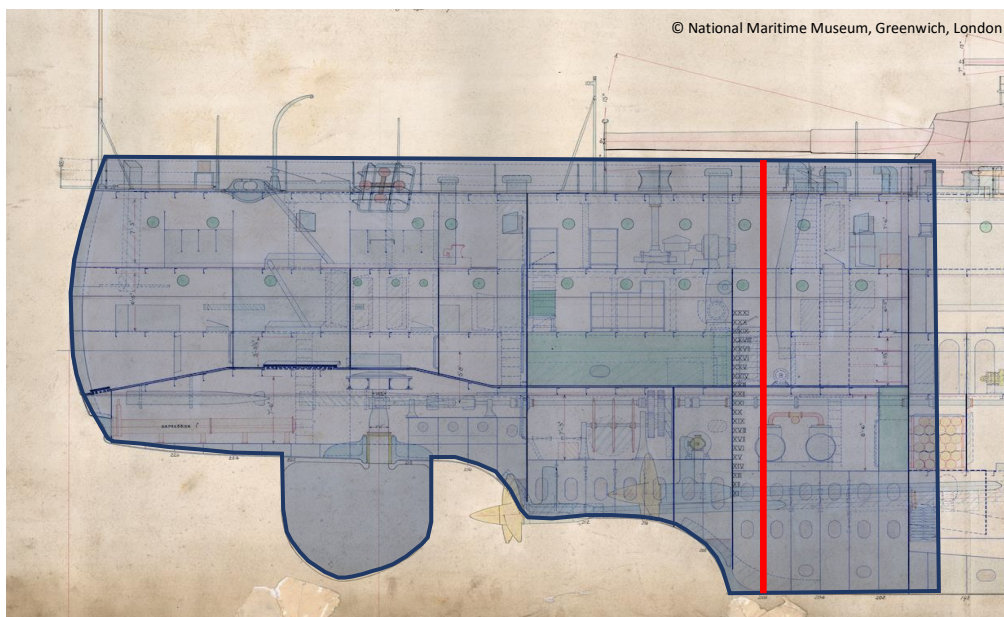
Figure 35: The extent of the intact stern section. The red line denotes the break in the deck

The stern section is located immediately south-east (aft) of the Engine Rooms and Y Turret. It remains ostensibly intact abaft frame 206 (aft of Y Turret) and resting on its port side. The name "VANGUARD" can still be read on the port side. The Stern is orientated approximately east/west, with the sternpost to the east. The teak on the Upper Deck is in remarkably good condition and is bent downwards at approximately 90 degrees just aft of the barbette

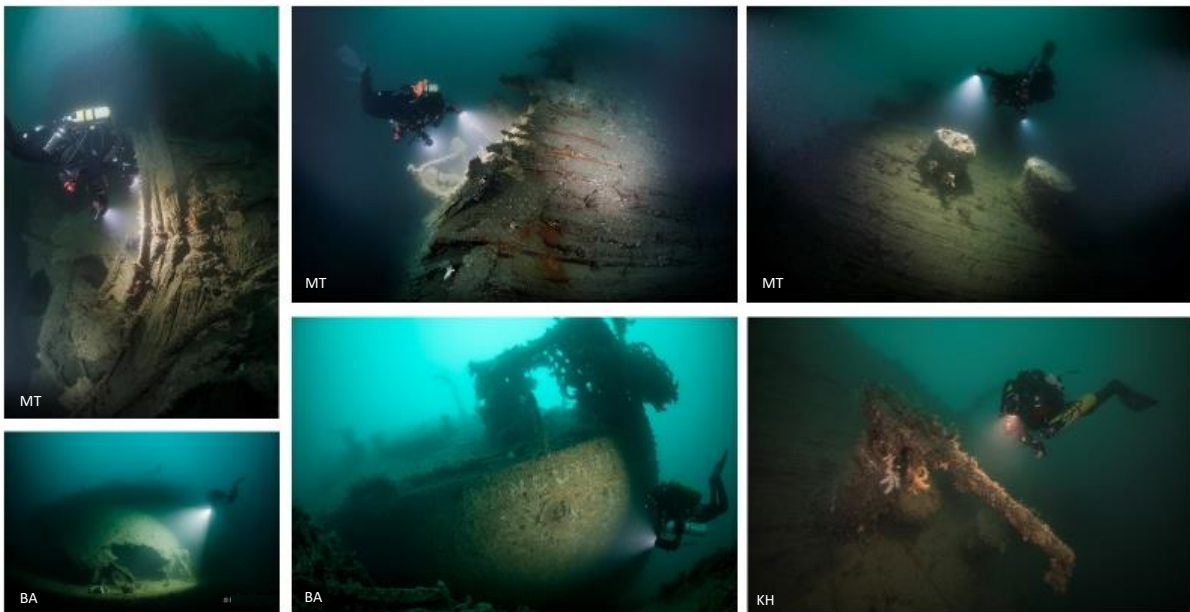
aperture at the “break” in the hull. This bent section of upper decking contains a distinctive curved edge, that is almost certainly the deck aperture for Y Turret barbette (frame 200). Adjacent to this, Y Turret sits upright on the seabed. The gun house and barrels are missing. On the seabed sits the only 12-inch barrel located during the survey. It shows signs of salvage – the barrel is broken and the base of the barrel is stuck in the seabed, but has salvage chains wrapped around it. X Turret sits 10m to the northwest from Y Turret. It is also upright with gun house and barrels missing. The turret has been displaced from its original position forward of the turbine rooms.

Figure 38: Y Turret teak deck ring; 90 degree snapped deck; identifying capstan and vent at snapped stern section; torpedo salvage hole; stern name lettering; Hotchkiss gun

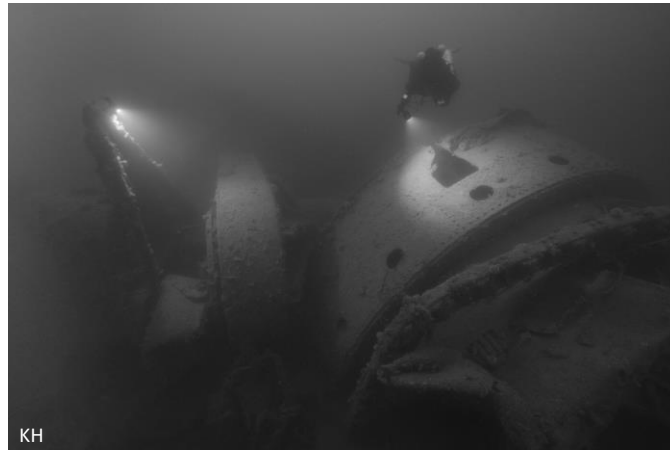
Figure 39: A Turret

**A Turret** is located in the A Turret & Bridge wreckage on its side on top of other wreckage. The barbette is broken open to reveal the training rack. A Turret lies approximately 15m due east of the current position of the bow.

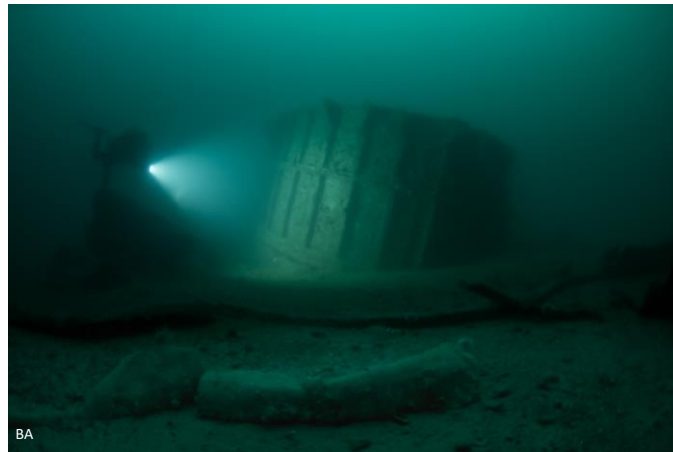
Figure 41: Q Turret

**Q Turret** is located on the seabed approximately 55m to the east of the datum line. Q Turret is the only turret that is inverted, and lies approximately 45m east northeast (directly to starboard) of its original position in the ship. Approximately 25m west southwest of Q Turret is its ammunition hoist tube, which shows substantial crush damage typical of the effects from explosion.

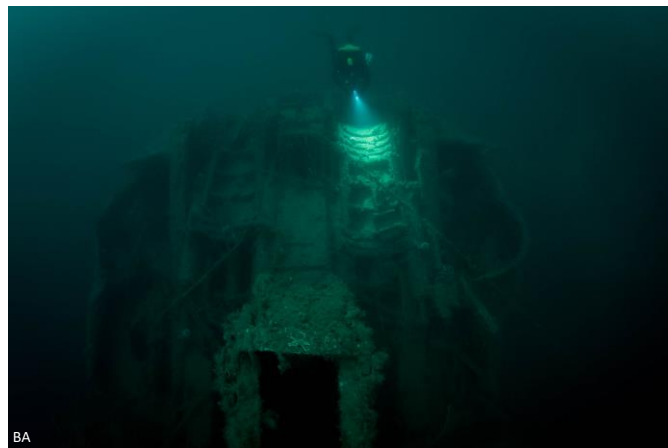
Figure 42: X Turret

**X Turret** is located in the Main Aft section and is in the best condition of the five turrets. It lies upright on the seabed approximately 10m to the west of Y Turret. X Turret lies approximately 25m south-southwest (port-aft) of its original position in the ship.

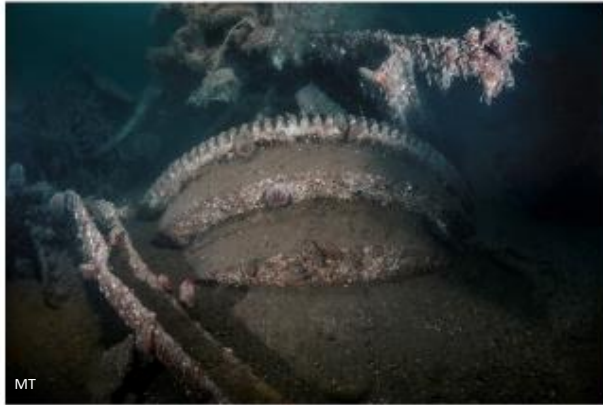
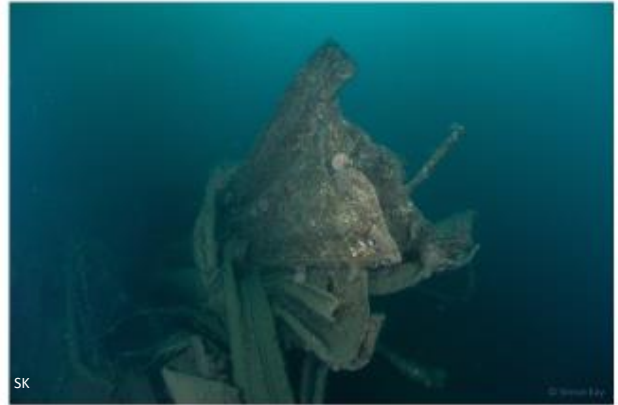
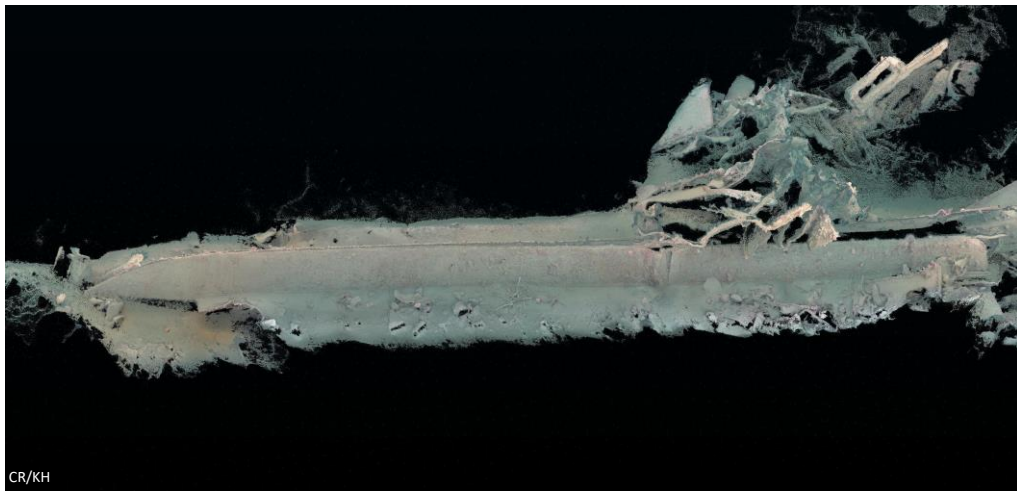
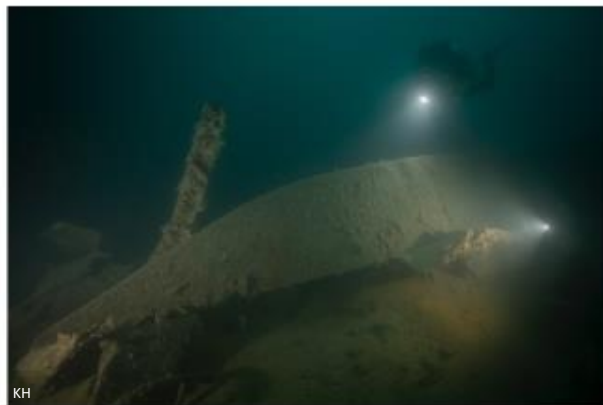
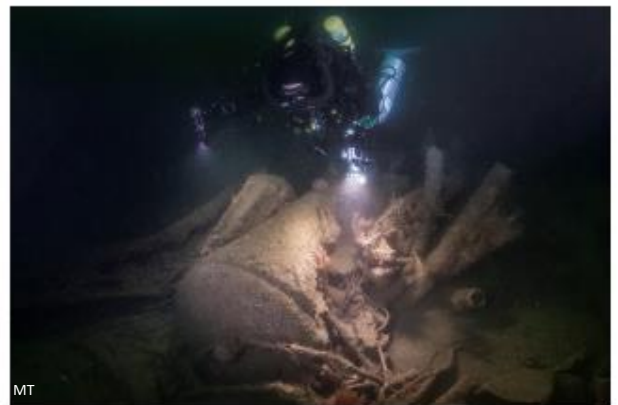
This area is characterised by a large amount of scattered and broken debris, mainly consisting of twisted steel plating and pipes. Most of the debris is small in size, although there are two larger sections located 20-25m east of the datum line. One of these sections contains a magazine hoist trunk and revolving shell bogie, likely associated with Q Turret. To the east of the datum line there is a section of ship's hull, approximately 30m in length, orientated east/west, with 22.3m of bilge keel including the tapered forward end. This is almost certainly from the starboard hull, between A Turret and Q Turret, having been thrown here by the force of the explosion. In addition, two boilers (survey numbers 9, 10) are located in this area. Both of these boilers show compression damage consistent with an explosion.

Figure 44: NE wreck site wreckage. Top: Q Turret shell bogie upper rack; Q Magazine hoist trunk. bottom: starboard side forward bilge keel; 3D image of bilge keel wreckage; Boiler 10 showing compression damage

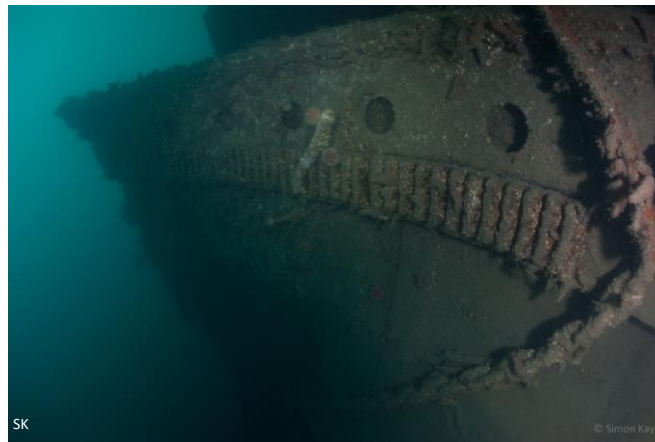
Figure 93: A Turret training rack in the broken open ring bulkhead
