Zekkos, Dimitrios and Athanasopoulos-Zekkos, Adda and Grizi, Athena and Greenwood, William (2016) The May 25th 2011 railroad embankment failure in Ann Arbor, Michigan, as a means for teaching geotechnical engineering. *International Journal of Geoengineering Case Histories*, 3 (4). pp. 234-245. ISSN 1790-2045

The May 25th 2011 Railroad Embankment Failure in Ann Arbor, Michigan, As a Means for Teaching Geotechnical Engineering

ABSTRACT: A 30-m long railroad embankment failure that occurred on May 25 2011 in the city of Ann Arbor, Michigan, is presented. Emphasis is given on the field observations of the failure, the characterization of the site conditions and the seepage and slope stability analyses, all of which represent important components of the training and practice of a geotechnical engineer. The failure occurred following a record wet season that resulted in ponding water against the embankment and high enough water pressures and exit gradients that resulted in instability of the railroad embankment. Detailed background material and the methodology for using the case history in geotechnical engineering education are presented.

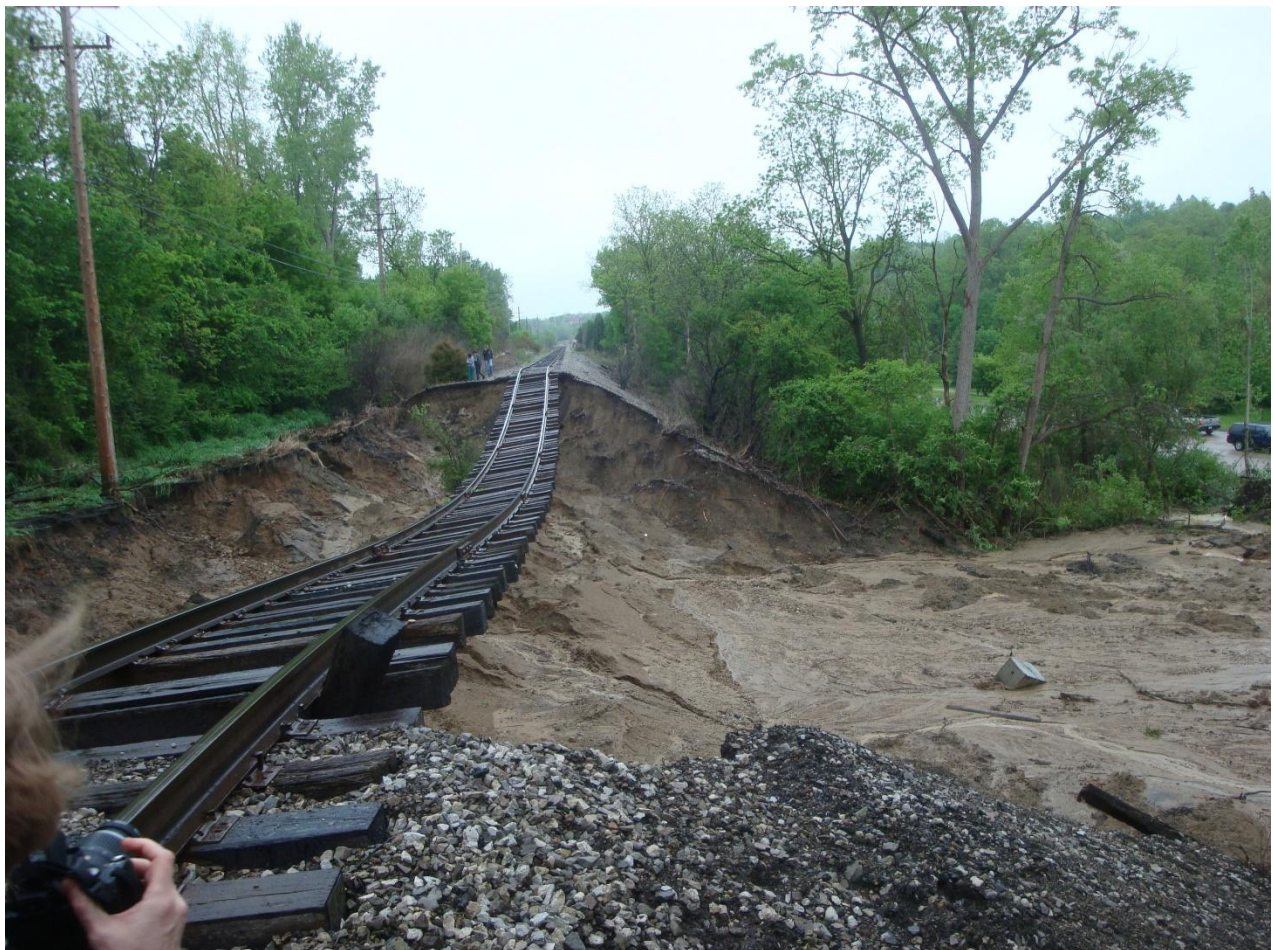
Figure 1. View of the railroad embankment failure looking East.

The failure surface appears to engage the entire railroad embankment that is supported on naturally sloping native ground. A 30-m long section of the embankment along the railroad axis slid, and the sliding mass moved a significant distance downslope, removing a number of trees that had grown in the downslope side of the embankment between the railroad embankment and Plymouth Rd. The interpreted failure surface per field observations is shown in Fig. 5 and 7 and is in the vicinity of the contact between the native ground and the embankment fill, but appears to be restricted within the embankment fills and not involve the native soils.

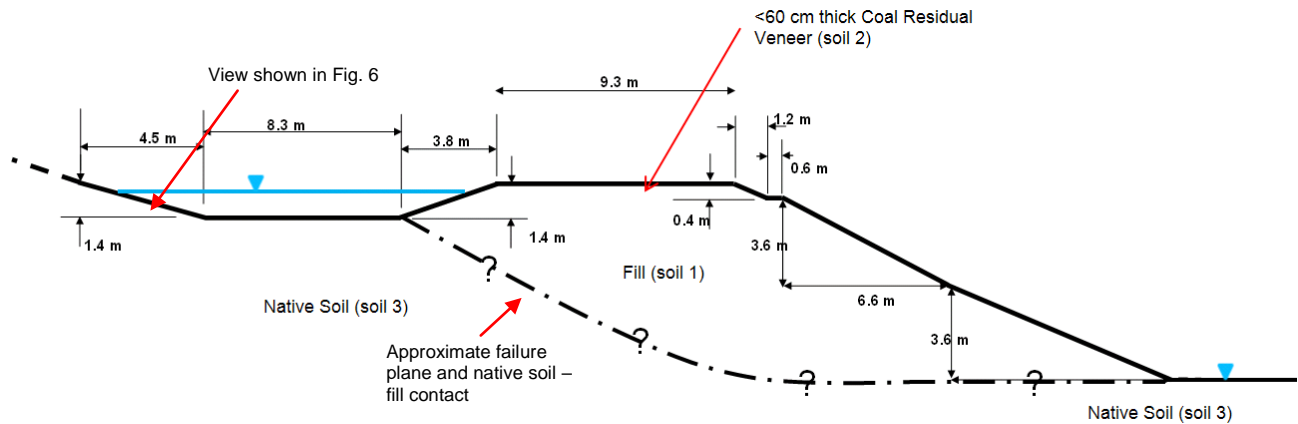
The embankment is constructed partially on a naturally sloping ground and has a total height of 7.6 m as shown in Fig. 5. Its crest, that supports the railroad lines, has a width of 9.3 m. The embankment fill consists of two layers. The main layer (Fill Soil 1) is a silty sand (SM). A surficial layer of very small thickness is also present and consists of coal ash residuals (Soil 2). The natural soil that underlays the embankment is a sandy clay of low plasticity (CL) that geologically is described as very dense glacial deposits (Native Soil-Soil 3).

Figure 5. Cross-section of the railroad embankment at the location of the failure.

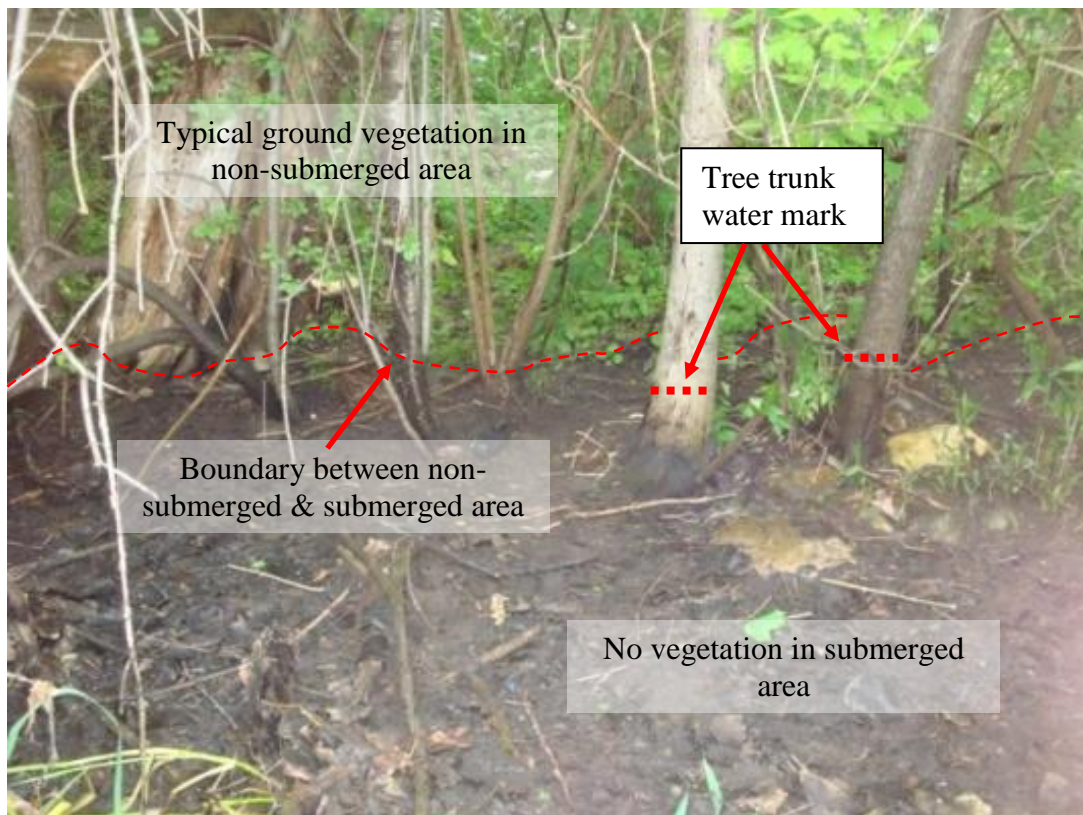
During the site visit, it was observed that the failure location was at a local natural depression that was receiving and accumulating surface water from a wider area. After careful inspection, the authors hypothesized the existence of seasonal ponding water. The surface soil on the uphill side of the embankment was very wet with vegetation that is typical of marshes, such as reeds. Next to the embankment where the water appeared to nearly permanently ponding and below trees there was no vegetation (see web-based supporting information titled “Photos and “Videos”). These conditions were found to be unique compared to other locations along the axis of the embankment. In addition, the level of water could be clearly seen as a watermark on the trunks of trees, as shown in Fig. 6. Based on these observations it was evaluated that the depth of the ponding water could have reached up to 120 cm. Local residents confirmed the existence of ponding water adjacent to the embankment. In fact, it appears that a neighbor used to feed visiting ducks at that location. Retention of ponding water was not part of the original embankment design. It is important to note that ponding water existed for at least some

Figure 6. Area previously covered by ponding water and water mark on tree trunks.

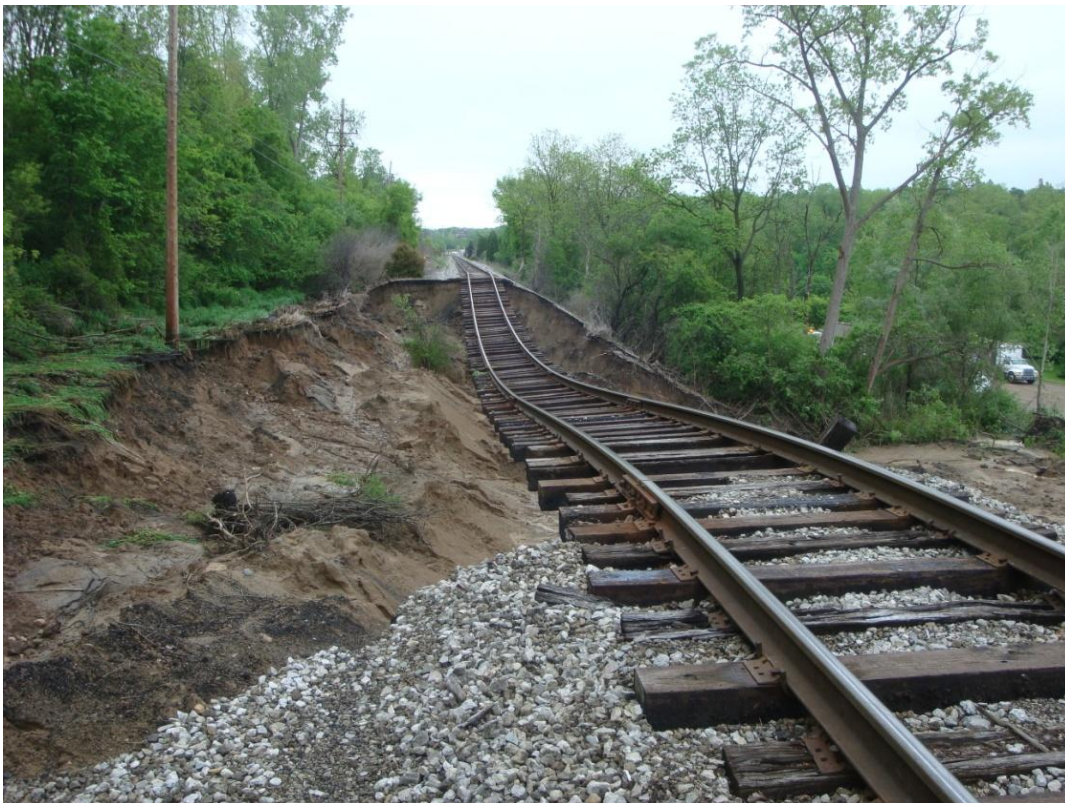
Figure 7. View of the failure along, and perpendicular to, the railroad embankment axis.

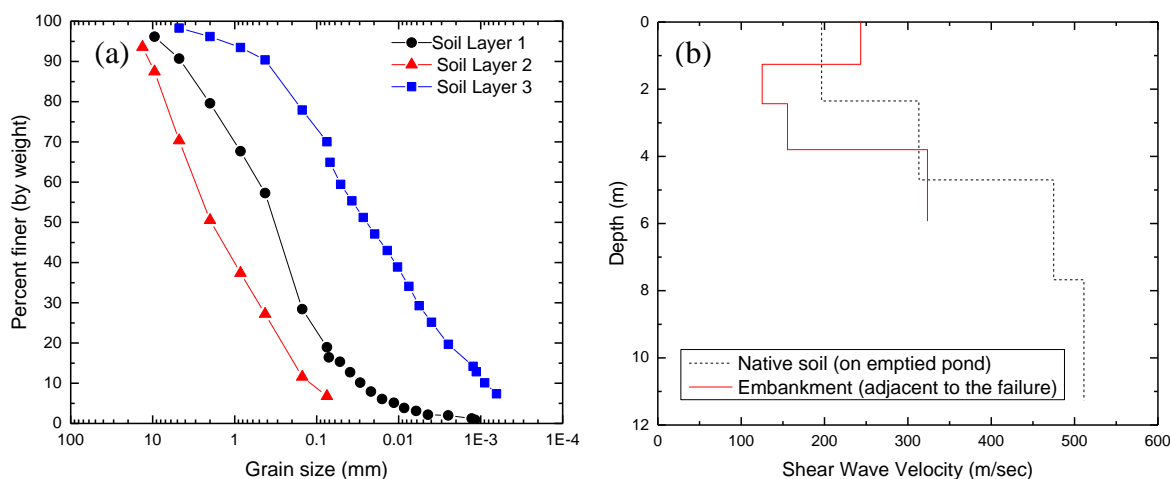
Soil Layer 1: This soil layer represents the main embankment layer, as shown in Fig. 5, and is classified per USCS as silty sand (SM). 18.9% of the material are non-plastic fines as shown in Fig. 8a. Since undisturbed samples were impossible to collect for the sandy fill, tests were conducted on reconstituted specimens at two different density states to evaluate the range of shear strengths expected for these materials. The direct shear tests were conducted in dry conditions. The shear strength of the material at a dense state was evaluated on the basis of direct shear testing, and the peak friction angle was found to be equal to 46° , whereas the post-peak was found to be equal to 38° without any cohesion, as shown in Fig. 9. The large-displacement friction angle at a dense state is approaching the peak friction angle of the soil at the loose state that was found to be equal to 35° . The hydraulic conductivity of the soil at a dry unit weight of 1.71 gr/cm^3 , was equal to $5.1 \cdot 10^{-5} \text{ cm/sec}$ based on a falling head hydraulic conductivity test conducted in the laboratory.

Figure 8. Results of (a) grain size distribution analyses and (b) in-situ shear wave velocity

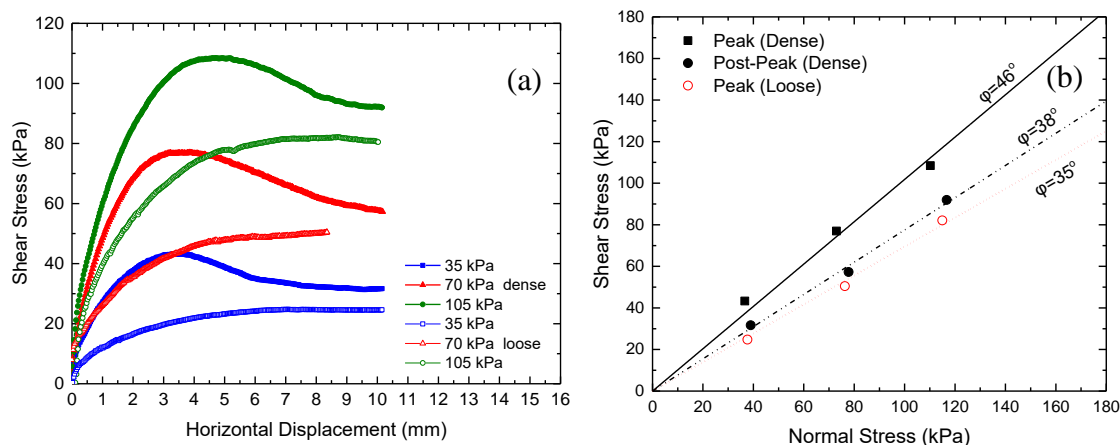
Figure 9. Direct shear results at nominal vertical stresses of 35 kPa, 70 kPa, and 105 kPa on reconstituted specimens of Soil Layer 1.

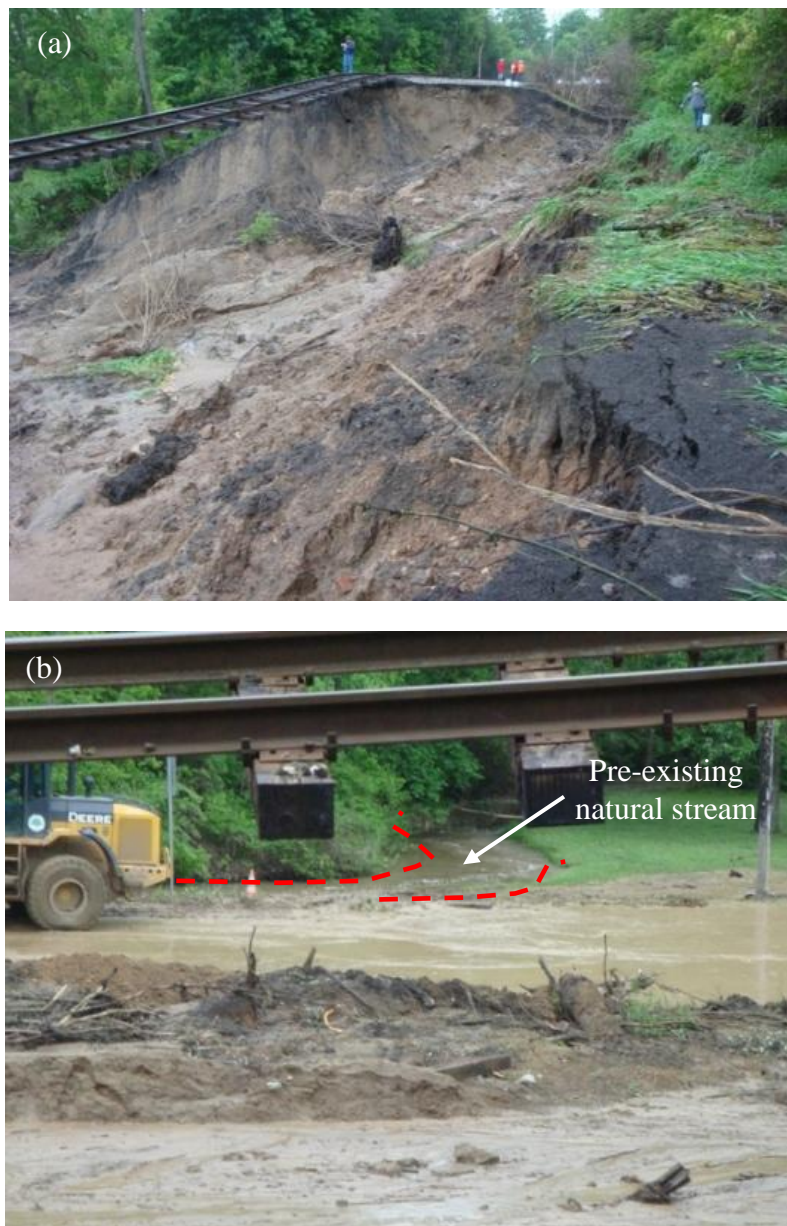
Soil Layer 2: This embankment layer is restricted to the top few cm from the surface and is essentially coal ash residuals that are black in color and can be clearly seen in Fig. 10. The fines are non-plastic and represent only 6.8% of the total mass of the soil, whereas the gravelly size particles are equal to 29.6%. It is classified per USCS as well-graded gravelly sand with silt (SW-SM). This soil layer is not expected to have played a significant role in the failure since it is of very small thickness and restricted at the surface only. Thus, more comprehensive testing to characterize its properties was not conducted.

Figure 10. View of the failure from the crest of the failure surface where (a) the left-in-place embankment is shown; (b) the mass of soil with large amount of water is shown at the toe of the failure reaching the pre-existing natural stream.

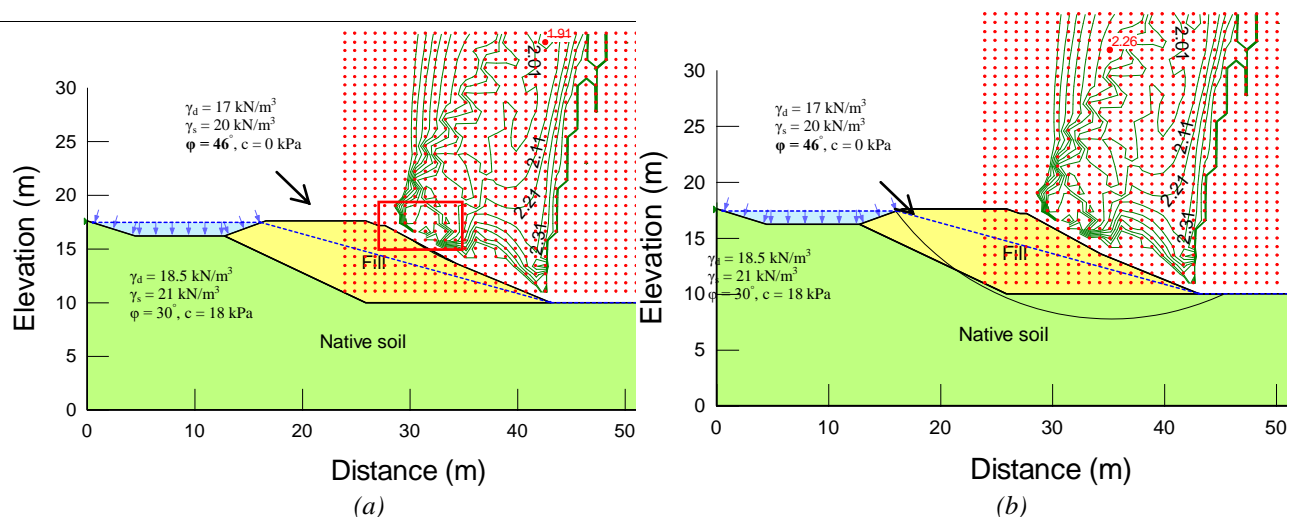
Following site characterization and the assessment of the embankment and failure surface geometry, stability and seepage analyses were conducted using the software programs SEEP/W and SLOPE/W (Geostudio, 2007) and the Spencer method of analysis (Spencer 1967). For stability assessment, parametric analyses were also conducted for reasonable variations of soil properties, as well as variations of the water depth of the ponding water (60 – 120 cm) that is reasonably well documented based on the field observations. These parametric analyses are critical in assessing the impact of uncertainties in the results. The parametric stability analyses indicate that even for the highest ponding water depth, the factor of safety remains significantly higher than one, i.e., it varies between 1.4-1.9 (for friction angles equal to 38° and 46° respectively) for a shallow failure surface that is restricted within the embankment, and is shown in Fig. 11a within the red box. Note that although the failure planes shown are “classic” numerical failure surfaces of purely frictional material with zero cohesion, even for low cohesions of 1-3 kPa, the observation that shallow failure surfaces are most critical remains valid. Higher values of factor of safety that vary between 1.5 and 2.3 were calculated for deeper failure surfaces that intersect the native soil (soil layer 3). Example results of the analyses are presented in Fig. 11.

Figure 11. Indicative results of embankment stability analyses for hydrostatic pore pressures. (a) showing lowest Factor of Safety (FS) of 1.91 for shallow failure planes (in the red box); (b) showing indicative FS of 2.26 for a failure plane that intersects the native soils.

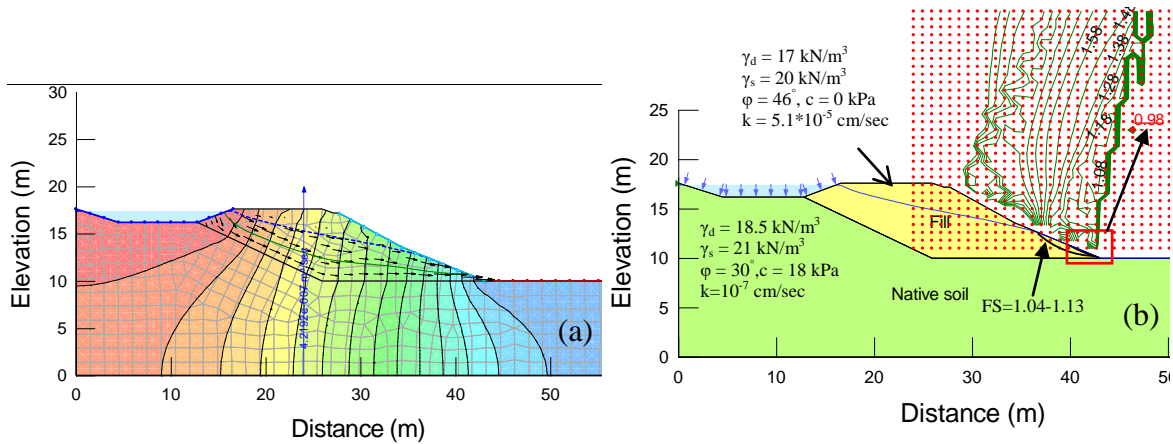
Subsequently, seepage analyses were conducted using the estimated hydraulic conductivities. As described earlier, the natural soil has significantly lower hydraulic conductivity than the embankment soils. Thus, the analyses indicate that when the ponding water depth increases, the exit gradients at the toe of the embankment become high, and vary between 0.48 and 0.78, which are dangerously high and close to critical gradients (~ 0.9). The stability analyses using the calculated hydraulic pressures, indicate failure of the embankment with factors of safety around one, as shown in Fig. 12. Note that this is not surprising as the seepage analysis gives a more realistic pore pressure profile (Fig. 12a) than that of an arbitrarily assumed piezometric surface (e.g., Fig. 11) with the flow concentrating more on the higher hydraulic conductivity soil. The results, indicate that the failure is caused by the high pore pressures that may even cause piping. The numerical results, are supported by the following interesting field observation: The reeds in the ponding water area adjacent to the embankment were found to be bent sideways and positioned horizontally with a direction that was pointing with great accuracy to the exact location where the ponding water initially drained quickly, as shown in Fig. 12.

Figure 12. Indicative results of combined (a) seepage and (b) stability analyses using seepage analyses results
