**The materials, technique, conservation treatment and after-care of
*Interior de um Convento***

Dissertação apresentada na Faculdade de Ciências e Tecnologia da
Universidade Nova de Lisboa para a obtenção do grau de Mestre em
Conservação e Restauro, especialização em pintura sobre tela

Dezembro, 2011

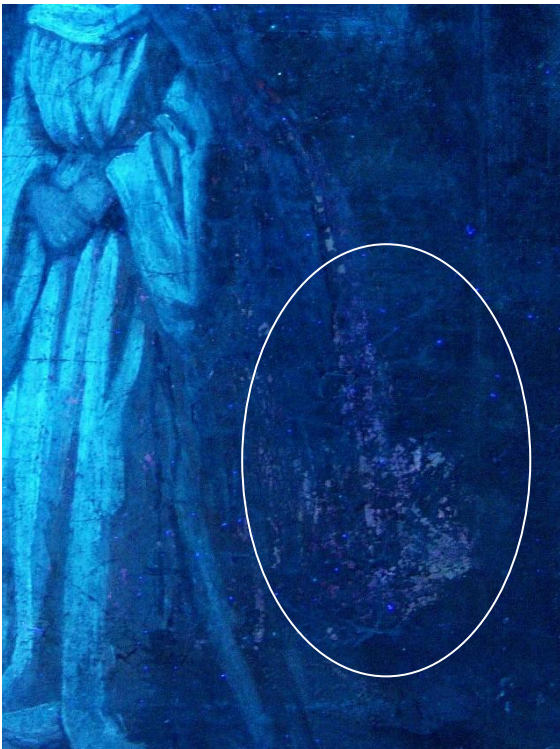
Fig.III.3.1. UV photographic detail of orange fluorescence on area of paint losses where it has another painting underneath (white circle).

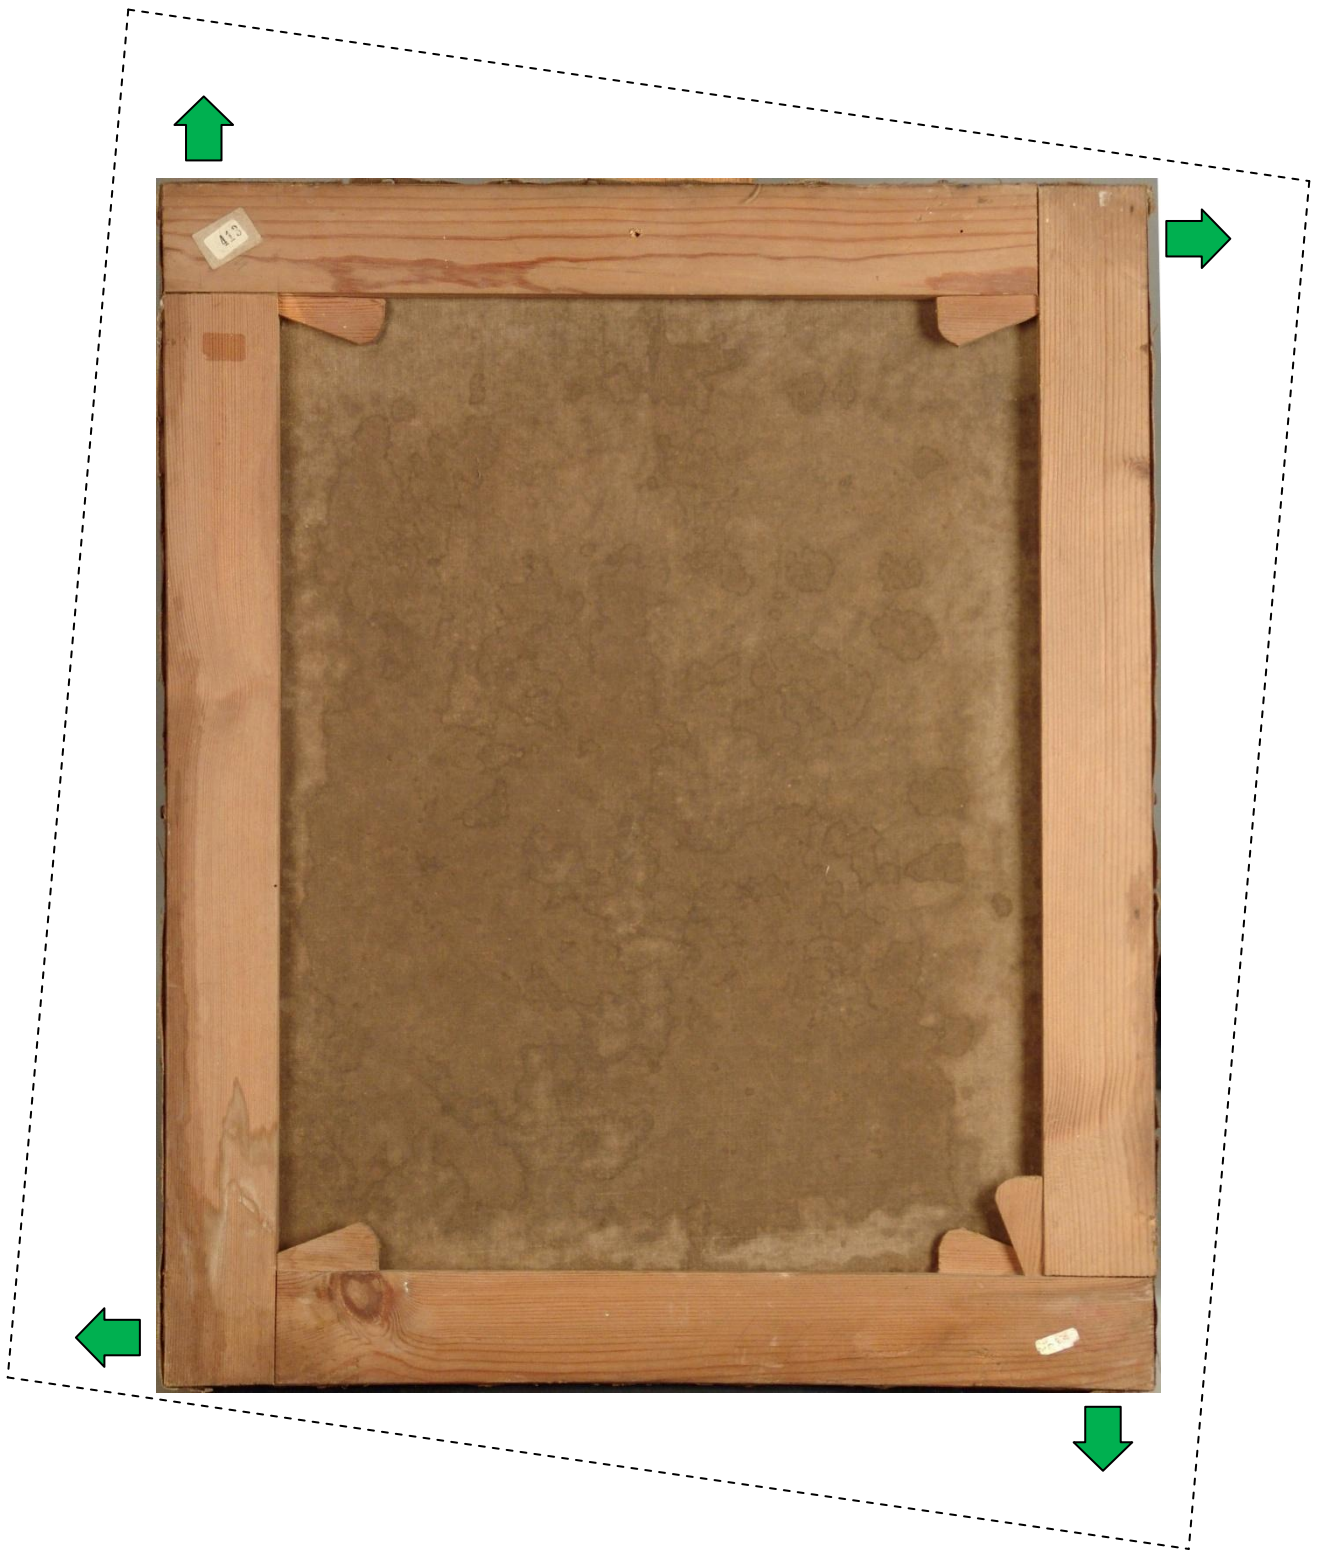
In relation to its condition, there is evidence of staining on the lower left and right corners likely due to previous water damage (**Ap. IV, Fig.IV.2, p.66**). There are also traces of mechanical damage, specifically some abrasion/incision marks over the top and bottom bars (**Ap. IV, Fig.IV.5, p.68**) and “exit-holes” in the wood, evidence of previous insect infestation. Otherwise, the stretcher was in good condition. The circular exit holes are characteristic of xylophagous attack, and their 1.5 to 2mm diameter size are typical of the species *Anobium punctatum*. [10] Another sign of insect infestation was the presence of wood dust and frass (mostly larvae fecal pellets). Therefore, it was decided to put the painting in quarantine: it was wrapped and sealed in a transparent sheet of Melinex® and left undisturbed for seven days, after which it was checked for traces of active infestation (wood dust and new exit holes). It was determined that the insects were not currently active.

Fig.IV.2. Normal light photograph of the back of the painting with arrows which indicate the one direction of movement for each of the corner joints. This type of rotary stretcher creates a parallelogram (dashed lines).

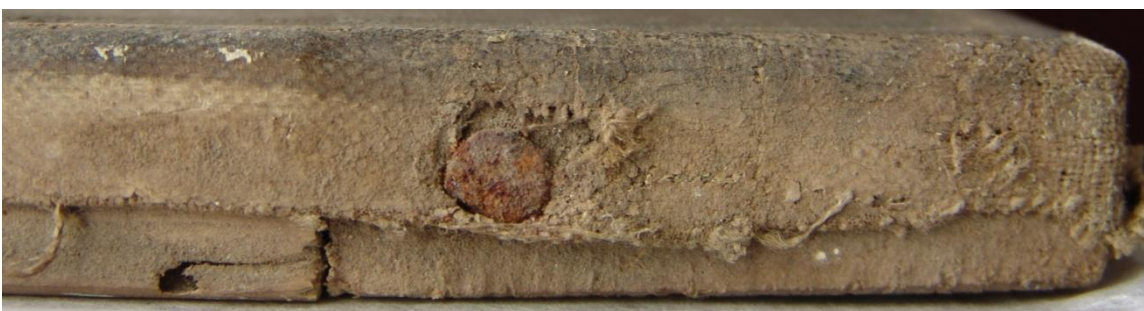
The canvas is attached to the stretcher bars with a total of 37 metal tacks and their distribution can be easily seen in the x-radiograph (Ap. IV, Fig.IV.3, p.67). The surfaces of all tack heads were flaking and powdering most likely due to corrosion, as evidenced by the orange and brown spots mixed with the original black colour found on the tacks (Ap. IV, Fig.IV.4, p.67), the usual corrosion products associated with iron-based artefacts. [9] Continuous exposure to high relative humidity (RH) levels facilitates corrosion which leads to the formation of an uneven surface on the tacks heads, thus allowing both water and oxygen to penetrate to the underlying metal surface, where further corrosion occurs. [9]

Fig.IV.4. Normal light photographic detail of rusted tack at the top of the right tacking margin of the painting.

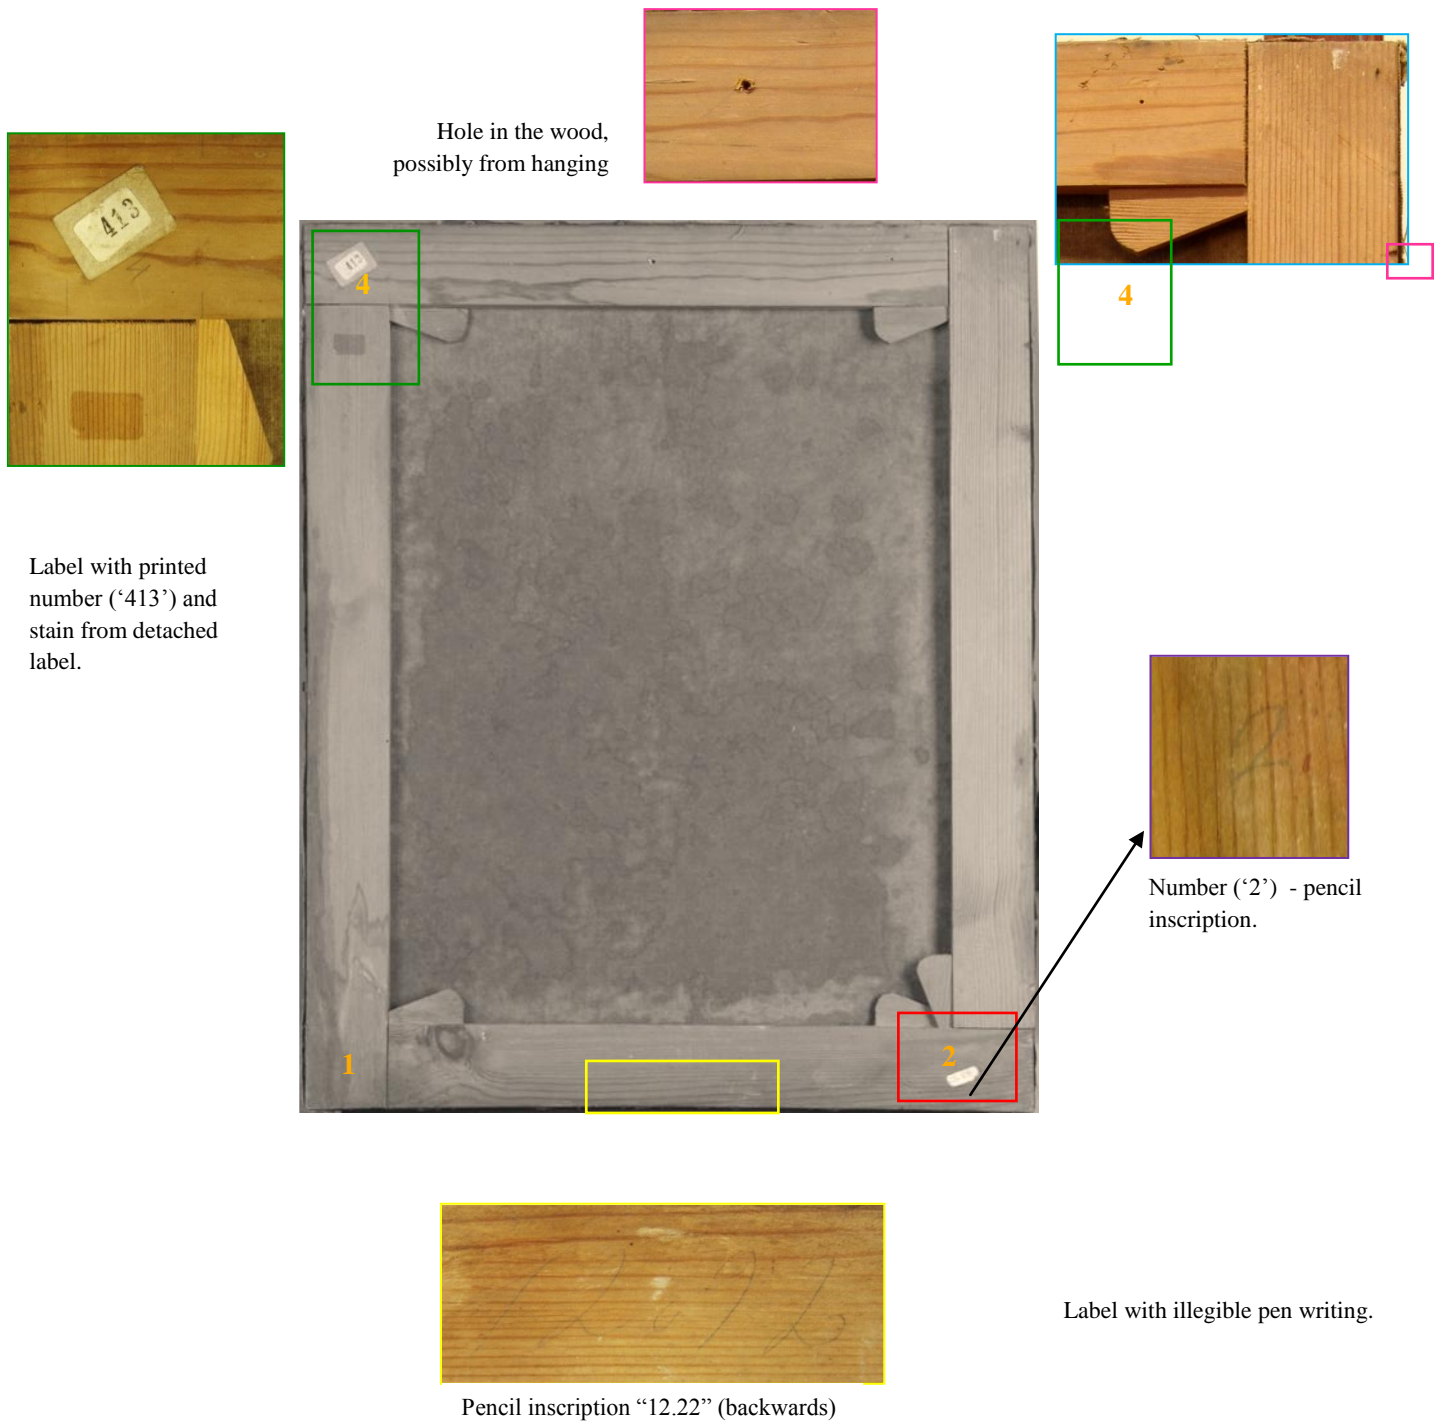
The left corner of the top stretcher bar has a paper label with the printed number "412" and below a dark squared shaped stain, most probably from a previous label now detached. There is another label with illegible pencil writing on the right corner of the bottom bar. Pencil inscriptions of numbers can be found near each corner joint (1 to 4), likely used to assemble the stretcher's bars, and on the bottom bar ("12.22"), probably the stretcher's price. A small hole on the centre of the top bar may have been caused by a nail used for hanging the picture (Ap. IV, Fig.IV.5, p.68).

Fig.IV.5. Modified normal light photograph of the back of the painting with mapping of details (coloured squares) that indicates from where each detail was photographed. Numbers in yellow indicate the local of the pencil inscriptions (numbers 1 to 4) possibly associated with the assemblage of the stretcher's bars.

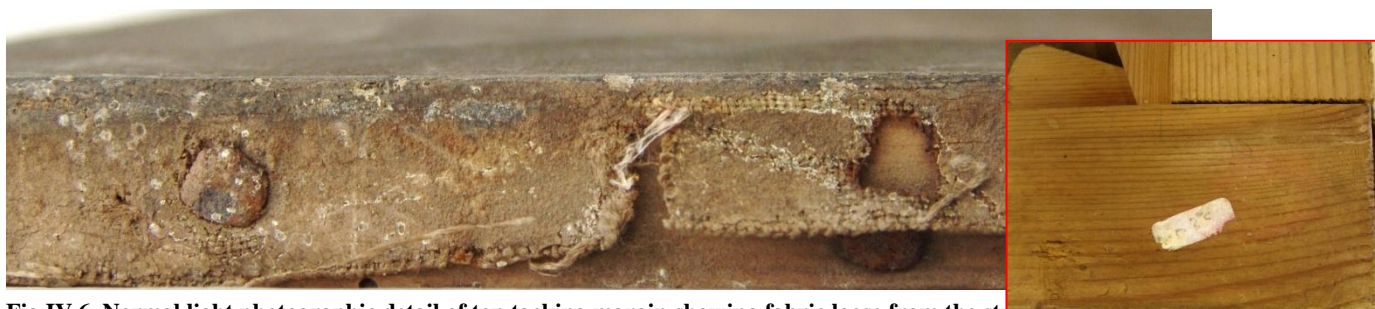
Concerning the fabric's condition, the major concern was that the canvas was not under uniform tension because it was not entirely attached to the stretcher. Four tack holes had become enlarged (likely due to fabric deterioration from rust associated with the tacks²) which released the tacking margin along the top edge (**Ap. IV, Fig.IV.6, p.68**), resulting in a sharp depression in the front of the painting accentuating the top stretcher-bar crease. Despite the oxidation of the fabric, careful observation under the stereoscopic-microscope indicated that, overall, the textile appeared strong and not brittle. Given that the fabric was slack on the stretcher, this resulted in a sharp depression in the front of the painting just below the top stretcher bar which accentuated the top stretcher-bar crease. By raking light observation, it is possible to see creases from all four stretcher's bars as well as cracking associated with the keys at the back of the fabric (**Ap. IV, Fig.IV.7, p.69**).

Fig.IV.6. Normal light photographic detail of top tacking margin showing fabric loose from the stretcher.

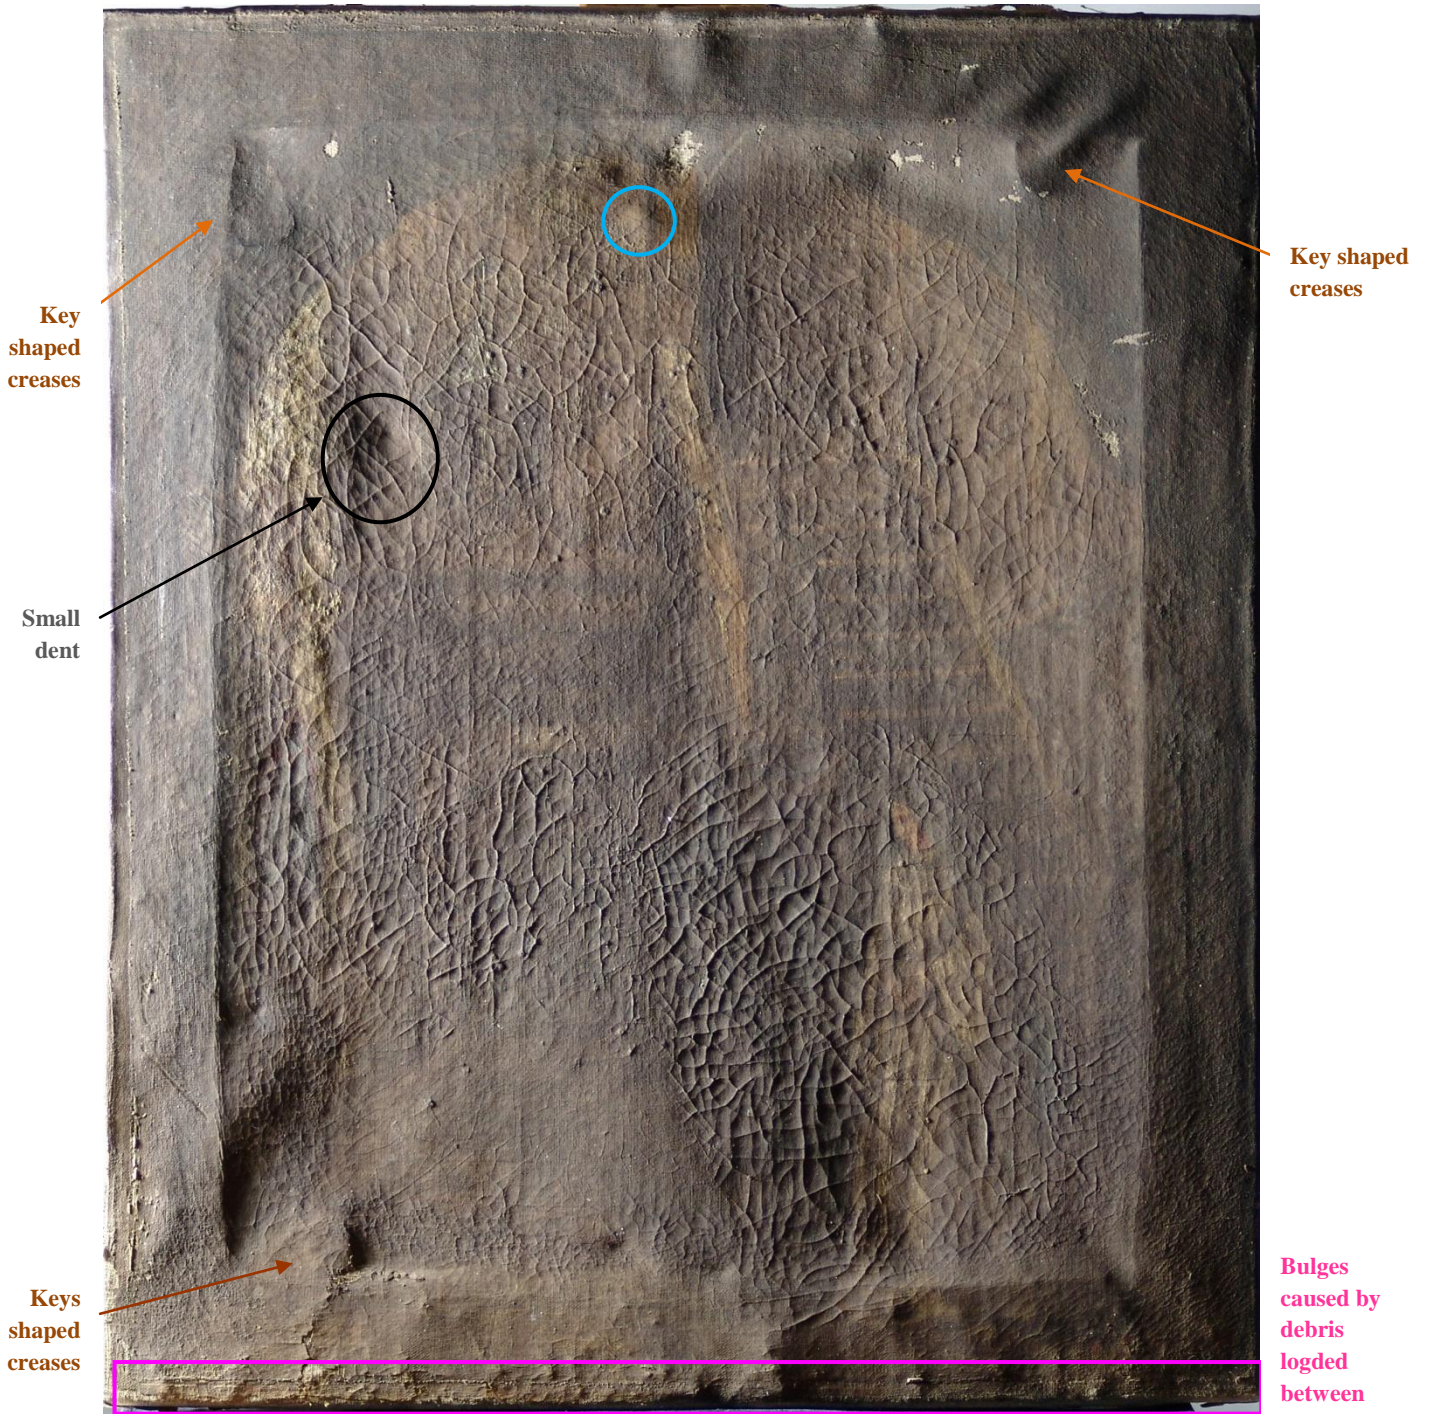
Fig.IV.7. Left raking light photograph of front of the painting showing all creases and sharp deformations of the fabric and the sharp crack pattern of the paint layers. Arrows, circles and square points to different types of deformation and causes.

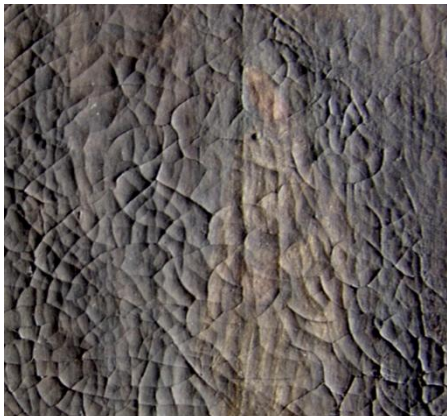
Fig.IV.8. Right raking light photographic detail of front of the painting showing crack pattern of the front of the painting around the figure of the nun.

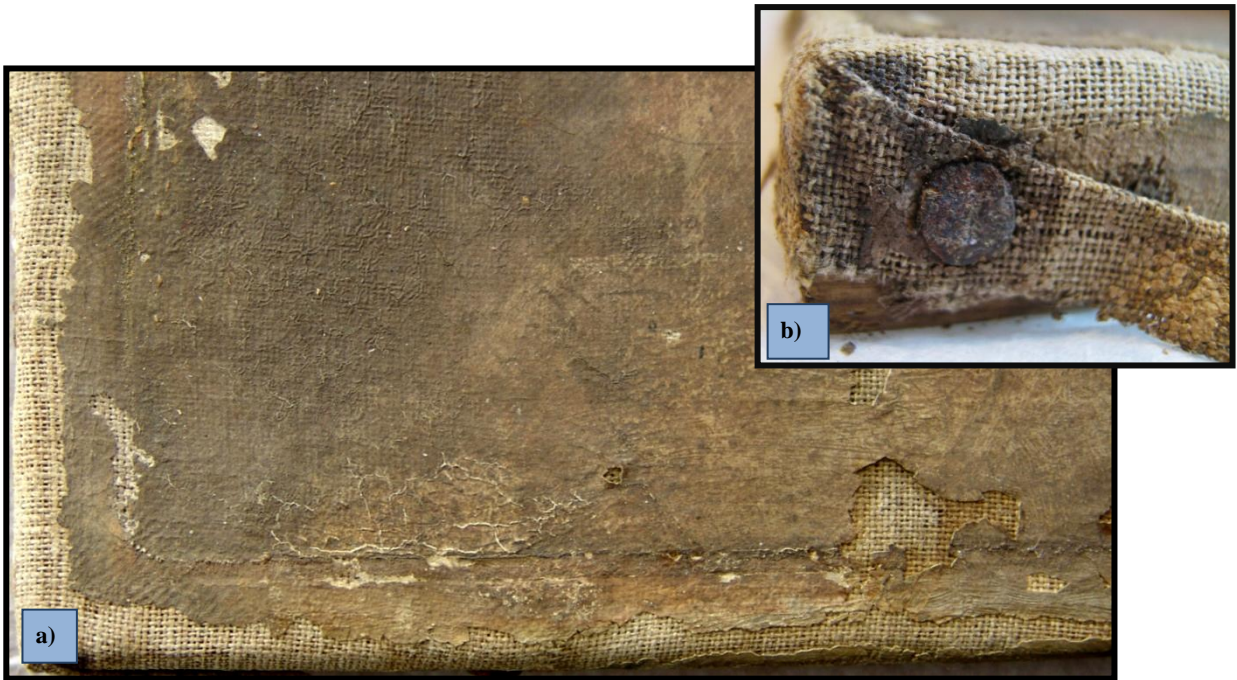
With regard to its condition, the four tacking margins had areas of (or in risk of) flaking ground, especially at the turn-over edge of the bottom left corner and along the bottom tacking margin. In these areas, a large section of both ground and paint loss showed sharply lifting edges with near detachment, a sign of poor adhesion to the support (**Ap. IV, Fig.IV.9.a, p.70**). The location of these severe damages along the bottom and turn-over edge of the painting can be related to the staining on the stretcher bars associated with water exposure. The presence of debris between canvas and stretcher offers a site for moisture retention and associated damages. It is possible to imagine a situation where the painting was hanging with its bottom stretcher bar touching a wet wall, leading to an excess of moisture being absorbed by the wood. This would in turn result in local swelling and shrinking of the fabric near the stretcher bar. During mechanical cleaning, pieces of plaster, likely fallen from the wall to the back of the canvas, were found lodged between the canvas and the bottom stretcher bar, thus explaining some of the deformations, losses and lifting ground/paint.

Fig.IV.9. a) Normal light photographic detail of corner in the front of the painting demonstrating area of paint losses, flaking paint and ground layers, especially evident in the turn-over edge. b) Normal light detail of the corner of the bottom tacking margin showing flaking ground and rusted tack.

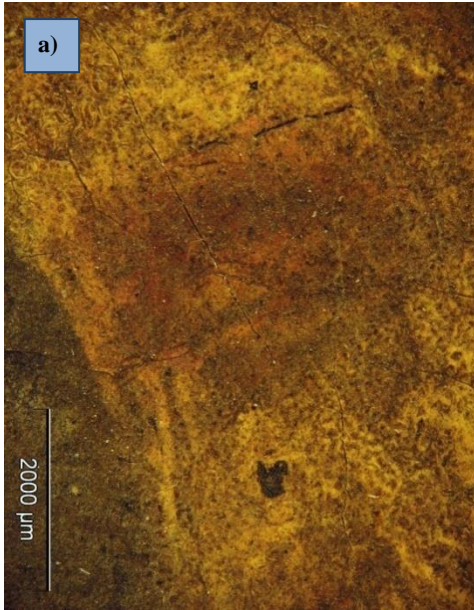
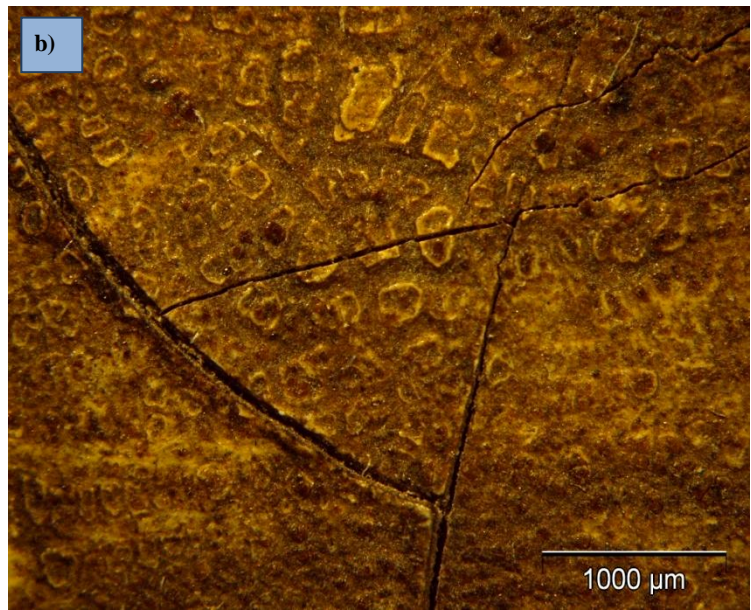
With stereo-microscope observation it was possible to conclude that the dirt was incrustated and could not be removed without mechanical action that could weaken the fabric. The canvas appeared darker in lines which followed the crack pattern of the paint layers; this can be associated with varnish penetrating the fabric through cracks, but it was not clear if that was the case.

Fig.IV.11. a) Photographic detail under stereo-microscope, 7x, showing incrustated dirt in the nun's face; b) Photographic detail under stereo-microscope, 63x, showing "micro-cissing".

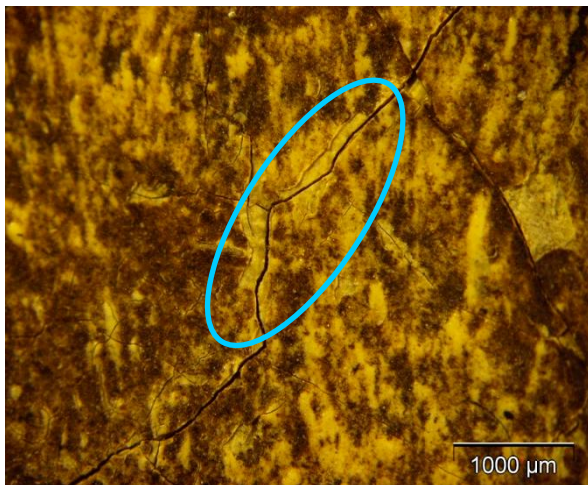
Fig.IV.12. Photographic detail under stereo-microscope, 25x, showing interlaminar cleavage in the white paint of nun's habit.

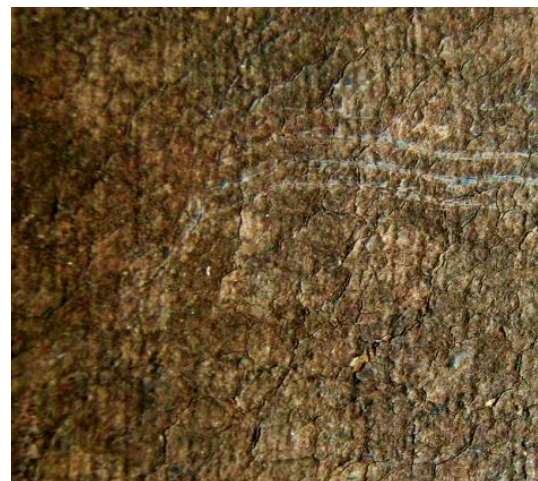
Fig.IV.13. Normal light photographic detail of stretcher bar crack pattern.

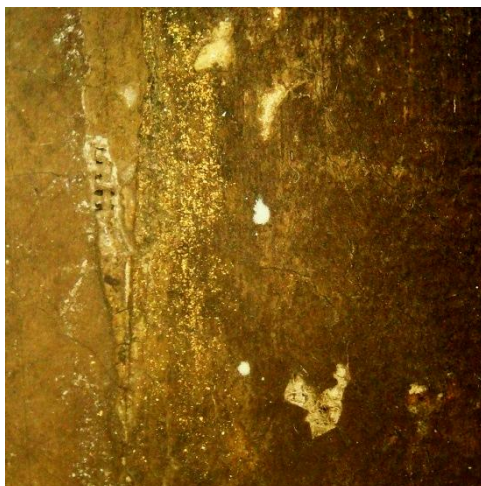
Fig.IV.14. Normal light photographic detail showing traces of gold paint, probably from a past frame, and lumps of plaster stuck to the paint.
