***Reconstitution of the failure of the Fonte Santa mine tailings dam.
Modelling of the dam breaching process.***

Dissertação apresentada na Faculdade de Ciências e Tecnologia da
Universidade Nova de Lisboa para obtenção do grau de Mestre em
Engenharia Civil Perfil de Estruturas e Geotecnia.

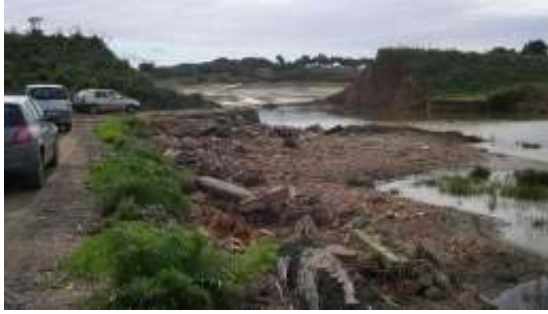
Figure 1. Breach of Herdade da Misericórdia dam (2006).

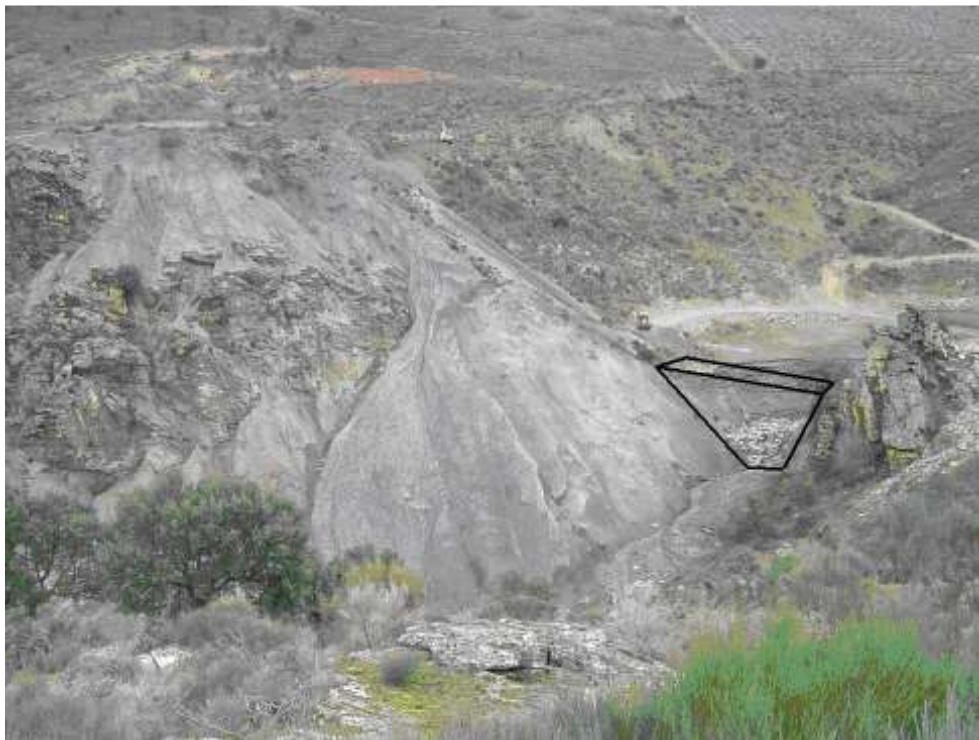
Figure 8. View from downstream of the dam. A scar in the reservoir bottom is visible.

The dam is located in a section of the valley where a rock formation exists (Figure 8). There is no knowledge of a dam project; apparently the dam material was placed to contain the sludge without any specific criteria. An embankment road was built along the downstream valley providing access to dam toe and in the field visit it was possible to see its remains on the first 400 m of the valley. This road allowed local contractors to access the dam gravel and to explore the embankment material illegally (fine gravel used as a construction material), excavating

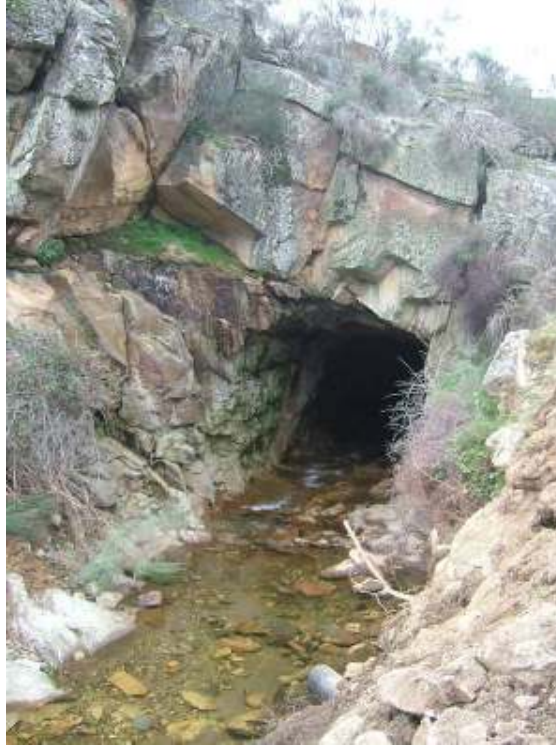
directly from the downstream dam toe. A spillway excavated in the rock exists in a valley adjacent to the reservoir (Figure 9) with a roughly circular section of 2 m diameter (FRANCA *et al.*, 2007).

Figure 9. Upstream section of the spillway.

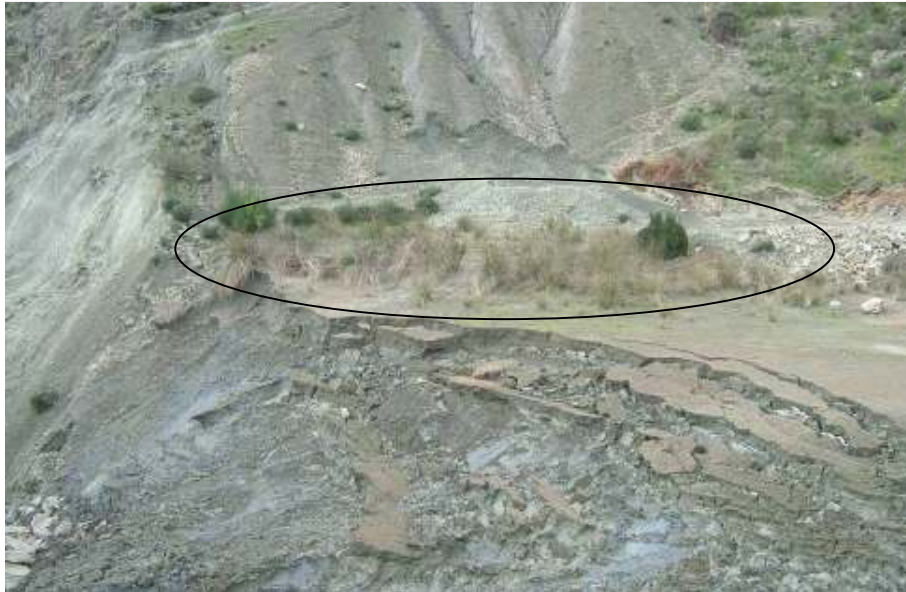
Probably in the summer the water level was low and the mud was visible. The explanation to this observation is based on the photos taken in 2007. In the winter season, the normal water level was at 504.4 m asl or above this. The difference between normal operating level and mud level of 3.4 m was inferred from the photos collected during survey. Figure 12 corroborates such analysis, showing that the bushes in the dam body grew eventually in the summer and had been under water in the winter season (deduction by the dry bushes).

Figure 12. The remains of the dam slope and the wedge mud (at elevation 501 m asl). Dry bushes due to submersion in the winter season indicated with the black line.

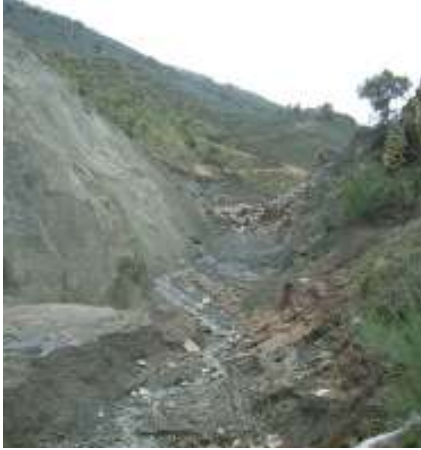
Figure 15. Dam breach, view from downstream. The rock formation from the riverbed is visible.

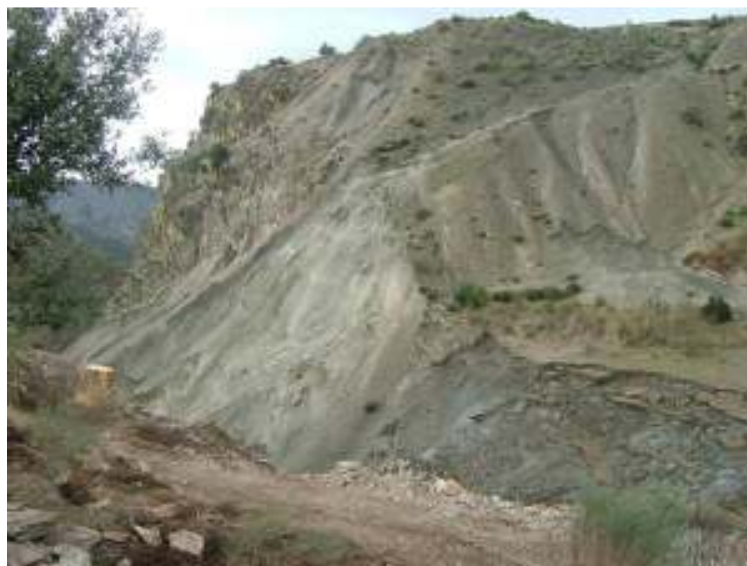
The eroded amount of sludge from the upstream deposits in the reservoir is evidenced by a scar in the reservoir bottom (cf. Figure 8, Figure 12, Figure 15 and Figure 18)

Figure 18. Dam breach, view from upstream. The wedge of mud is visible.

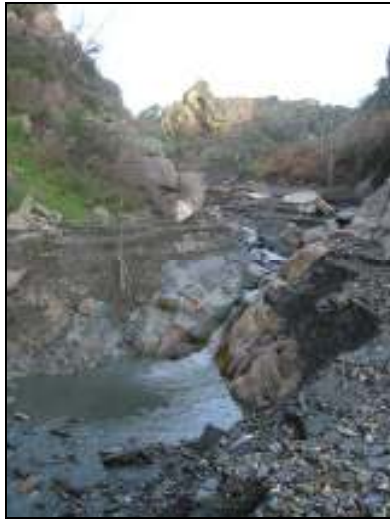
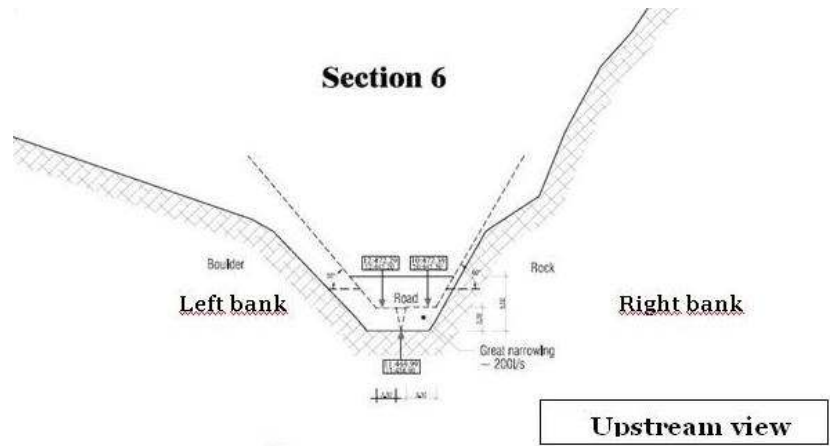
For each section a schematic drawing was made (Annex IV). Figure 19 shows one of these, sections; corresponding to section 6. This section is near the dam containing the road to access to the dam toe previously mentioned and that was eroded.

Figure 19. Cross-section 6, example of the detailed survey (cf. Annex IV).

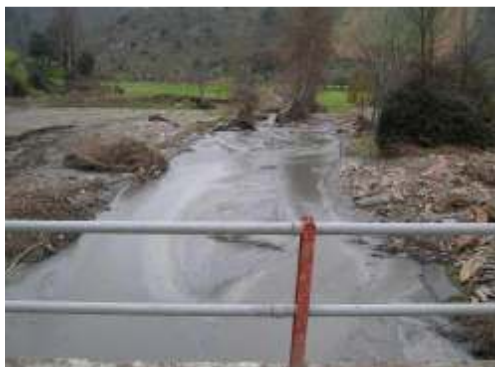
It is important to refer that about 2000 m downstream the dam there is a bridge, where a reduction of the channel width exists (Figure 21 and Figure 22). This constitutes a control section and during the flood a reservoir was created upstream.

Figure 21. View from the bridge to downstream (Section 29).

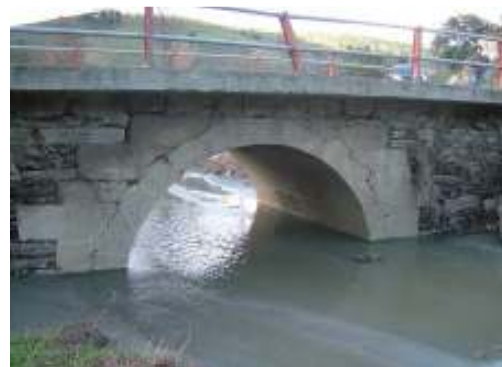
Figure 22. View from the bridge from upstream (Section 29).

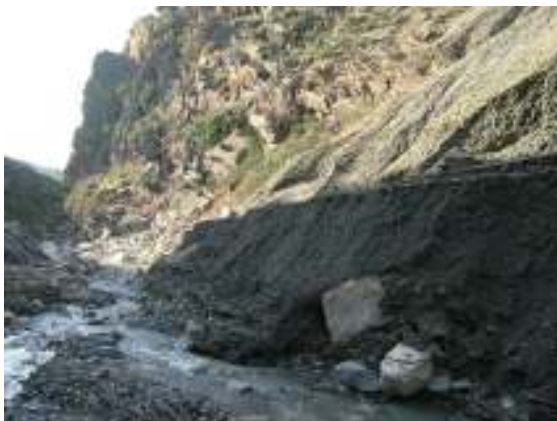
Figure 26. Section with high erosion.

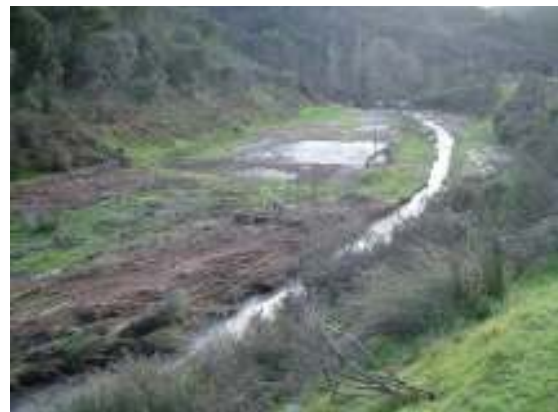
Figure 27. Section with high deposition.

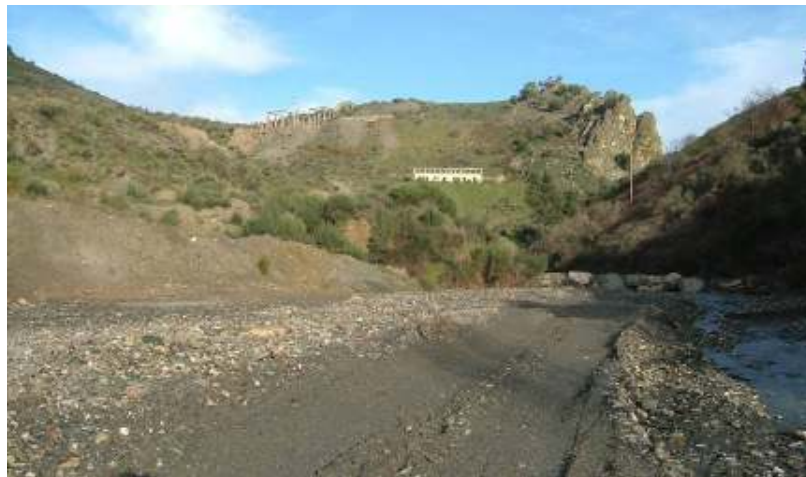
Downstream the dam it is possible to see that the fraction of deposition is nearly the double of the erosion, this last one is concentrated near the dam section, where the valley was filled with the illicit road referred previously. Downstream, mainly deposition of the dam material is verified due to the immense volume of fine gravel that composed the informal dam body (Figure 28). It was verified locally that some part of the deposited material throughout the valley is originated from the same material of the dam body.

Figure 28. Example of a local where large deposition occurred (roughly at section 10').
