Treatment of a nineteenth century male portrait in oil including the characterisation of materials, technique and a study of the lead soap aggregation in the paint composite

This project involved the conservation of a 19th century portrait in oils from the Ecomuseu do Seixal (Portugal). The painting of “*João Luiz Lourenço*” was in very poor condition. Because of the range and severity of the problems presented, it offered an opportunity to explore important aspects of painting conservation in-depth. The approach to its treatment required an empirical investigation of a number of materials and techniques used in the field of conservation/restoration. Of additional interest, the painting exhibits widespread evidence of metal soap (lead carboxylate) aggregates protruding through the paint from the ground layer. The painting’s materials and the metal soaps aggregates were studied and characterised with different analytical techniques: μ -EDXRF (*Energy Dispersive X-ray Fluorescence*), μ -Raman Spectroscopy, μ -FTIR (*Fourier Transform Infrared Spectroscopy*) and SEM-EDX (*Electron Scanning Microscopy with Energy Dispersive X-ray Spectroscopy*).

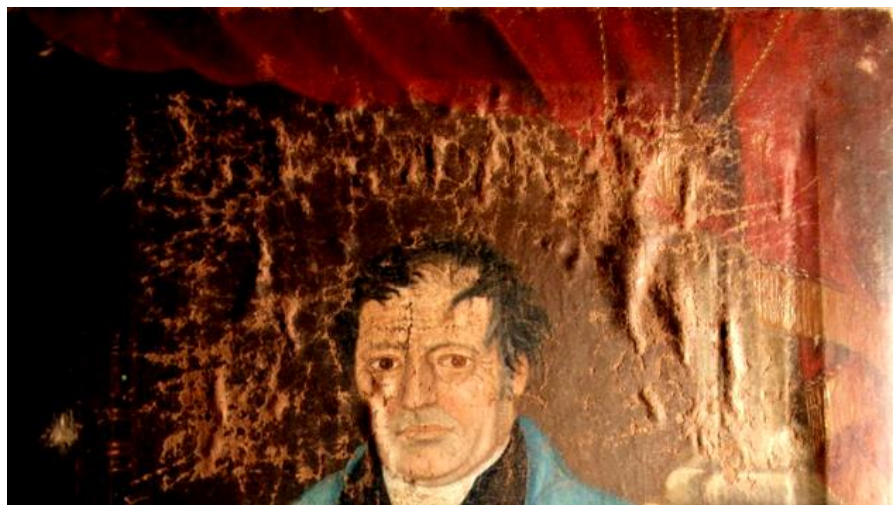
The major problem presented by this painting, which contributing to an unstable state, is the series of significant, overall out of plane distortions (Fig.2). The extreme deformations in *João Luiz Lourenço* are related to the different response to moisture/water of the different materials in the painting. Sized canvas reacts characteristically to RH changes: when the RH is high, the sized threads expand and the fabric contracts and becomes stiff [6]. In contrast, the animal glue present in lining adhesive swells, loses strength and

Figure 2: Before treatment, detail, raking light showing deformation on the original support associated with paint losses.

adhesive properties in very humid conditions [9]. Therefore, these deformations appear to result from the lack of adhesion between the painting and the lining support, due to the loss of strength of the lining adhesive.

The brittle aged paint/ground composite was unable to conform to the extreme distortions in the fabric. As well, its adhesion to the original canvas at the size layer compromised by high levels of moisture, thus the paint/ground separated and was lost. Further details in appendix III.2.

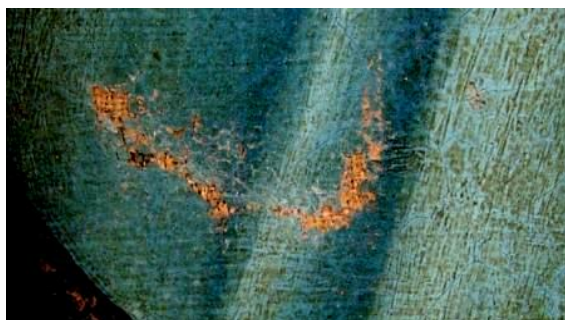
The major problem associated with the paint layer is overall losses (appendix IV). The small tear is also associated with paint losses and flaking (Fig. 6). There was some significant flaking at the interface of the paint/ground and the canvas, in the location of distortions, which appeared to be more recent. These areas presented a high risk of further losses to the pictorial layer (Fig. 7). There are also paint losses and abrasions due to mechanical damages as well as signs of surface abrasion (appendix I and IV).

Figure 6: Before treatment detail of the tear located on blue jacket of the figure.

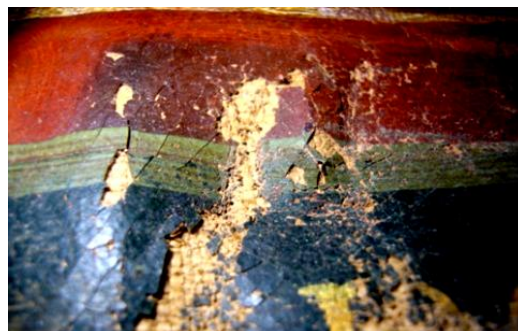
Figure 7: Before treatment detail photograph of flaking at the interface of the paint/ground and the canvas.

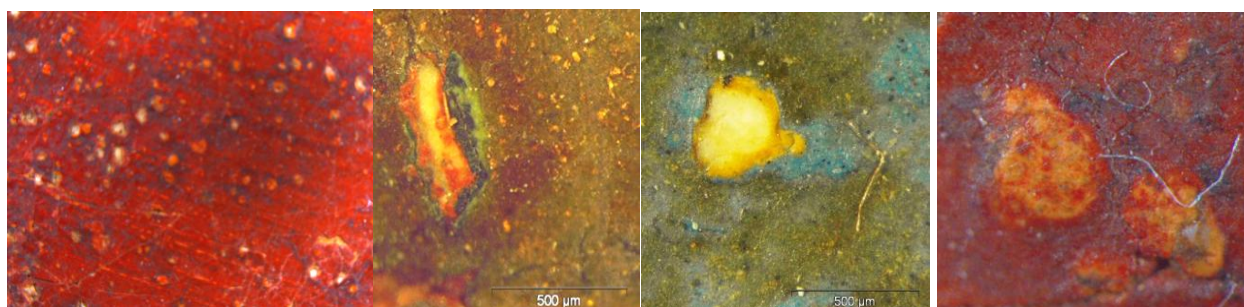
The painting exhibits widespread evidence of small white spots protruding through the paint layer, with associated round shaped paint losses. There is no obvious relation to coloured areas. These protrusions disturb the surface of the painting and create a textured effect (like paint plus sand), as it can be seen in the following images (Fig.9). The visual characteristics of the protrusions and losses observed on this painting correspond to characteristics attributed to metal soap aggregates in various publications [15, 23,25-28]. This is identified as an oil paint defect, and they can affect the stability of the paint layers [23,32].

Figure 9: Before treatment details. The appearance of Lead soap aggregates at the paint surface.

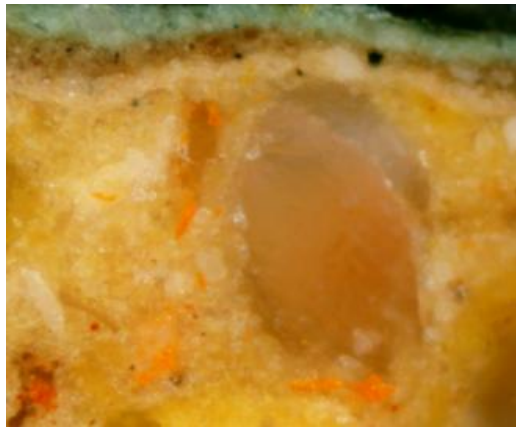
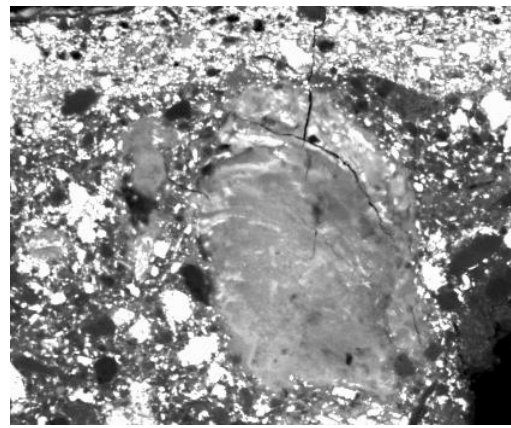
Figure 22: OM image: 200x mag. Polarized Light (right) and BSE image of the sample X10

The transparent aggregate does not have an evident well-defined structure like the others aggregates (Fig. 22). According to Boon et al., saponified areas appear darker in the backscatter image than intact leads white due to their higher organic content and minor mineral fraction [31]. Therefore, it can be concluded that the grey amorphous area visible on the BSE image (Fig.22) is a lead soap with a lower lead carbonate content. This information is in accordance with the μ -Raman analysis of this sample, where only peaks associated with lead and none for carbonate were detected (Fig.18).

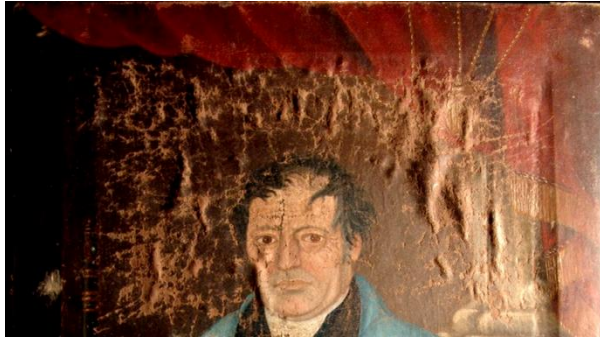
Figure 40: Before treatment, detail, raking light showing deformation.

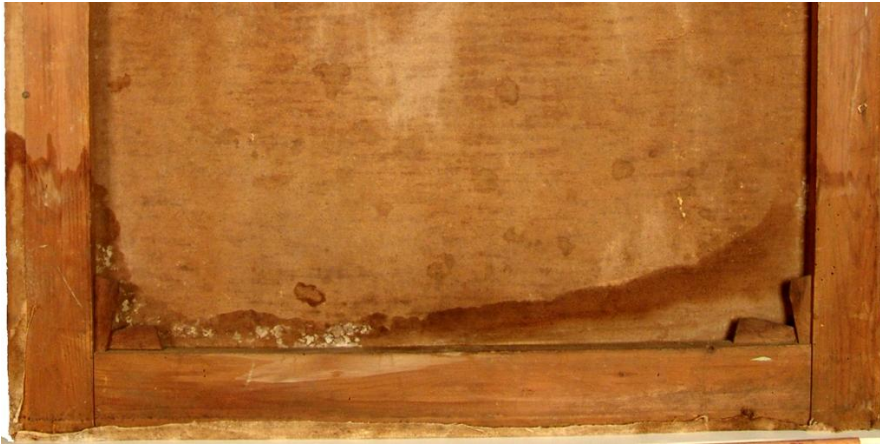
Figure 1: Signs that the painting had been in direct contact with water: dark tide line and significant spotting with dark and light areas likely due to the existence of fungi.

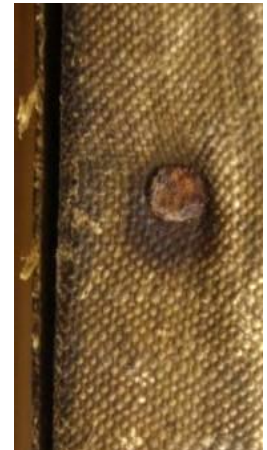
Figure 3: The tacks were in poor condition (rusted). The tacking margins of the lining fabric were deteriorated (brittle), extremely dirty, with poor attachment, in part due to the condition of the tacks.

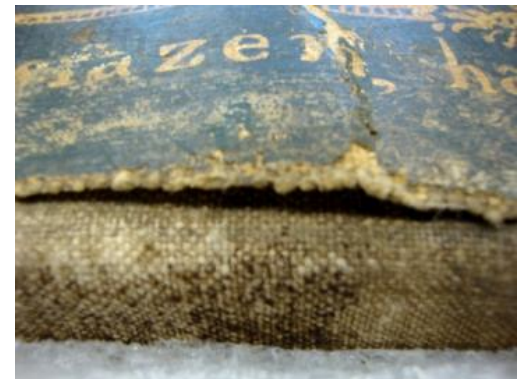
Figure 5: The adhesion between the lining and original canvas was very poor.

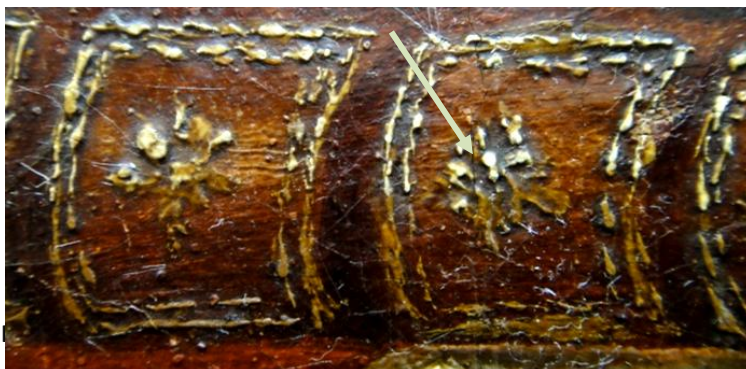
Figure 6: Flattening and loss of texture thought to be associated with the lining can be seen in the impasto.

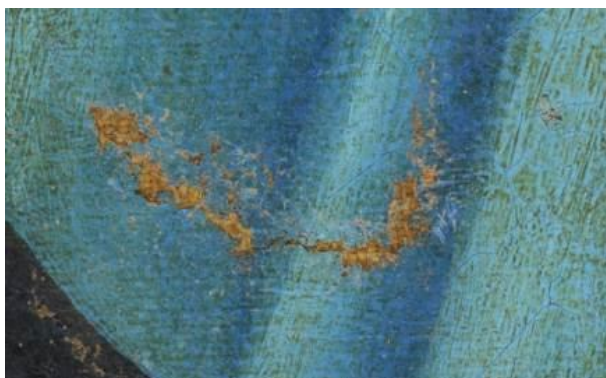
The lining canvas generally appeared to be strong, but a small tear (4cm long) is clearly evident (Fig.2, appendix II.5). This was presumably caused by a blow to the front of the painting, which tore both the original and the lining canvas. On the back, the lining canvas exhibited significant spotting with dark and light areas likely due to the existence of fungi (Figure 1&2, appendix II.1). The fixtures were tacks in a poor condition (rusted) (Fig.3, appendix II.1). There was evidence of 63 metal tacks being present originally, but some were missing. This resulted in a lack of tension in the painting. The tacking margins of the lining fabric were deteriorated (brittle), extremely dirty, with poor attachment to the stretcher, in part due to the condition of the tacks.

Figure 9: The tear (4cm) on the original support with loss of paint associated.

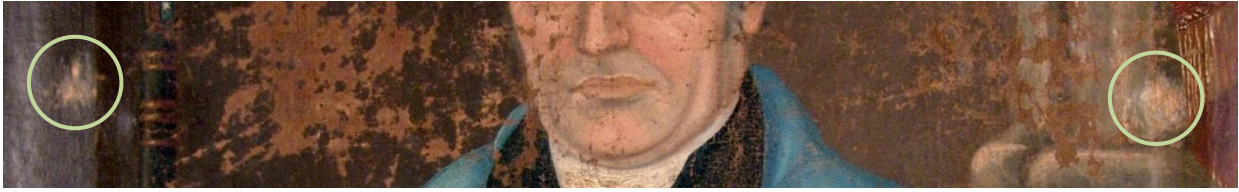
Figure 11: Damages (green circles) thought to be associated with projecting hanging hardware from another painting

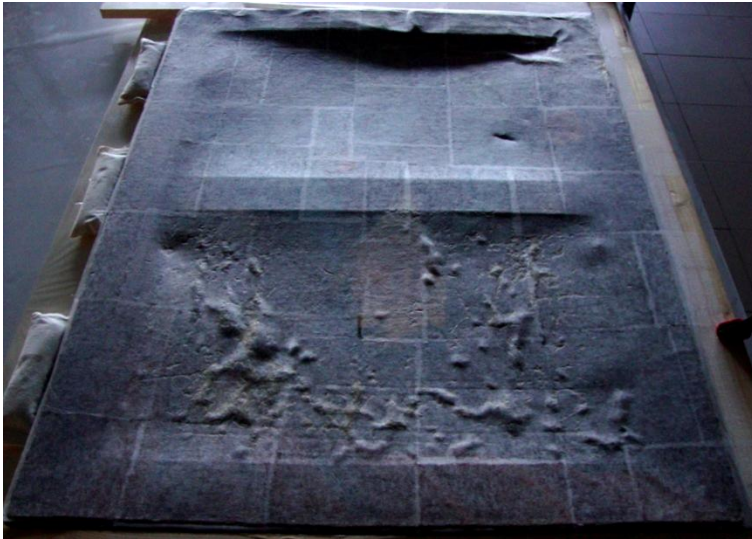
Figure 12: During treatment: After facing, raking light, demonstrating the severe distortions in the top half of the painting, and the major depression at the bottom edge (top of this image).

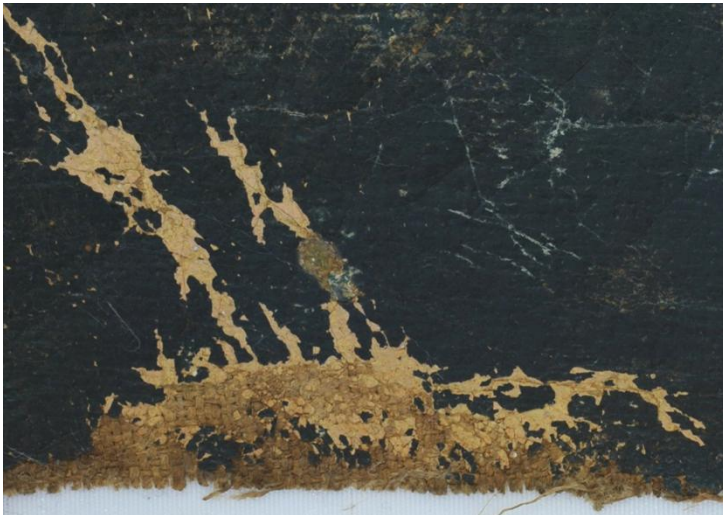
Figure 13: Loss of the paint layer on the bottom of the painting where it is possible to observe the ground layer.

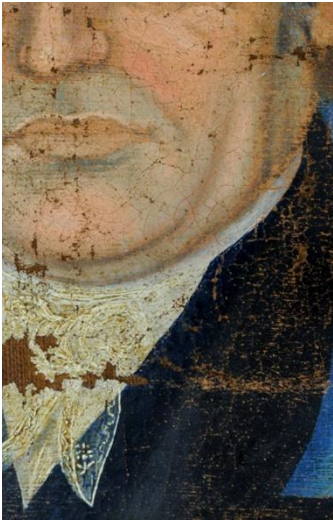
Figure 14: Abrasions on the paint surface due to mechanical damages and probably also due to over-cleaning.

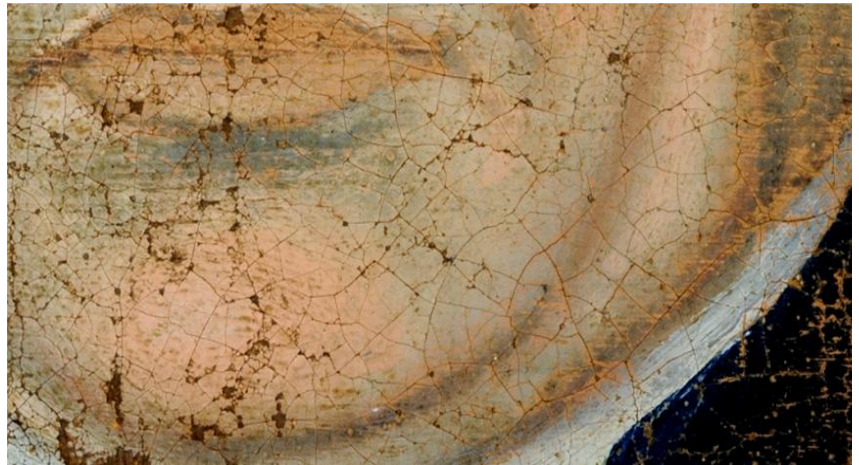
In unaffected areas, the paint cohesion appears to be good with a good layer adhesion, despite the overall mechanical cracking (associated with normal aging of an oil painting) (Figs. 14 and 15, appendix II.5).

Figure 15: Mechanical cracking in the paint.

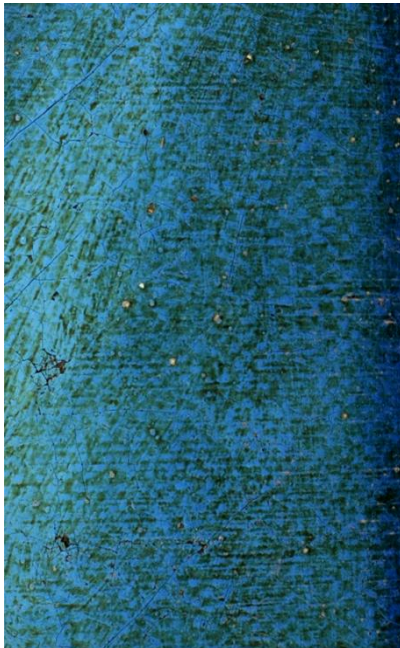
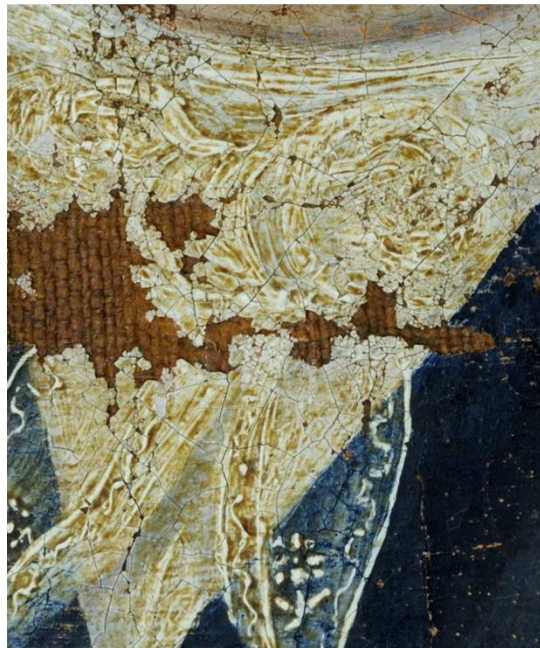
There was visual evidence of a discoloured varnish. In normal light, varnish residue is most evident on the blue coat and the white scarf (Figs. 16 and 17, appendix II.6). It's overall appearance is patchy with a low-level satin lustre. In some places (Fig. 18, appendix II.6) there is significant blanching (associated with previous water damage). The varnish which remains is significantly yellowed and degraded.

Figures 16 and 17: Areas where it is possible to see varnish residues, significantly yellowed and degraded.

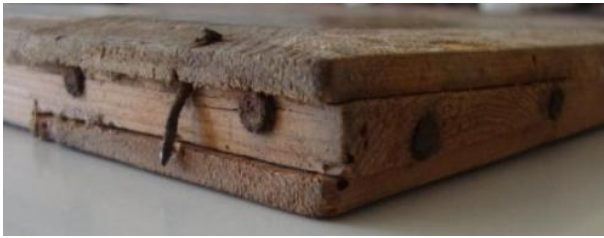
Figure 19: Corner detail: simple mortise & tenon with square corners. Protruding nail is evident.

To replace the current warped stretcher with a newly constructed stretcher

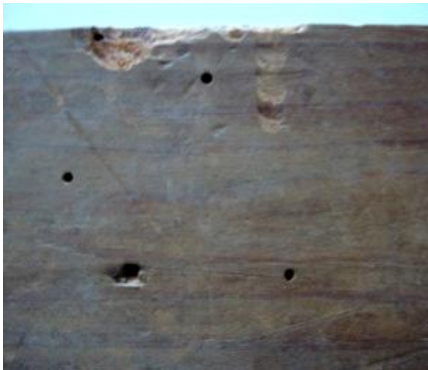
Figure 20: Exit holes from wood boring insects: small circular holes distributed randomly.
