Troia Roman Baths (Portugal) – Assessment of history of interventions

SUMMARY: *This paper presents a study of one of the roman architectonic complexes from Troia archaeological site: the Roman Baths. The first archaeological excavations campaigns and the different Roman monuments that constitute the whole site are presented, as well as the historical past conservation and restoration interventions and the most important decay factors. The Roman Baths are one example of a complex that has been intervened in, at least, two different periods of time. An assessment was made in order to understand and document its actual state of conservation, to help planning a future coherent conservation operation.*

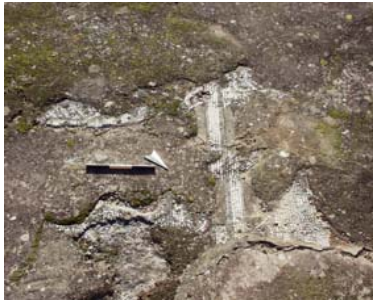
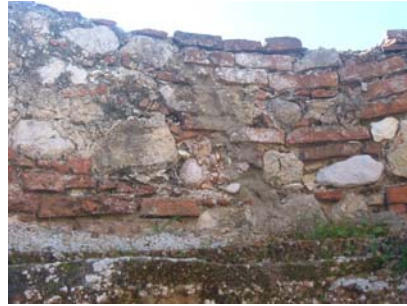
Various Roman interventions can be identified, with very similar approaches and objectives. Floor covering reformulations was carried through a late Roman period [2], eventually for guarantee its constant use. Some different materials (mortars) were applied over the ancient ones. It happened in the interior of the circular swimming pools (*caldarium* and *frigidarium*) where ruptures and waterproof problems probably existed. The solution adopted constituted in the application of thick layers of a coarse hydraulic mortar based on hydrated lime, with brick powder and fragments as a major component (*opus signinum*). Other example of a Roman repair can be observed in the *frigidarium* floor. The floor was primitively covered by an *opus tessellatum* pavement and due to its use or other occurrence, it was subjected to intervention. Two different types of repair can be registered: one similar to the former, where 80% of the floor had been overlapped by a fine grained *opus signinum* plaster and other where some missing parts of the mosaic pavement were mended by a coarse grained mortar.

Figs. 8 and 9 – Two examples of Roman ancient interventions.

After a first analysis, based only in an accurate visual observation, it is possible to say that all the carried interventions during Roman times present a adequate behavior since there is still a good adhesion between the repair mortar and the original substrate. No signs of fissuring were observed. In an aesthetical point of view, these repairs did not respect the original structure and its authenticity, occulting them and devaluating it. The systematic use of a hydraulic mortar could be eventually connected with durability and functionality aspects.
