Analysis and Treatment of a Nineteenth Century Portrait, Study of Artsorb® and a Proposal for a Microclimate Frame

Dissertação para obtenção do Grau de Mestre em
Conservação e Restauro, especialização em pintura

PART 1: ANALYSIS AND TREATMENT OF THE PORTRAIT OF DOMINGOS AFFONSO	1
1. INTRODUCTION	1
1.1. Description of the Image	1
1.2. Historical Context	1
2. EXAMINATION: CONDITION, MATERIALS AND TECHNIQUE	3

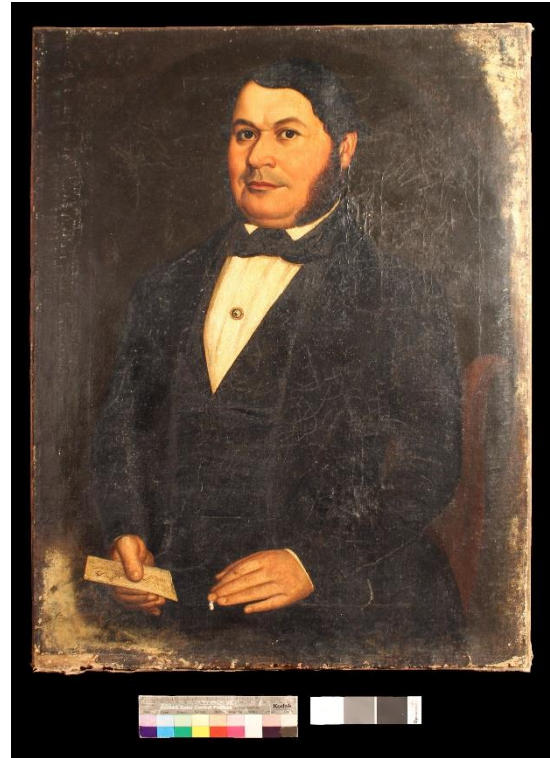
Figure 1 - Portrait of *Domingos Affonso*. Before treatment under normal light.

The painting portraying *Domingos Affonso* exhibited both structural and aesthetic problems primarily due to water exposure (evident in tide line staining in the original and lining fabrics). The painting was lined in the past and one of the most prominent structural problems was the detachment between the original canvas and the lining canvas. The lining fabric showed evidence of being weak in the form of tears and deterioration at the tacking margins and was therefore not providing adequate support for the painting. Some of the deterioration appeared to have been caused by mould in areas where tide lines showed evidence of the extent of water damage. The original canvas also exhibited tears in the bottom part as well as a small missing strip of original canvas. With regard to the paint composite, the most significant problem was the areas with tenting and cupping associated with active flaking occurring at the interface of paint/ground and ground/canvas. In addition the varnish was very yellow, largely obscuring the image, and had severely blanched at the edges of the image apparently due to water damage. Apart from the dirt and dust present on the painting's surface, there was also extensive mould growth both on the front and back of the painting.

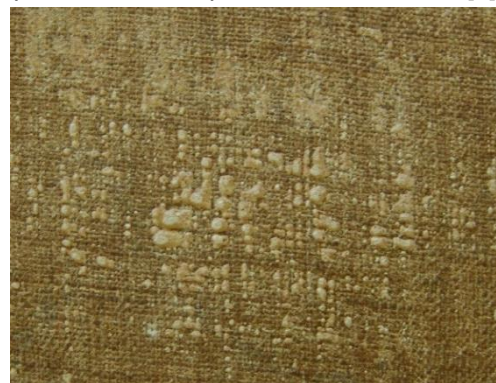
Figure 3 - Ground sticking out at the back of the original canvas (photography taken after the removal of the old lining canvas).

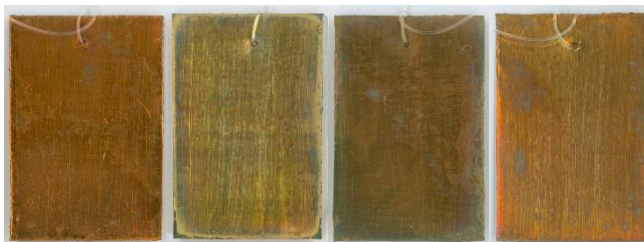
At the end of the first Oddy test (Test 1) it was seen that the coupons had corroded by different mechanisms: while the control corroded by a wet process, the other coupons corroded by a dry process. It was then proposed that the buffers may have extracted the water from the environment since the Artsorb® was pre-conditioned at 50% RH and the silica gel was dry. All the coupons enclosed with the buffers exhibited a green or yellow colour contrasting with the copper coupon from the control which had an orange colour. Although visual comparison between the control and the other coupons from the first Oddy Test was difficult, it was possible to observe a higher degree of corrosion in the ones exposed to the orange silica gel and Artsorb® (Figure 12). The copper coupons were the easiest to evaluate visually. The silver and lead coupons did not show significant evidence of corrosion (only a few localized corroded areas were seen in the silver) (see Table VII.1 Appendix VII.3).

Figure 12 - Copper coupons from the left to right: control, orange silica gel, Artsorb®, Artsorb® with Tyvek® cover.

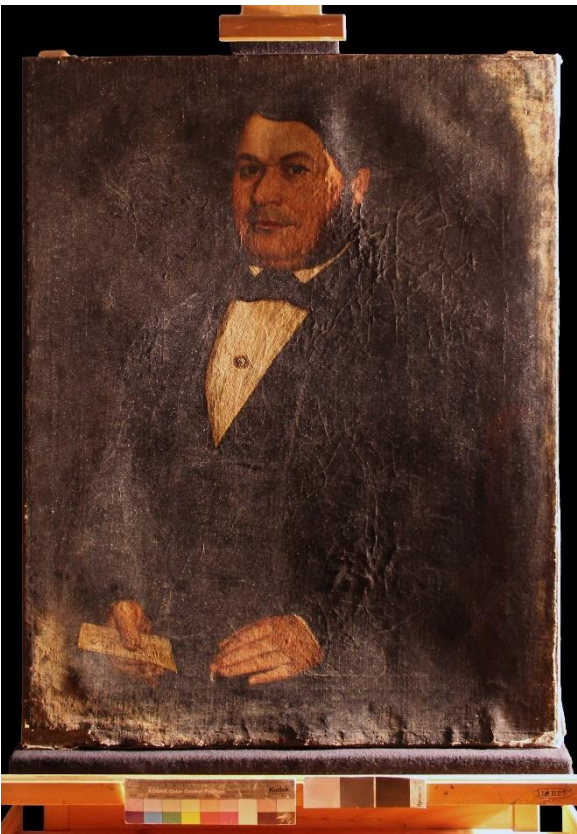
Figure I.3 – Raking light from the right side, front, showing painting and canvas deformations.

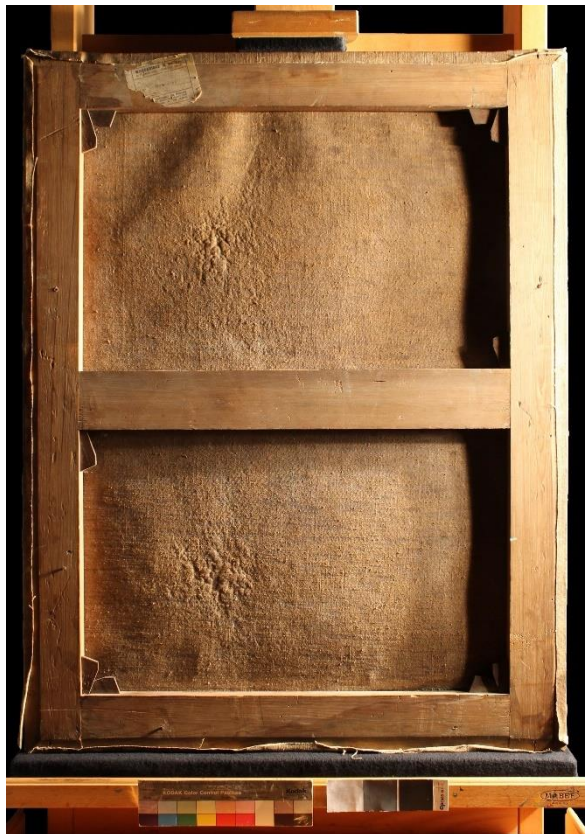
Figure I.4 – Raking light from the right side, back, showing canvas deformations.

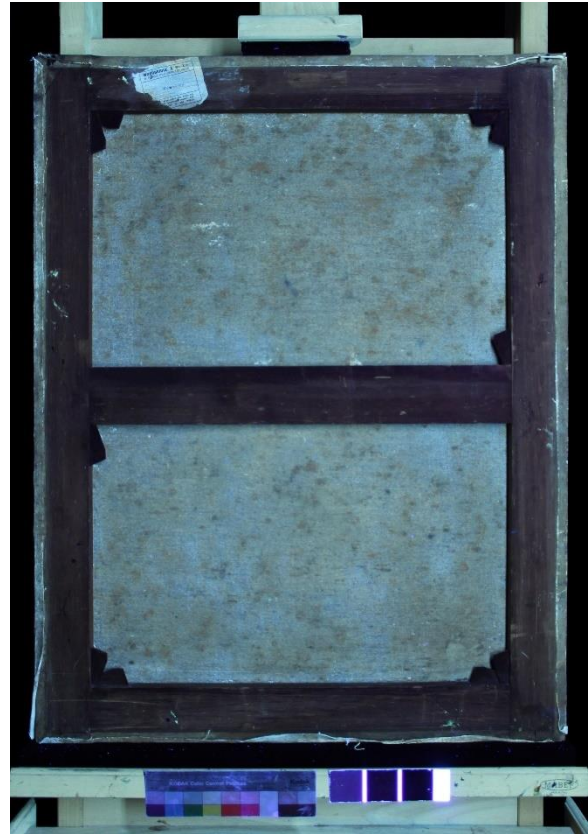
Figure I.6 – Ultraviolet light, back, showing canvas staining.

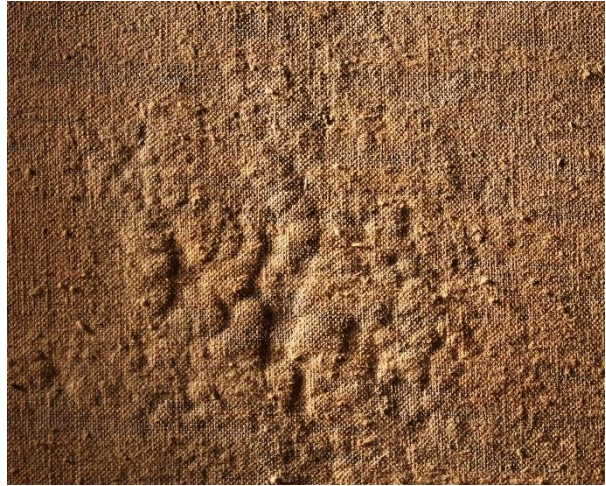
Figure II.2 – Distortions on the canvas, visible from the back of the painting, corresponding to the area of tenting and cupping paint at the front.

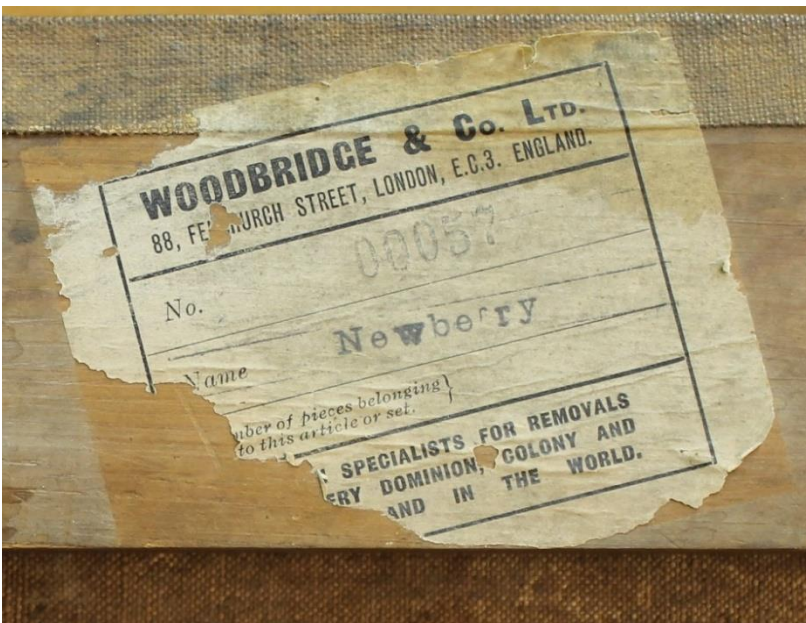
Figure II.5 – Label of the British transport company placed on the painting's stretcher.

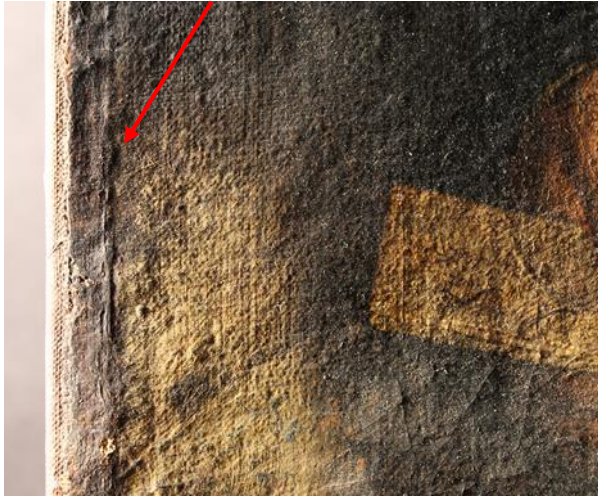
Figure II.6 – Arrow indicates distortions at the turnover edge of the original left tacking margin.

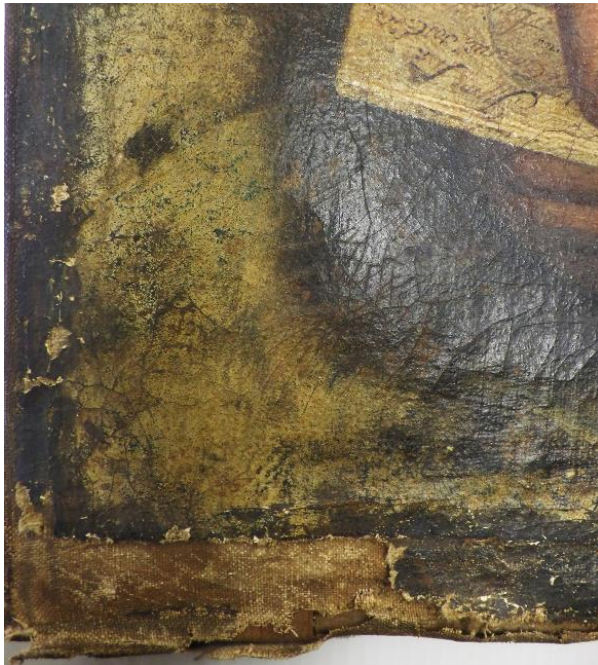
Figure II.8 – Blanched varnish and missing original canvas. The lining canvas is visible underneath.

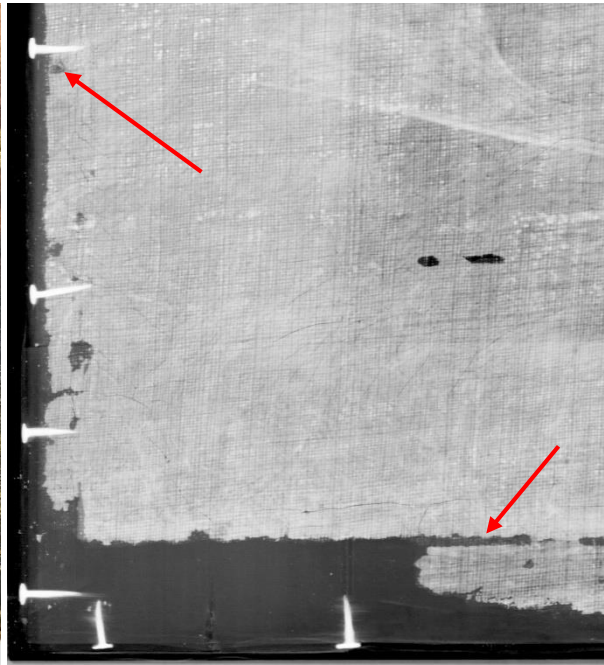
Figure II.9 – X-radiography detail. Original tacking margins at the left and bottom of the painting. The left arrow indicates a tack hole and the right arrow indicates the infilled turnover edge.

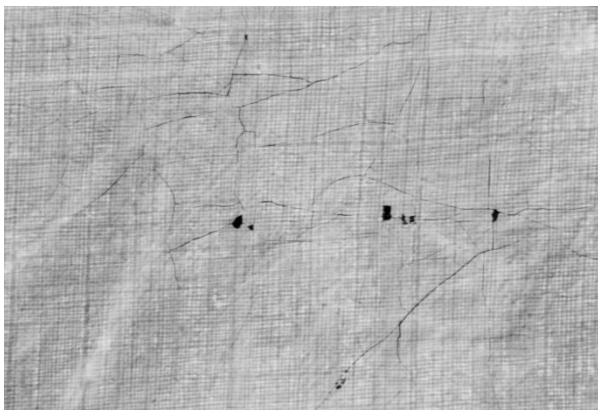
Figure II.10 – X-radiography detail where cracks in the ground are evident.

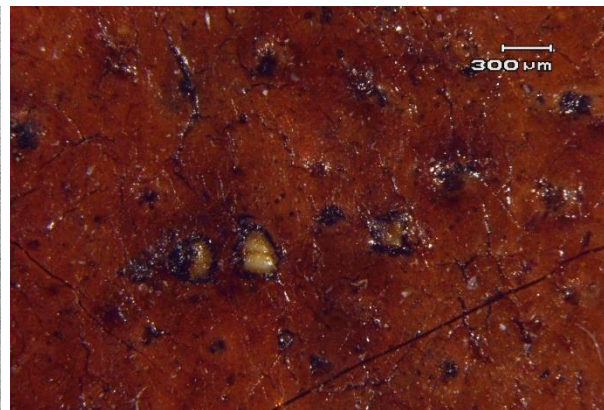
Figure II.11 – Stereomicroscopic image of protrusions in the flesh paint from the finger (see Figure II.17).

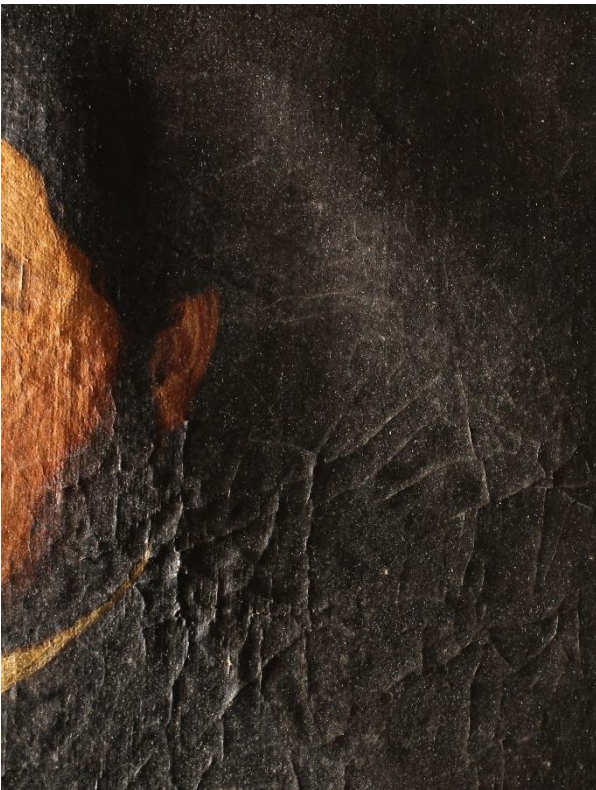
Figure II.15 – Tenting and cupping paint at the top, near the figure's head.

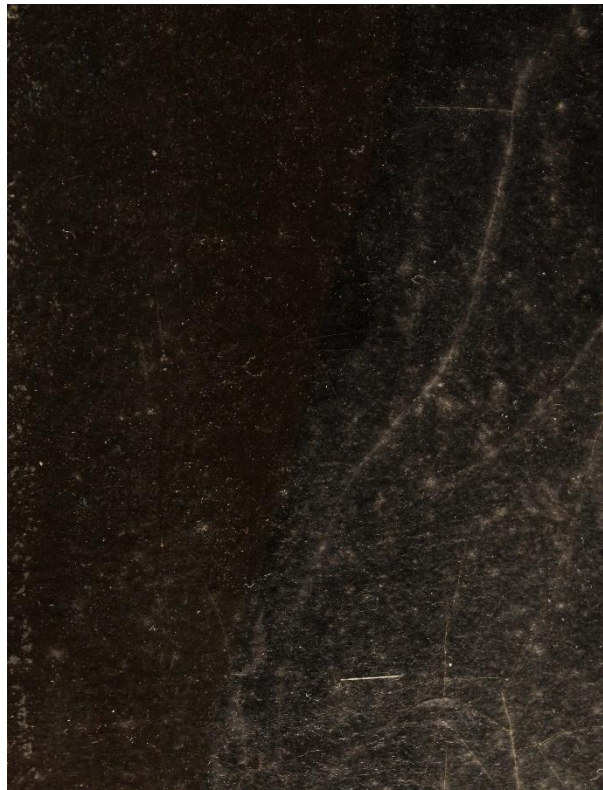
Figure II.16 – White spots, thought to be mould, in the black paint.

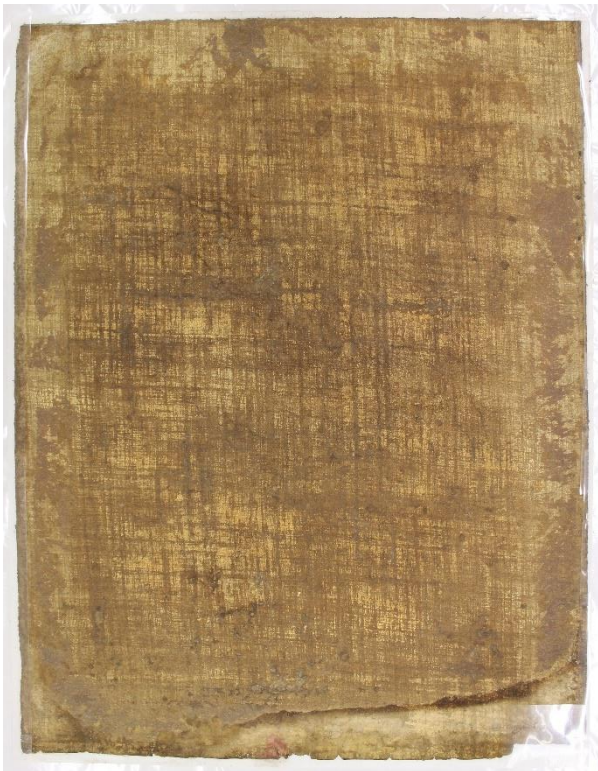
Figure V.18 – Back of the original canvas before the lining adhesive removal.

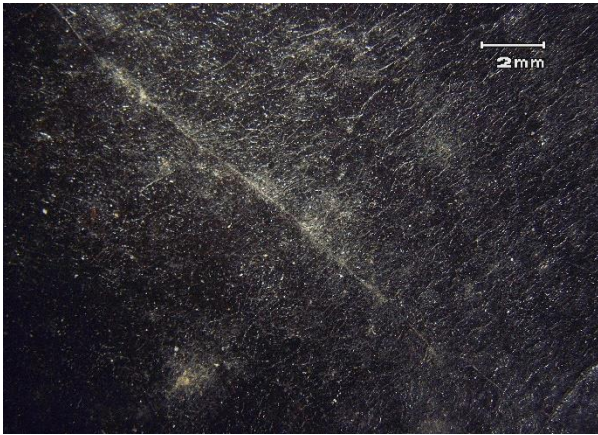
Figure VI.4 – Stereomicroscopic image of the small white dots on the surface of the black paint and between cracks.

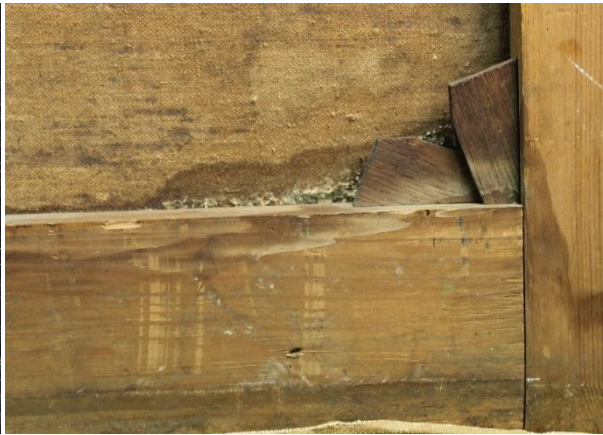
Figure VI.5 – Mould growth between the stretcher and the lining canvas.

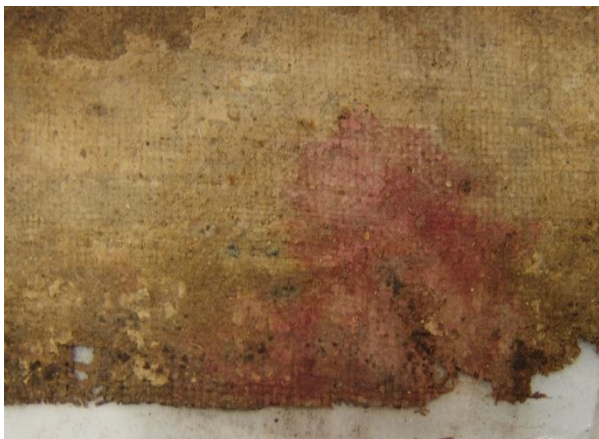
Figure VI.8 – Pink stain in the original canvas thought to be associated with mould.

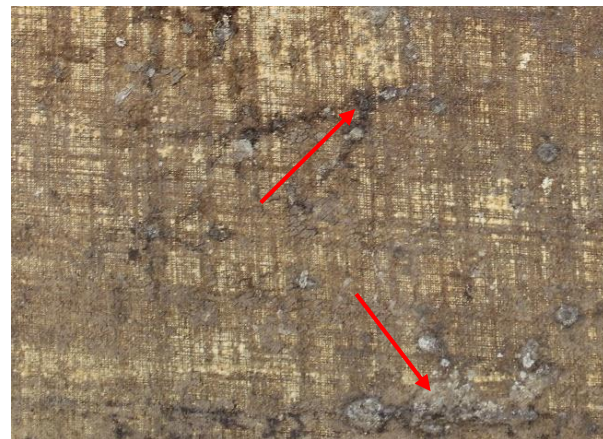
Figure VI.9 – Mould growth on the original canvas and in the lining adhesive. The arrows indicate two sampling areas.
