Strong-Motion Characteristics and Visual Damage Assessment Around Seismic Stations in Kathmandu after the 2015 Gorkha, Nepal, Earthquake

Subeg Bijukchhen,^{a)} Nobuo Takai,^{a)} M.EERI, Michiko Shigefuji,^{b)} Masayoshi Ichiyanagi,^{c)} and Tsutomu Sasatani^{a)}

A rapid visual damage assessment of buildings around four strong-motion seismic stations in Kathmandu Valley was carried out after the damaging Gorkha, Nepal, Earthquake ($M_w 7.8$) of April 25th, 2015. The waveform of the mainshock recorded at these stations were compared with the damage to buildings around the stations. The damage was found to be related to strong-motion characteristics of the earthquake. A dominance of long-period oscillation could be observed in the records. The damage to low-rise buildings in the Valley was less than anticipated from an earthquake of this magnitude given that majority of buildings were built without proper engineering consideration. The acceleration response spectra of one of the sedimentary sites show high response in 1-2 s period range, and nearly 10% of buildings, which were all low-rise, suffered damage around this site.

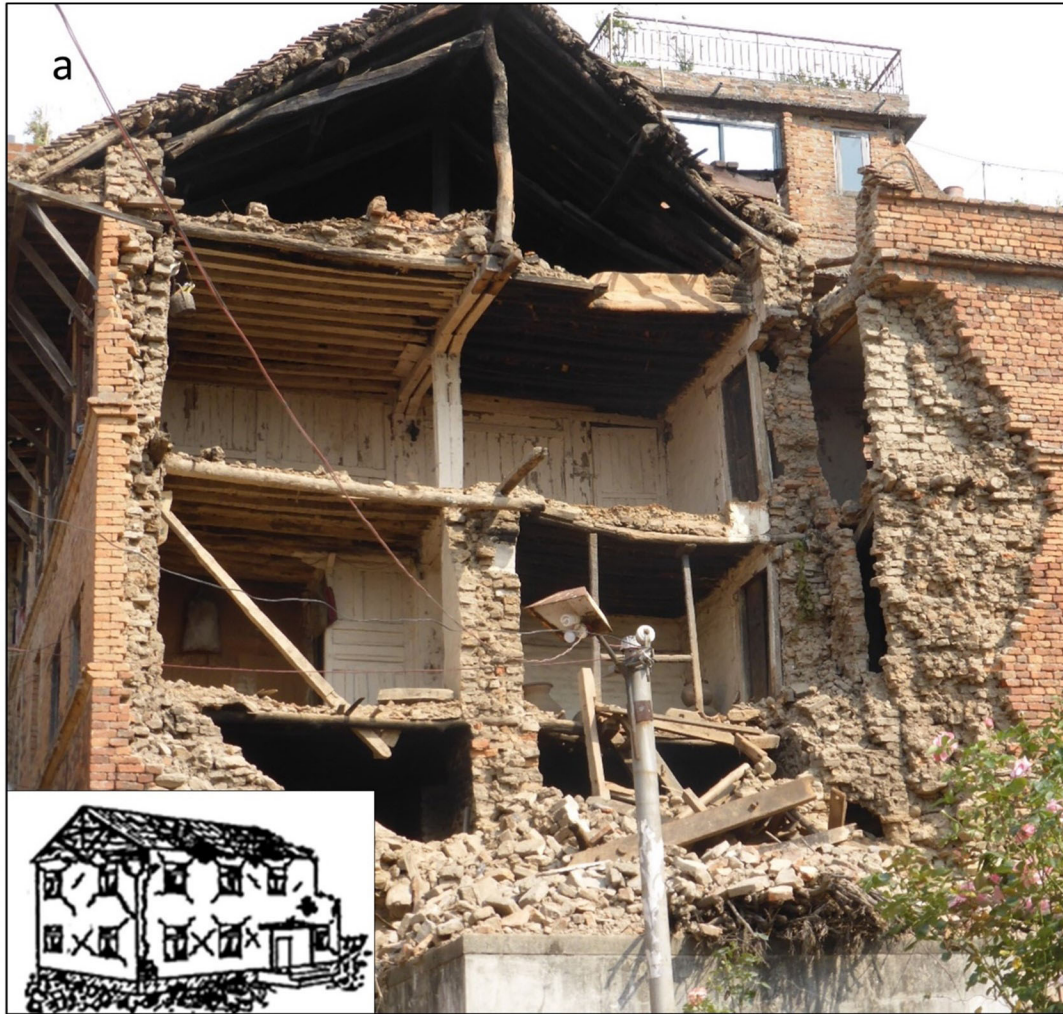
Though all RC infill frame buildings remained unscathed, one masonry mud-mortar building was heavily damaged. The three-story building built on a steep topography suffered

the collapse of the façade facing the slope (Figure 4a). Apart from this, instances of cracks in the inner walls (Figures 4b) were observed in few masonry buildings. We also found fallen roof tiles from some of these houses nevertheless, only less than 6% of total buildings suffered moderate to heavy damage during the earthquake.

Figure 4. (a) Heavily Damaged building with a façade collapse and, (b) cracks in wall inside of a Slightly Damaged building around KTP. The inset shows the diagram of corresponding damage grade (EMS 98).

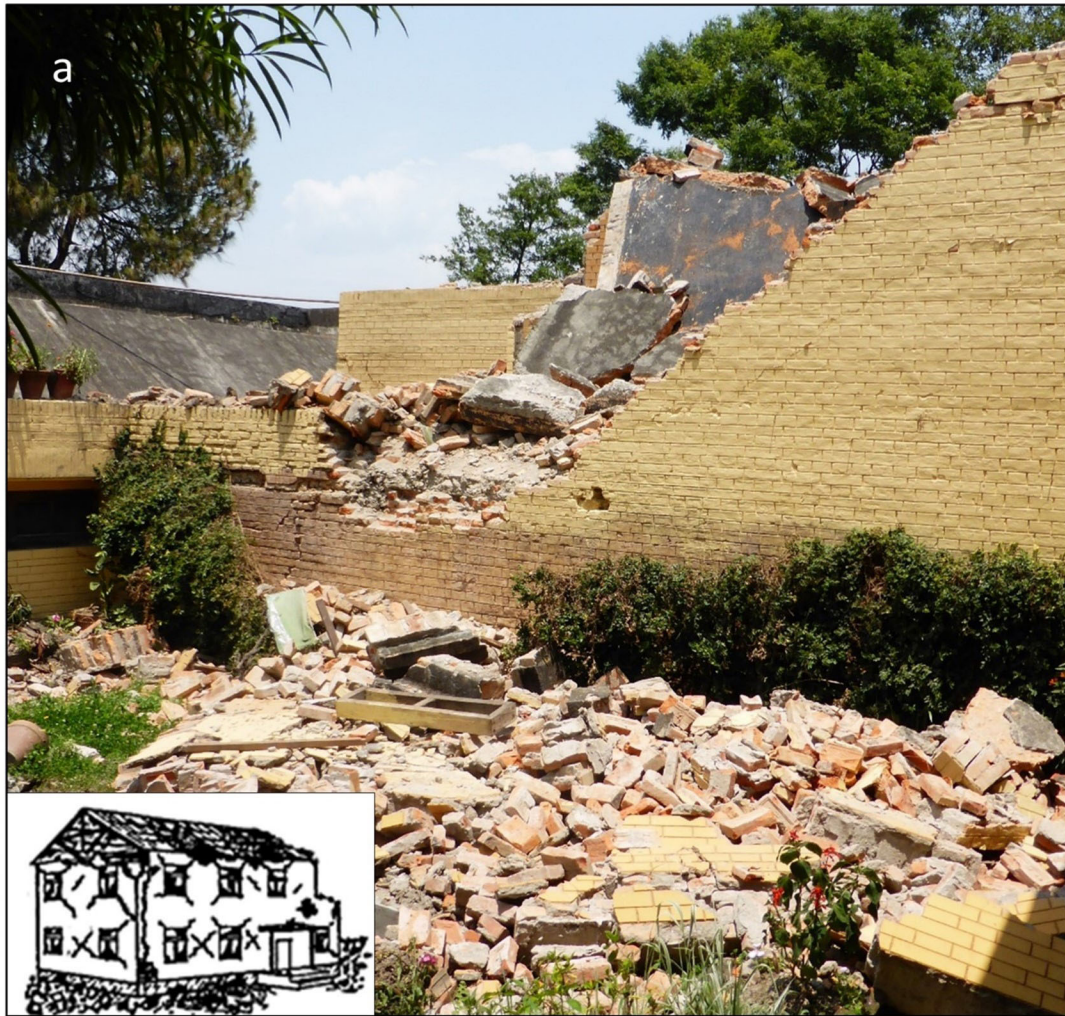
a

Figure 6. (a) Heavily Damaged masonry building and, (b) damage to foundation of Moderately Damaged RC building around TVU.

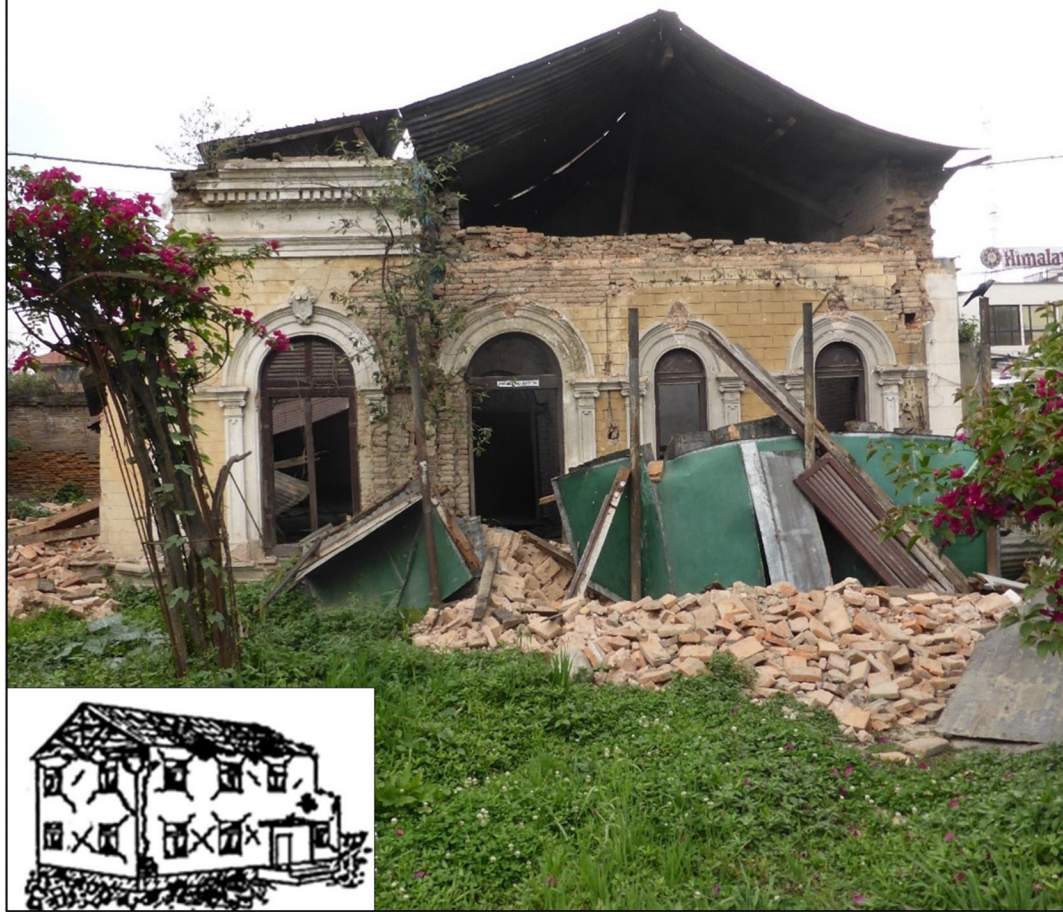
a

Figure 8. (a) Heavily Damaged masonry building with lime mortar and, (b) shear cracks developed in Moderately Damaged RC building around PTN.

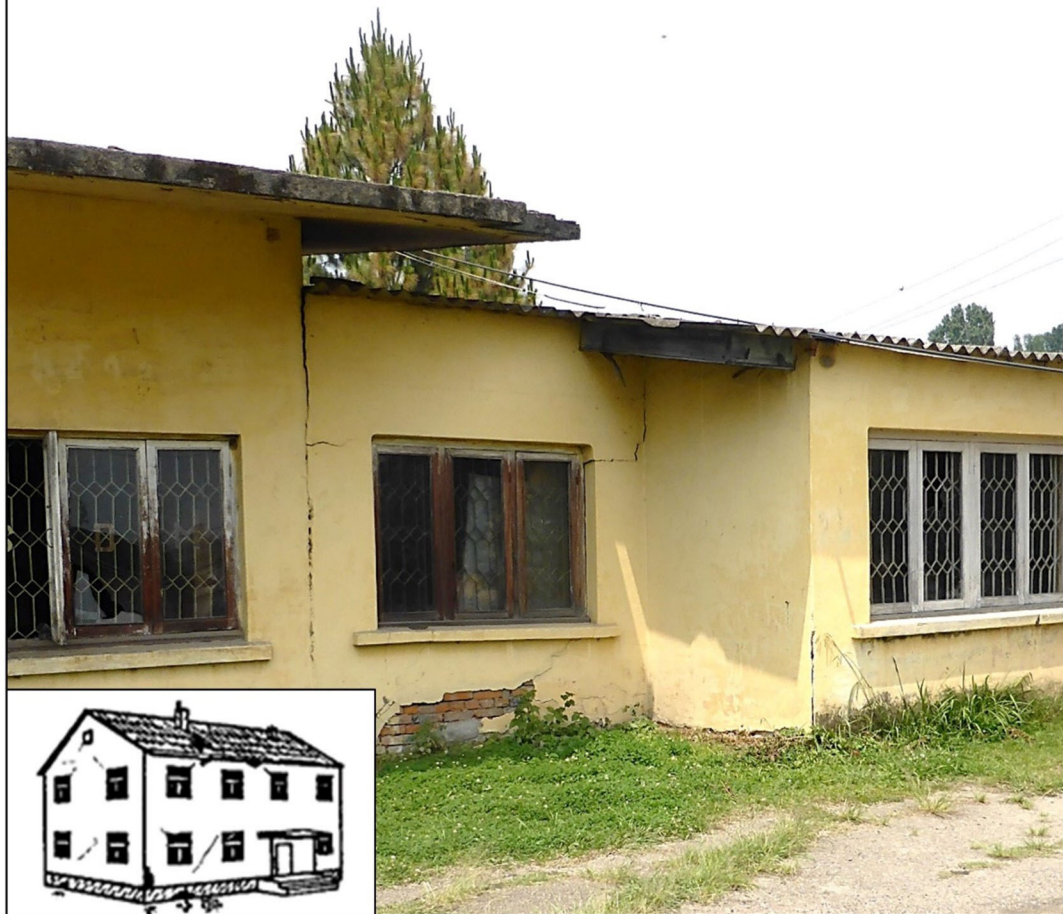
settlement, most of the buildings are RC structures but there are public buildings which are masonry structures (Figure 9a). This site suffered the least damage (Figure 9b) when compared to the other sites. A masonry school building suffered moderate damage and wall cracks (Figure 10a) were clearly visible. A few fallen tiles from the roof were also observed in another building of the same school. The compound walls around the school (Figure 10b) and around a government office collapsed after the earthquake.

Figure 10. Damage around THM, (a) Moderately Damaged masonry building and corresponding damage classification according to EMS98 in inset and, (b) collapsed masonry compound wall.

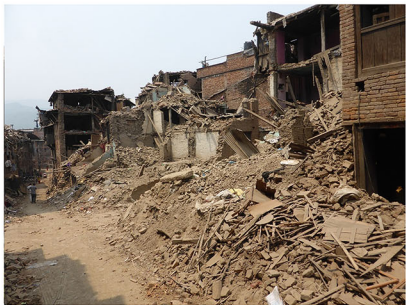
a

Figure 141. Damage to building in other parts of the Kathmandu Valley (a) Damage to masonry structures in Bhaktapur, (b) Tilted and damaged RC infill frame building in Gongabu, (c) Damaged RC infill frame structure in Sitapaila and, (d) collapse of RC infill frame structure in Ramkot.
