# Ranking Matthiessen State Park Trails by Hazard Rather Than Difficulty

Olivet Nazarene University

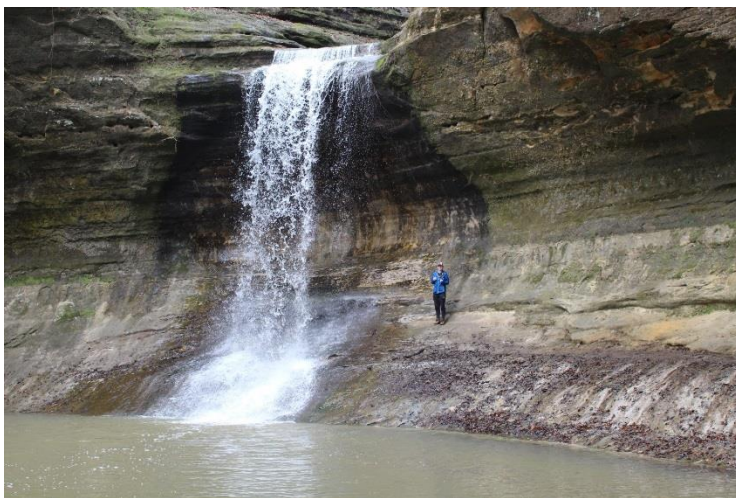
**Figure 1:** Headward erosion caused by waterfall.

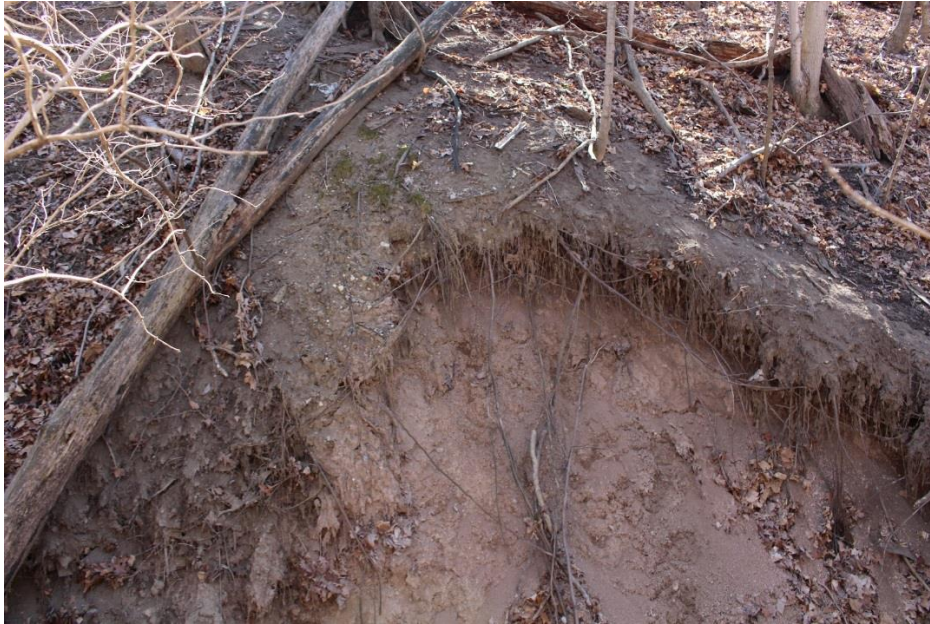
**Figure 8:** This photo shows an example of an erosional surface.

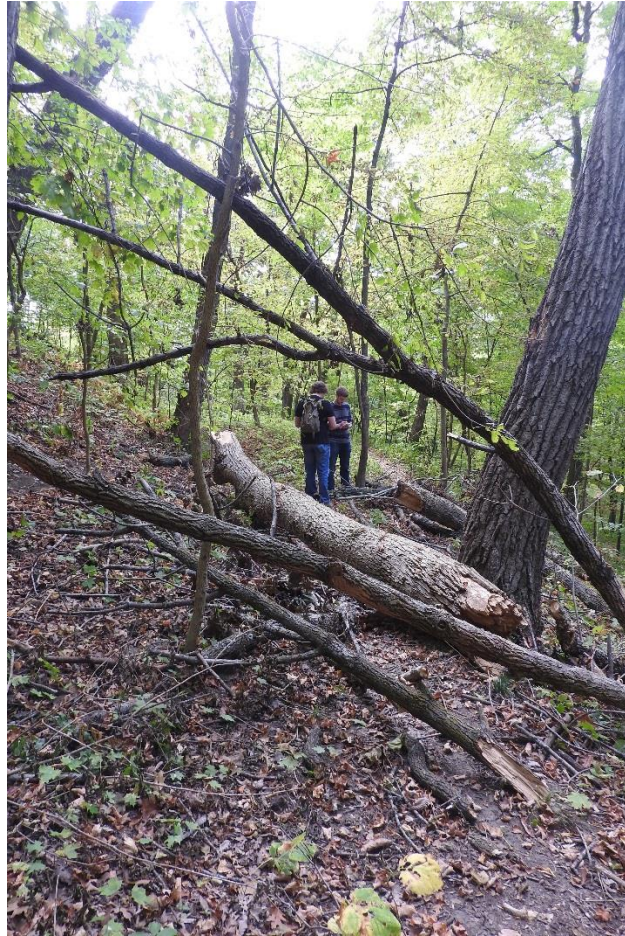
**Figure 9:** This is a photo of a fallen tree. This caused the park to divert the trail around the tree.

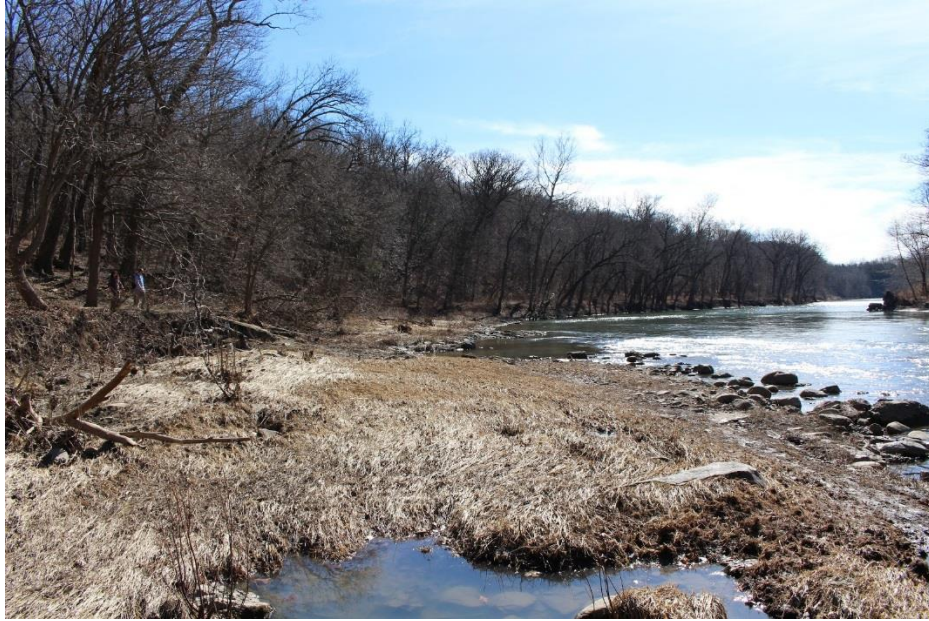
**Figure 10:** This photo represents a flooding hazard.

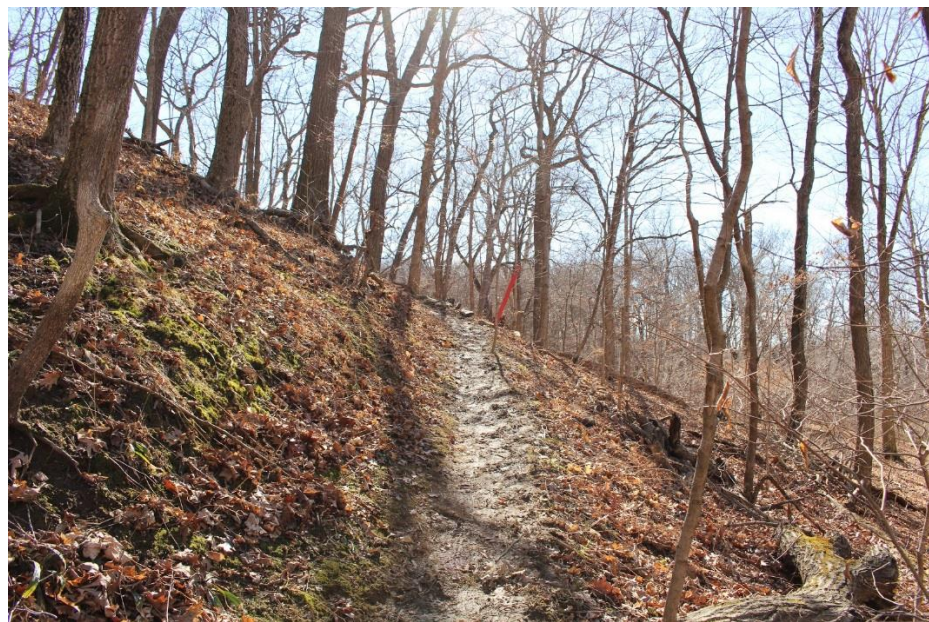
**Figure 11:** This is an example of a steep climb.

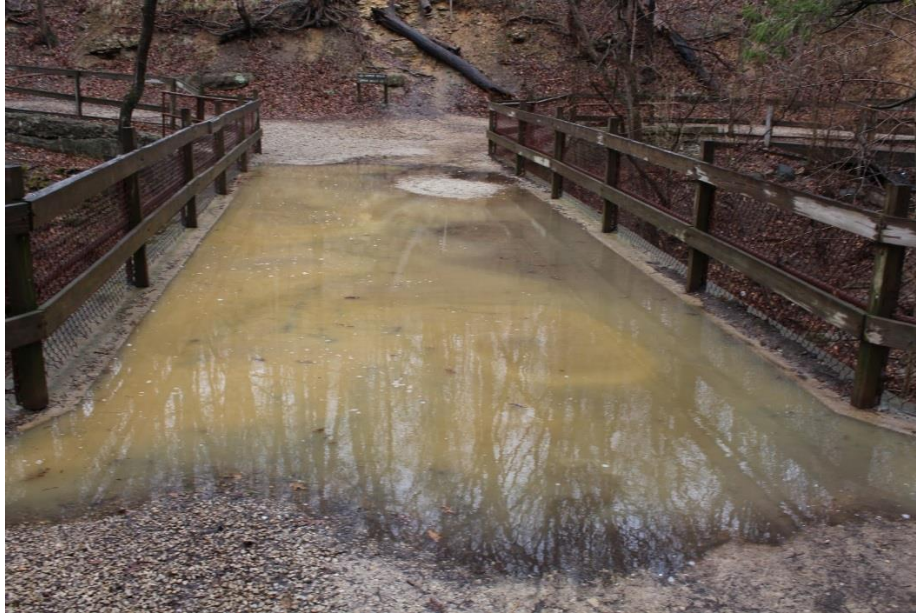
**Figure 12:** This is an extreme example of flooding on a bridge. The bridge had no drainage system installed, thus, stopping water from dispersing.

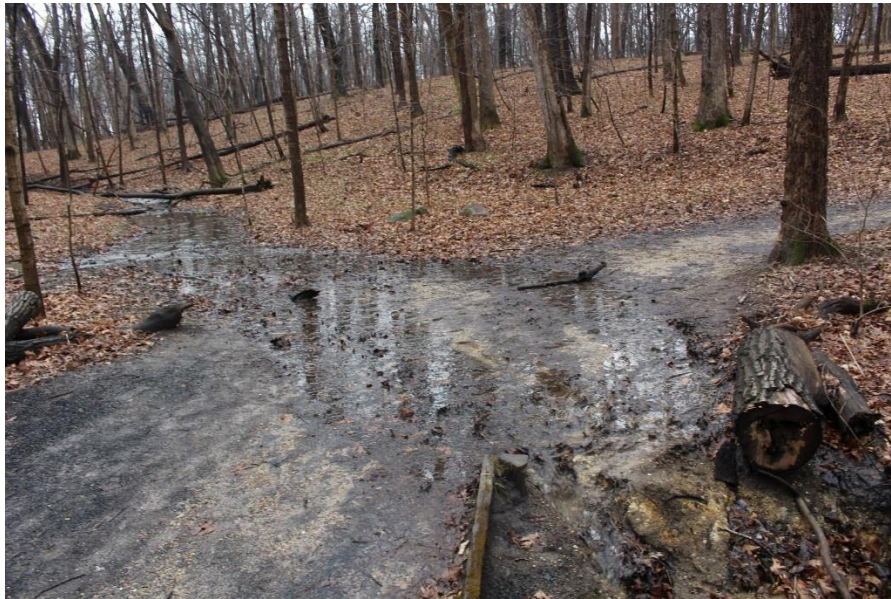
**Figure 13:** This is an example of a flooded pathway. This pathway became flooded due to a lack of drainage.

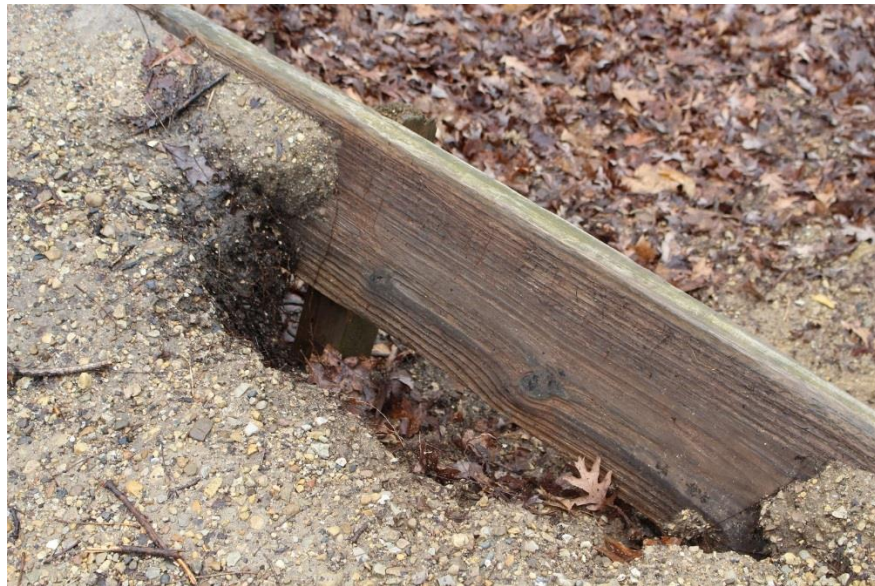
**Figure 15:** This photo shows how the support structure is failing as the water has removed the soil and a hole has developed.

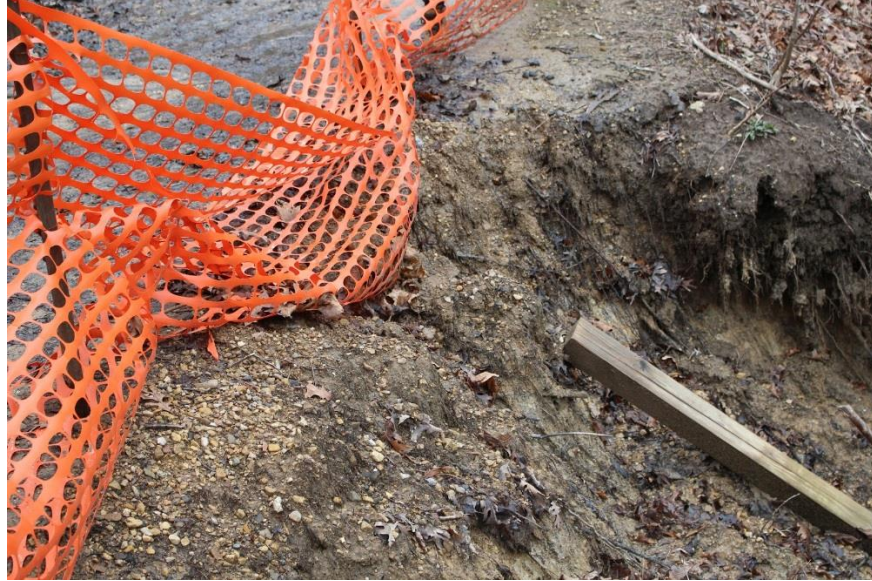
**Figure 16:** This photo shows a failed support. The park had to put up this orange fence to warn the public of the drop off that was created by erosion.

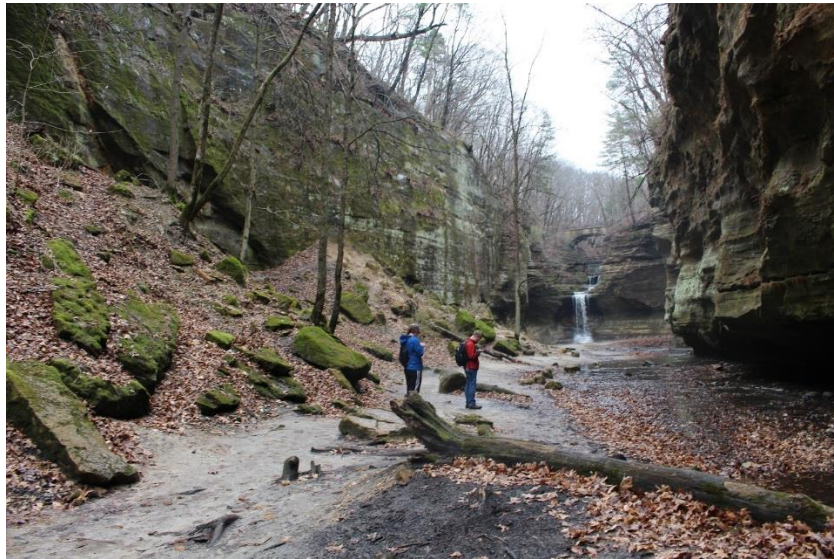
**Figure 17:** This photo shows one of the rockfalls that are found on the Lower Dells path. The picture also shows the 45 foot canyon walls that run parallel with the Upper Dells trail. That would be an example of a shear surface.

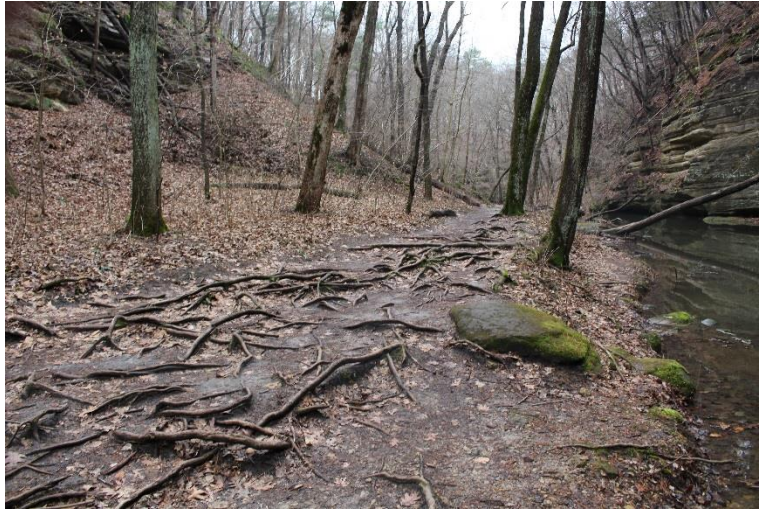
**Figure 18:** This figure shows the effects of erosion on the path exposing the tree roots causing a trip/slip.

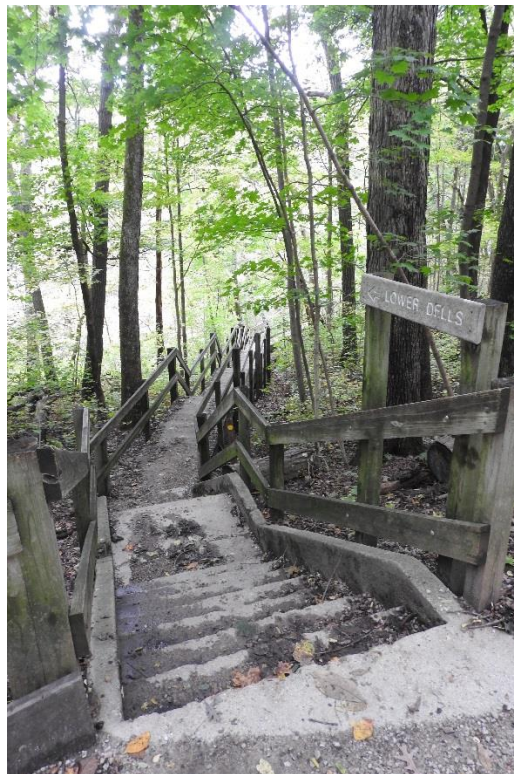
**Figure 19:** This picture depicts one of the many staircases in the state park. The only way to enter the Lower Dells is by taking the stairs down.
