The ALSEP Data Subsystem has been evaluated by an independent contractor to provide added confidence that no allowable sequence of commands can prevent proper operation of the ALSEP System. This report assesses the significance of the failure modes disclosed in this study.

**Aerospace Systems Division**

Evaluation of Data Subsystem Failure Modes

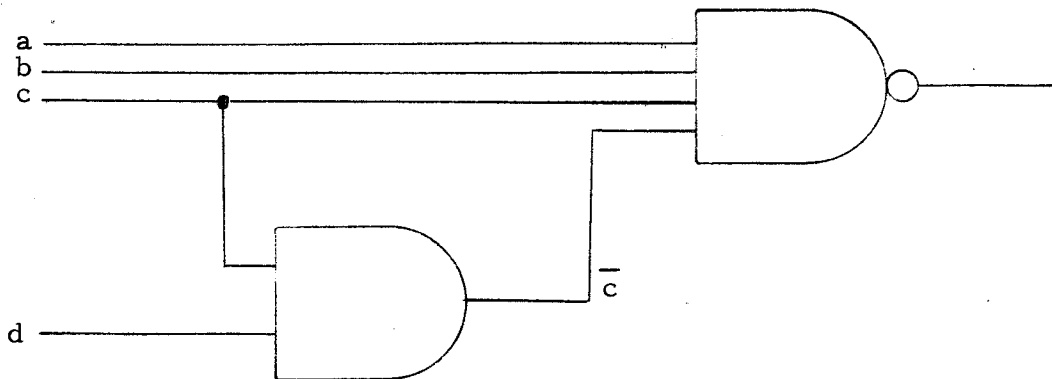
Situation (d). Abnormal Generation of Switching Pulse. - Under an unusual combination of logic gate operations a switching pulse could be generated in the loss of threshold reset circuit. This could result in a premature reset occurring preventing either command execution or command verification from occurring.

Discussion. The circuit considered in situation (d) is schematically shown below for discussion purposes.

The point in question is the switching time delay between points  $c$  and  $\bar{c}$ , where  $\bar{c}$  is the inverted output of  $c$ . As per Fairchild LPDT $\mu$ L 9042 data sheet, the delay time between the input and output signals are typically 60 nanoseconds and are 150 nanoseconds maximum for devices sinking and supplying current to 10 other logic devices. For one unit load application, as described above, the average delay time is greater than the maximum specified for 10 unit loads.

The situation described is therefore not a potential problem area because 150 nanoseconds delay is more than sufficient to guarantee proper operation.
