Investigation of Flight II Central Station
Overvoltage Condition

NO.	REV. NO.
ATM 800	
PAGE <u>1</u> OF <u>14</u>	
DATE 9/12/68

The purpose of this ATM is to document the results of the Reliability/Engineering investigation of the overvoltage condition that occurred while performing the Flight II Central Station power dissipation test. The objective was to assess the flight worthiness of the C/S components and to identify any overstressed piece parts.

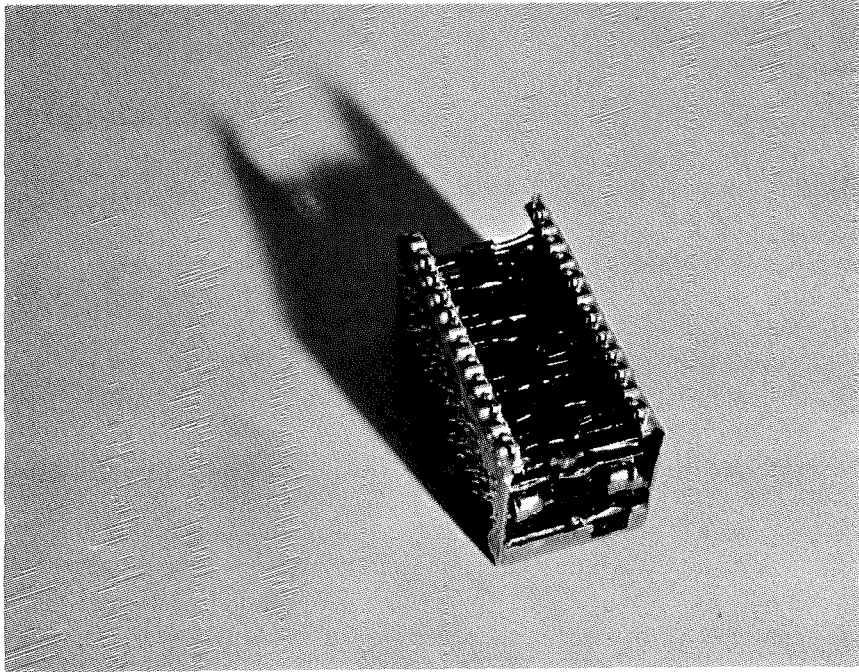
Figure 1

Submodule	Symbol	Ohms	Overvoltage	Rating	Stress Ratio
Regulator B	R37	909 Ω	11.5V	0.1 W	146%
Over/Under Switch	R33	301 Ω	15.5V	0.1 W	800%

Since the two overstressed resistors are MIL RNR Film Resistors that are burned in at 5 times rated power for one hour, it is apparent that R37 was capable of handling the 146% overload it dissipated for one minute. R33, however, dissipated 8 times rated power for the one minute during which the Switching Module, sensed an overvoltage. Mepco Inc., the supplier of the R33 resistors, was contacted to determine the effect of such an overload condition. Several RNR 55E resistors were drawn from Mepco's stock and repeatedly exposed, in air, to 8 times rated power. In approximately 13 to 15 seconds, the resistor's temperature rose 100°C above ambient. After one minute, the hot spot temperature rose to approximately 180°C to 184°C and the resistance drifted approximately 0.33%. Examination of the resistors under 90x magnification showed no damage. Mepco stated that the critical temperature for these resistors is 175°C but, as a result of their test, if exposure to the 800% overload is limited to one minute and that the application conducted heat away better than free air, the resistor would function normally.

R33 is packaged in a cordwood assembly and conformally coated with Stycast 2850FT. (Refer to Figure 1) Stycast has good conductivity and therefore should aid in the dissemination of heat away from the resistor. It would be impossible to determine the actual hot spot temperature rise of resistor R33 without instrumenting and duplicating the overvoltage condition. However, it can be concluded the resistor did not exceed the 184°C temperature measured by the samples tested. In fact with the assistance of the stycast coating, it is highly probable the temperature did not exceed the 175°C which the manufacturer specifies as the maximum allowable temperature before degradation begins to occur.

Even assuming the worst case condition of 184°C temperature rise, the measured ΔR was only 0.33%. For the given application a resistance range of 100-3K Ω is acceptable before functional degradation will occur. Therefore, it has been concluded by BxA Reliability that any parametric change in R33 as a result of the overvoltage condition, is inconsequential to the functional capability of the PCU and the reliability of the system.
