Array E S-Band Compatibility Test Results Analysis

АТМ.	-1093			
PAGE _	1	. OF .	6	
DATE

Abstract

This report documents an investigation of the MSFN/ALSEP S-Band Compatibility Test Results and provides a rationale and recommendation relative to the test validity and relative to Command Decoder Circuit Modifications made subsequent to the test performance.

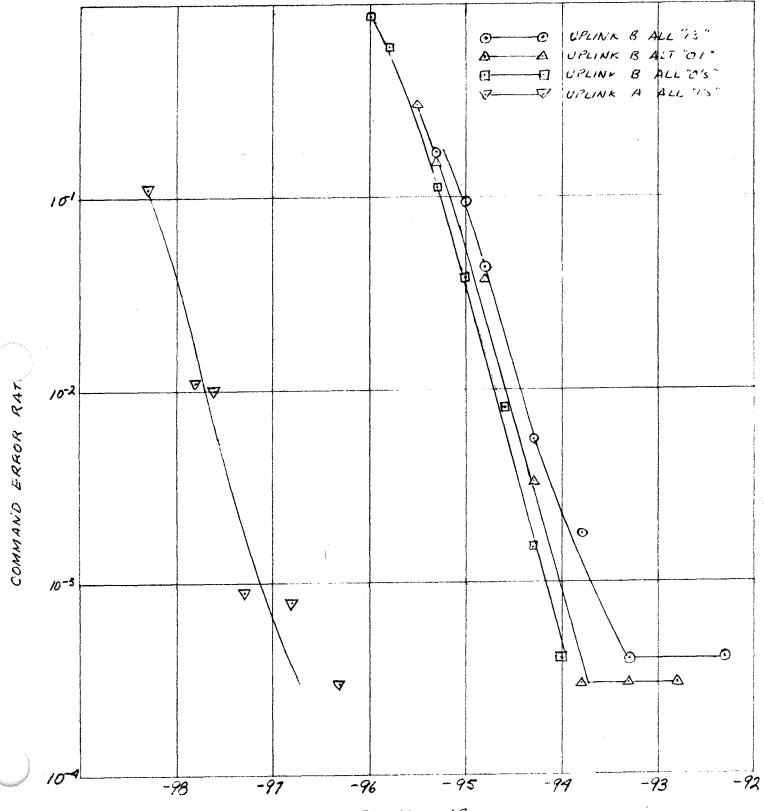
Figure 1, curves of command error rate as a function of total received power, was plotted from the MSFN/ALSEP compatibility test data. First it should be noted that the system does meet the specification limit of one command error in 10^3 at the minimum predicted signal level of -92 dBm. The second point of interest is the fact that as the received power was increased to a level where the measured bit error rate went to zero, the results still indicated that three (or four) out of 10,000 commands were not executed. In fact the curves of Figure 1 indicate that a further increase in received power would not result in a reduction in command errors.

As further background, it was noted during these tests that there were three command errors for the case of no bit errors if 1000 or 10,000 commands were transmitted. This indicates that the command errors were not occurring randomly in the test sample but were systematic and most probably occurred at the beginning of the test run. With no further knowledge it is possible to suspect Either the MSC test set up or the ALSEP uplink. However, thorough analysis of the Command Decoder circuitry by both Bendix and MSC personnel failed to uncover any mechanism for failure to execute a command when an error free bit stream is delivered to the command decoder. Furthermore, during DVM and Qual model testing, thousands of commands have been transmitted to Array E ALSEP with no indication of systematic rejection of commands. Finally,
