SWS Contract Report 375

**AN ASSESSMENT OF BOTTOM SEDIMENT CONDITIONS
IN THE ILLINOIS RIVER
IN THE VICINITY OF PEKIN COMBINED SEWER OVERFLOWS**

Prepared for the City of Pekin
in cooperation with Randolph & Associates, Inc.

December 1985

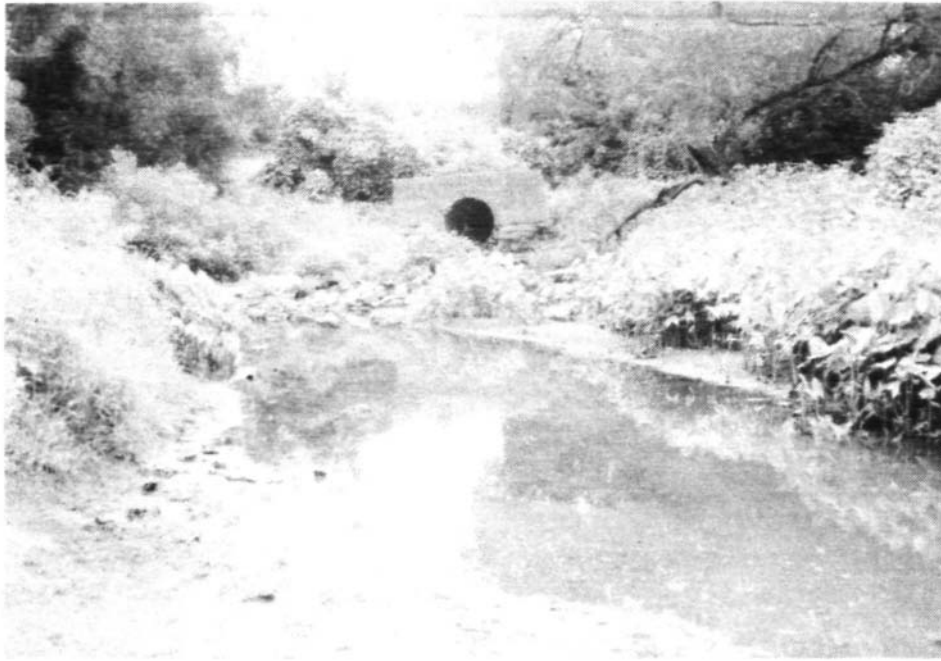
Figure 2. State Street outfall

overflow channel empties into the slough. Figure 2 shows the outfall viewed at sampling station 21 (figure 10). The overflow channel is lined with watery sludge and muck which supports a lush stand of arrowhead along the banks. Figure 4 shows the slough viewed downstream of station 21. Sludge deposits were observed in the slough below the outfall channel in the localized area shown on figure 10. These sludge deposits were approximately 30 to 36 inches deep, smelted septic, and emitted gas bubbles when disturbed. The State Street overflow channel was free of trash and debris often associated with CSOs. The slough below station 20 is free of any significant sludge deposits. This may be an indication that the observed sludge deposits in the State Street outfall area are residual from historical dry weather overflows which frequently occurred prior to extensive lift station rehabilitation during 1972 and 1973.

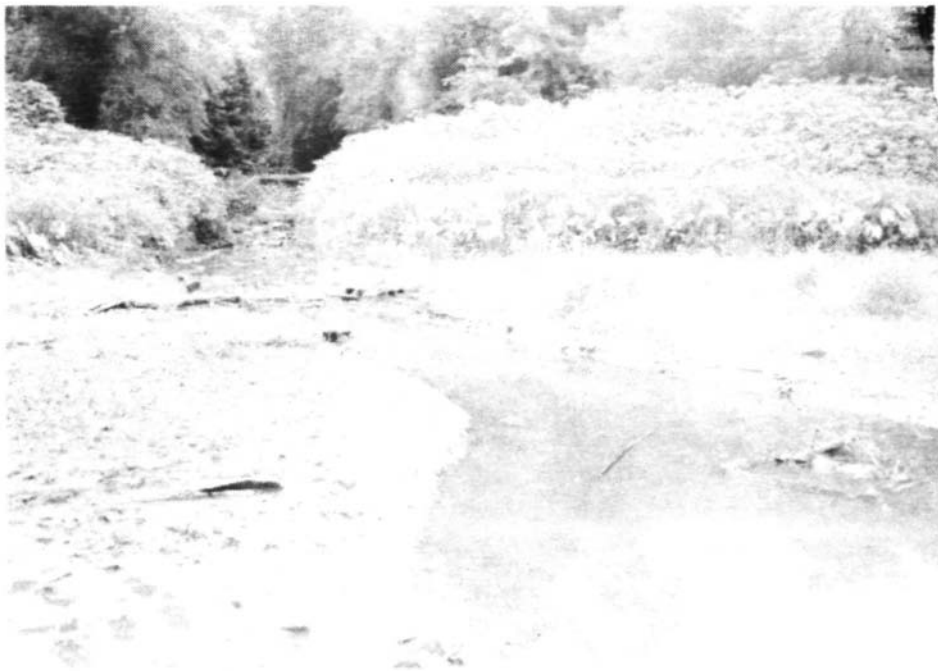
Figure 3. Caroline Street outfall

The Caroline outfall channel is shown on figure 3 and its location is shown on figures 1 and 10. The channel is free of sludge or polluttional depositions with the bottom consisting primarily of compacted sand. The channel contains some man-made and natural trash and debris. The sewer outfall is set back from the slough approximately 200 feet and is shrouded in a lush canopy of woody vegetation and weeds.

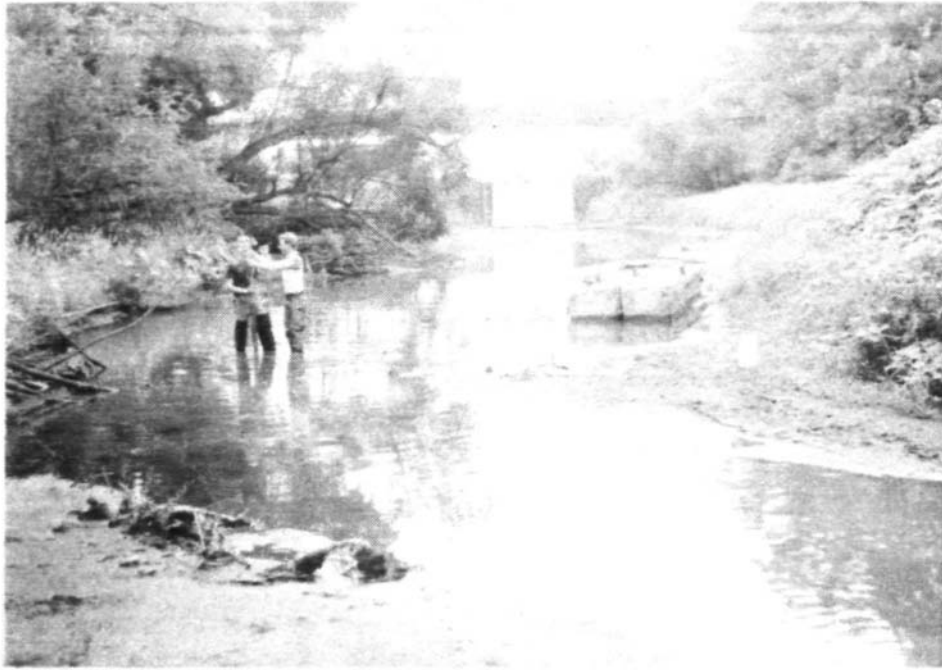
Figure 4. State-Caroline Streets outlet slough, looking downstream from State Street

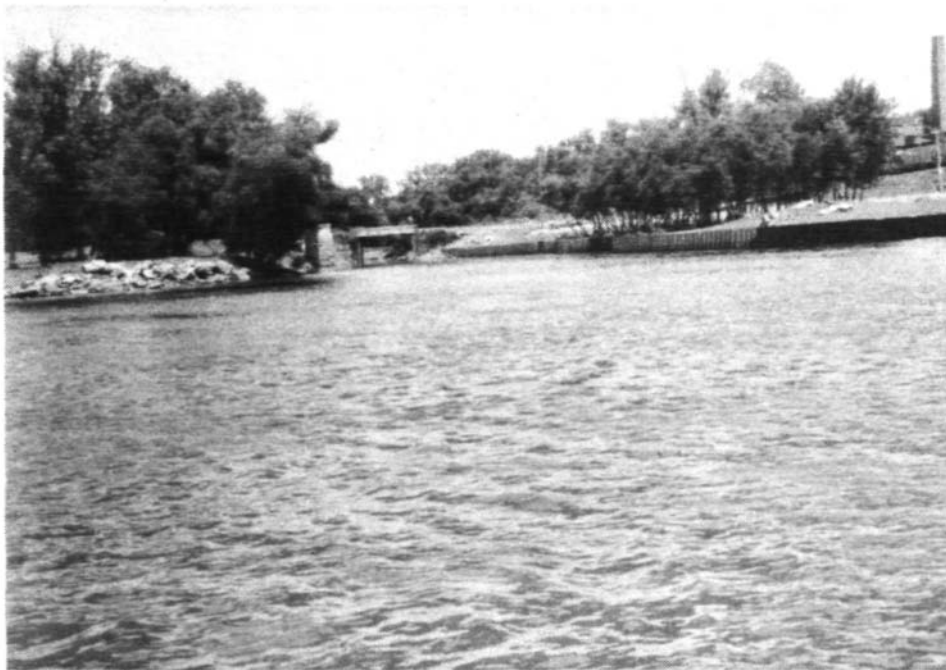
Figure 5. State-Caroline Streets outlet slough, looking upstream from river bay

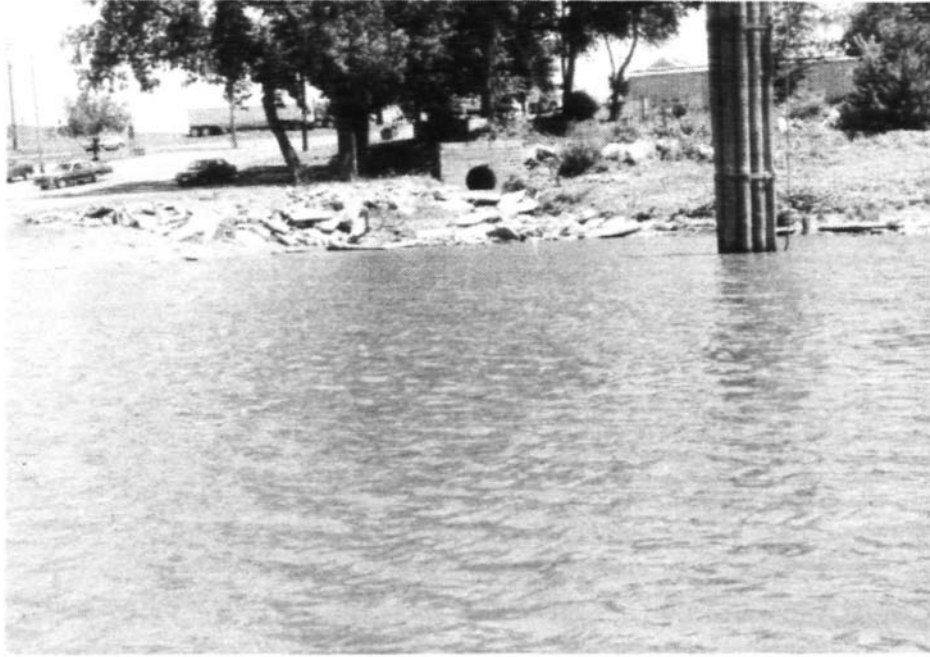
Figure 6. Court Street outfall

The Court Street outfall area is shown in figure 6 and depicted diagrammatically in figure 11; its areal location is shown on figure 1. Figure 13 shows a close-up view of the outfall channel. The course to the river is short, elevated, and lined with riprap. This rough trace causes trash and debris to hang up in the stones and concrete fragments during overflow periods (figures 13 and 14). Immediately downstream of the outfall is a grain elevator barge loading dock, the upstream-most mooring pier of which is shown on figure 6. The spillage of grain in the loading area appears to affect localized bottom conditions.

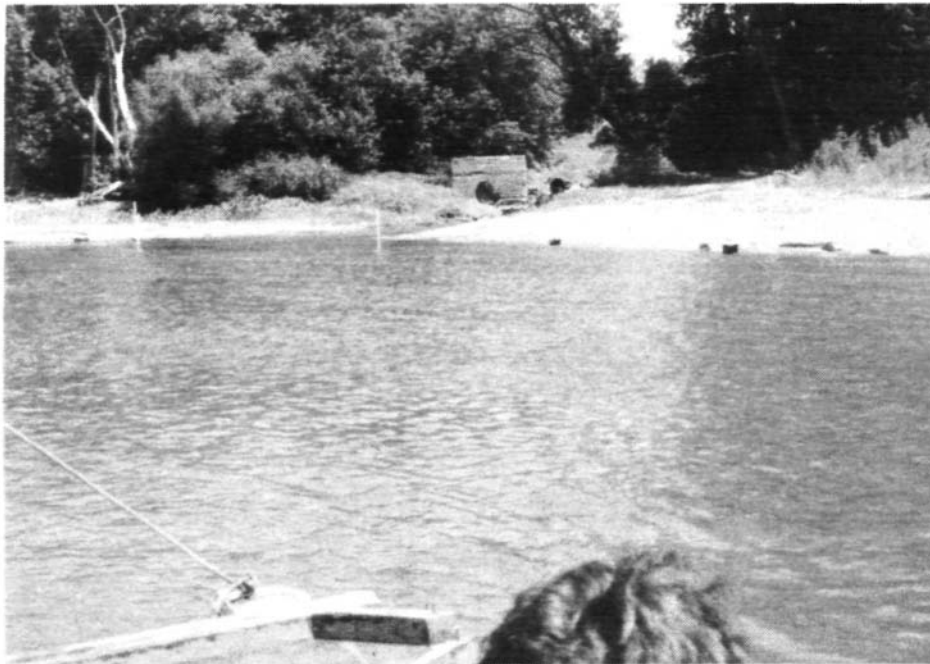
Figure 7. Fayette Street outfall

The Fayette Street outfall area is shown in figure 7 and depicted diagrammatically in figure 12; its areal location is shown on figure 1. The outfall pipe terminus shown on figure 15 is over 250 feet back from the river shoreline. The outfall channel bottom is lower than the river water surface and is therefore always flooded with about 2 feet of water (figures 9 and 15). An old headwall and attendant pipe opening

stand isolated about 100 feet back from the river (figures 7 and 9). The bottom and sides of the outlet channel are relatively firm and free of sludge. The water in the channel, however, shows evidence of pollution. The water appears somewhat black and septic and contains wastewater-related material such as floating solids and condoms. The outfall pipe terminates at the edge of a railroad track, and the area in the vicinity of the pipe is choked with debris and fallout from the tracks (figure 15).

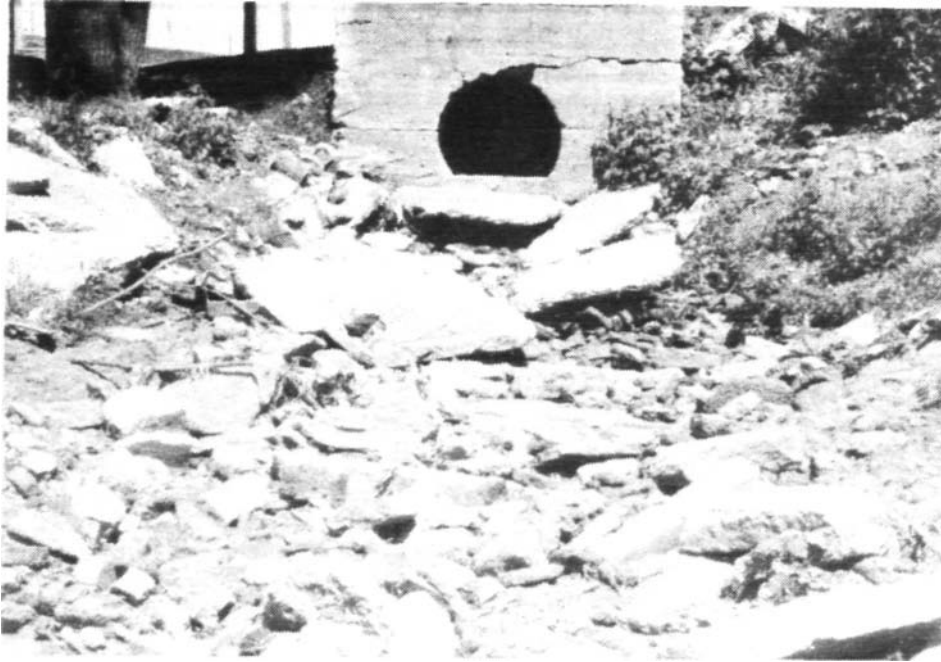
Figure 13. Close-up of Court Street outfall channel

Of the four CSOs, Court Street comes the closest to discharging directly into the river. It is set back only about 50 feet from the river bank, and the overflow pipe is elevated 4 to 5 feet above the normal river pool elevation, allowing any overflow to cascade rapidly over riprap in its short course to the river. Consequently, the chances for sludge buildup and pooling of contaminated water in the outfall channel are negligible. Nevertheless, public health and aesthetic problems persist around the outfall. Sewage-borne debris and trash have accumulated in the riprap and rocky crevices, creating unwholesome, odorous, and unsightly conditions.

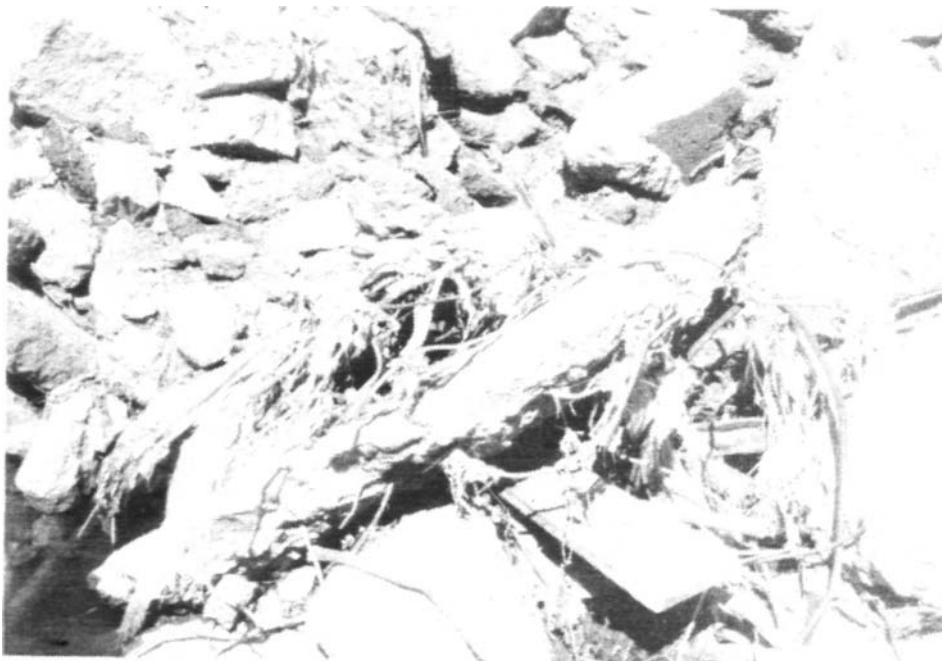
Figure 14. Close-up of debris collection in Court Street outfall channel

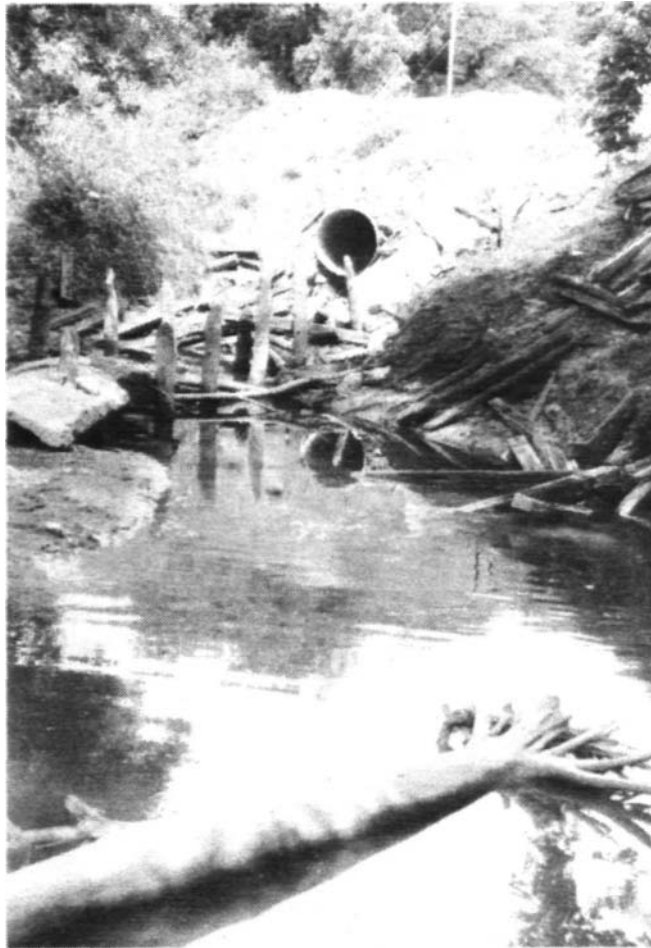
Figure 15. Close-up of Fayette Street outfall pipe

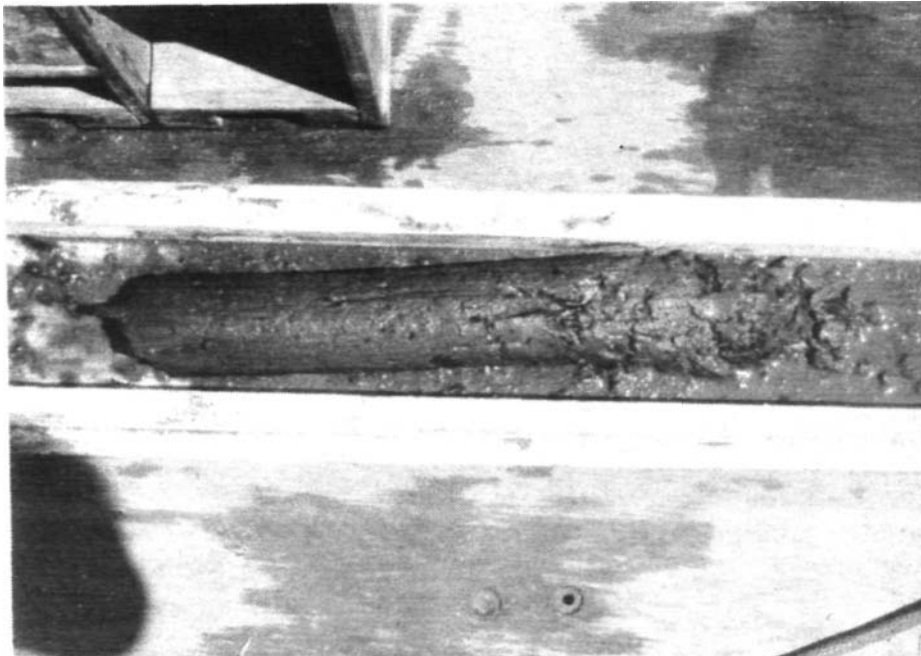
Figure 17. Core sample at State-Caroline sampling station 14

The core sample taken at station 14 in the bay revealed no evidence of present or past sewage sludge deposition or contamination. The core sample information in table 1 indicates that the sediments in this area consist of about 5 inches of black coarse sand on top of gray-black gelatinous musty smelling muck. The core samples taken in the slough, however, show signs of sewage contamination, the degree of which increases in the upstream direction. The core samples taken at stations 18 through 21 are shown as figures 18 through 21, respectively. Samples 18, 19, and 20 were taken in the centerline of the slough, while sample 21 was taken in the center of the State Street outfall ditch (figure 10). Note

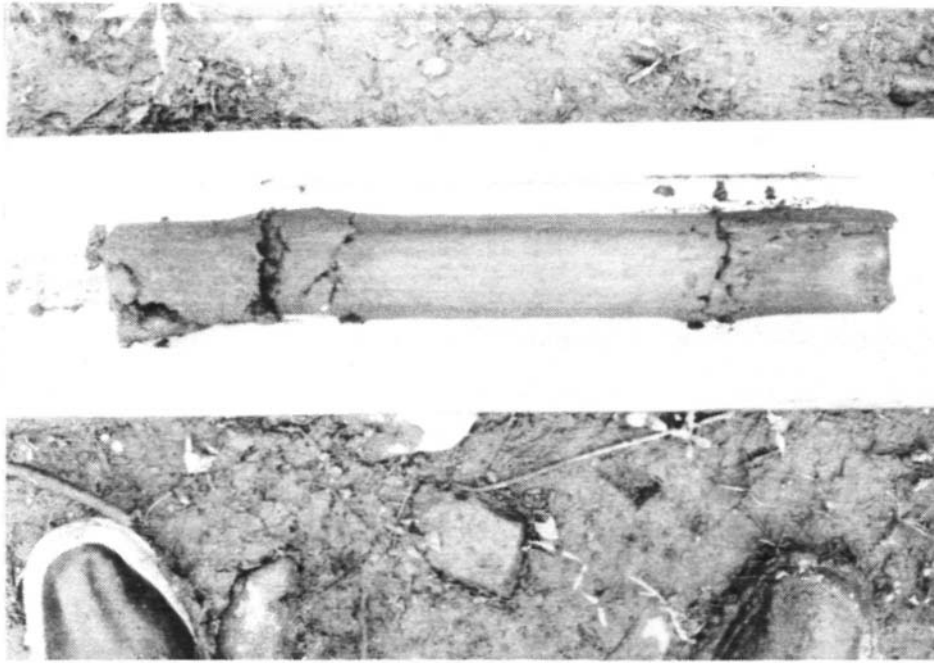
Figure 18. Core sample at State-Caroline sampling station 18

from table 1 that the sample at station 18 is relatively clean and odorless, that at 19 smells septic, and those at 20 and 21 smell of sewage. The centerline samples, however, consist mostly of black septic-looking sands, while the left shore above station 20 (looking downstream) was lined with sewage sludge deposits at least 30 inches deep. Such a deposit is evident in the foreground of figure 4; core sampling at station 20 is shown in the background of the photograph. Note from table 5 that the water and percent volatile content at station 21 was the highest of any measured at any location in the study area. Both values are indicative of significant organic pollution from sources other than natural.

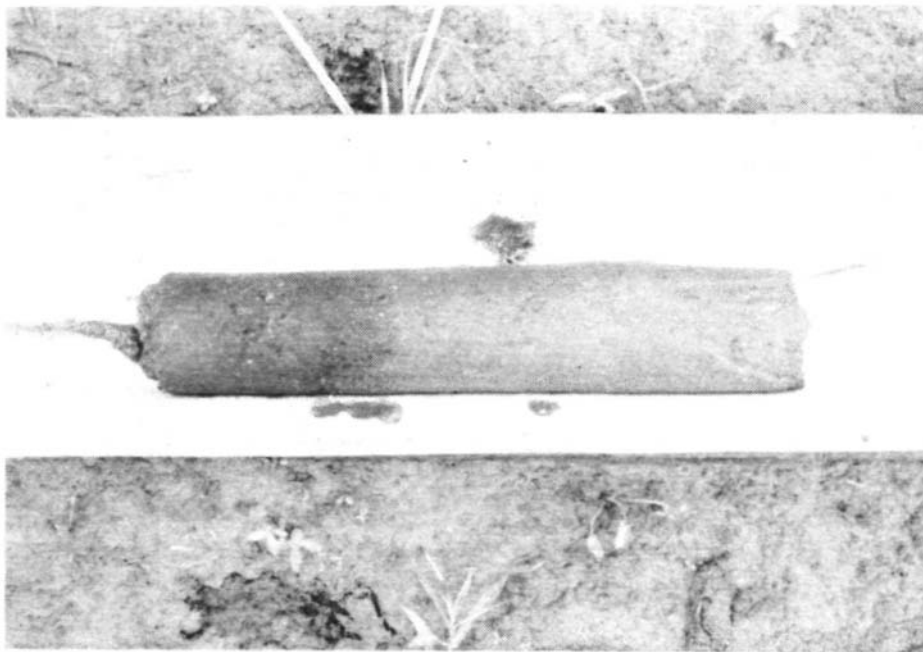
Figure 19. Core sample at State-Caroline sampling station 19

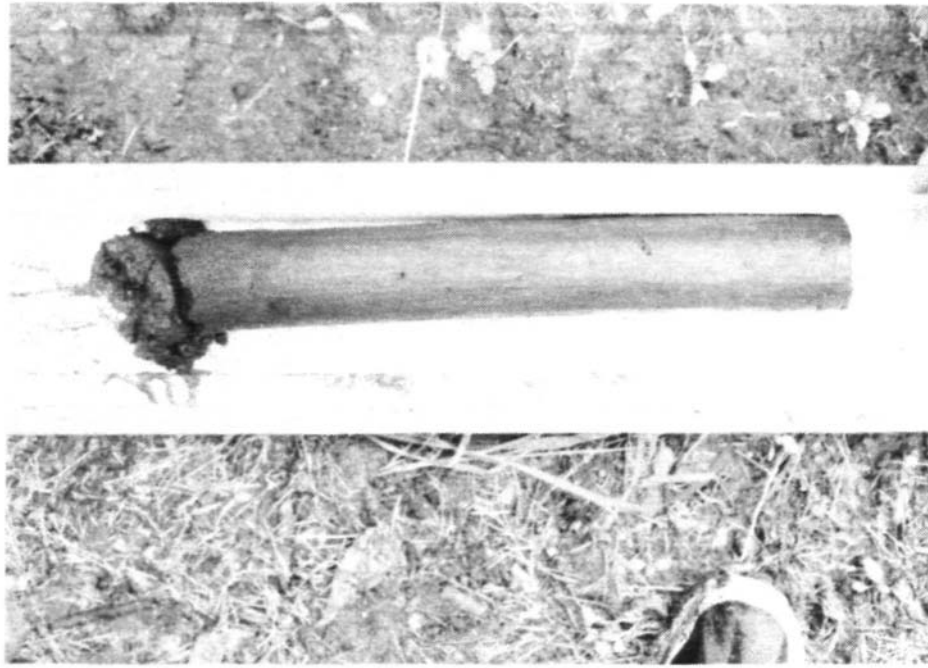
Figure 20. Core sample at State-Caroline sampling station 20

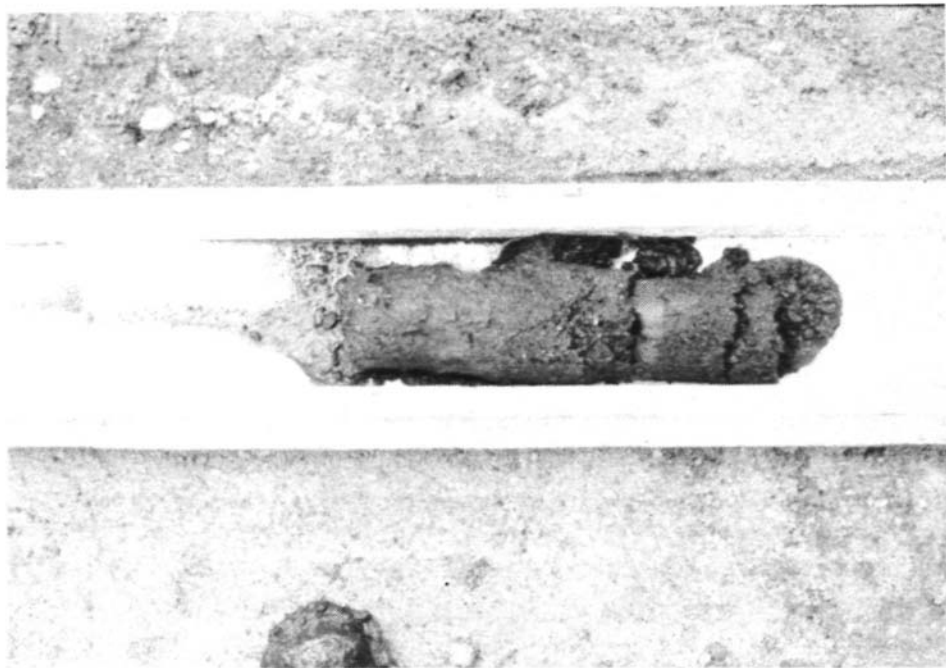
Figure 21. Core sample at State-Caroline sampling station 21

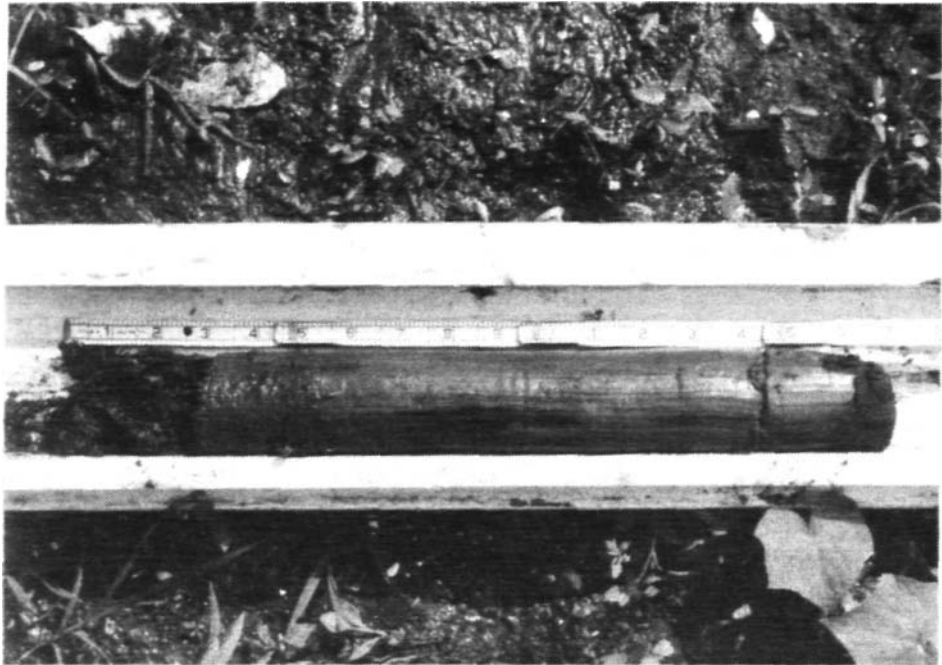
Figure 22. Core sample at Fayette Street sampling station 26

The sediments in the Fayette Street outfall channel showed evidence of chronic sewage contamination; the standing water in the outfall channel appeared stagnant and of poor quality. Condoms and floating solids were seen in the channel, and the water pooled around the outfall pipe near the railroad tracks was black and looked septic. However, no sludge deposits, similar to those documented in the State-Caroline outfall slough, were observed. The two core samples taken in the center of the channel are shown as figures 22 and 23. The gray-black color is indicative of chronic sewage contamination, and the sample at station 27 (closest to the outfall) had a slight septic odor (see table 1 descriptions). The volatile content of both samples, however, was relatively low as evidenced by the results in table 5. The volatile solids content of the station 27 sample was lower than that at station 26 because the surface deposition at this station consists of a much coarser material (see figures 22 and 23). The compacted material below the coarse material appears to be native soil.

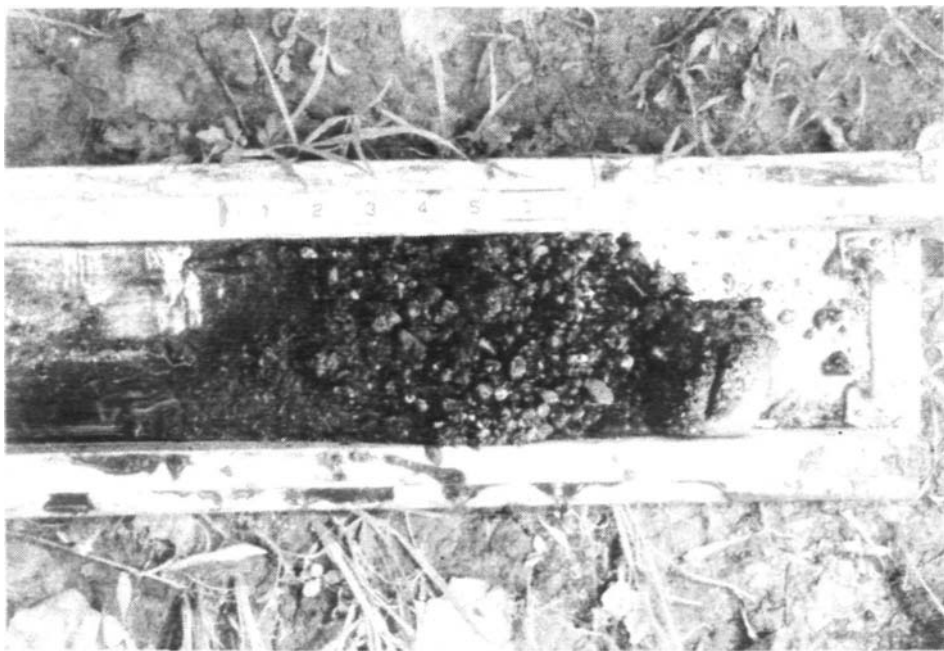
Figure 23. Core sample at Fayette Street sampling station 27
