SWS Contract Report 411

**AN ASSESSMENT OF ILLINOIS RIVER BOTTOM SEDIMENTS  
IN THE VICINITY OF HAVANA COMBINED SEWER OVERFLOWS**

*by Thomas A. Butts*

January 1987

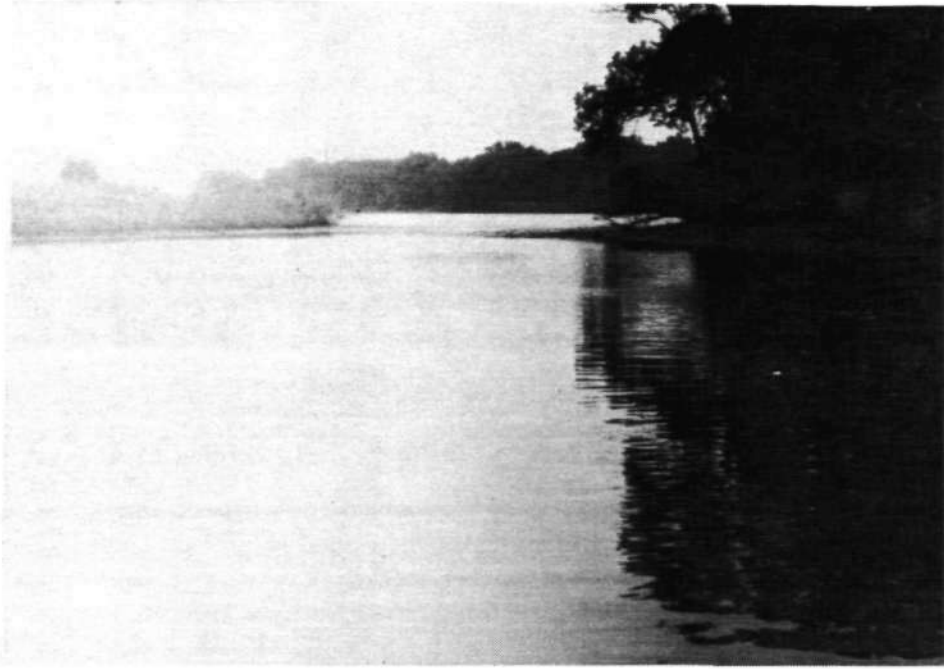
This is the upstream-most of the four overflow sewers. It discharges into a shallow off-channel slough or bay-like area (figures 1, 2, 3, and 14). At the time of the survey, the shoreline of the bay was very wet and "mucky" due to the rapid drop in high pool levels caused by recent high-water conditions. The area around the outfall had grown up in willows, weeds, and bushes and had to be cleared to be examined (figure 3). No evidence of sludge or pollutional depositions of sewage origin existed on the bank above the edge of the water. The outfall area was totally free of undesirable odors and overflow trash and debris such as rags and paper products.

***Figure 2. Tremont Street outfall bay looking toward river entrance***

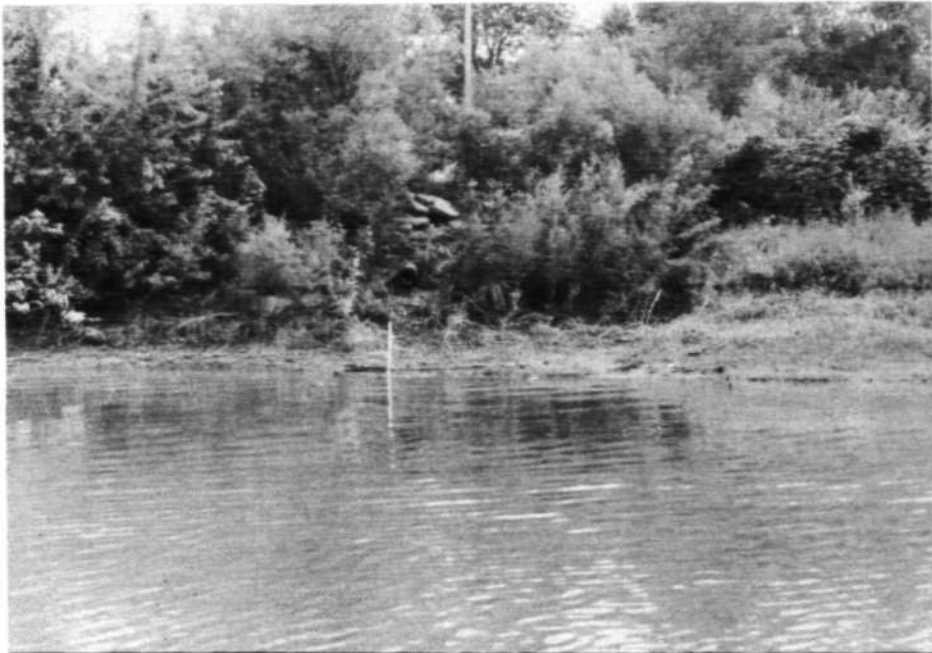
The four outfall areas above the Havana wastewater treatment plant which were examined and evaluated are shown on figure 1. The outfalls are identified by the street locations at which the discharges occur. In downstream sequence, they are Tremont, Market, Washington, and Illinois. Note that the Tremont Street outfall discharges into a bay-like slough area (figures 1 and 2D. This outfall, a 15-inch welded steel pipe, is shown in figure 3; at low pool elevations, it is located approximately 38 feet back from the water's edge. Since late spring of 1986, the diversion regulator at the Tremont Street pumping station has been closed and overflows no longer occur at this location. However, sampling was conducted in the bay area to document if a historical buildup of polluttional sediments has occurred.

***Figure 3. Tremont Street outfall***

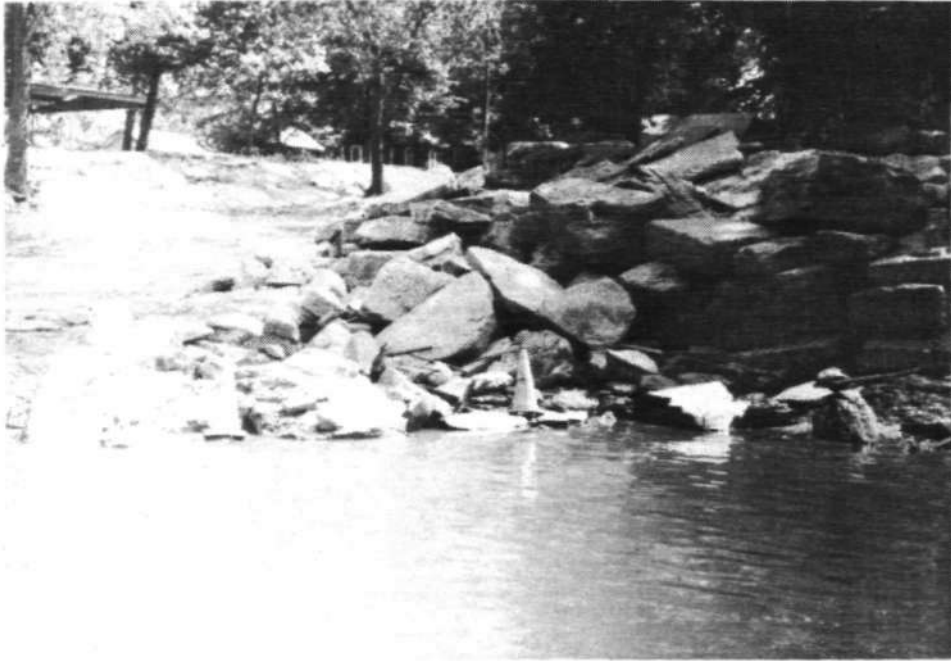
The Market Street outfall location is shown in figure 4. The exact location and pipe size are obscured since the opening is covered by riprap. The discharge runs over and through the riprap starting about 20 feet back from the water's edge in line with the left traffic cone shown in figure 4 and enters the river at a point marked by the right traffic cone.

the hose hit something firm and stopped. Repeated ramming with the hose caused a slight breakthrough, producing a distinctive red flow from the riprap about 15 to 20 feet from the water's edge. The beginning and ending discharge points are noted by the traffic cones shown on figure 4.

The outfall area displayed no evidence of chronic or recent overflow. No sewage or sewage-like odor could be discerned; overflow debris which commonly hangs up in riprap-receiving areas was totally absent. Only a persistent trickle of clear water was evident, indicating that ground-water infiltration into the overflow line was probably occurring. The overflow line blockage, the difficulty of breaking through it, and the total absence of any residual signs of overflow at the river indicate that the line probably has not overflowed into the river in the recent past. The steady clear water discharge may indicate a broken line in addition to a plugged one.

*Figure 4. Market Street outfall area*

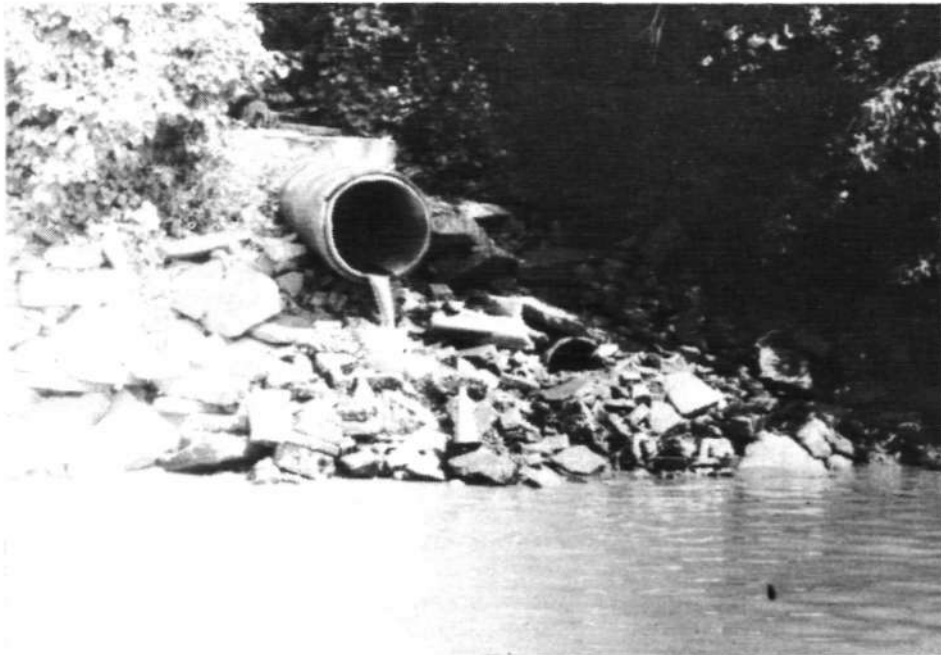
The Washington Street outfall is a 36-inch reinforced concrete pipe discharging onto riprap about 9 feet back from the edge of the water (figure 5). The outfall is located in the middle of a grain-barge-loading operation. The outfall was overflowing when the photograph was taken. Rain might possibly have fallen several hours before the photograph was taken at 10:00 a.m. on August 4, 1986. By 10:30 a.m., the overflow had stopped.

This sewer overflow is known to be active and, as noted previously in this report, it was observed to be overflowing once during a study visit (figure 5). The discharge point is a free drop onto riprap about 9 to 10 feet back from the edge of the water during normal pool levels. The riprap is clean; a sewage odor emanates from the 36-inch sewer pipe but not from the receiving area on the bank. The appearance of the overflow was one of very diluted or weak sewage free of floating debris and trash. No sludge deposits or accumulation of sewage debris were evident at any time during the study visits.

*Figure 5. Washington Street outfall*

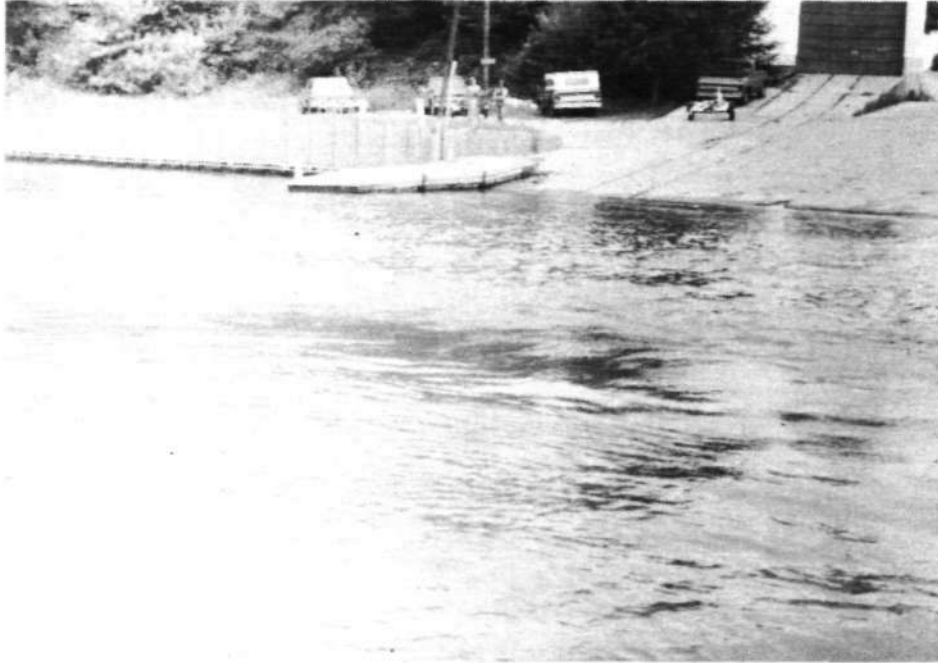
Figure 6 shows the Illinois Street outfall area. The outfall extends about 25 feet into the river from the retaining wall face and is about half submerged under the boat dock in line with the traffic cones shown in figure 6.

The Illinois Street outfall, extending about 25 feet into the river, exhibited no evidence of sewage-related debris or solids accumulations in the area of the boat ramp.

***Figure 6. Illinois Street outfall area***

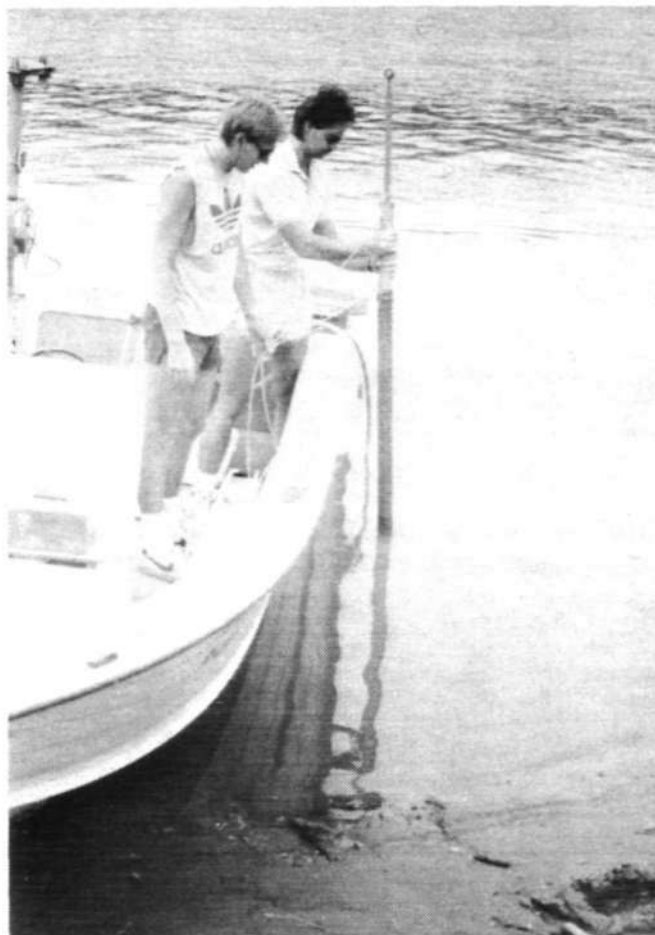
***Figure 9. Sediment core sampling attempt near shore at Market Street outfall area***

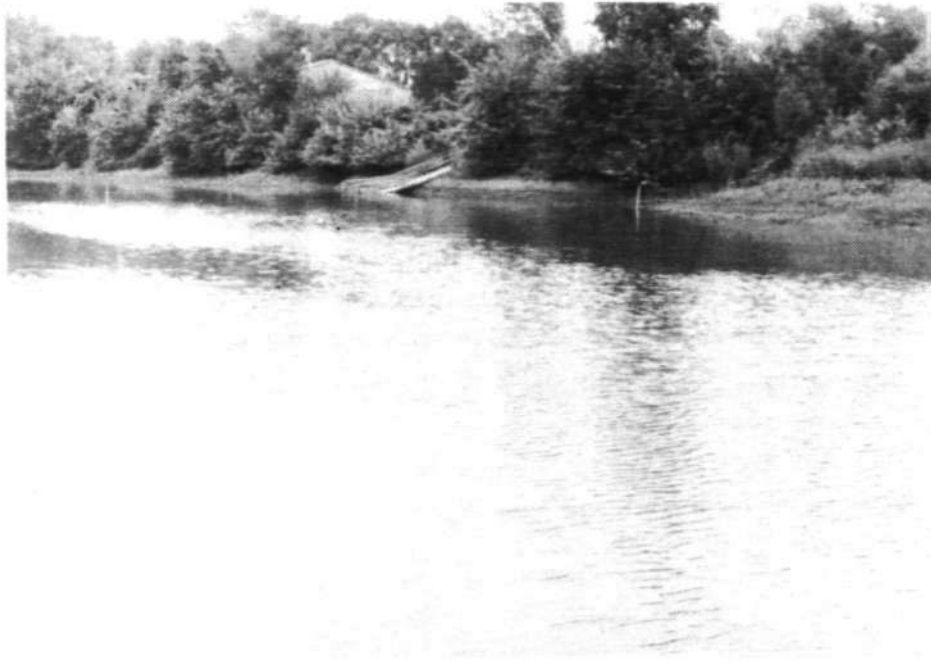
**Figure 14. Tremont Street bay area showing shoreline and sampling reference stakes**

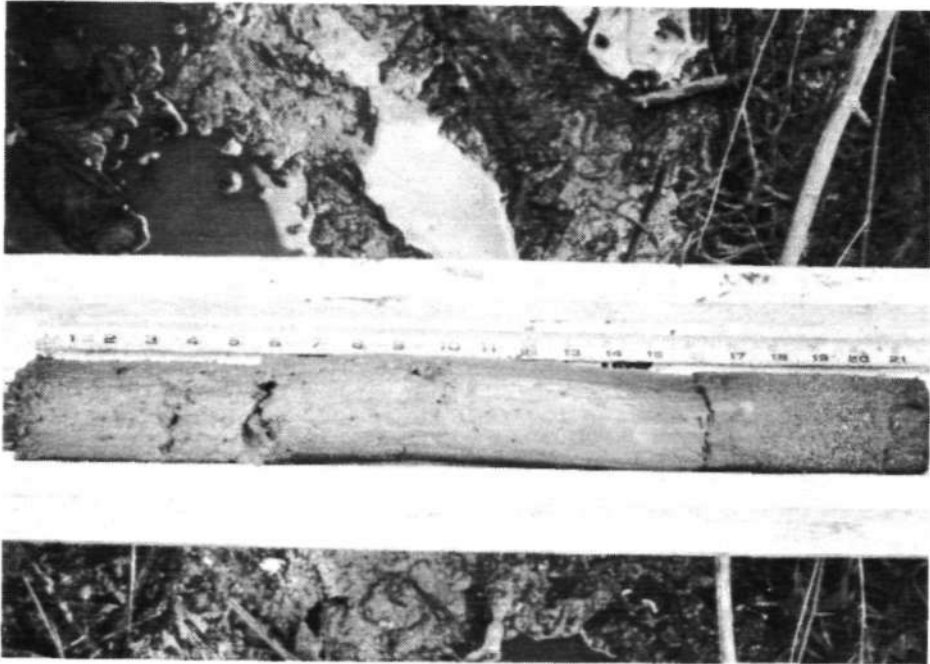
**Figure 17. Tremont Street outfall area core sample 1**

<u>Sample number</u>	<u>Depth interval (inches)</u>	<u>Description</u>
1	0-2	Tan-gray, silt-clay mixed with coarse sand and fibrous detritus, no smell
	2-5	Tan-gray, silt-clay mixed with medium to coarse sand, small pea gravel, and medium gravel
	5-6	Gray medium sand to medium gravel
	6-8	Gray, tacky silt-clay
	8-13	Compact gray silt-clay interspersed with large gravel, some very fine fibrous detritus
	13-16	Clean, mixed silt and fine sand
	16-21	Uniform tan-brown fine to medium sand
2	0-2	Sterile-looking somewhat watery gray silt-clay
	2-19	Compact sterile-looking gray silt-clay

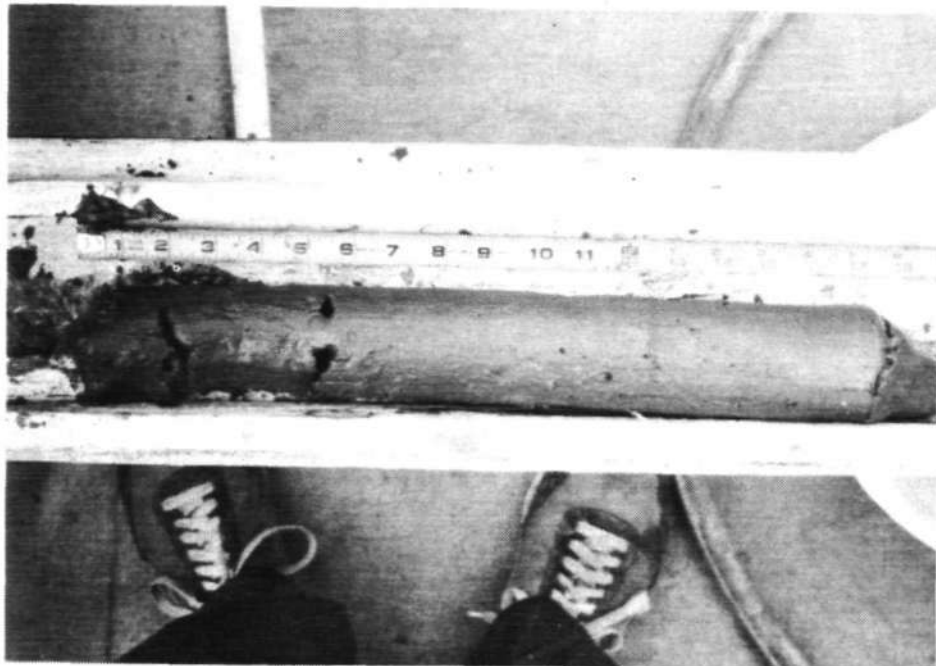
**Figure 18. Tremont Street outfall area core sample 2**
