Reduction of Non-Revenue Water through Continuous Acoustic Monitoring

David M. Hughes
American Water

RR-132
February 2016
www.istc.illinois.edu

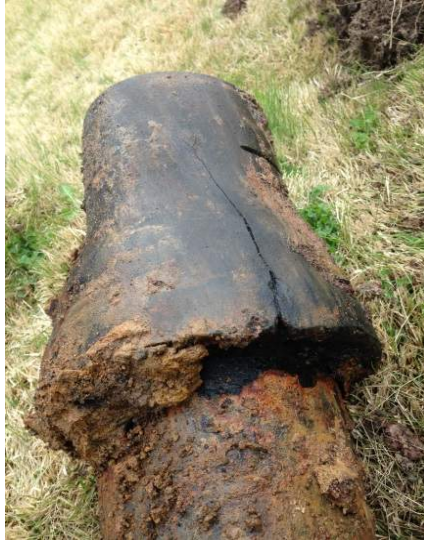
A leak identified remotely from the Toronto office of Echologics in the beta test site of Liberty, Pennsylvania, demonstrated the potential of the system to be piloted for the ISTC project. Although monitored flow at night suggested that there were no significant leaks in the Liberty distribution system, Echologics determined that there was a leak between two monitors. The leak was not initially detected by on-site listening devices; although on-site correlation confirmed a leak in the area, microphones in contact with the road surface over the pipe failed to confirm the leak for two weeks. By the third week, the software indicated the noise continued to persist and was growing louder, so Echologics dispatched their best technician and American Water agreed to excavate the dimly heard suspected leak location. The leak matched the correlation of both the CAM system and the field correlation. Figure 1.4 shows the crack in the bottom of the excavated pipe. The location of the crack and the porous soils inhibited such a leak from surfacing; in fact, the top of the pipe was dry when initially excavated.

The location of the leak at the bottom of the pipe, coupled with the water pocket formed underneath, minimized the transmission of the leak noise to the ground surface. It is both the experience of our leak detection specialists and those around the world that a leak such as this might run undetected for months, leading to the pipe's eventual rupture under pressure, and resulting in a large flow with significant water loss.¹ This find likely saved the system from losing about half a million gallons of water.

Figure 1.4 Cracked pipe from Liberty, PA. Leak found by acoustics.

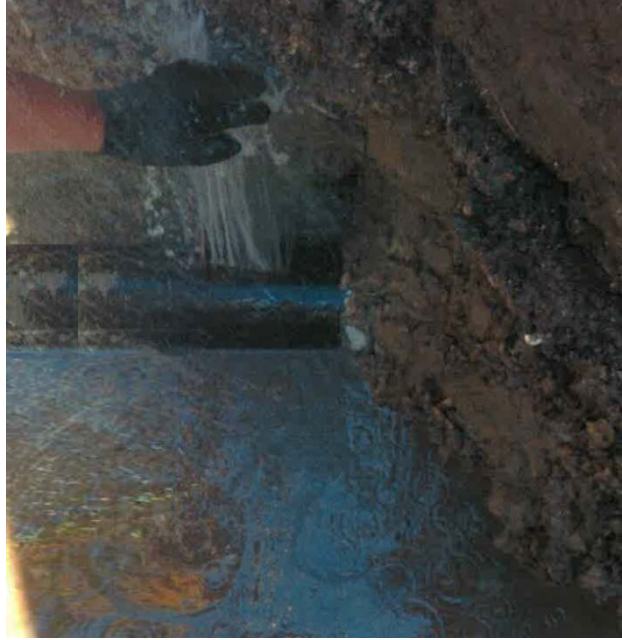
experience with non-surfacing leaks of this size suggests that as the leak slowly grows, the pathway to the sewer manhole would likely become more defined and could leave the leak undetected for weeks or months. It is possible that the sounds of the leak splashing into the manhole could have alerted the public to the problem, but this was not evident at the time of repair.

Figure 3.4 Leak on a six inch pipe Kincaid Court.

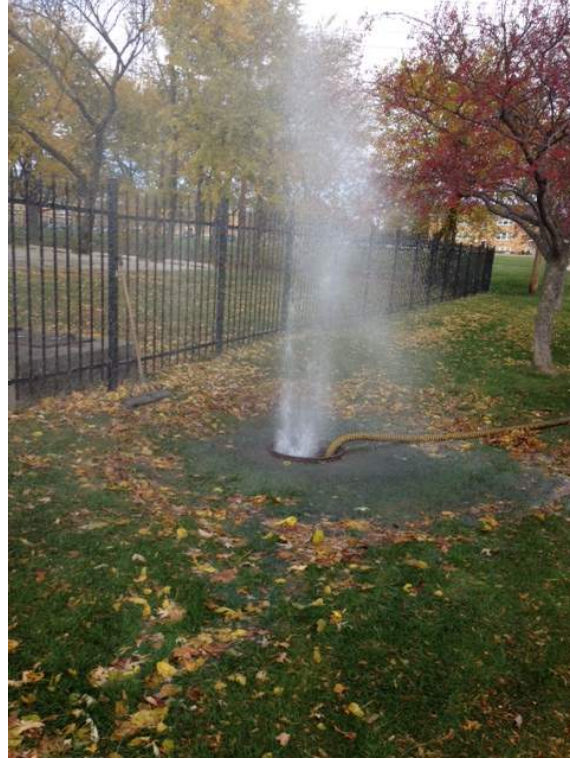
Echologics performed a high-sensitivity correlation with the working primary unit and a secondary unit more distant from the leak and confirmed that the system was able to find the leak through the local asbestos cement pipe. Figure 3.6 shows the location of the closest three units. The unit closest to the leak (WY00001) was the failed unit. Note that the closest working unit (WY00004) was more than 800 feet from the leak and the secondary correlating unit (WY00007) was more than 1,400 feet away. Leaks can be detected even from distant units such as these (Figure 3.7) if sensitive enough; however, too much sensitivity can lead to distracting data from multiple sources, including false positives. Had the failed unit been working, the leak would have been identified immediately. In any event, the time required to find this leak would not have changed the time required to repair it.

Figure 3.5 Linneman Road leak in meter pit on shutoff valve.

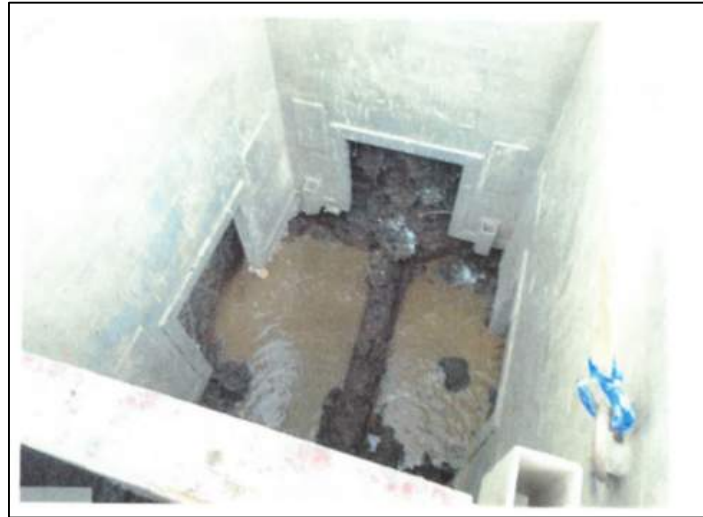
in the form of an acoustic monitor attached at the end of the system (on a curb stop or buried on the pipe) or a software modification that would provide for alarms when leaks occur out of bracket.

Figure 3.13 Leak repair at 1181 Stark Place.

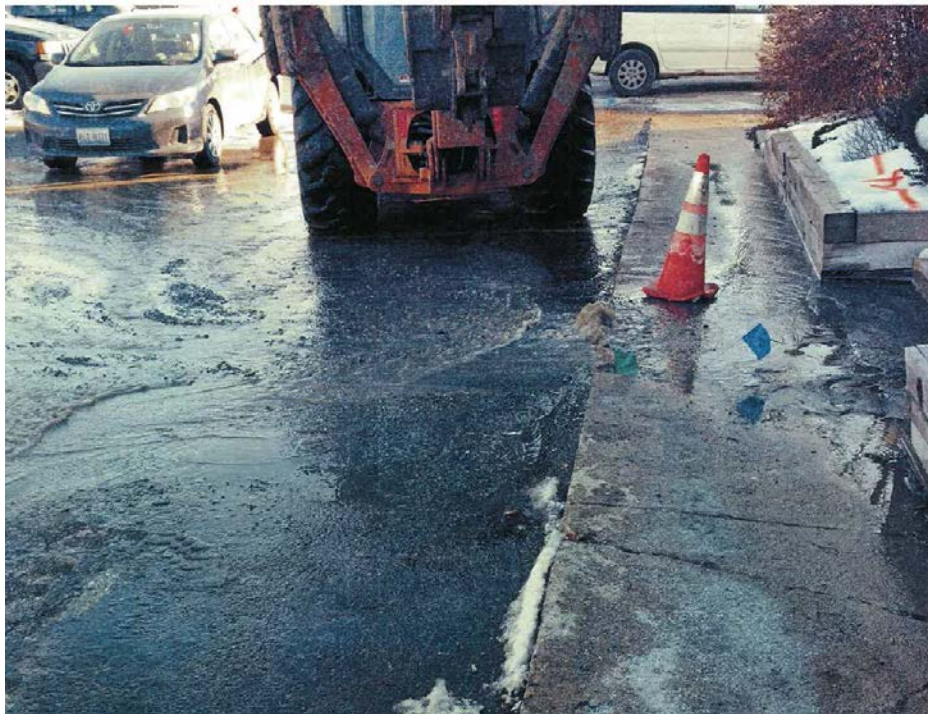
The Echologics monitors did not report this leak. Three loggers, WY046, WY047, and WY049 (Figure 3.18), were in the vicinity of the leak; the closest logger (less than 100 feet away) was WY046. Due to technical issues, the loggers (WY046, WY047 and WY049) failed to upload the acoustic files to the Echologics main server. The files, containing resonance information collected from the pipe, were saved and later uploaded to the server. These files were subsequently analyzed and studied by Echologics to provide leak information based on the acoustic data collected by the different nodes. Echologics was unable to confirm the root problem in its system. A few files were retrieved, but they were insufficient to allow a firm conclusion. But, given the nature of the leak and information that could be gathered prior to the leak surfacing, it is likely that the leak surfaced immediately.

Figure 3.19 Leak surfacing 724 Algonquin Road.

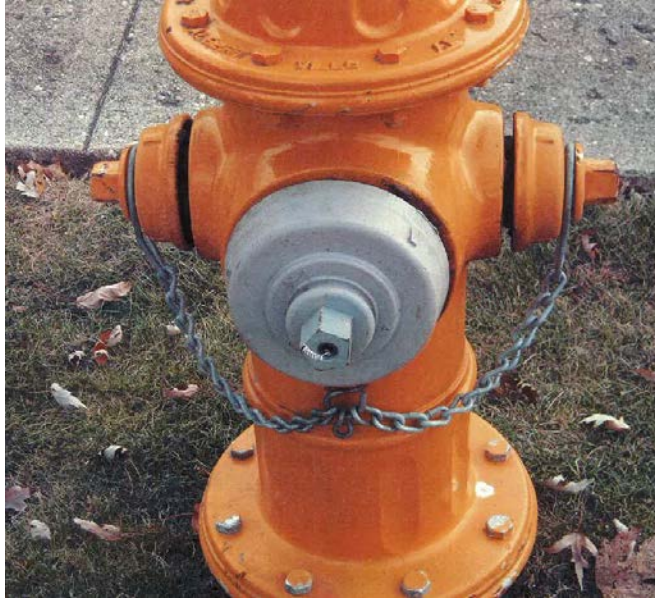
Echologics experienced one more functional issue in their startup manufacturing process of the new units. An internal clerical error generated several units with duplicate serial numbers, which prevented transmissions from one of the duplicate units Illinois American Water received. Again, the locations of the problematic units overlapped with leak locations. To their credit, Echologics responded proactively by performing a thorough analysis of functional loggers and performing a local field analysis to verify that units were functioning when sudden leaks occurred.

Figure 4.1 Damage on hydrant cap.

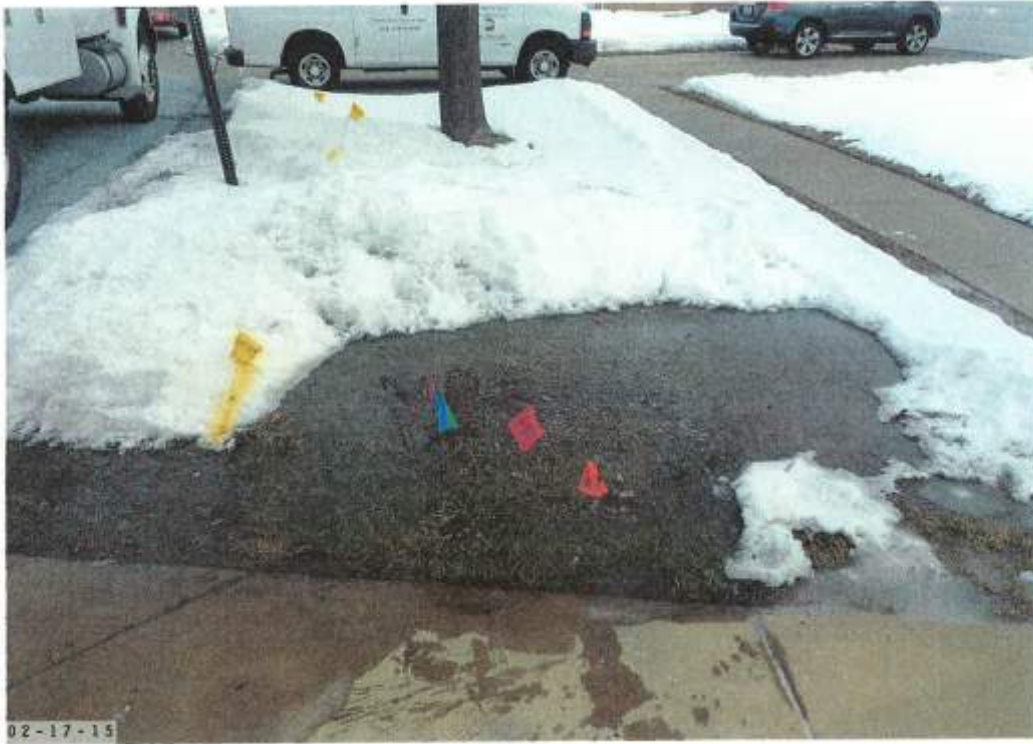
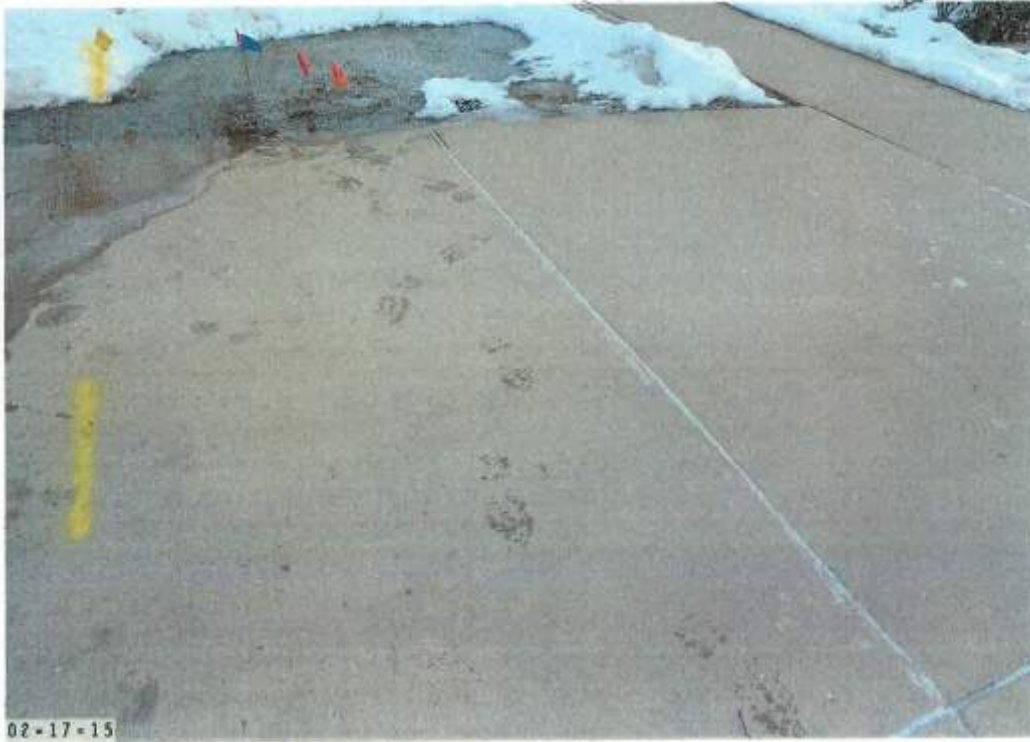
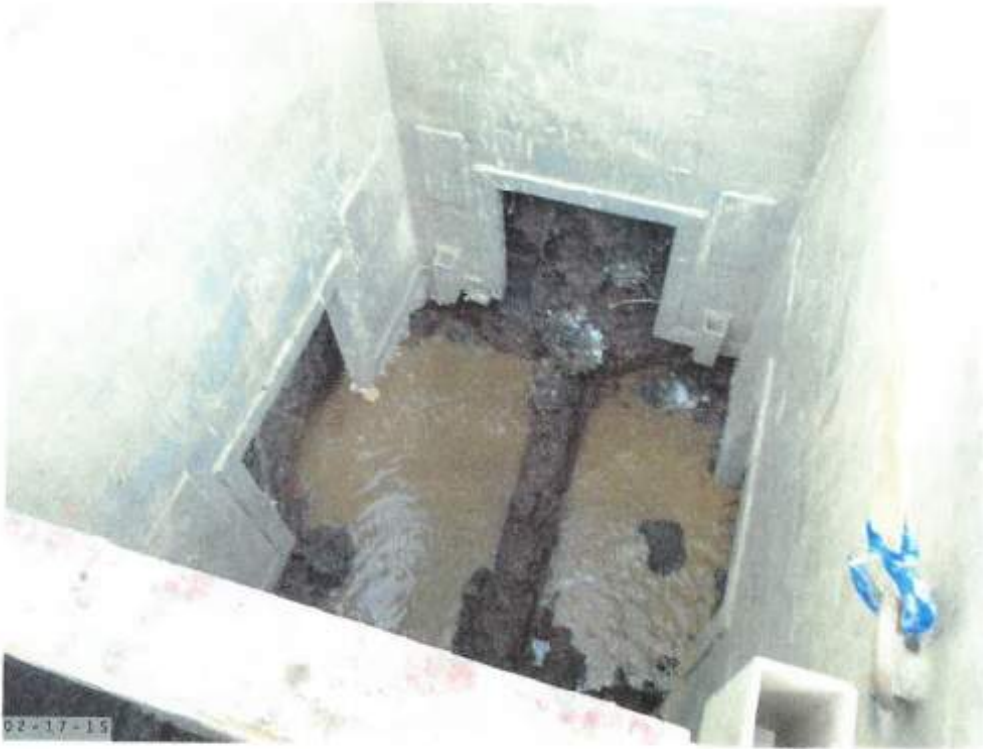
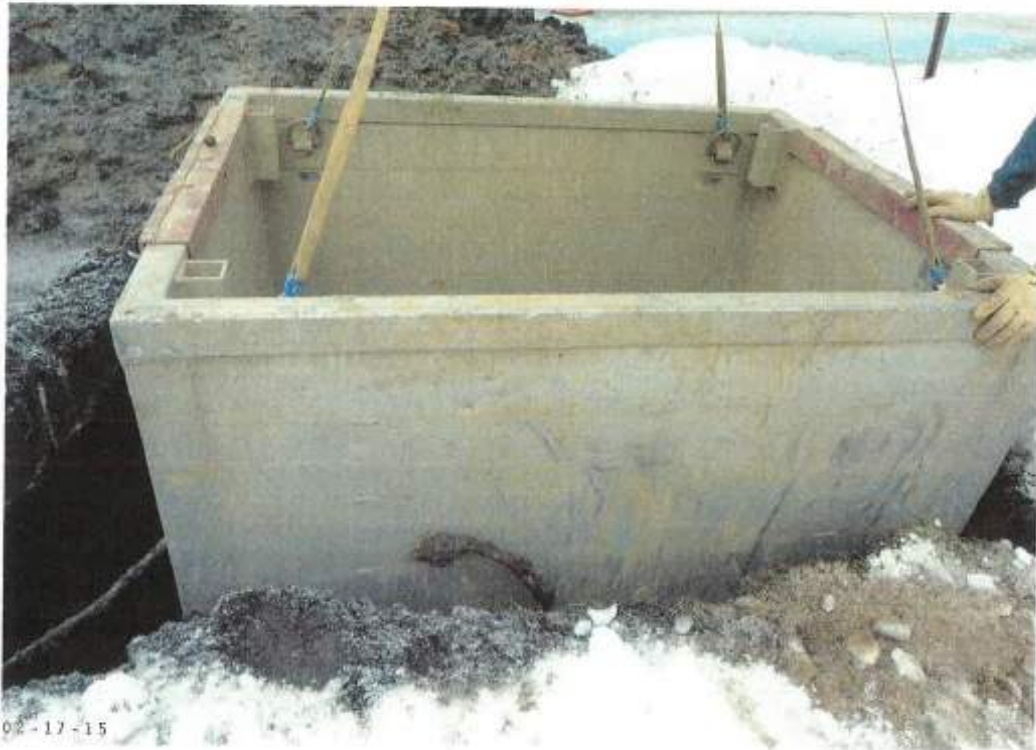
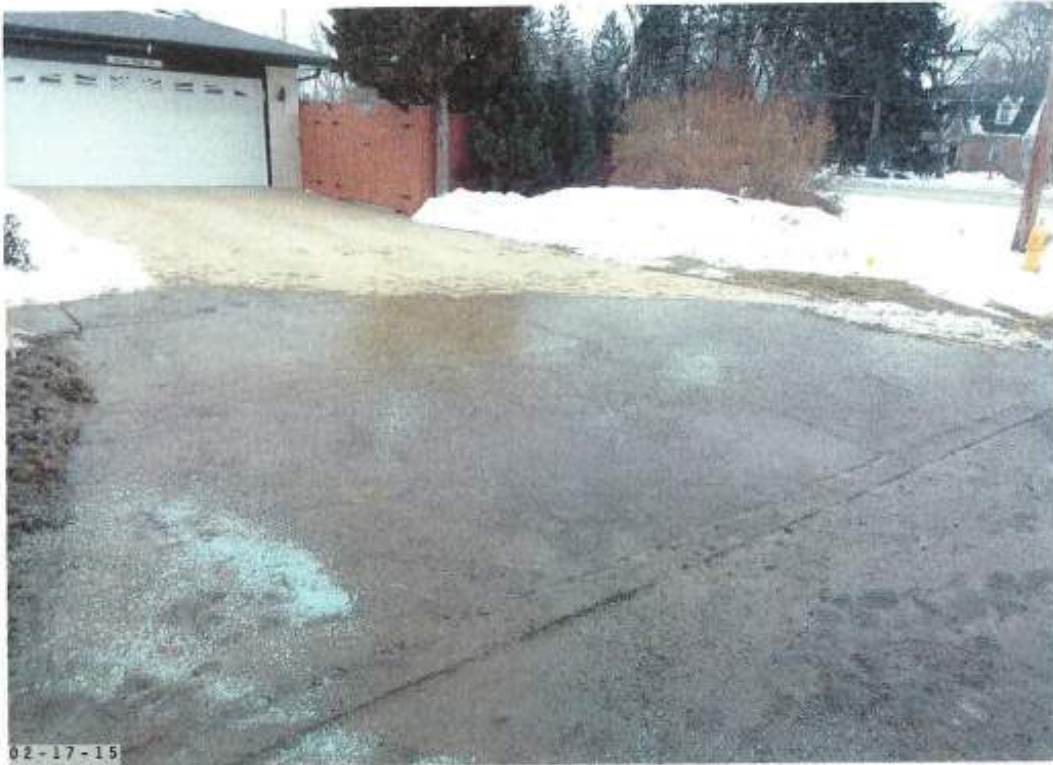
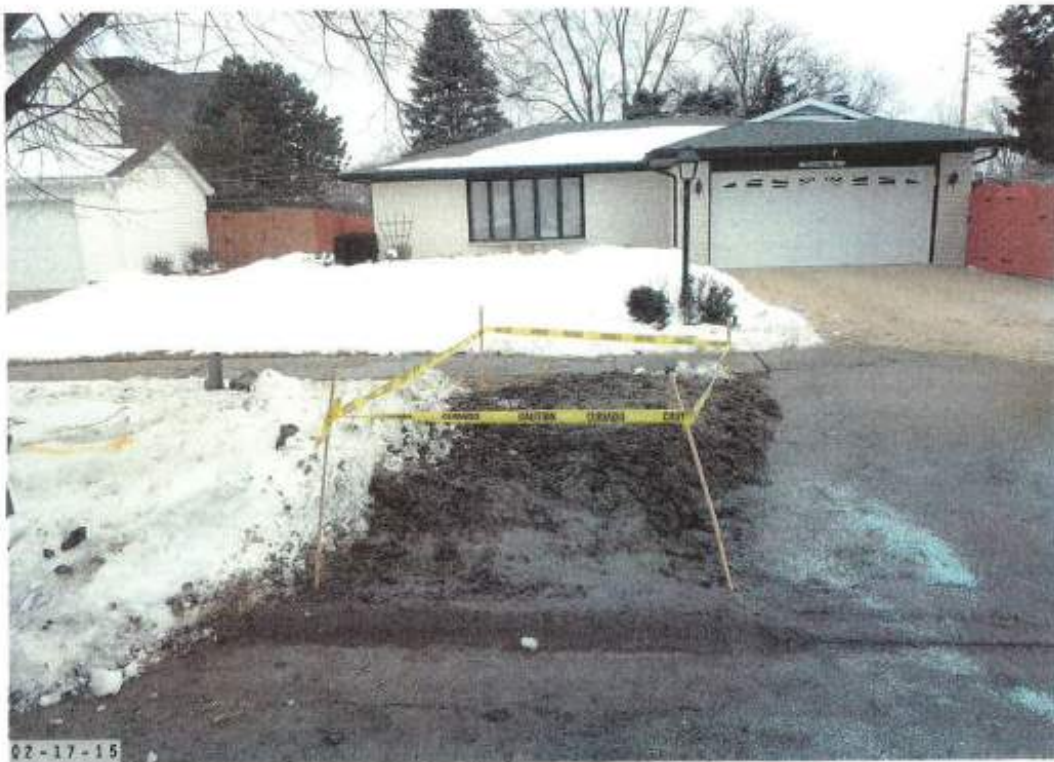
Figure B.1 Sample photos taken by staff at locations of leaks.
