INVENTORY OF PHYSICAL CHARACTERISTICS
OF THE
ILLINOIS SHORE NORTH OF CHICAGO

Charles Collinson
Patricia L. Drake
Charlene K. Anchor

Prepared by the
ILLINOIS STATE GEOLOGICAL SURVEY
for
THE ILLINOIS COASTAL ZONE
MANAGEMENT PROGRAM

October 1975

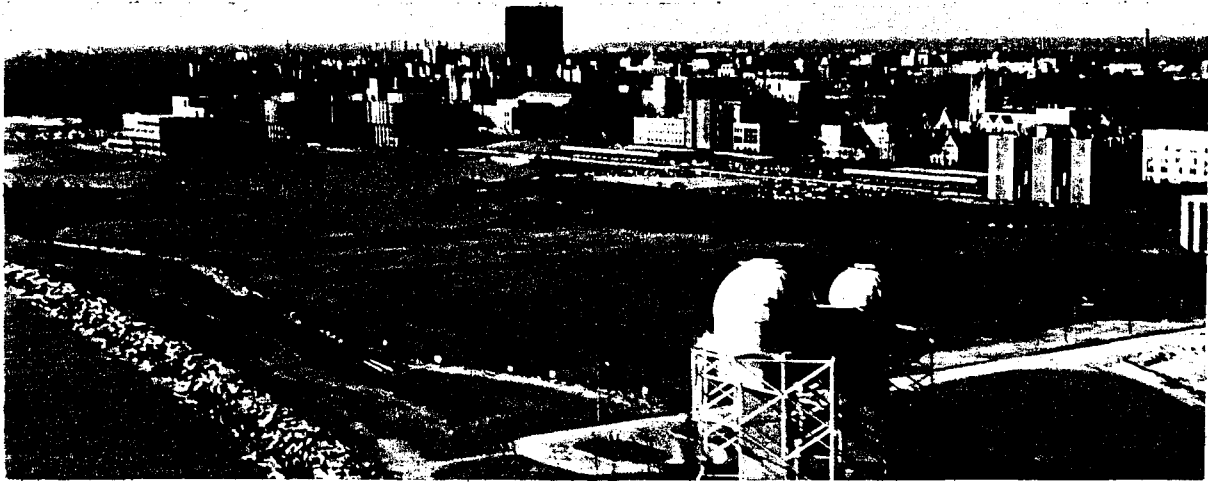
Fig. 2 - (middle) View, looking southwest, at the Northwestern University landfill and lagoon area (E14). The fill is well protected by organized rubble mound seawalls. The area projects more than a 1000 feet into the lake and is one of the major promontories on the shore. Some littoral sediment is impounded on its north side, whereas other sediment is deflected into deeper water. Current and sediment distribution studies may lead to discovery of usable sediment resources associated with the structure.

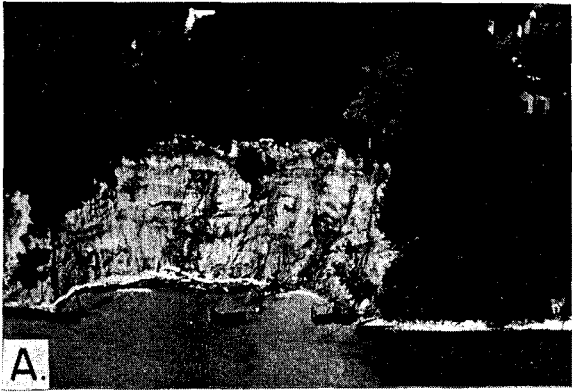
- A. A high bluff reentrant at LB23 in Lake Bluff. The bulkhead failed in 1969 and the reentrant has formed since then. The dark areas mark seeps. This photo was taken August, 1974. Rubble-fill has been added during 1975.

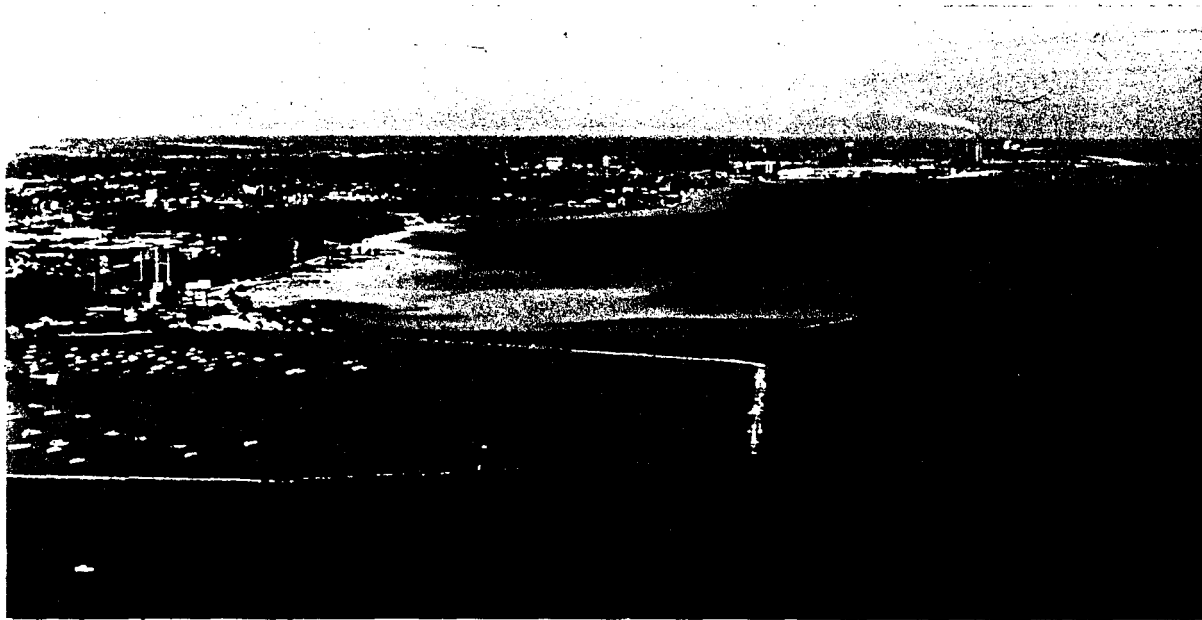
The jetties extend 1/3 mile into the lake. Their effect on long-shore littoral sediment drift is the subject of detailed study for FY1976. As can be seen in Fig. 8, plumes of sediment are deflected into the open lake as well as impounded north of the harbor. Detailed hydrographic mapping is part of the FY1976 study.

Fig. 5 - View of Great Lake Naval Training Center harbor jetties, showing shallow water turbidity within the harbor. North of the harbor a sediment plume drifts offshore in the face of a northeast wind.

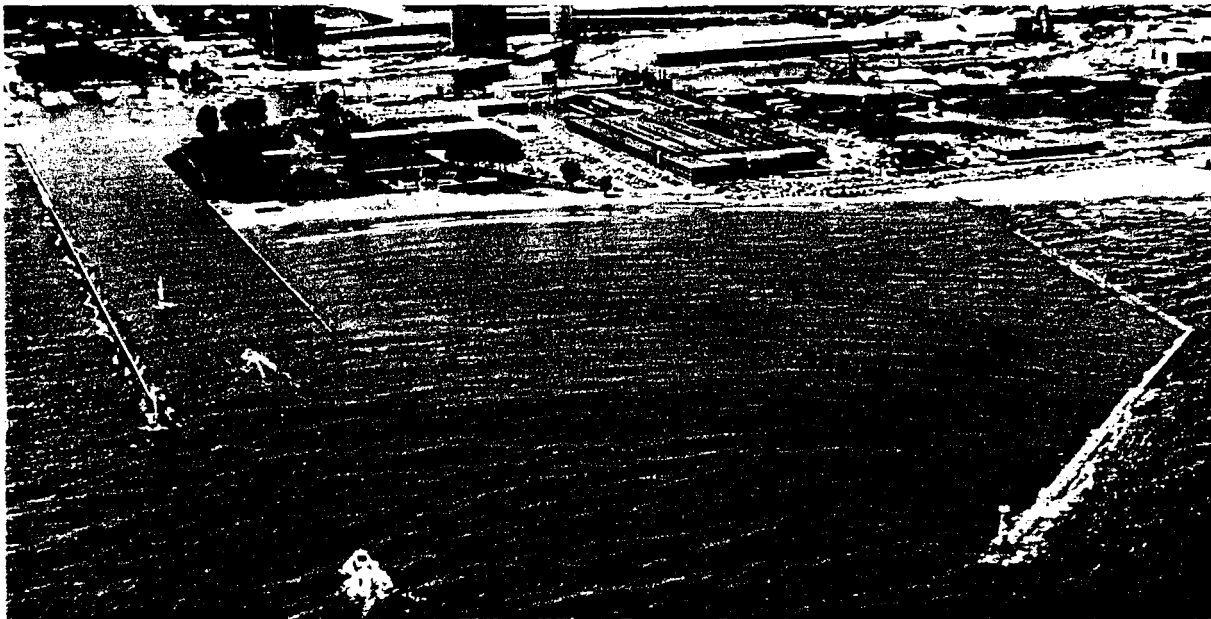
Fig. 6 - View of Waukegan harbor showing the outer jetties and the inner channel (left). This is the south end of the Zion beach ridge complex.

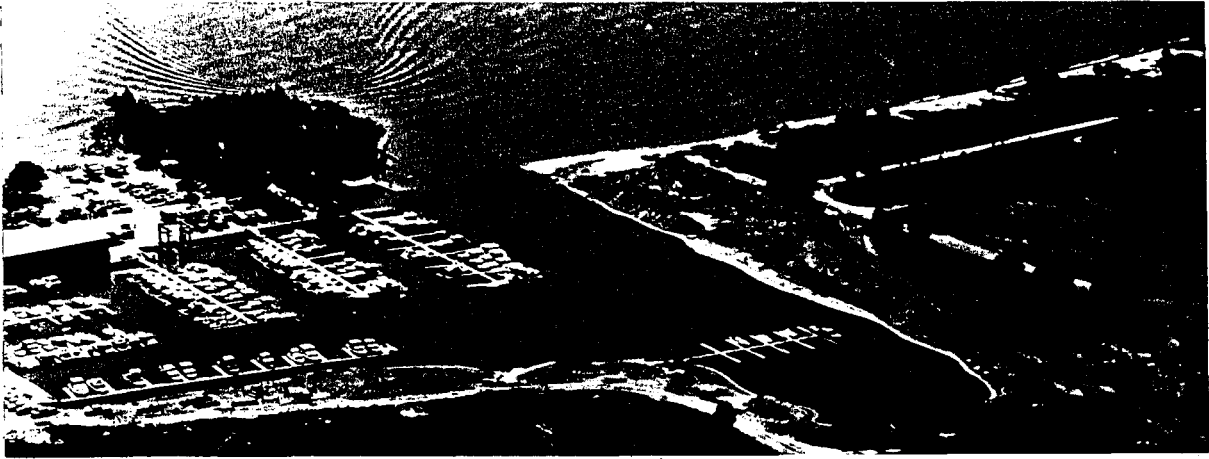
Fig. 11 - (top) View of Trident Harbor from the northwest. The Wisconsin-Illinois boundary is at the south shore of the harbor. The area just south of the harbor has shown the greatest rate of erosion on the Illinois shore during the past 100 years--more than 500 feet.
