NSEL Report Series
Report No. NSEL-046
December 2016

Structural and Geotechnical Observations after the April 25, 2015 M7.8 Gorkha, Nepal Earthquake and its Aftershocks

**Larry A. Fahnestock
and
Youssef M. A. Hashash**

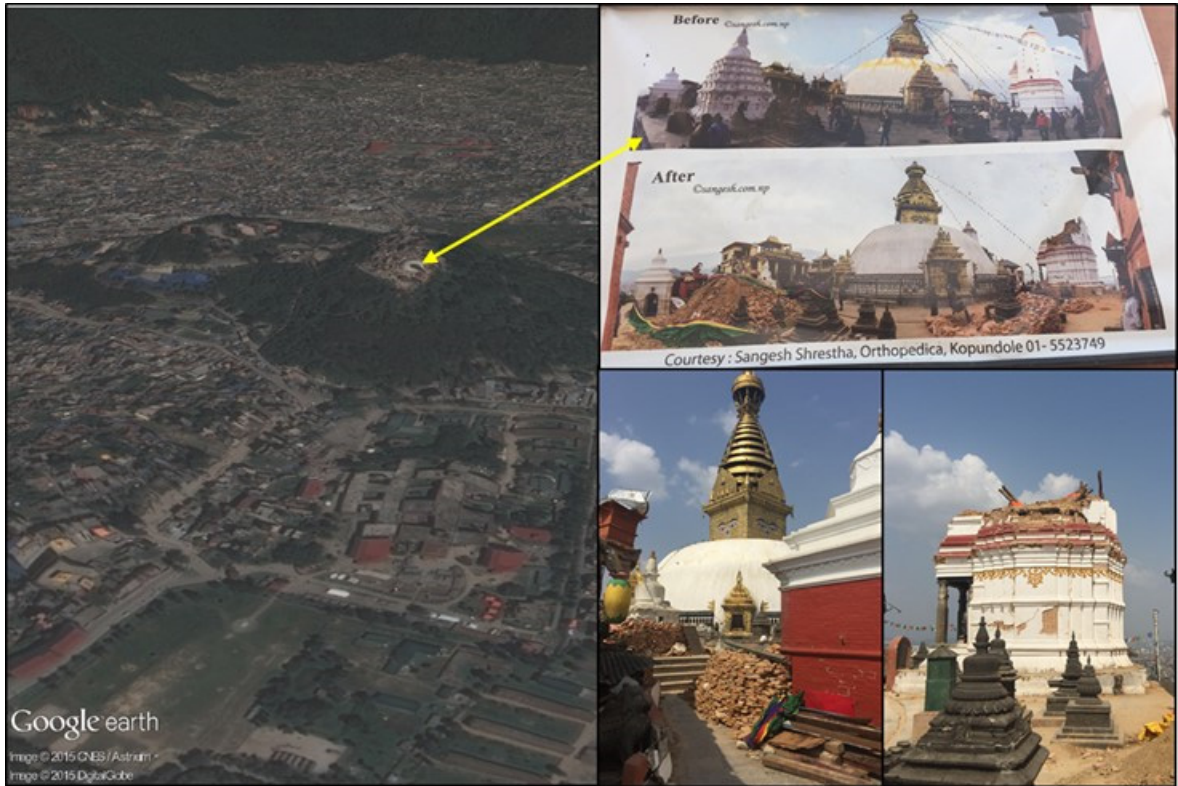
Figure 2.4 Damage in Swayambhu (Monkey) Temple (27.715270 N, 85.290231 E) (after Hashash et al. 2015).

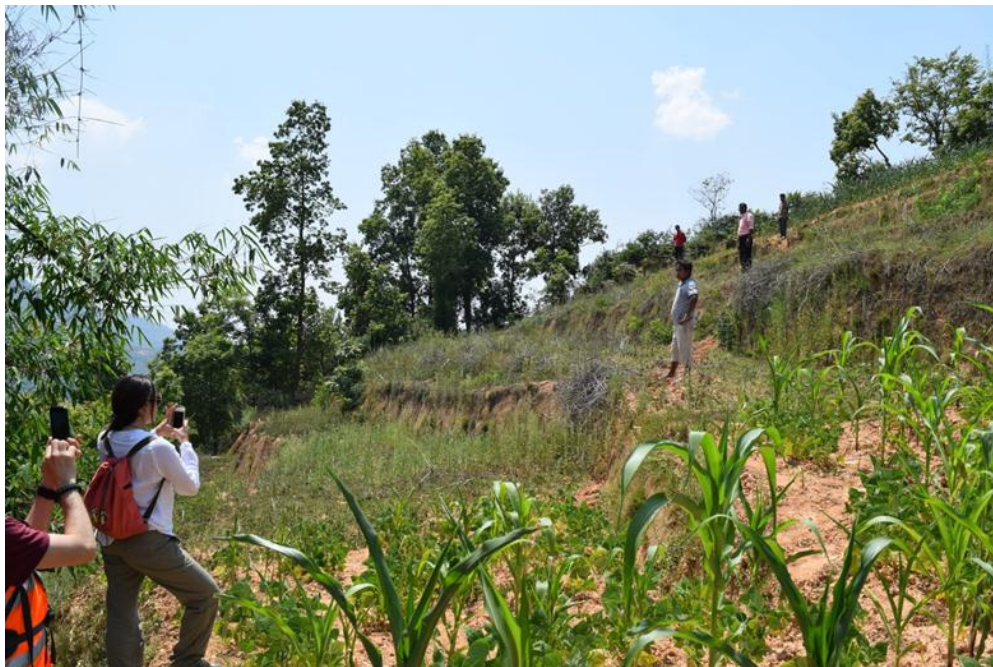
A more comprehensive description of the landslides from this event can be found in Collins and Jibson (2015). A landslide fissure was observed at the ridge of Ramkot Village, which is located at the edge of the Kathmandu Valley (Figure 2.6). The extensive fissure is more than 15 cm wide.

Figure 2.6 Head scarp observed on the ridge of the slope triggered by the 2015 earthquake (after Hashash et al. 2015).

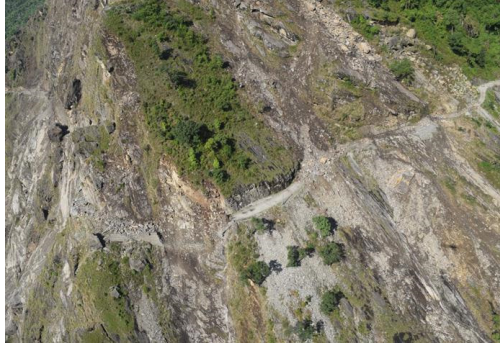
Figure 2.7 Charikot-Lamabagar road sector affected by landslides triggered due to the earthquake .

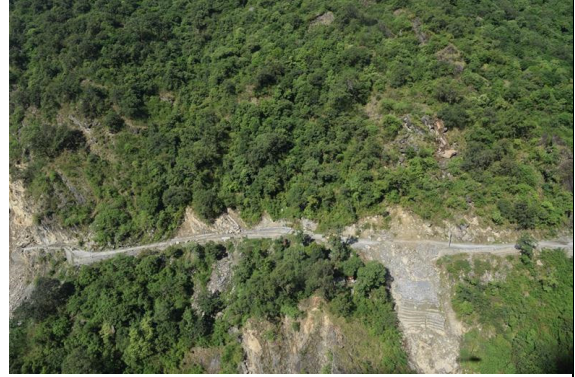
Figure 2.8 Gabion retaining walls that did not perform well along the Charikot-Lamabagar Road.

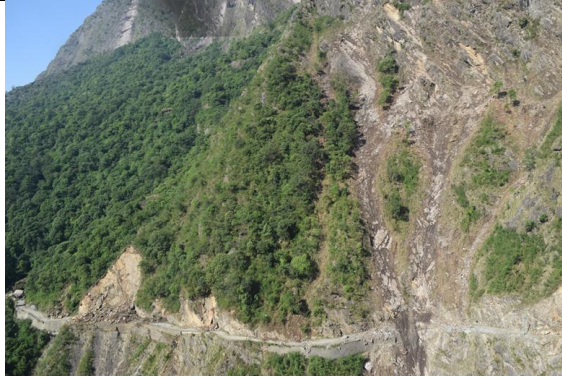
Figure 2.9 Landslides observed along the road alignment constructed along steep terrain.

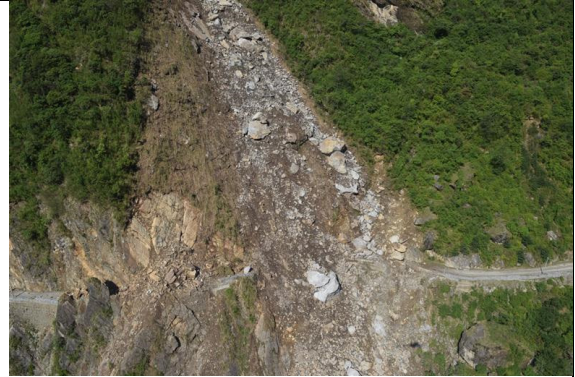
Figure 2.10 Large scale landslides that affected the Charikot-Lamabagar Road sector.

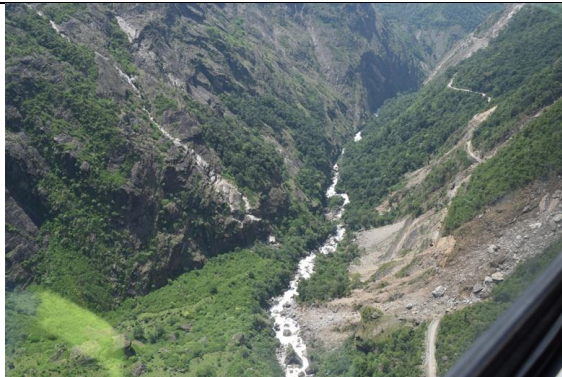
Figure 2.11 Landslide near the dam site of the hydropower project that damaged the road.

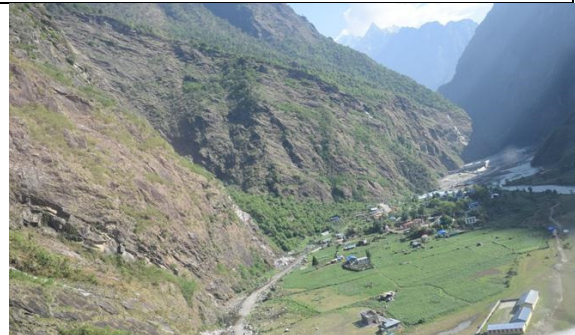
Figure 2.12 Landslides observed along dam site of the Upper Tamakoshi Hydropower project.

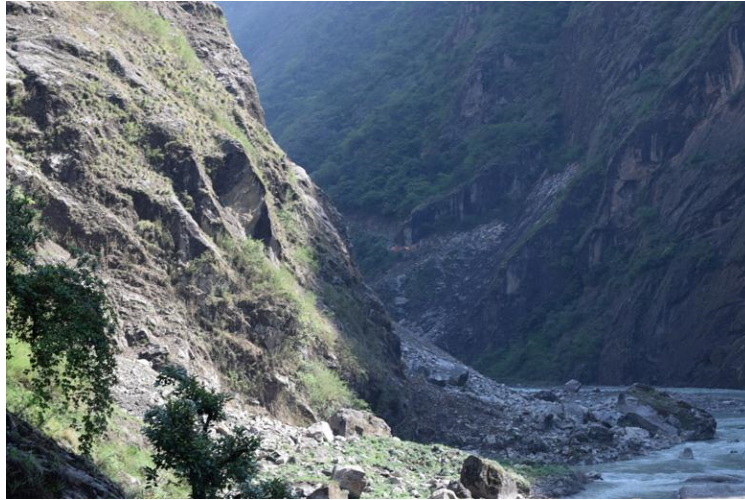
Figure 2.13 Rockfall upstream of the hydropower project (after Hashash et al. 2015).

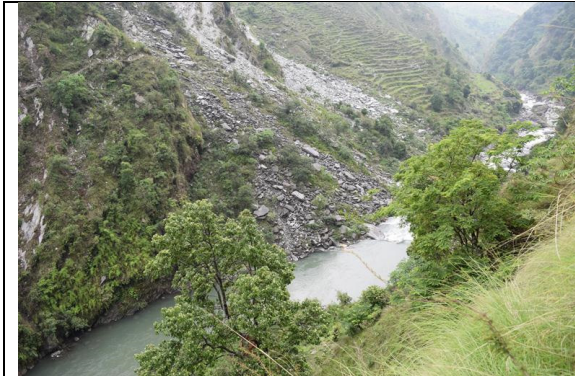
A landslide dam was observed at Pandise, located in the Sertung Village Development Committee of the Dhading District (Figure 2.14). The landslide occurred at Ankhu Khola, a tributary of the Budi Gandaki River. The slope gradient of the tributary was approximately 30-35°, and large boulders traveled down the tributary of Ankhu Khola, blocking the river channel for about a week (Figure 2.15). The landslide dam was breached naturally.

Figure 2.14 A landslide dam at the tributary of Ankhu Khola right after the 2015 Gorkha earthquake main shock (28°40.6'0"N, 83°59.8'0"E).

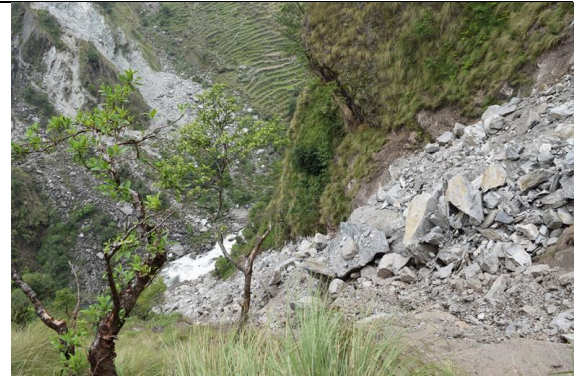
Figure 2.15 Debris mass from the left bank of the river that caused the landslide damming.

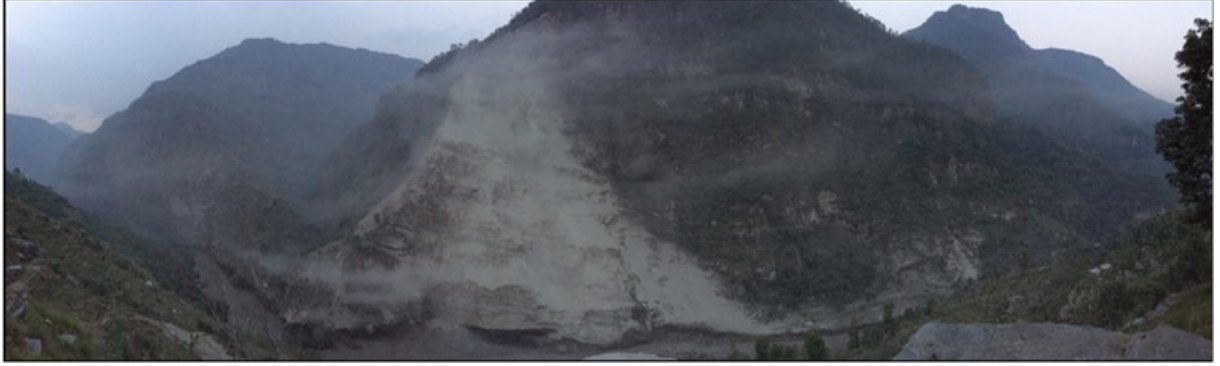
Figure 2.16 The landslide blocked the Kali Gandaki River forming approximately 2 km long and 150 m deep artificial lake (28°24'8.48"N, 83°35'47.5"E) (after Hashash et al. 2015).

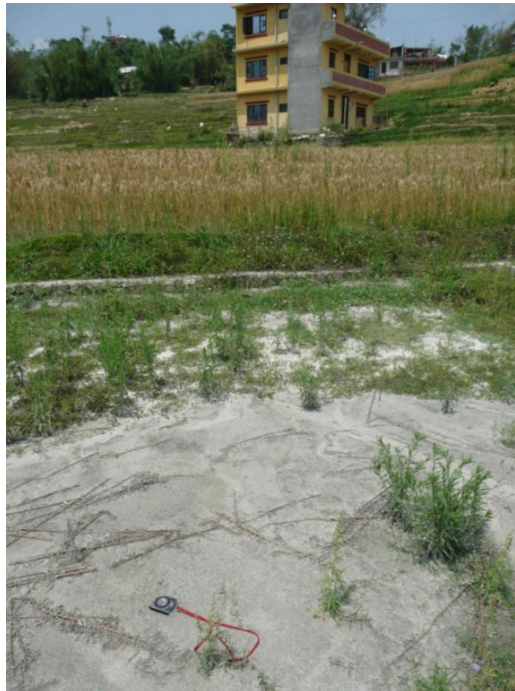
Figure 2.17 Liquefaction ejecta in agricultural field. Material was very fine, primarily silt with some sand. No damage to the building in the background (27.711025°N, 085.262290°E) (after Hashash et al. 2015).

According to the locals, the ground flooded during the earthquake and remained flooded for two days. Locals also claimed that other plots in the vicinity liquefied, but surface effects of liquefaction were not evident elsewhere. Auguring on this site revealed that the soil profile generally consists of interbedded layers of loose fine sand and silt up to 2.5m depth. The water table was located approximately 3m below the ground surface.

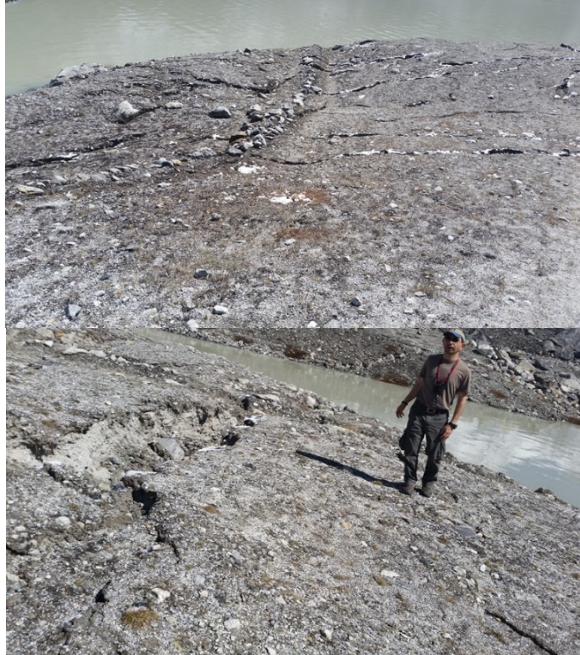
The Tsho Lorpa glacial lake dam is a natural lake located at an elevation of 4,535m (Figure 2.18). A spillway was built to control the water level in the lake and prevent overtopping and possible breaching of the natural dam. The site was visited by helicopter to examine the integrity of the natural dam material around the lake (Figure 2.19) as well as the spillway (Figure 2.20). The natural dam material showed no cracking or slumping. At the spillway, lateral spreading was observed on the lake side. Significant lateral and vertical displacement (Figure 2.21) are observed in excess of a total of approximately 1.5m laterally and 0.5 m vertically.

Figure 2.21 Lateral Spreading along the upstream side of the spillway (27°52'9.57"N, 86°27'44"E) (after Hashash et al. 2015).

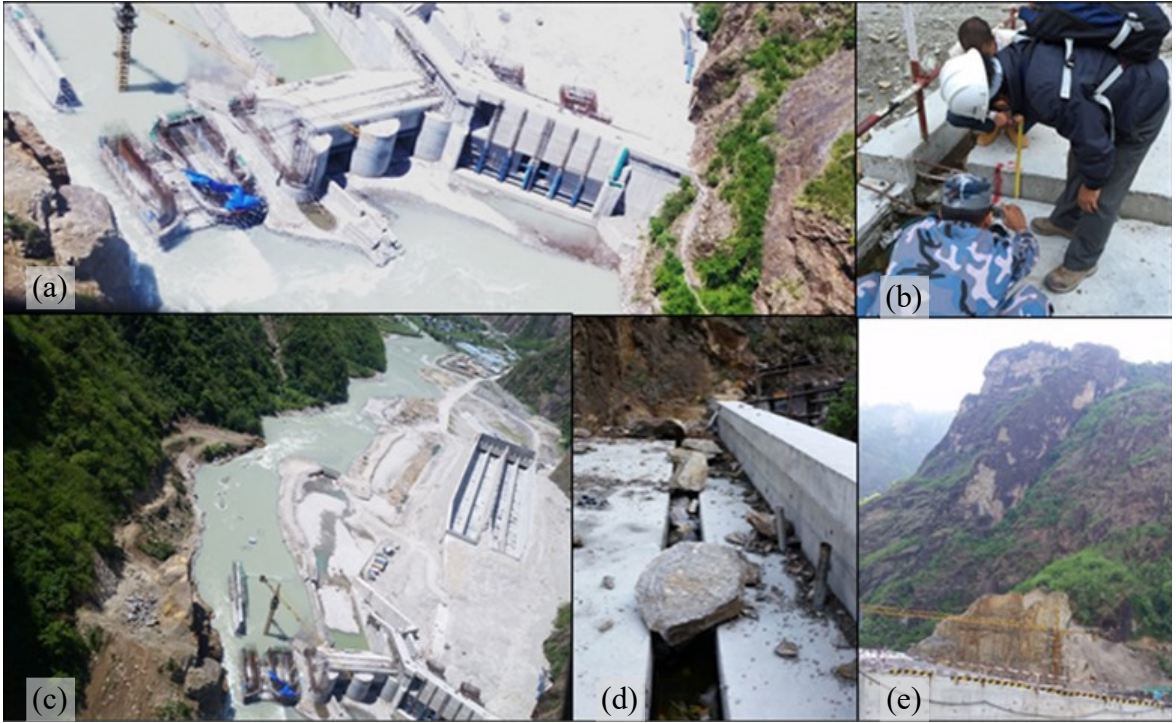
The 456 MW Upper Tamakoshi Power Plant was considered the national priority project, since upon completion, it will be the largest hydroelectric project in Nepal. The earthquake-induced ground shaking caused excessive settlement in the headworks resulting in an interruption in the construction schedule. According to the Upper Tamakoshi Power Plant authorities, 4cm of settlement occurred after a M5 earthquake on December 18, 2014. Settlement increased to 12 cm and 18 cm after the April 25 mainshock and the May 12 aftershock, respectively (

b). On April 27 a landslide induced by the April 25, 2015 earthquake closed the access road to the headworks. The earthquake also toppled a gabion wall used as a cofferdam/diversion structure (Figure 2.22c). Rockfalls were observed in the headworks area (Figure 2.22d). The very steep left and right abutments may create further landslide hazard at the site (Figure 2.22e).

Figure 2.22 Damage observed at the Upper Tamakoshi Power Plant: (a) Aerial image of the headworks; (b) settlement at the headworks; (c) breached cofferdam; (d) rockfalls; (e) steep slopes at the abutments ($27^{\circ}55'29.8''\text{N}$, $86^{\circ}12'46.4''\text{E}$) (after Hashash et al. 2015).

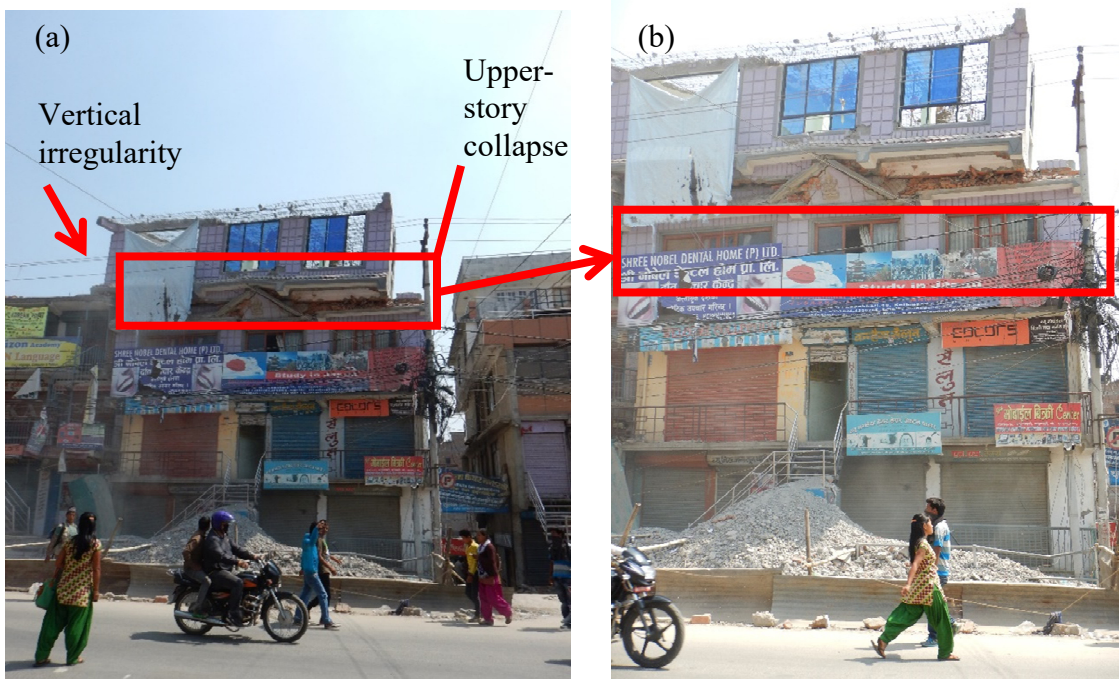
Figure 3.1 RC frame building with upper-story collapse; Balaju, Kathmandu: (a) overall view showing vertical irregularity; (b) zoomed-in view showing collapsed story.

Figure 3.1 shows a building with collapsed stories in the upper portion of the structure. (Note that for these and all subsequent photographs, GPS coordinates are provided in Appendix A.) The response of this building was likely affected by the adjacent shorter building, which was built tight up against its taller neighbor. This shorter building significantly stiffened the lower three stories and focused soft / weak story collapse at the vertical irregularity. Figure 3.2 shows a building that experienced soft / weak story collapse at the base of the building, which tipped and was subsequently arrested by a neighboring building. Figure 3.3 shows a building being demolished by hand after experiencing a multi-story pancake collapse. Residents of the neighborhood reported that this building survived the main shock and all occupants evacuated safely, but subsequently collapsed during a small aftershock. Figure 3.4 shows a building with a larger plan area that developed pancake collapses in the first and second stories. The columns contained light transverse reinforcement at large spacing, which led to shear failure and longitudinal bar buckling.

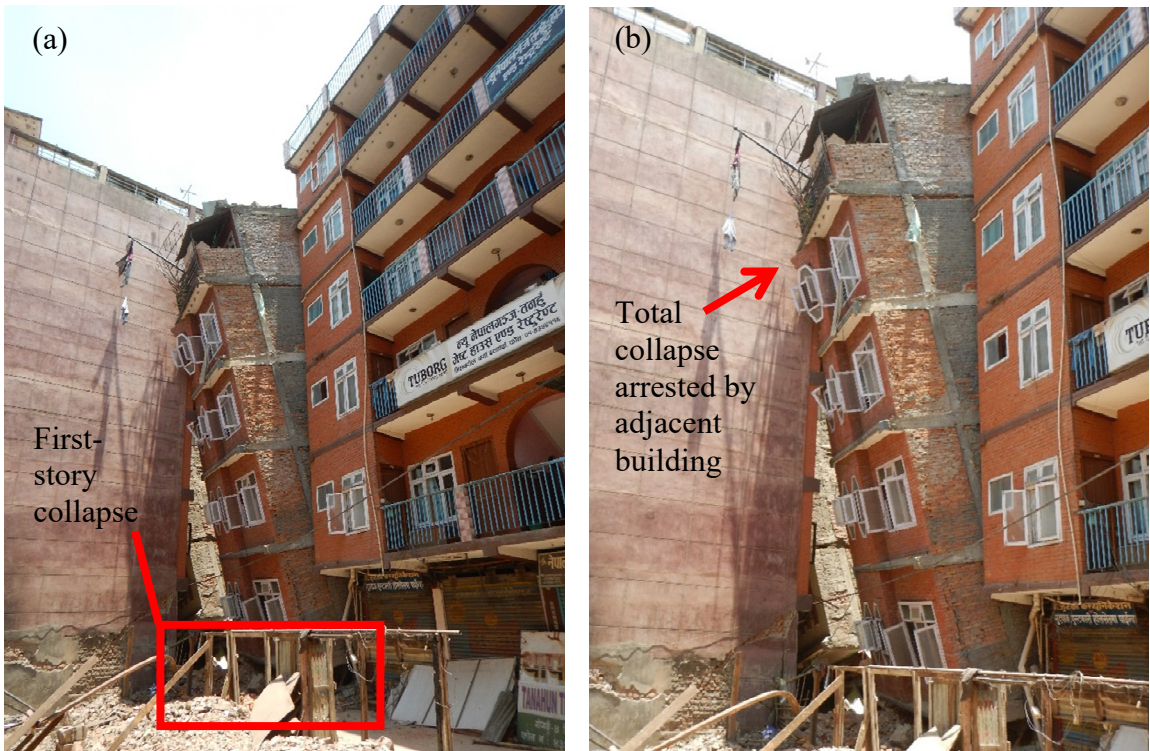
Figure 3.2 RC frame building with first-story collapse; Balaju, Kathmandu: (a) overall view showing first story collapse; (b) zoomed-in view showing contact with adjacent building.

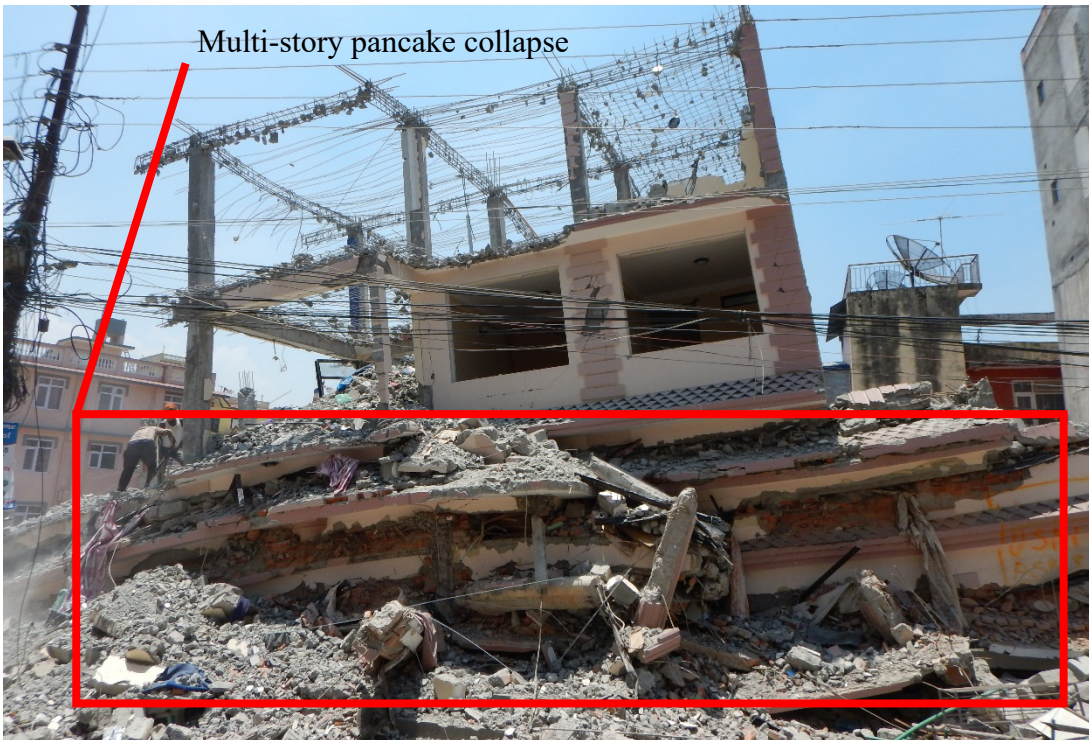
Figure 4.3 RC frame building with multi-story pancake collapse; Balaju, Kathmandu.

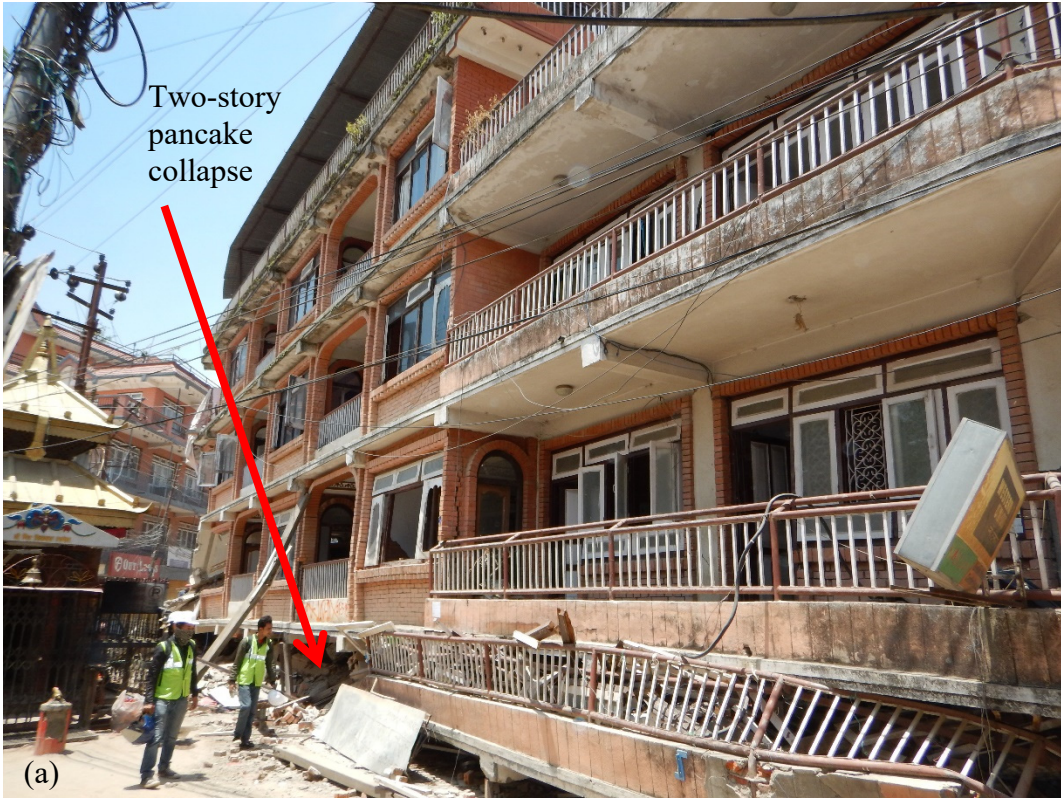
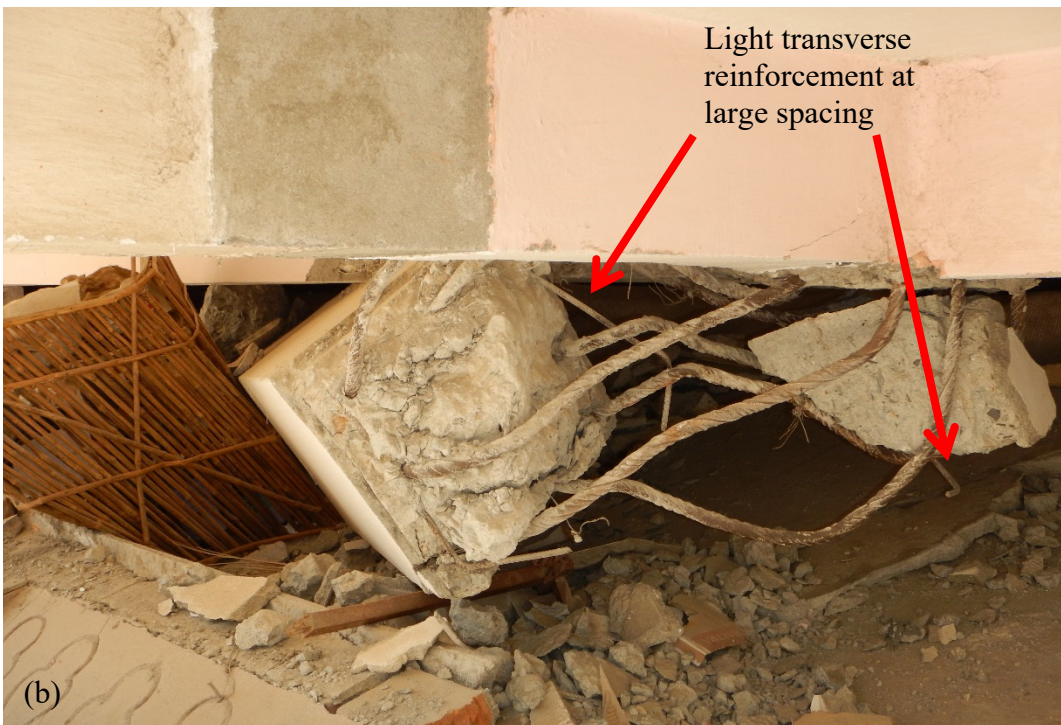
Figure 3.4 RC frame building with pancake collapse in first and second stories; Balaju, Kathmandu: (a) overall view of building; (b) zoomed-in view of column failure.

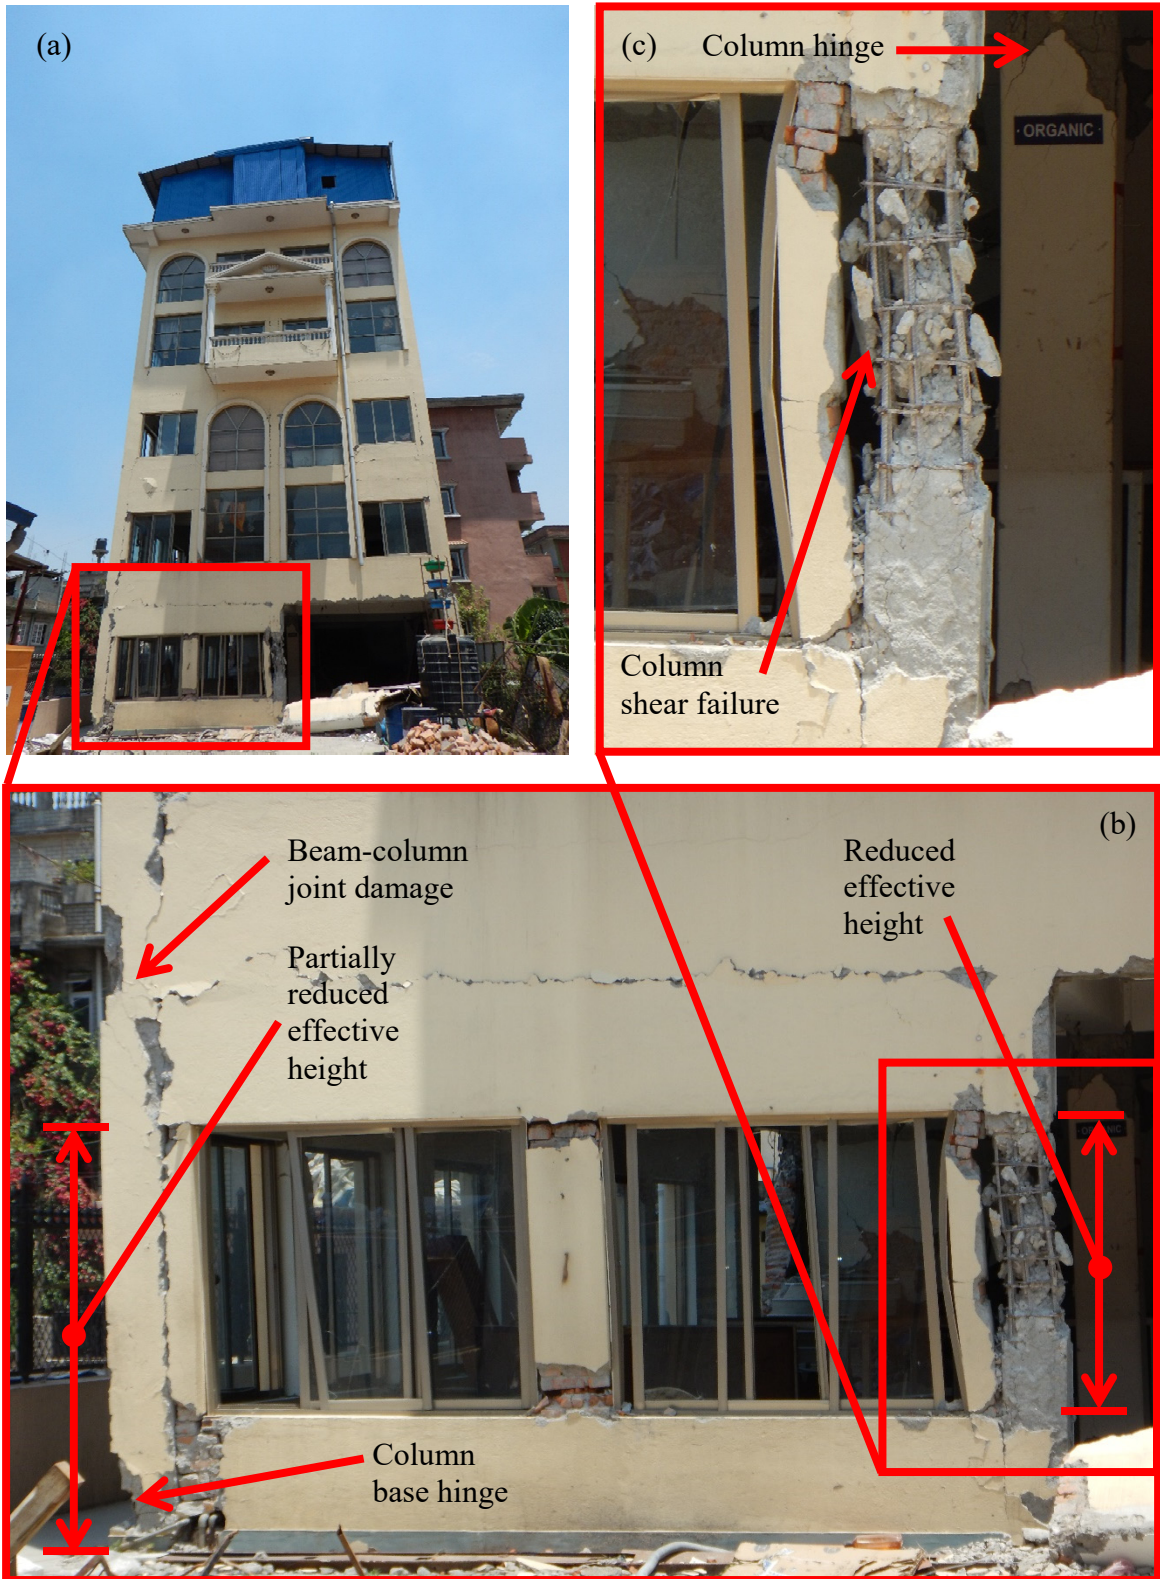
Figure 3.5 RC frame building with severe damage, but no collapse; Balaju, Kathmandu: (a) overall building view showing soft / weak first story due to drive-in bay; (b) zoomed-in view of partial first story; (c) zoomed-in view of column with shear failure.

Some RC frame buildings sustained severe damage, but did not collapse. For example, Figure 3.5 shows a multi-story residential building that has extensive degradation in the first story. (In these photos, North is to the left.) The first story was effectively softer / weaker than the upper stories due to the drive-in bay in half of the story, which did not contain masonry infill. In the other half of the first story, the partial masonry infill influenced the response. At the corner column, a hinge developed at the column base, with more damage evident on the outside of the building, which was the compression side when the building was being pushed to the North (Figure 3.5b). For loading in the North direction, this corner column was separated from the lower region of masonry infill (below the windows), such that the column effective height extended from ground to the top of the window region. This corner column did not develop a shear failure. In contrast, the center column was constrained by the masonry infill above and below the window region, and the reduced effective height caused the column to fail in shear (Figure 3.5c). However, the building did not collapse, and the damaged column reveals more tightly spaced transverse reinforcement (less than one column depth) than was observed in most other damaged / collapsed buildings. In Figure 3.5c, also note the development of a flexural hinge at the top of an interior column, which was not constrained by masonry infill. The damage pattern and post-earthquake lean of this building indicate that demand may have been more heavily concentrated in the North direction at this site.

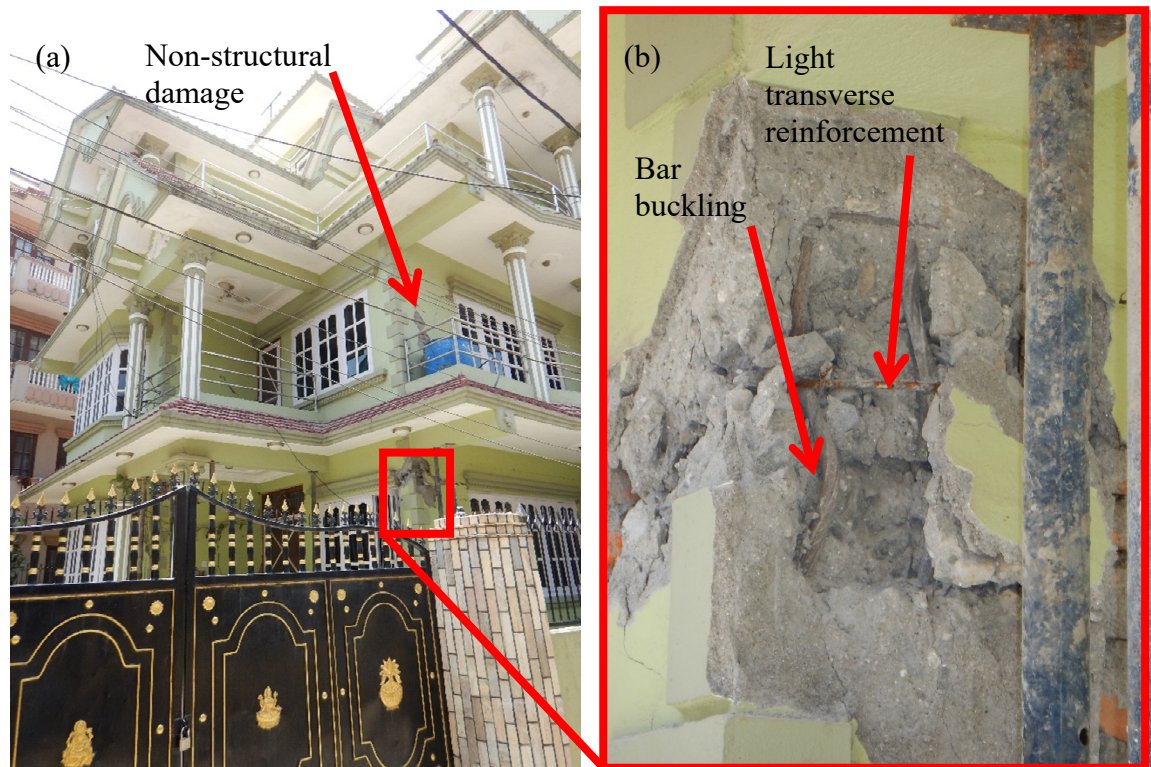
Demonstrating the marked variability in response within close proximity, Figure 3.6 shows a more ornate multi-story residential building that sustained only non-structural masonry damage and beam-column joint shear failure, but did not collapse. The damaged beam-column joint reveals only one visible transverse bar and longitudinal bar buckling.

Figure 3.6 RC frame building with significant damage, but no collapse; Balaju, Kathmandu: (a) overall view; (b) beam-column joint failure.

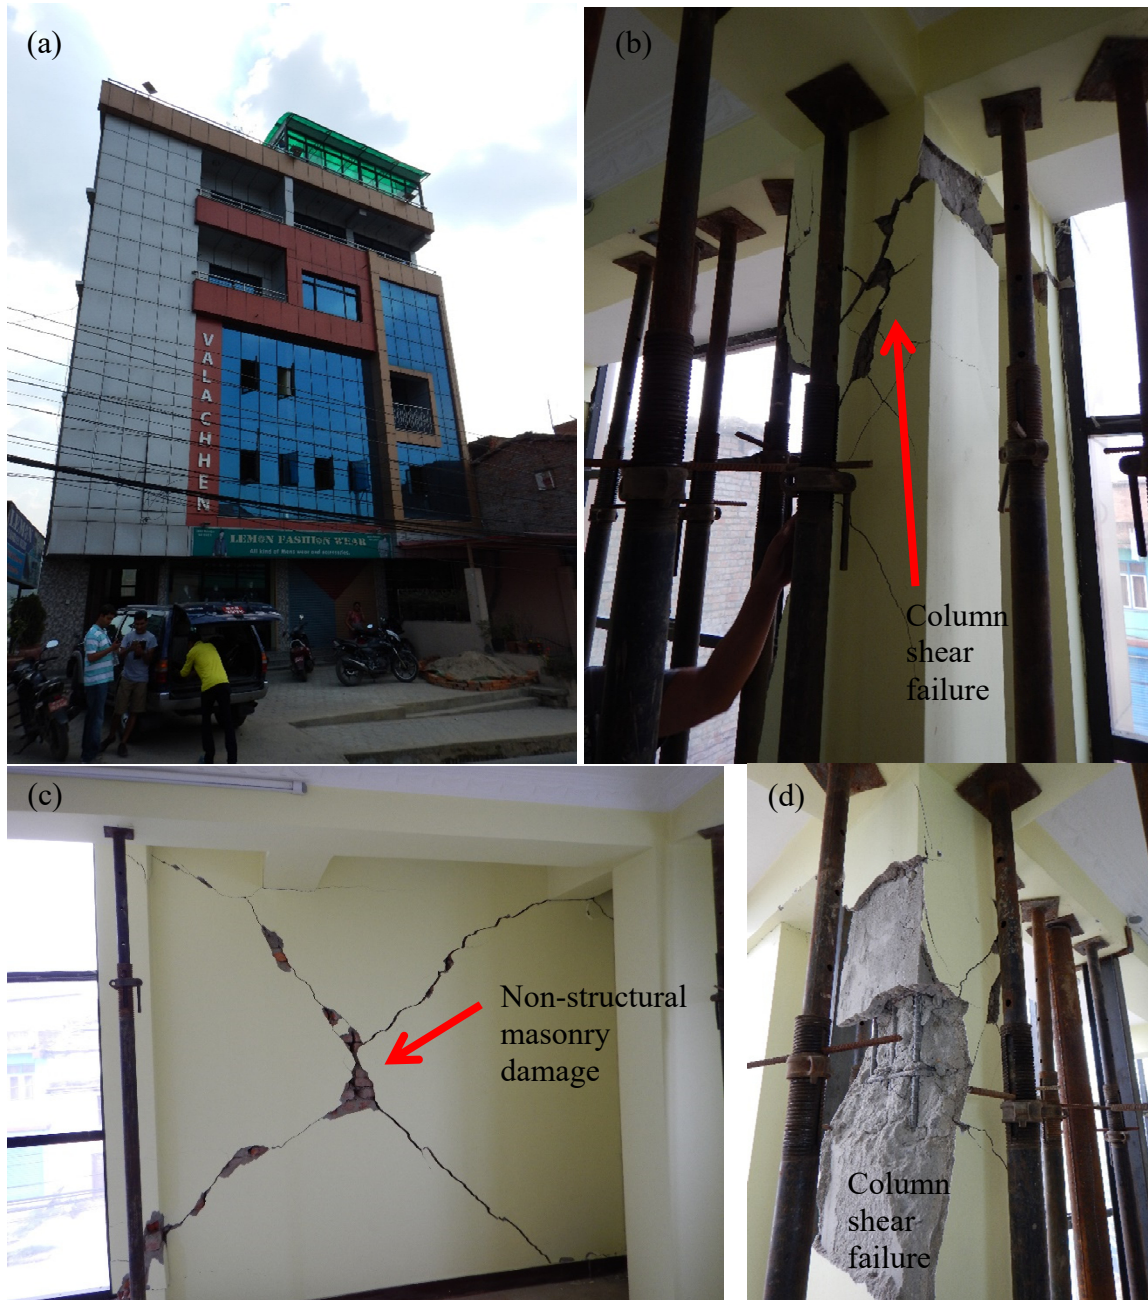
Figure 3.7 Valachhen Building, RC frame with structural and non-structural damage: (a) exterior elevation view; (b) column shear failure; (c) nonstructural masonry damage; (d) column shear failure.

One such structure is the Valachhen Building shown in Figure 3.7a, which was roughly two years old at the time of the earthquake. This building is located in the Harisiddhi region of Kathmandu, and it is situated on a ridge and built on a steep slope. Although the construction details and quality in the Valachhen Building appeared to be better than in the common RC frame buildings where severe damage and collapse were widely observed, significant structural and non-structural damage did occur. Shear cracking was evident in the non-structural masonry (Figure 3.7c), which was constructed tight up against the RC frame, and shear failure was observed in a structural column (Figure 3.7b and 3.7d). The shoring seen in these photos was placed after the earthquake. In addition, settlement was observed on the down-slope (back) side of the building. This building may have experienced larger ground shaking due to ridge amplification effects.

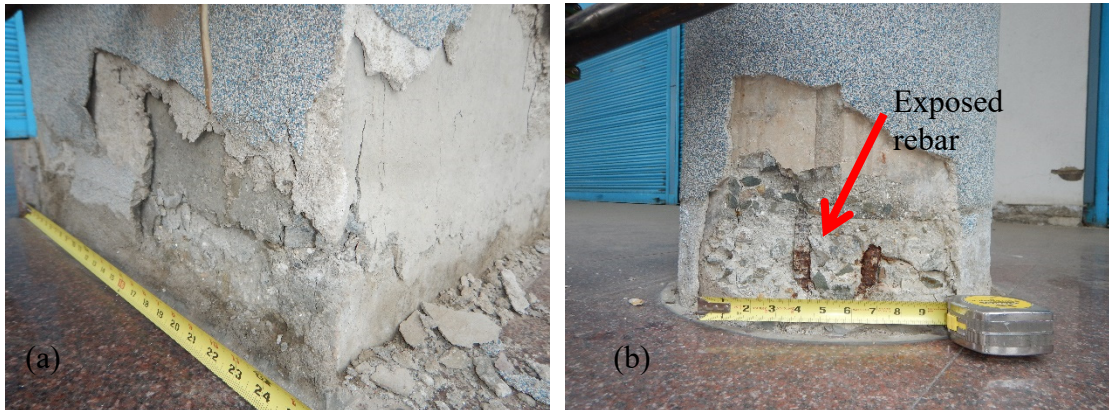
Structural damage in the CTC mall included concrete spalling at several column bases (Figure 3.9) and beam flexural cracking (Figure 3.10). On the west side of the building (away from Kanti Path), several inches of building settlement was observed. On the east side of the building, adjacent to Kanti Path, the backfill at the main entrance settled several inches. Near the center of the building, in plan, an interesting damage event was observed. The concrete elevator enclosure was terminated above the slab of the bottom

Figure 3.9 CTC Mall – concrete spalling at column bases: east side of building; (b) north side of building.

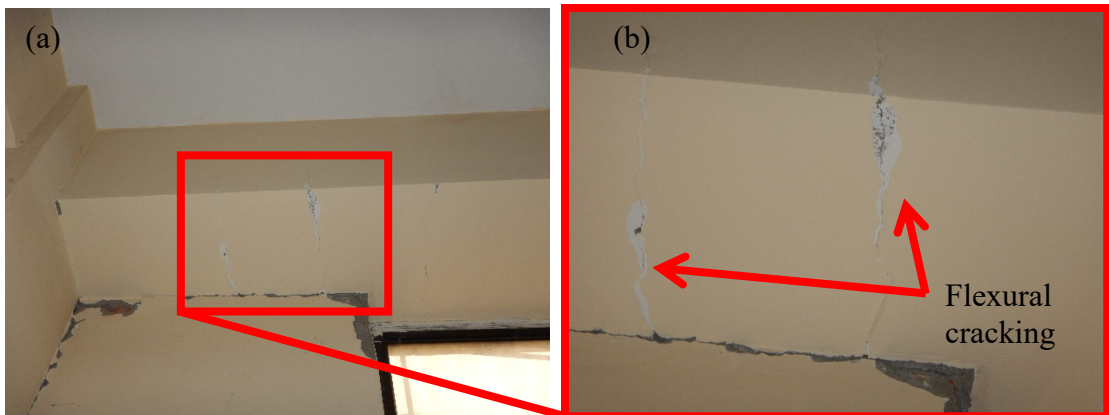
Figure 3.10 CTC Mall – beam flexural cracking: (a) overall view; (c) close-up view.

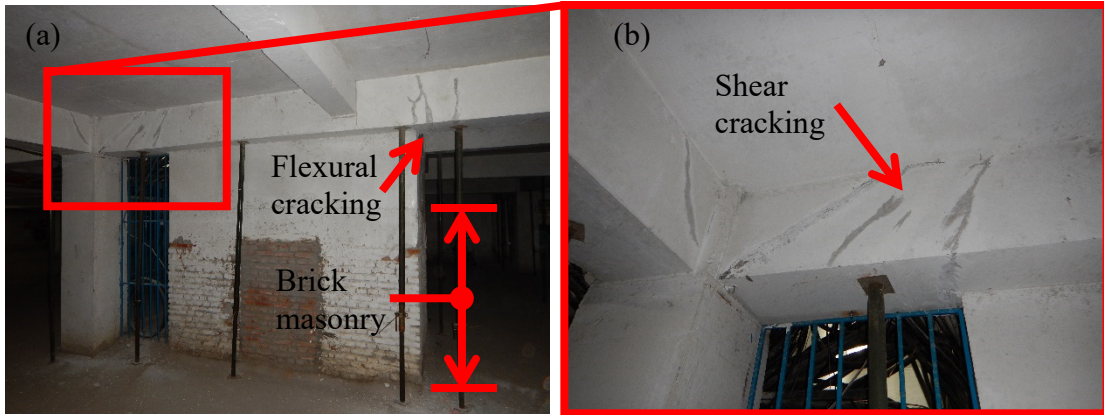
basement level, and the bottom portion of the elevator enclosure was brick masonry (Figure 3.11a). Although the elevator enclosure was not intended to participate structurally for lateral load resistance, it did attract demand during the earthquake, and the overturning effects from the elevator enclosure were not effectively resisted by the relatively weak masonry portion at the bottom of the enclosure. As a result, these overturning demands were transmitted to the concrete girders of the first basement level, and shear cracks developed near the girder support (Figure 3.11b) while flexural cracks developed in the girder span (Figure 3.11a), although collapse did not occur. The shoring seen in these photos was placed after the earthquake.

Figure 3.11 CTC Mall basement: (a) concrete elevator enclosure terminating on brick masonry; (b) close-up of beam shear cracking.

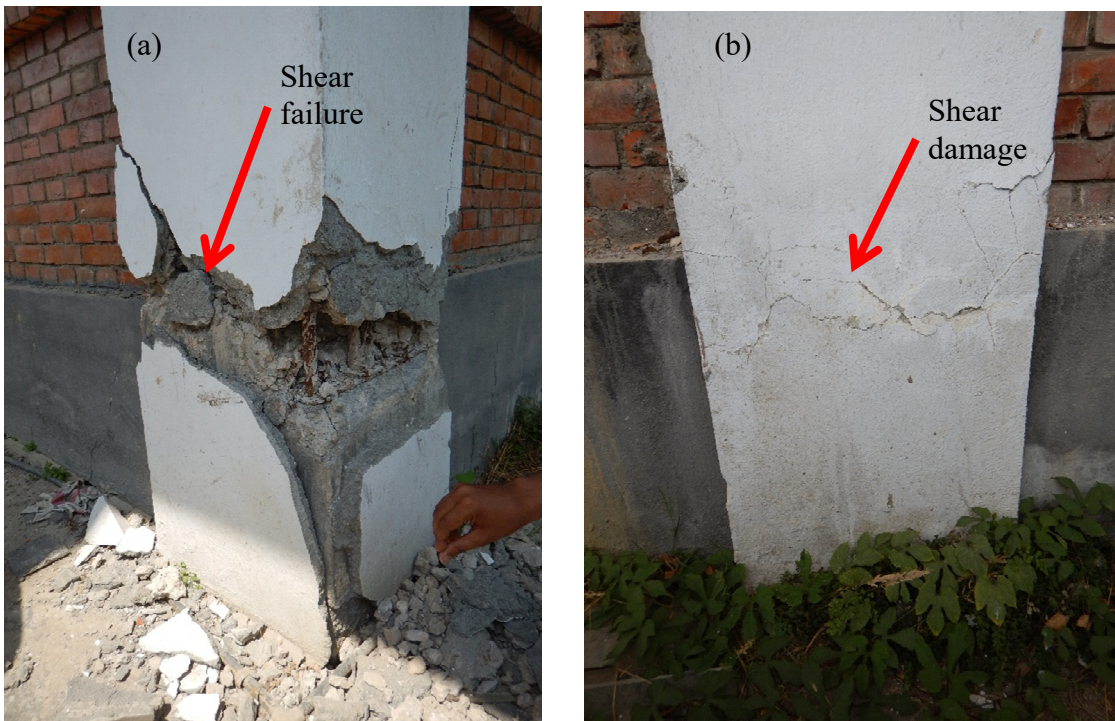
The Government of Nepal Central Fisheries Building, which houses the Directorate of Fisheries Development under the Ministry of Agricultural Development, is located in the Balaju region of Kathmandu, in close proximity to the heavily damaged and collapsed common residential / commercial buildings described above. As shown in Figure 3.14, this two-story building has a RC frame structure that is visually much stouter than the common residential / commercial buildings discussed above. Although the building survived the earthquake sequence, it did still sustain significant structural damage, which was concentrated in the first story. The second story had minimal structural damage. As shown in Figure 3.15, major damage was observed at the base of one corner column, and less visible shear cracking was observed at other column base locations. Figure 3.16 shows close-up views of representative shear failures that were observed at the tops of the first story columns in multiple locations throughout the building. Non-structural infill framing may have influenced the column response and reduced the effective height of the columns and contributed to the shear failures (Figure 3.16c).

Figure 3.15 Central Fisheries Building – column base damage: (a) corner column; (b) exterior column.

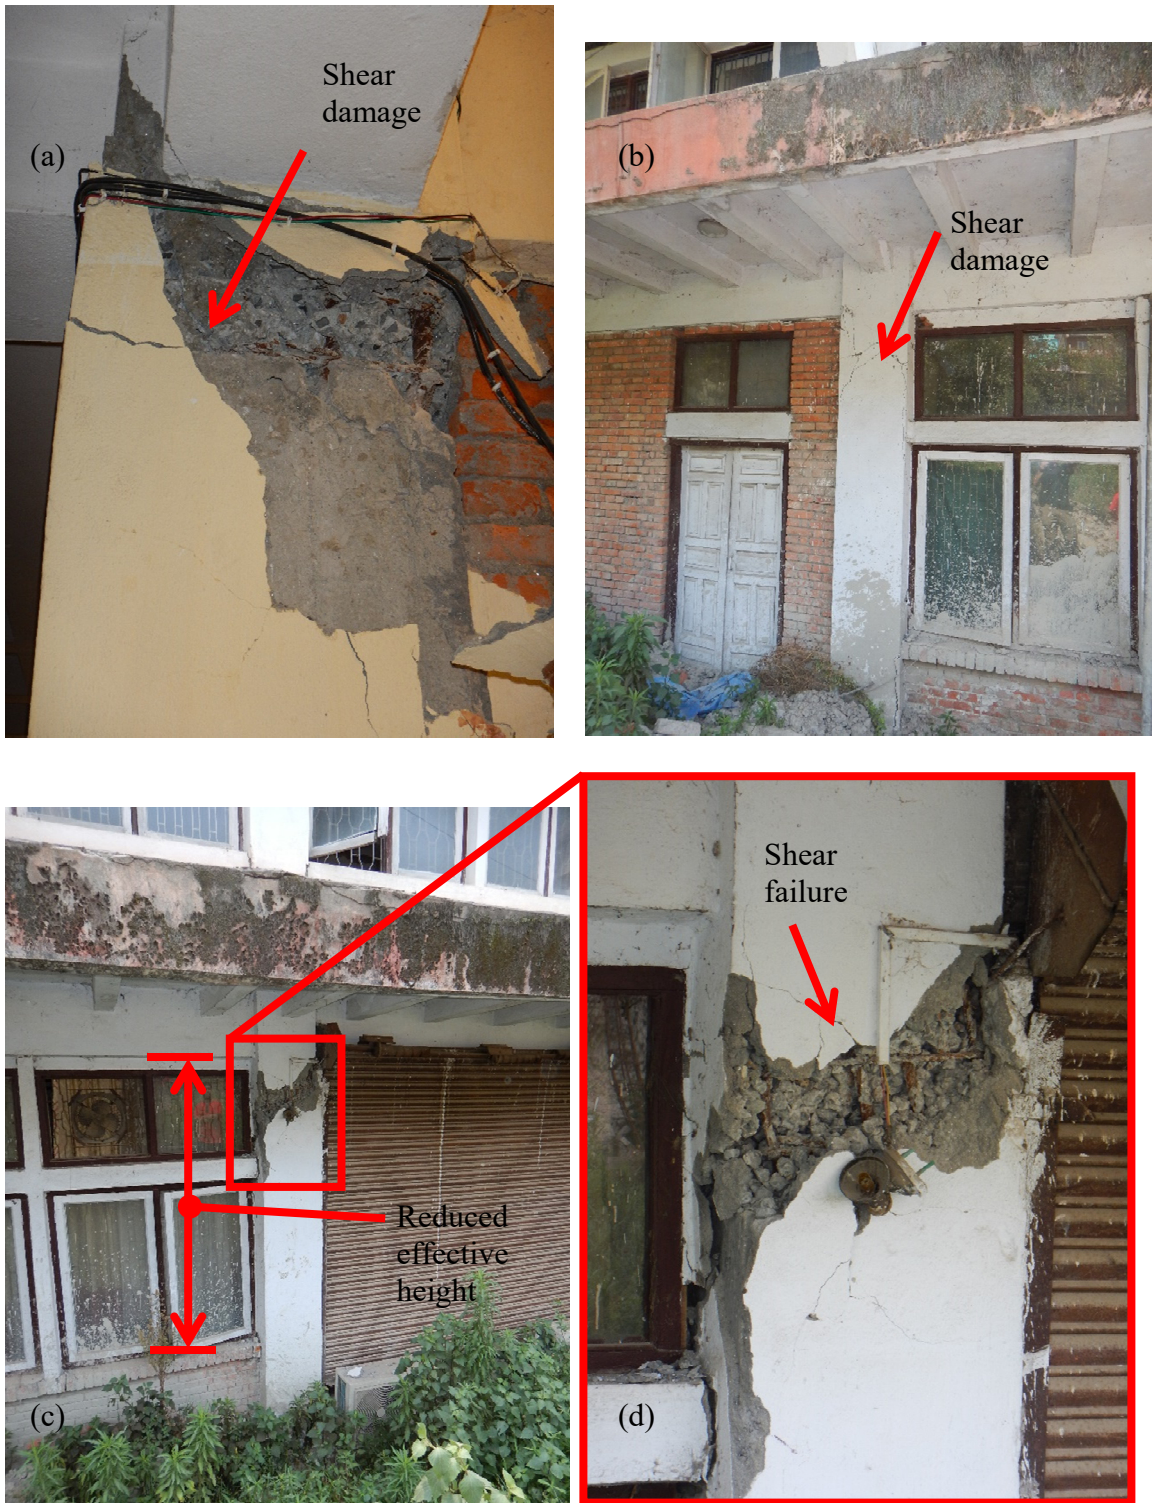
Figure 3.16 Central Fisheries Building – column shear damage at top of first story: (a) interior; (b) exterior; (c) exterior overall; (d) exterior close-up.

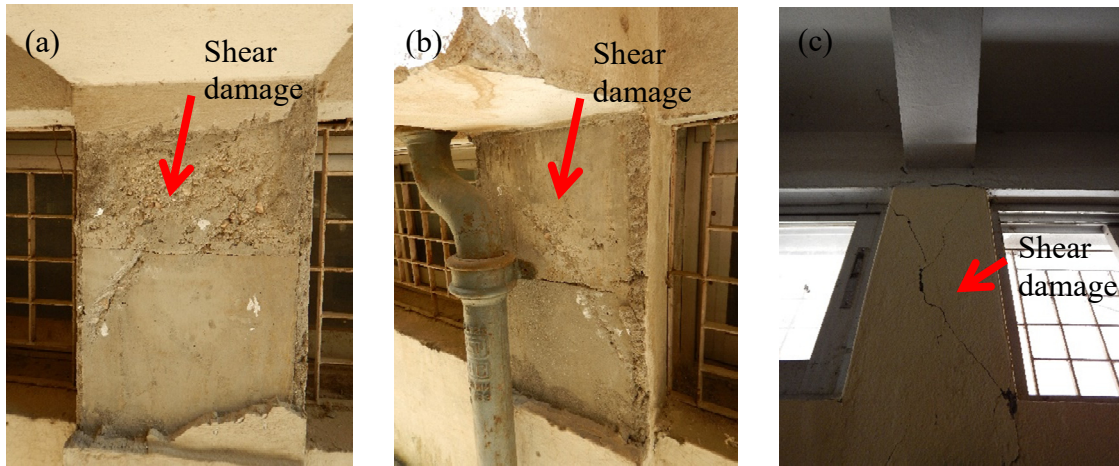
However, these columns were not reinforced like the columns in the new buildings (Figure 3.13) and they exhibited shear damage (Figure 3.17). In Figures 3.17a and b, concrete cover was chipped off to conduct post-earthquake inspection. Although the shear damage was evident, it was not nearly as pronounced as in other buildings, such as the Central Fisheries Building. Following the earthquake sequence, Tribhuvan University had evacuated the Block E Building, but officials were considering retrofit strategies to enable reoccupation.

Figure 3.17 Tribhuvan University Thapathali Campus Block E Building – short column shear damage: (a) exterior; (b) exterior; (c) interior.
