NSEL Report Series
Report No. NSEL-046
December 2016

Structural and Geotechnical Observations after the April 25, 2015 M7.8 Gorkha, Nepal Earthquake and its Aftershocks

**Larry A. Fahnestock
and
Youssef M. A. Hashash**

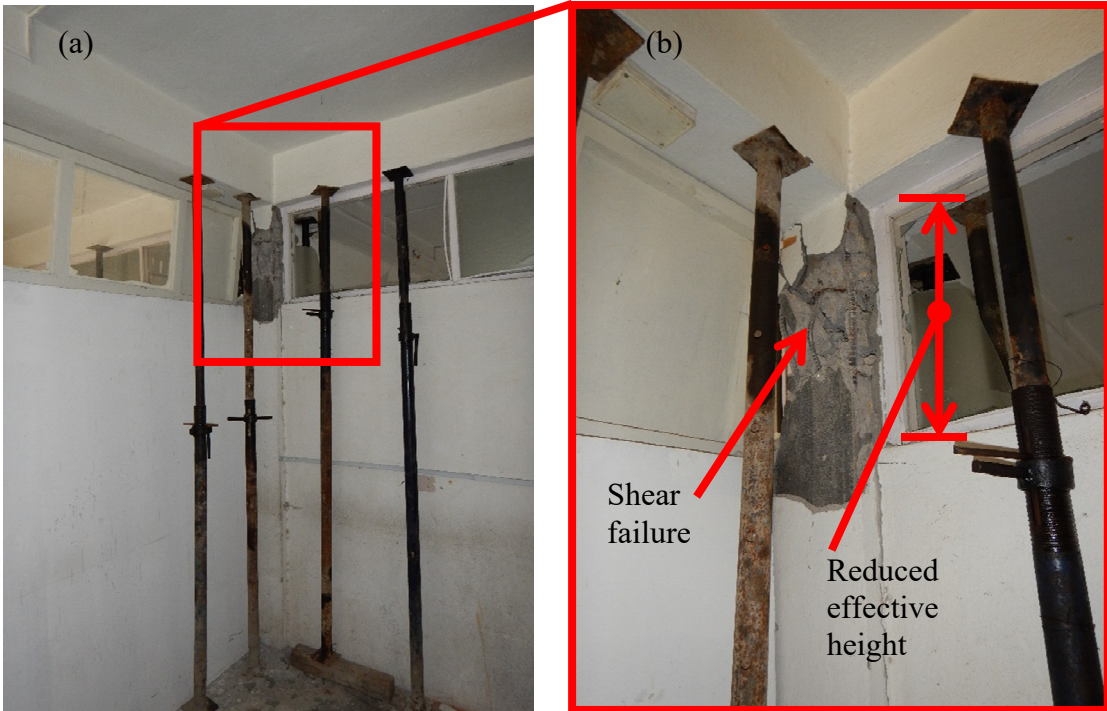
Figure 3.19 Kathmandu Engineering College Block C Building – short column shear failure: (a) overall view; (b) detail view.

On the campus of Kathmandu Engineering College (KEC), short column effects were responsible for column shear failure in the 4-story Block C Building, which was constructed in 1983. As shown in the exterior view in Figure 3.18, windows extended over the majority of the stories at the building perimeter, and the exterior columns were not damaged. However, on the interior, partial-height non-structural masonry walls were below windows that allowed natural light to penetrate into interior spaces, and column shear failure occurred in the short span within the window region (Figures 3.19 and 3.20). Almost no transverse reinforcement was evident and longitudinal bar buckling occurred. The interior walls were predominantly placed in the east-west direction (long direction of the building), so column response in the north-south direction primarily occurred over the full clear story height without constraint from the interior walls. The KEC Block C Building formed a first-story mechanism, with the remaining stories exhibiting no observable structural damage. The shoring seen in these photos was placed after the earthquake.

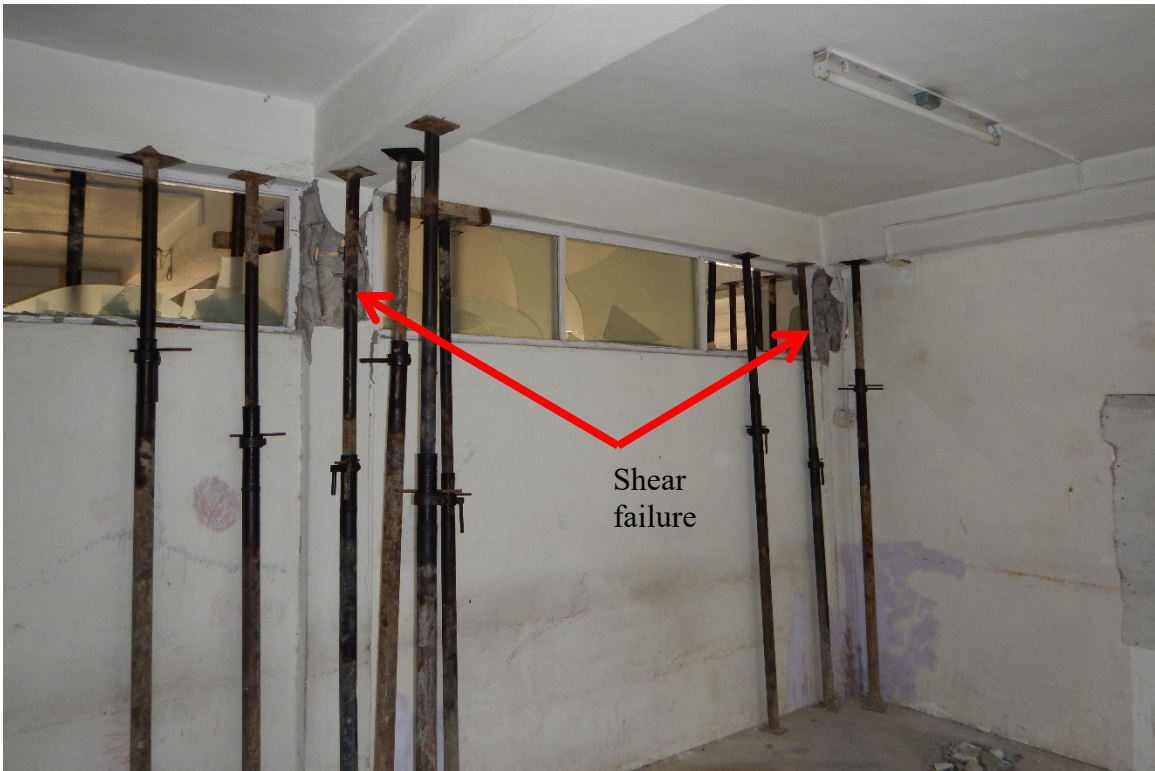
Figure 3.20 Kathmandu Engineering College Block C Building – short column shear failure.

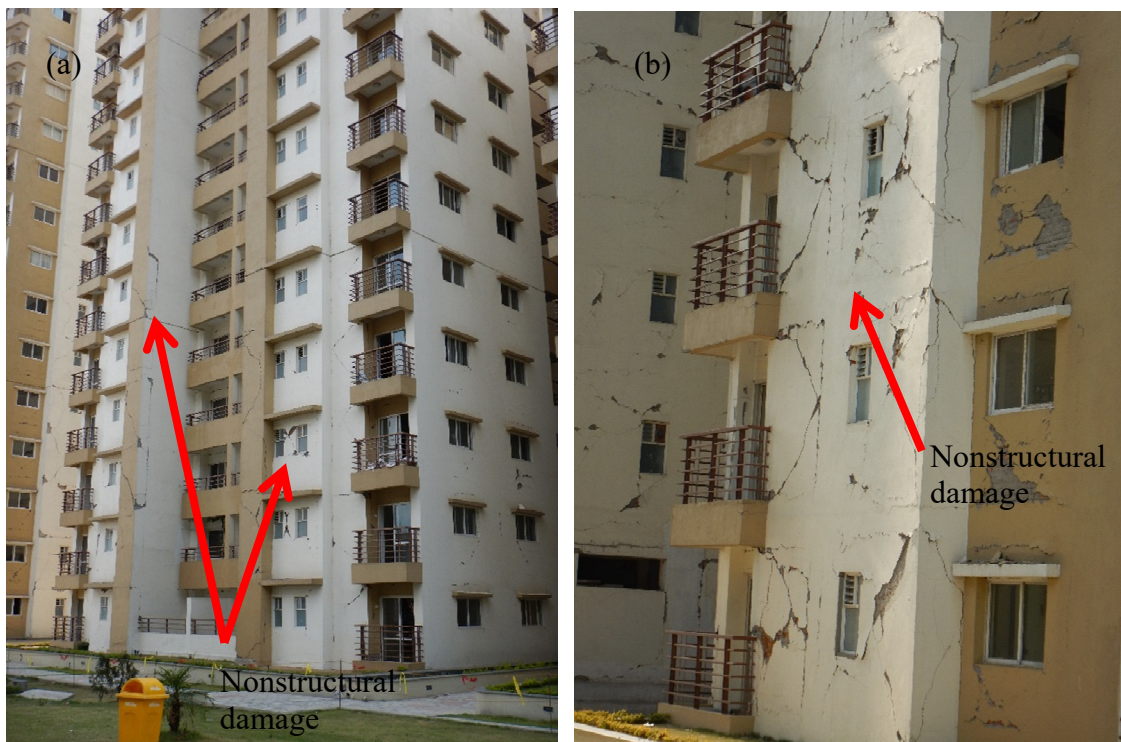
Figure 3.24 Cityscape – moderate non-structural damage: (a) overall view; (b) detail view.

Cityscape is a large residential development with low-rise and high-rise buildings, including four towers. The towers sustained moderate non-structural damage (Figure 3.24) but no structural damage was observed. Similar shear damage of non-structural masonry infill was observed in the Mero City complex, which was under construction at the time of the earthquake (Figure 3.25). Much more severe non-structural damage was observed at the Parkview Horizon complex (Figure 3.26), which consists of five towers built on the side of a hill. Whereas Cityscape and Mero City only developed diagonal cracking in non-structural masonry walls, Parkview Horizon had entire walls collapse, windows fall out, extensive falling debris around the building, and many portions of the buildings were left hanging precariously in danger of further collapse after the earthquake. A little over a month after the main shock, repair and rehabilitation efforts were underway at Cityscape, but Parkview Horizon remained inaccessible due to the serious safety concerns.

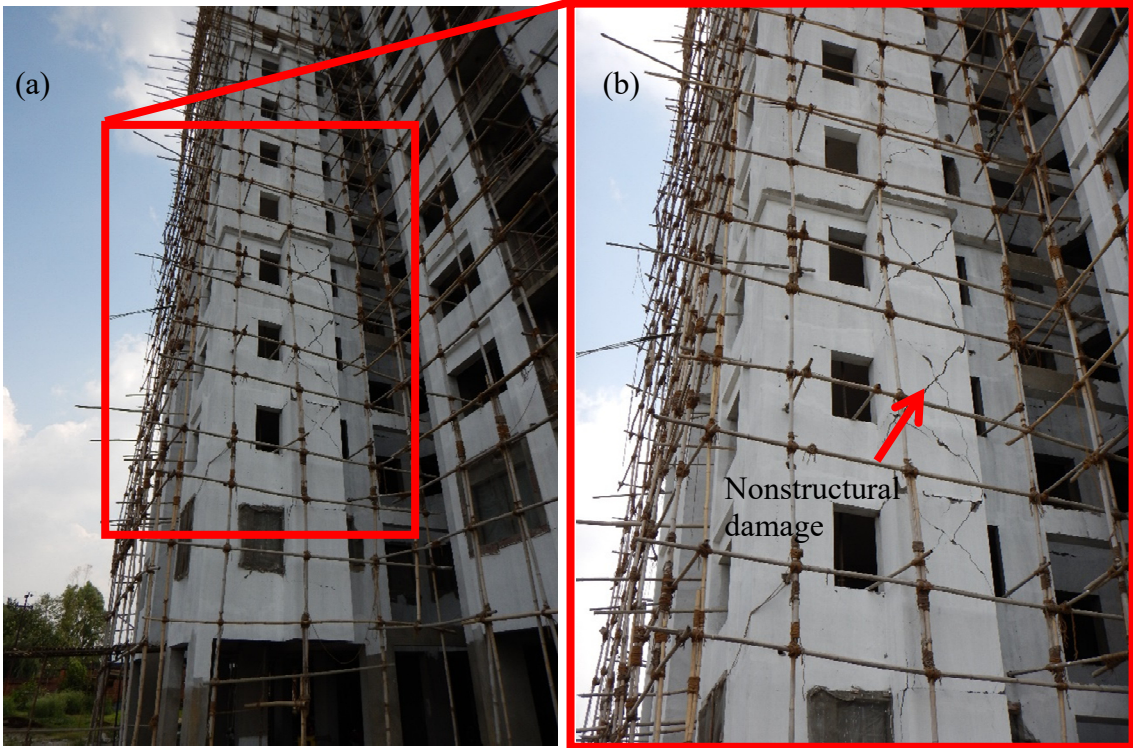
Figure 3.25 Mero City – moderate non-structural damage: (a) overall view; (b) detail view.

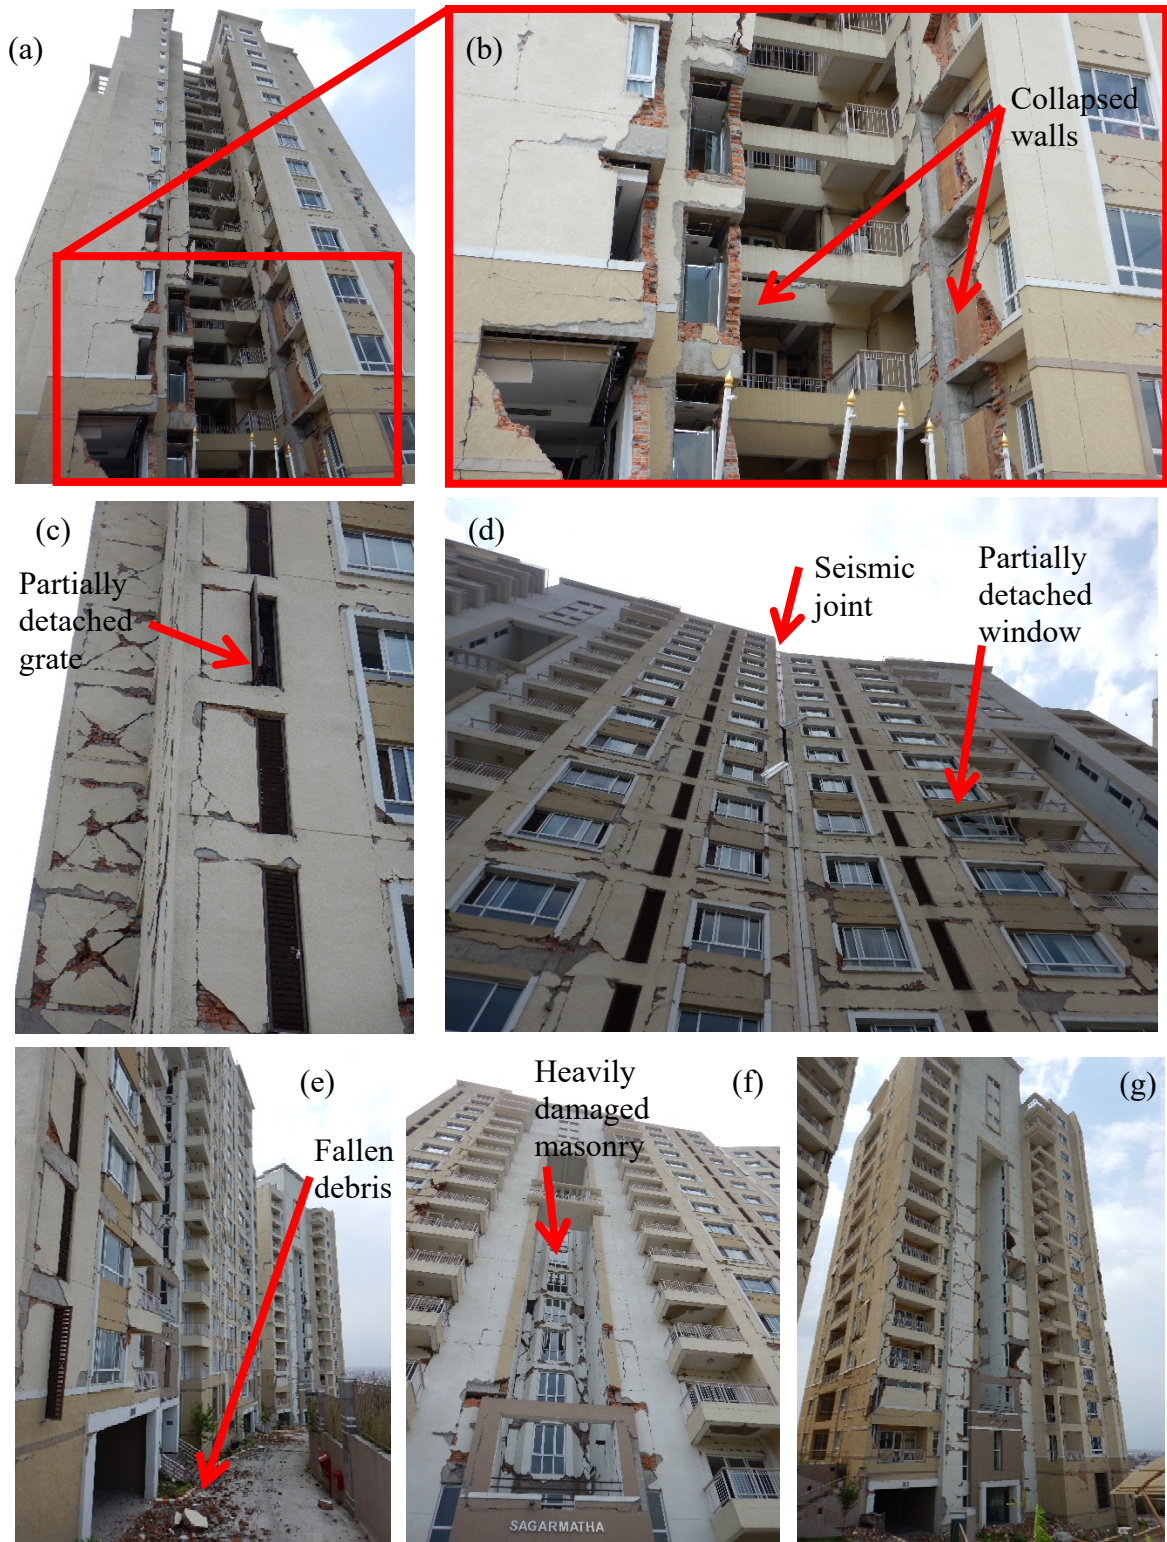
Figure 3.26 Parkview Horizon (Dhapasi) – heavy non-structural damage: (a) overall view Sagarmatha building east side; (b) close-up view Sagarmatha building east side; (c) northeast corner Sagarmatha building; (d) seismic joint between Sagarmatha and Kanchanjunga buildings; (e) looking along north side of complex; (f) north side of Sagarmatha building; (g) north side of Makalu building.

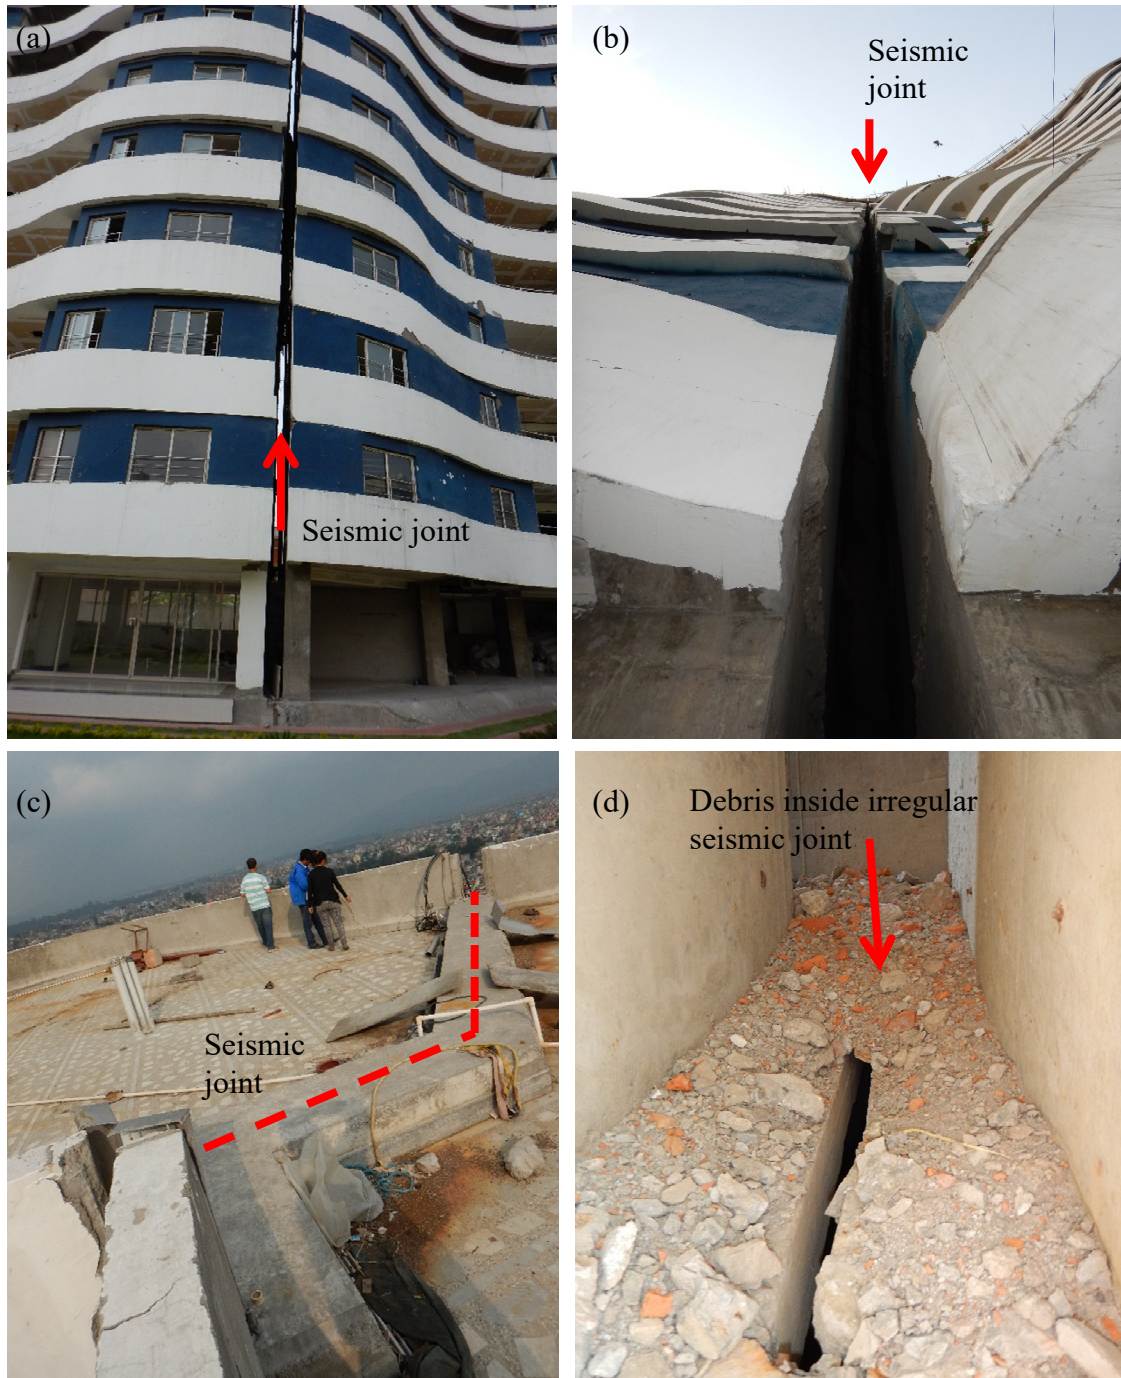
Figure 3.29 Silver City Apartment Complex – seismic joints: (a) south view of west joint, straight; (b) south view of east joint, irregular; (c) top view of east joint, irregular; (d) interior view of east joint, irregular.

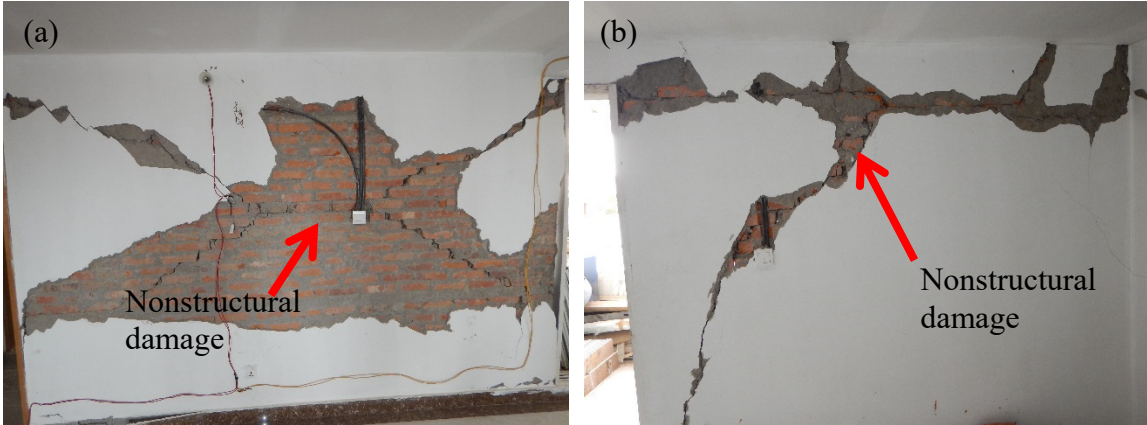
Figure 3.30 Silver City Apartment Complex – interior non-structural masonry wall damage in east-west direction.

Silver City suffered moderate to heavy non-structural damage, although not as severe as Park Horizon. Figures 3.30 and 3.31 show representative damage to interior and exterior masonry walls, respectively. In general, the damaged regions were fairly contained

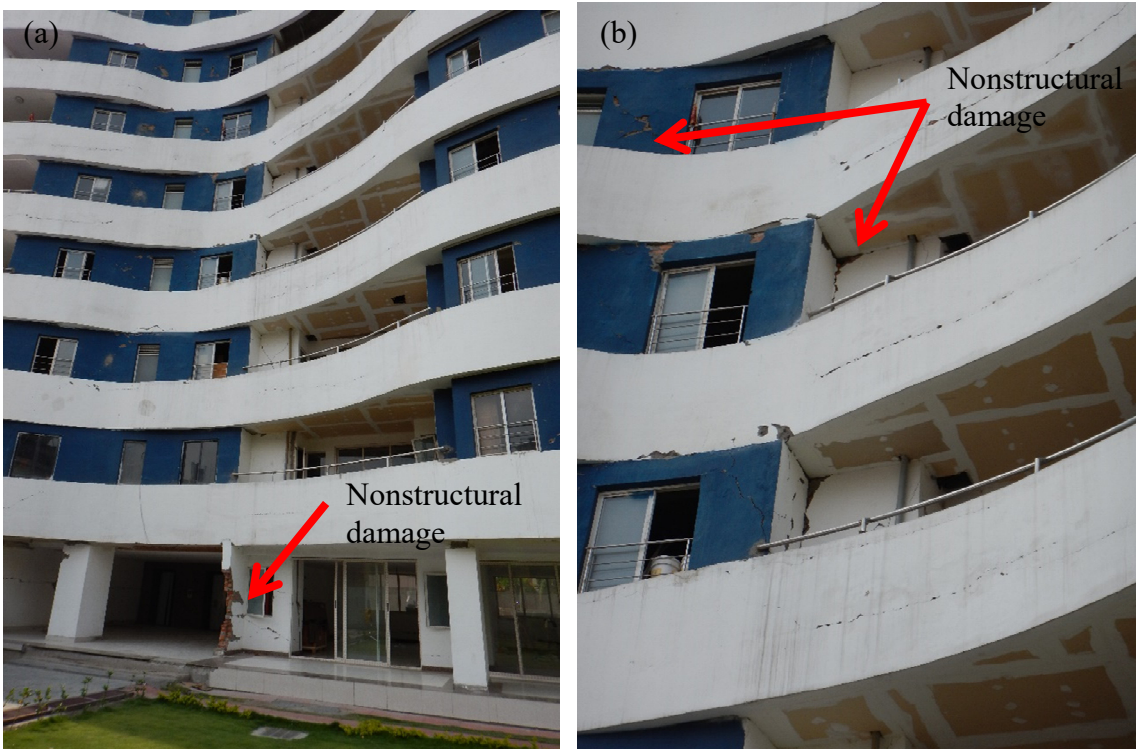
Figure 3.31 Silver City Apartment Complex – exterior non-structural masonry wall damage: (a) base; (b) upper stories around windows and reentrant corners.

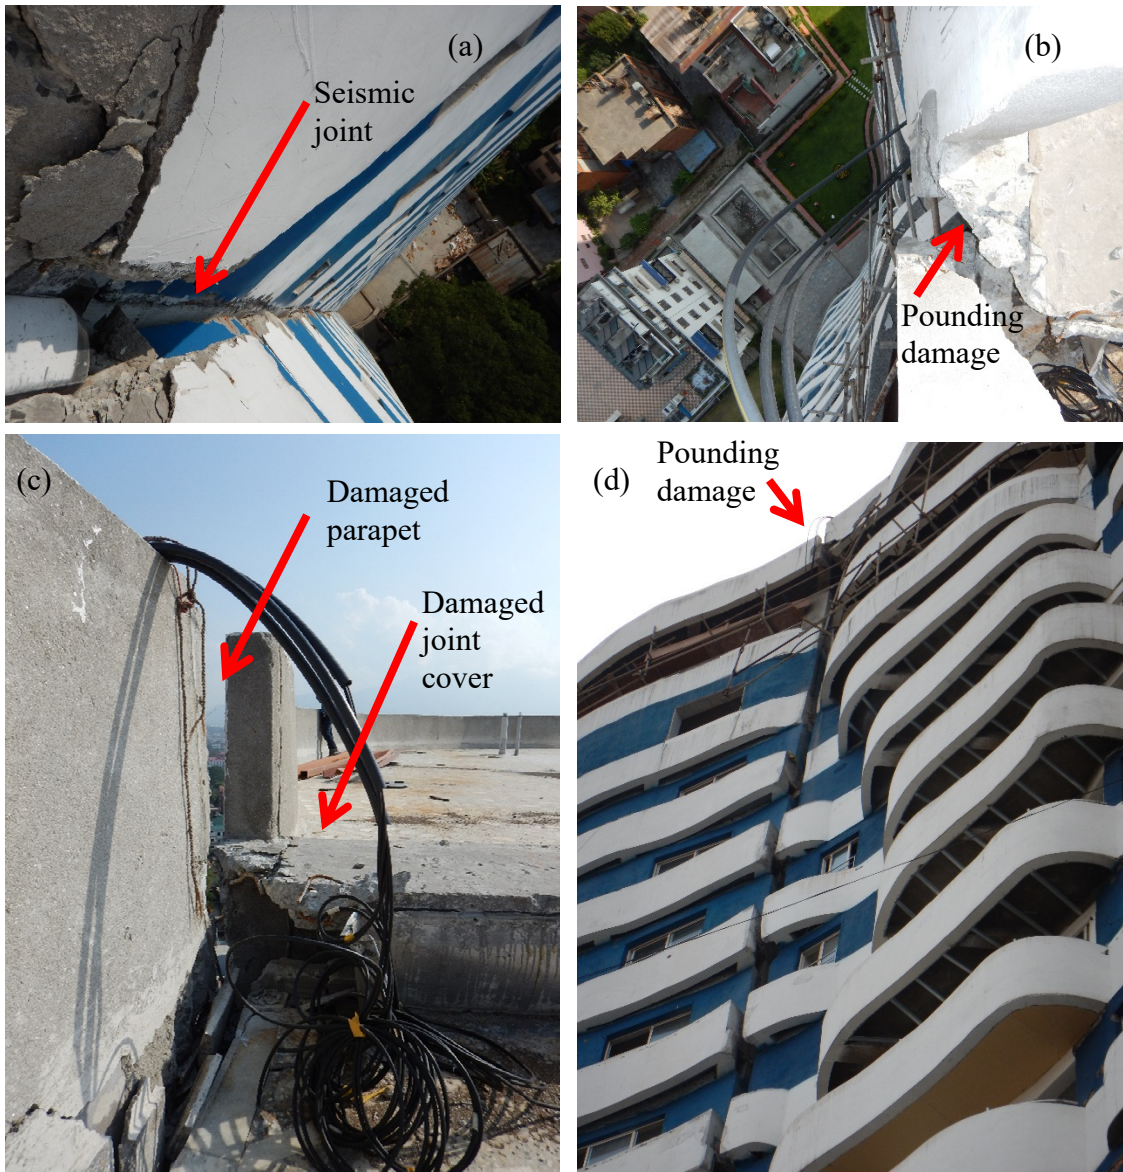
Figure 3.32 Silver City Apartment Complex – pounding damage: (a) looking down north side of east joint; (b) looking down south side of east joint; (c) detailed view top of east joint; (d) looking up at south side of east joint.

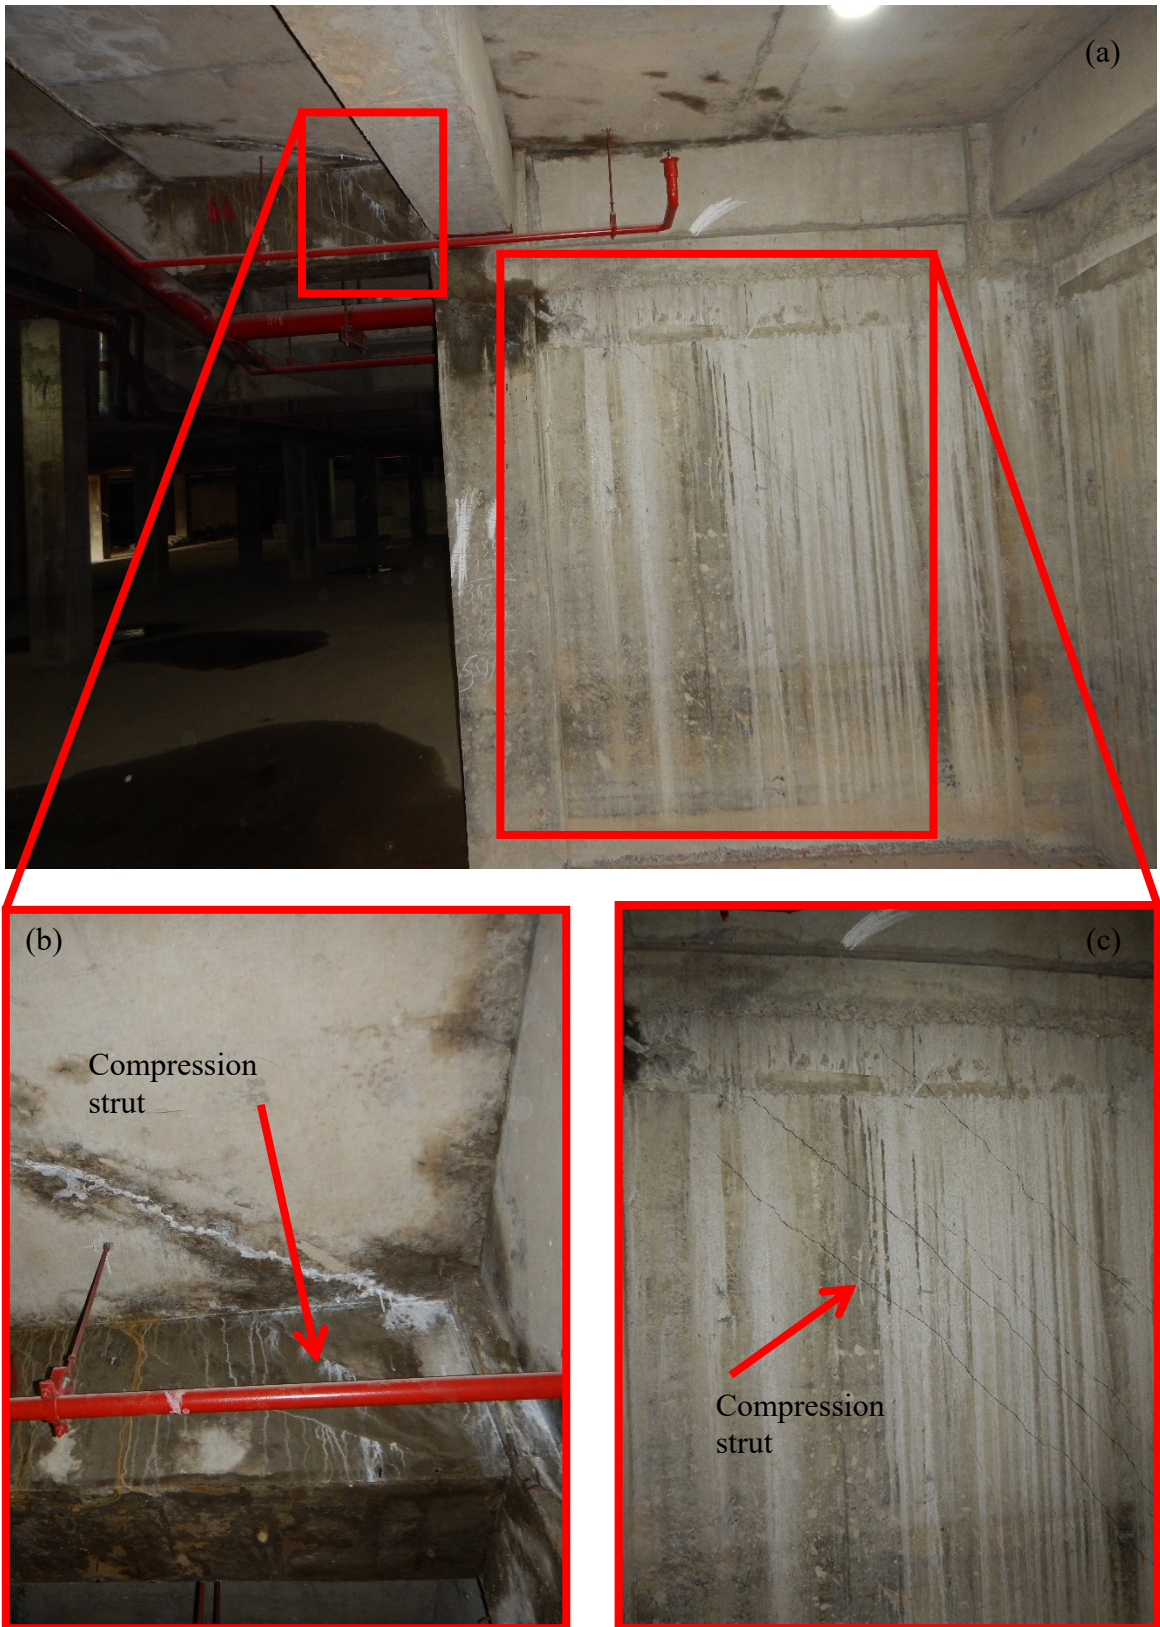
Figure 3.33 Silver City Apartment Complex – cracking in basement joint and wall: (a) overall view; (b) joint detail; (c) wall detail with cracks marked for clarity.

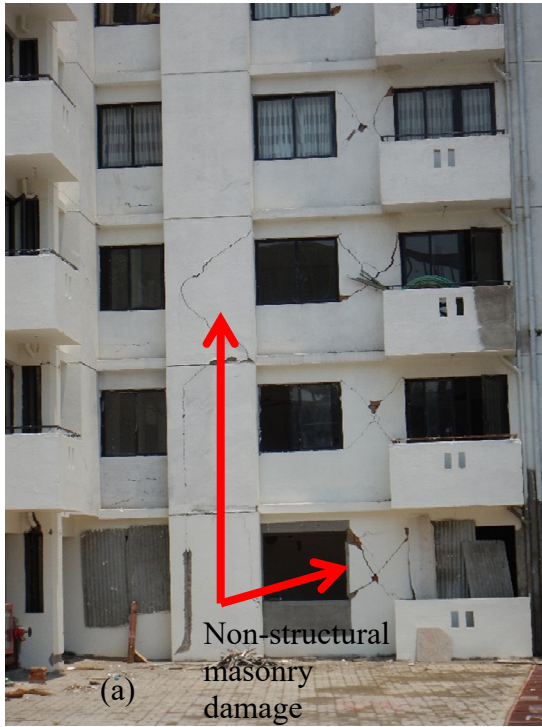
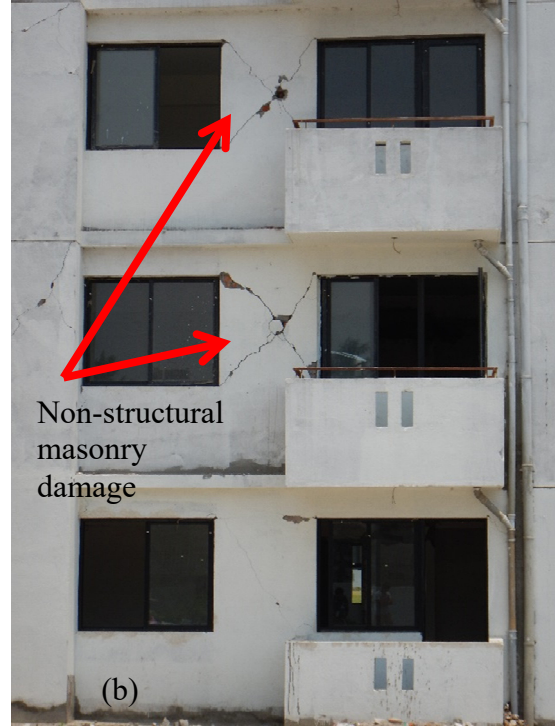
Figure 3.35 Sun City Apartment Complex – moderate non-structural damage in group of two buildings.

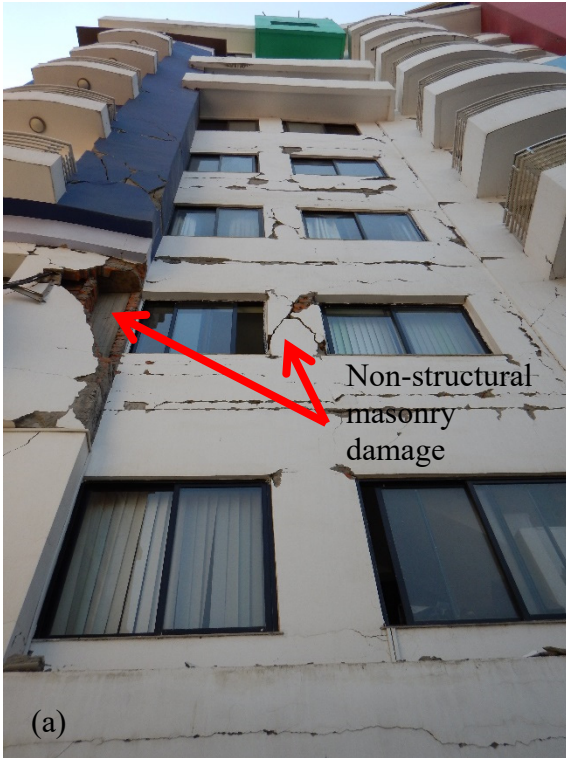
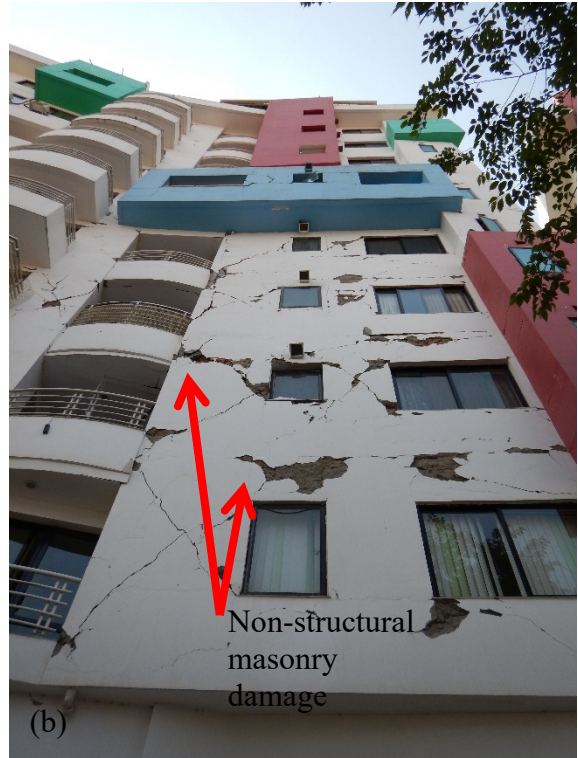
Figure 3.38 Swayambhu Apartment Complex – non-structural damage.

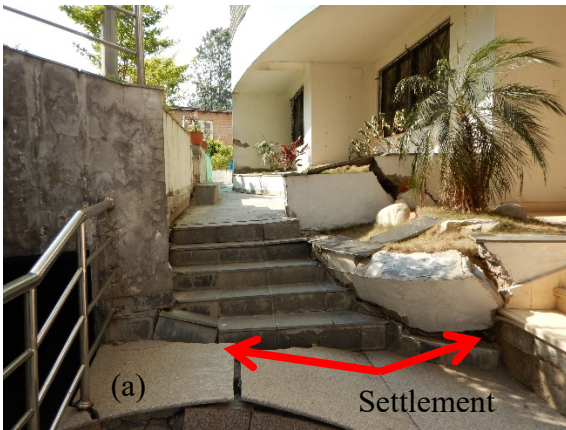
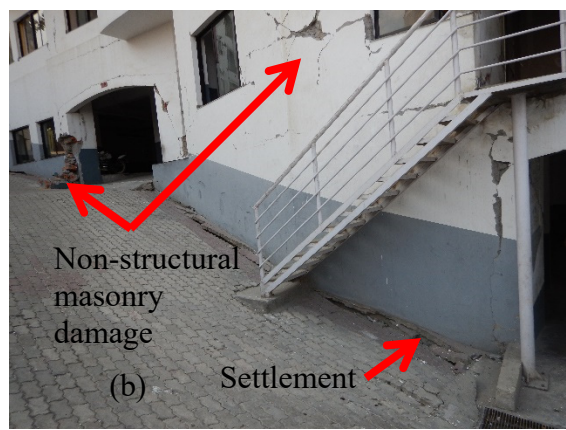
Figure 3.39 Swayambhu Apartment Complex – backfill settlement.
