Procedia Structural Integrity 5 (2017) 55–62

2nd International Conference on Structural Integrity, ICSI 2017, 4-7 September 2017, Funchal, Madeira, Portugal

Analysis of the environmental degradation effects on the cables of “La Arena” bridge (Spain)

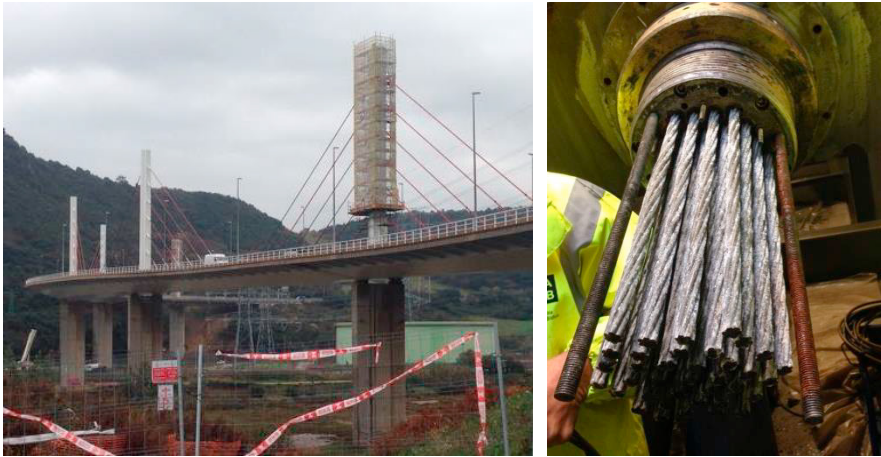
During a maintenance inspection of the bridge (see Figure 2), some fractured wires were detected. The fractures seemed to be linked to an environmental degradation process since some corrosion evidences –oxides and loss of material- were also observed. The fracture surfaces presented a quasi-planar typology (see Figure 3), with some apparently brittle features and some areas probably corresponding to fatigue crack growth. Loss of section also seems to have played a role in the failures as this type of defects are always present in the vicinity of fracture surfaces (see Figure 4). The reduction of area due to corrosion was between 10 and 20% for all the broken wires. The number of detected broken wires per strand was usually 2 or 3, being the central wire always undamaged. It is also important to notice that the original zinc-base protective coating is partially missing in some of these wires.

Fig. 2. Left: Bridge during inspection tasks; right: strands conforming one of the bridge's tendons during an inspection.

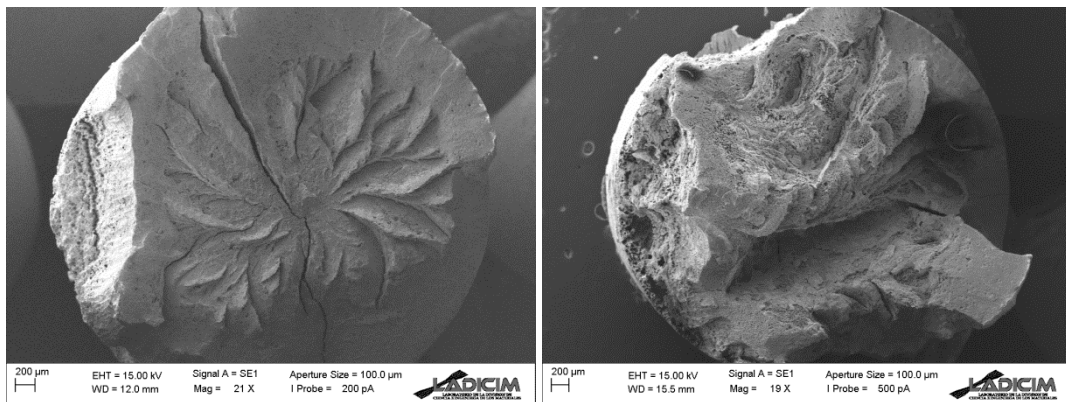
Fig. 3. Fracture surfaces of two of the broken wires detected during maintenance inspection of the bridge.

In view of these conclusions, two main remedial actions are recommended. First of them is the replacement of those strands with generalised corrosion in all their wires. The second is to control the environment and the humidity levels in order to preserve the properties of the galvanising layer as no fractured wires are expected if this coating is in good condition.

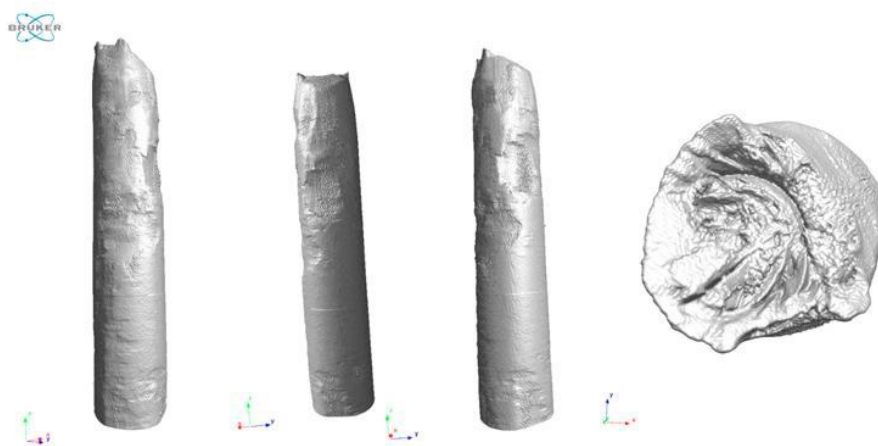
Fig. 4. Computerised Axial Tomography (ACT) image of a wire close to the fracture surface. Loss of material due to corrosion can be observed.

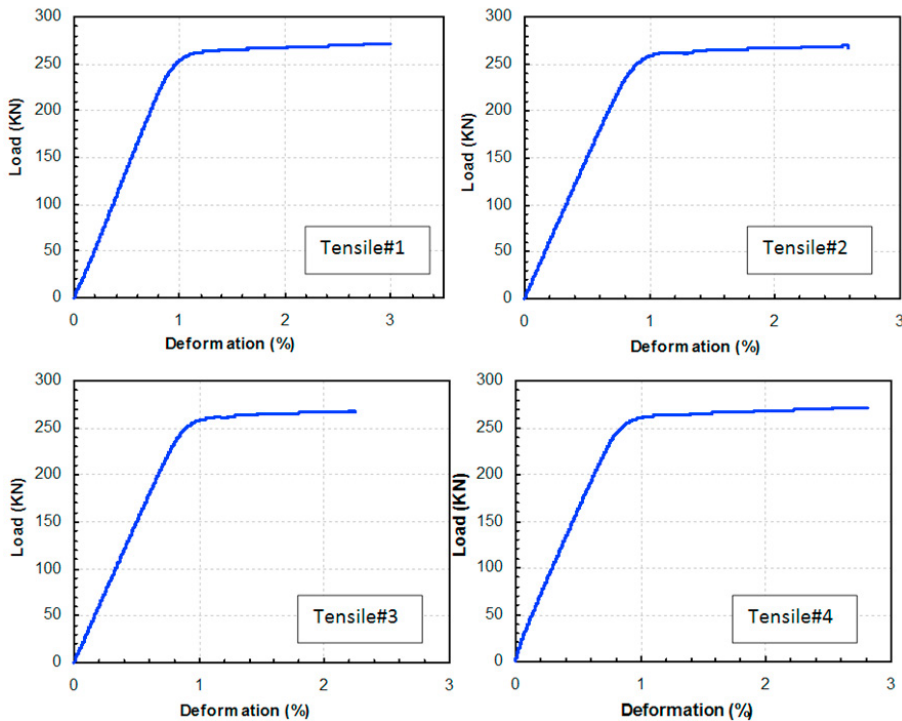
Four in-service wires were collected from the same tendon of the bridge and used to perform laboratory tensile tests and, again, hydrogen content analysis, as presented in Table 2 and Figure 5. In each case the test was performed in elongation control conditions up to the first wire failure (in one case, Tensile#4, a second wire containing a flaw of lower entity failed due to the stress redistribution when the first one failed). In all the cases the hydrogen content determination tests were performed on the broken wire of each strand.

No one of the strands tested presented relatively large flaws, being all of them of low entity. Despite this fact, none of them fitted the standard requirements, presenting a rupture in one of its wires prior to reaching the minimum required breaking load or minimum required deformation.

Fig. 5. Load-Strain curves from tensile tests.

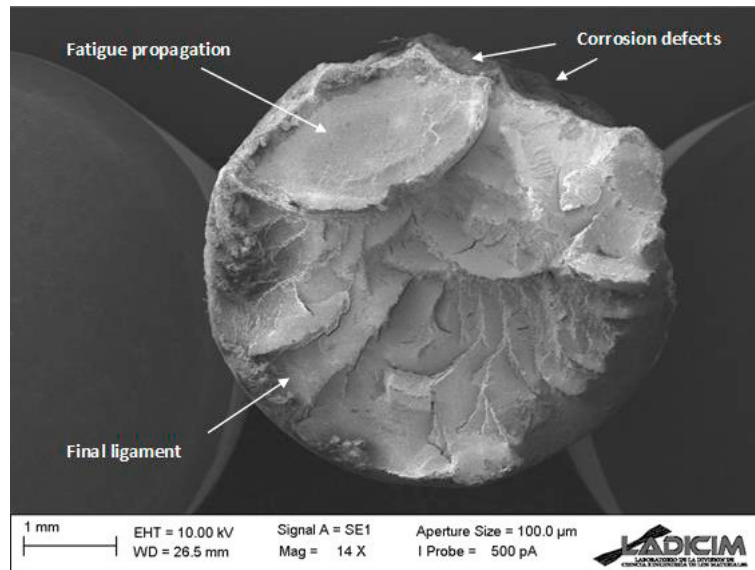
Figure 6 shows a SEM image of one of the broken wires of sample *Fatigue #3*. This sample has been taken as an example but all the fracture surfaces of the wires broken during the fatigue tests exhibit the same features. In Figure 6, 3 different regions can be observed:

- Corrosion defects (loss of section).
- Fatigue propagation area.
- Final fracture ligament.

It seems to be clear that the fatigue crack initiates from surface corrosion defects. These corrosion defects play the role of surface stress concentrators that reduce drastically the time needed for crack initiation in the fatigue process.

Fig. 6. SEM image of one of the broken wires of sample Fatigue #3.

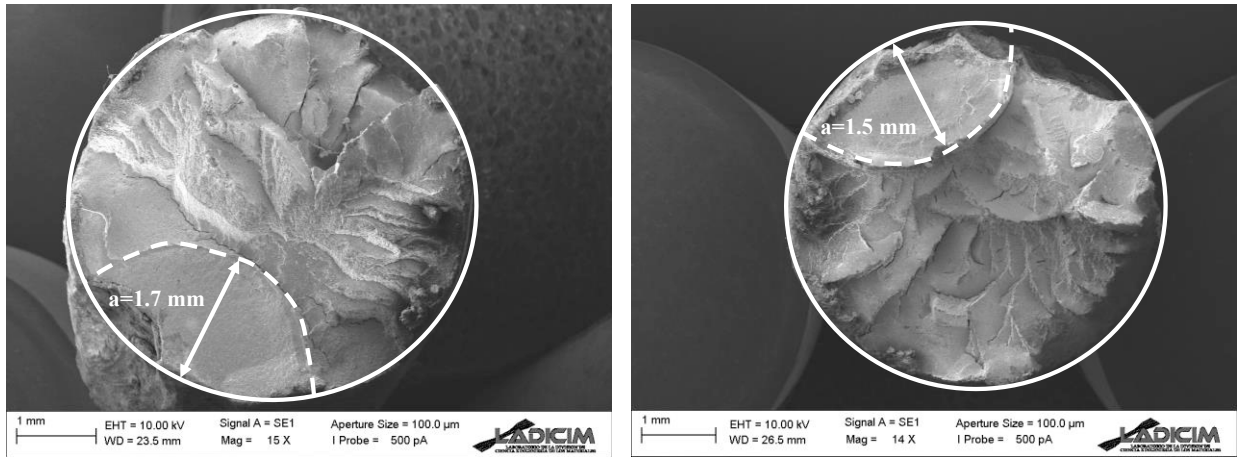
In the sample *Fatigue #3*, the extension of the fatigue crack in the two first broken wires can be clearly identified (Figure 7). The effective maximum load acting on each of the wires without any of them broken is 17.94 kN (total load divided by 7), while when one of the wires is broken the total load has to be distributed among the 6 unbroken wires, so then, the effective load on each element is 20.93 kN. Given that, the wire with a deeper crack –Wire #A– (Figure 7) is supposed to be the first suffering fracture.

Fig. 7. Broken wires of sample Fatigue #3. Left: Wire A; right: Wire B.

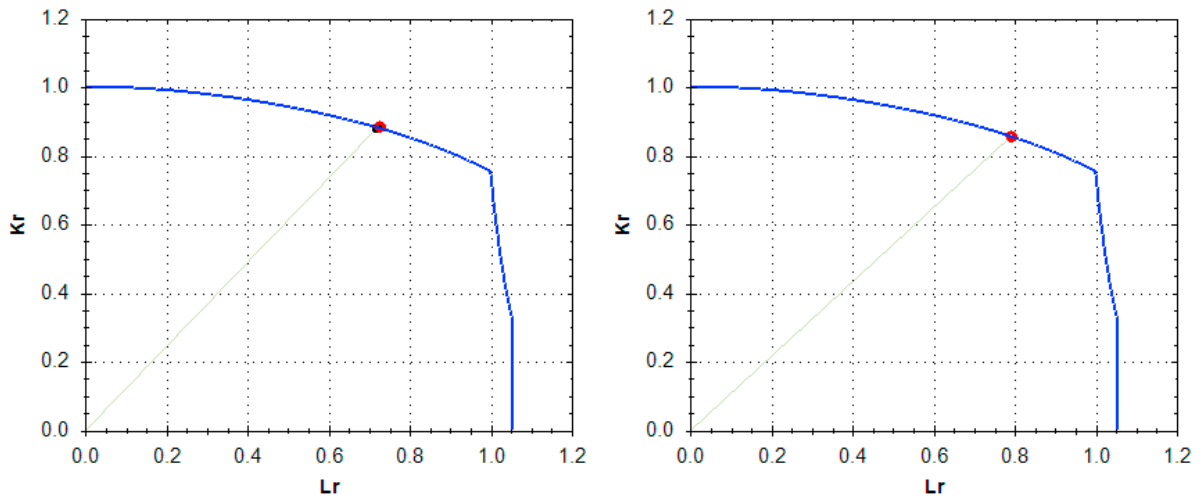
With these data –crack length and maximum applied load– a fracture assessment was performed using the procedures of BS7910:2013. In the analysis, Failure Assessment Diagrams (FAD) were used. As fracture toughness of the material, K_{mat} , was initially unknown the analysis consisted of searching a value for this parameter that made the assessment point lies exactly on the Failure Assessment Line (Figure 8). The values obtained for K_{mat} with the analysis were $80 \text{ MPa}\cdot\text{m}^{0.5}$ for Wire #A and $83 \text{ MPa}\cdot\text{m}^{0.5}$ for Wire #B. These values are in good agreement with the obtained by Toribio et al. (2006) for undamaged cables. These results means that, in spite of the high hydrogen contents detected in the wires, no evidences of embrittlement have been observed in fracture toughness values.

Fig. 8. FAD assessment of the wires of sample Fatigue #3. Left: Wire A; right: Wire B.

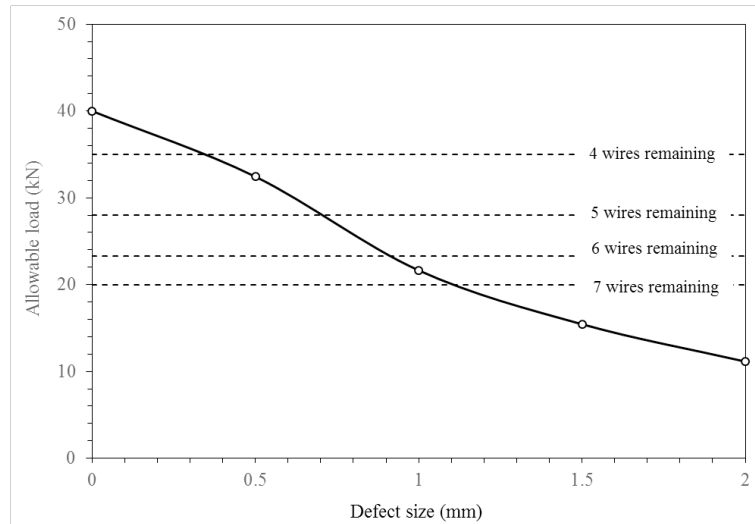
Following again the rules of BS7910:2013, a complementary structural integrity assessment was performed in order to determine the critical load value as a function of the corrosion defect size. In this analysis, according to the results of the previous section, a value for fracture toughness of $80 \text{ MPa} \cdot \text{m}^{0.5}$ was assumed. The corrosion defects were considered as cracks taking into account that stress corrosion cracking and fatigue (or environmental fatigue) cannot be discarded as degradation processes in the strands. A straight front crack was used in the analysis. In Figure 9 the relationship between allowable load (per wire) and critical defect size can be seen. With all the 7 wires of an strand working, the critical size of a defect for a typical working load of 50% of the nominal maximum load of the strand, was about 1.1 mm. This value decreases as the number of broken wires increases, but on the other side, the results show that, for the working conditions of the bridge, theoretically at least 5 wires must have corrosion damage before the collapse of the whole strand. The results of this analysis are in good agreement with the behavior observed in in-field failures.

Fig. 9. Allowable load vs. defect size.
